**REFERENCE:** New Century Hall, PA Steelwork fixing methodology

This letter is to confirm that Workspace Design & Build Ltd and subcontractors under our instruction, will install the steelwork to facilitate the positioning of the PA speakers at New Century Hall, as per drawing HC-21643-(20)-01 rev A.

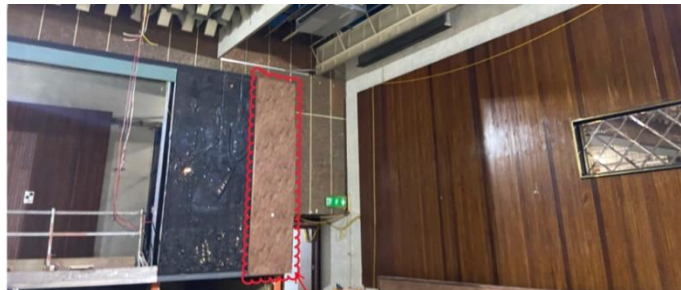
1. Careful removal of all timber paneling (not the Asbestos Insulation Boards) and lights (as required) to facilitate works. Paneling to be removed is to the side of the murals, as marked on image below, and offset from the main stage wall. Main stage wall with copper paneling which contains asbestos will not be affected by the panel removal. All works to remove timber and beading will be done using hand tools, and taking appropriate care so as not to damage either the timber paneling or the adjacent black mural panels.

2. The mural and timber panel abut each other, but are separated by a c. 20mm gap, which is covered by black mastic beading. This beading will also be carefully removed prior to works.
