## WINDOWS AND DOORS

## RENDER SPECIFICATION

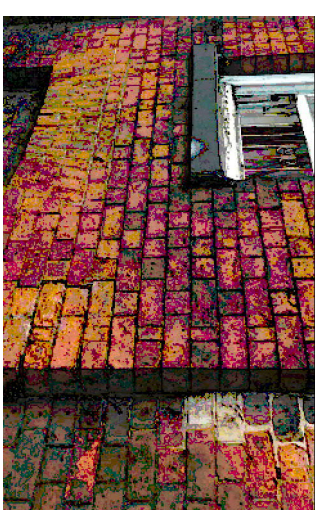
## EXAMPLE OF EXISTING POINTING BRICK REPAIRS

## BRICK REPAIRS

WHERE POINTING HAS DETERIORATED THEN REPOINTING WILL BE REQUIRED. FOR EXCESSIVELY DAMP AREAS OF BRICK THE CAUSE OF DAMP SHOULD BE INVESTIGATED AND REPAIRED FIRST EG BY INSERTION OF DPC (EVIDENCE OF A CHEMICAL DPC IS PRESENT TO SOME AREAS OF BRICK) OR BY THE REPAIRS TO GUTTERS AND DOWNPIPS THAT MAY HAVE LEAKED. AREAS OF THIN JOINT POINTING WILL GENERALLY BE SOUND AND REPOINTING MAY NOT BE REQUIRED OR COULD CAUSE MORE DAMAGE TO THE BRICK

JOINTS SHOULD BE MANUALLY RAKED OUT OR CUT WITH A HAND SAW AND NOT BY POWER TOOLS.

THE JOINTS SHOULD BE SQUARE CUT TO A MINIMUM TWICE THE DEPTH OF THE JOINT HEIGHT
