## DOMIS CONSTRUCTION

Viadux, Albion Street, Manchester

Piling Risk Assessment

AJS/C4460/9231 Rev D

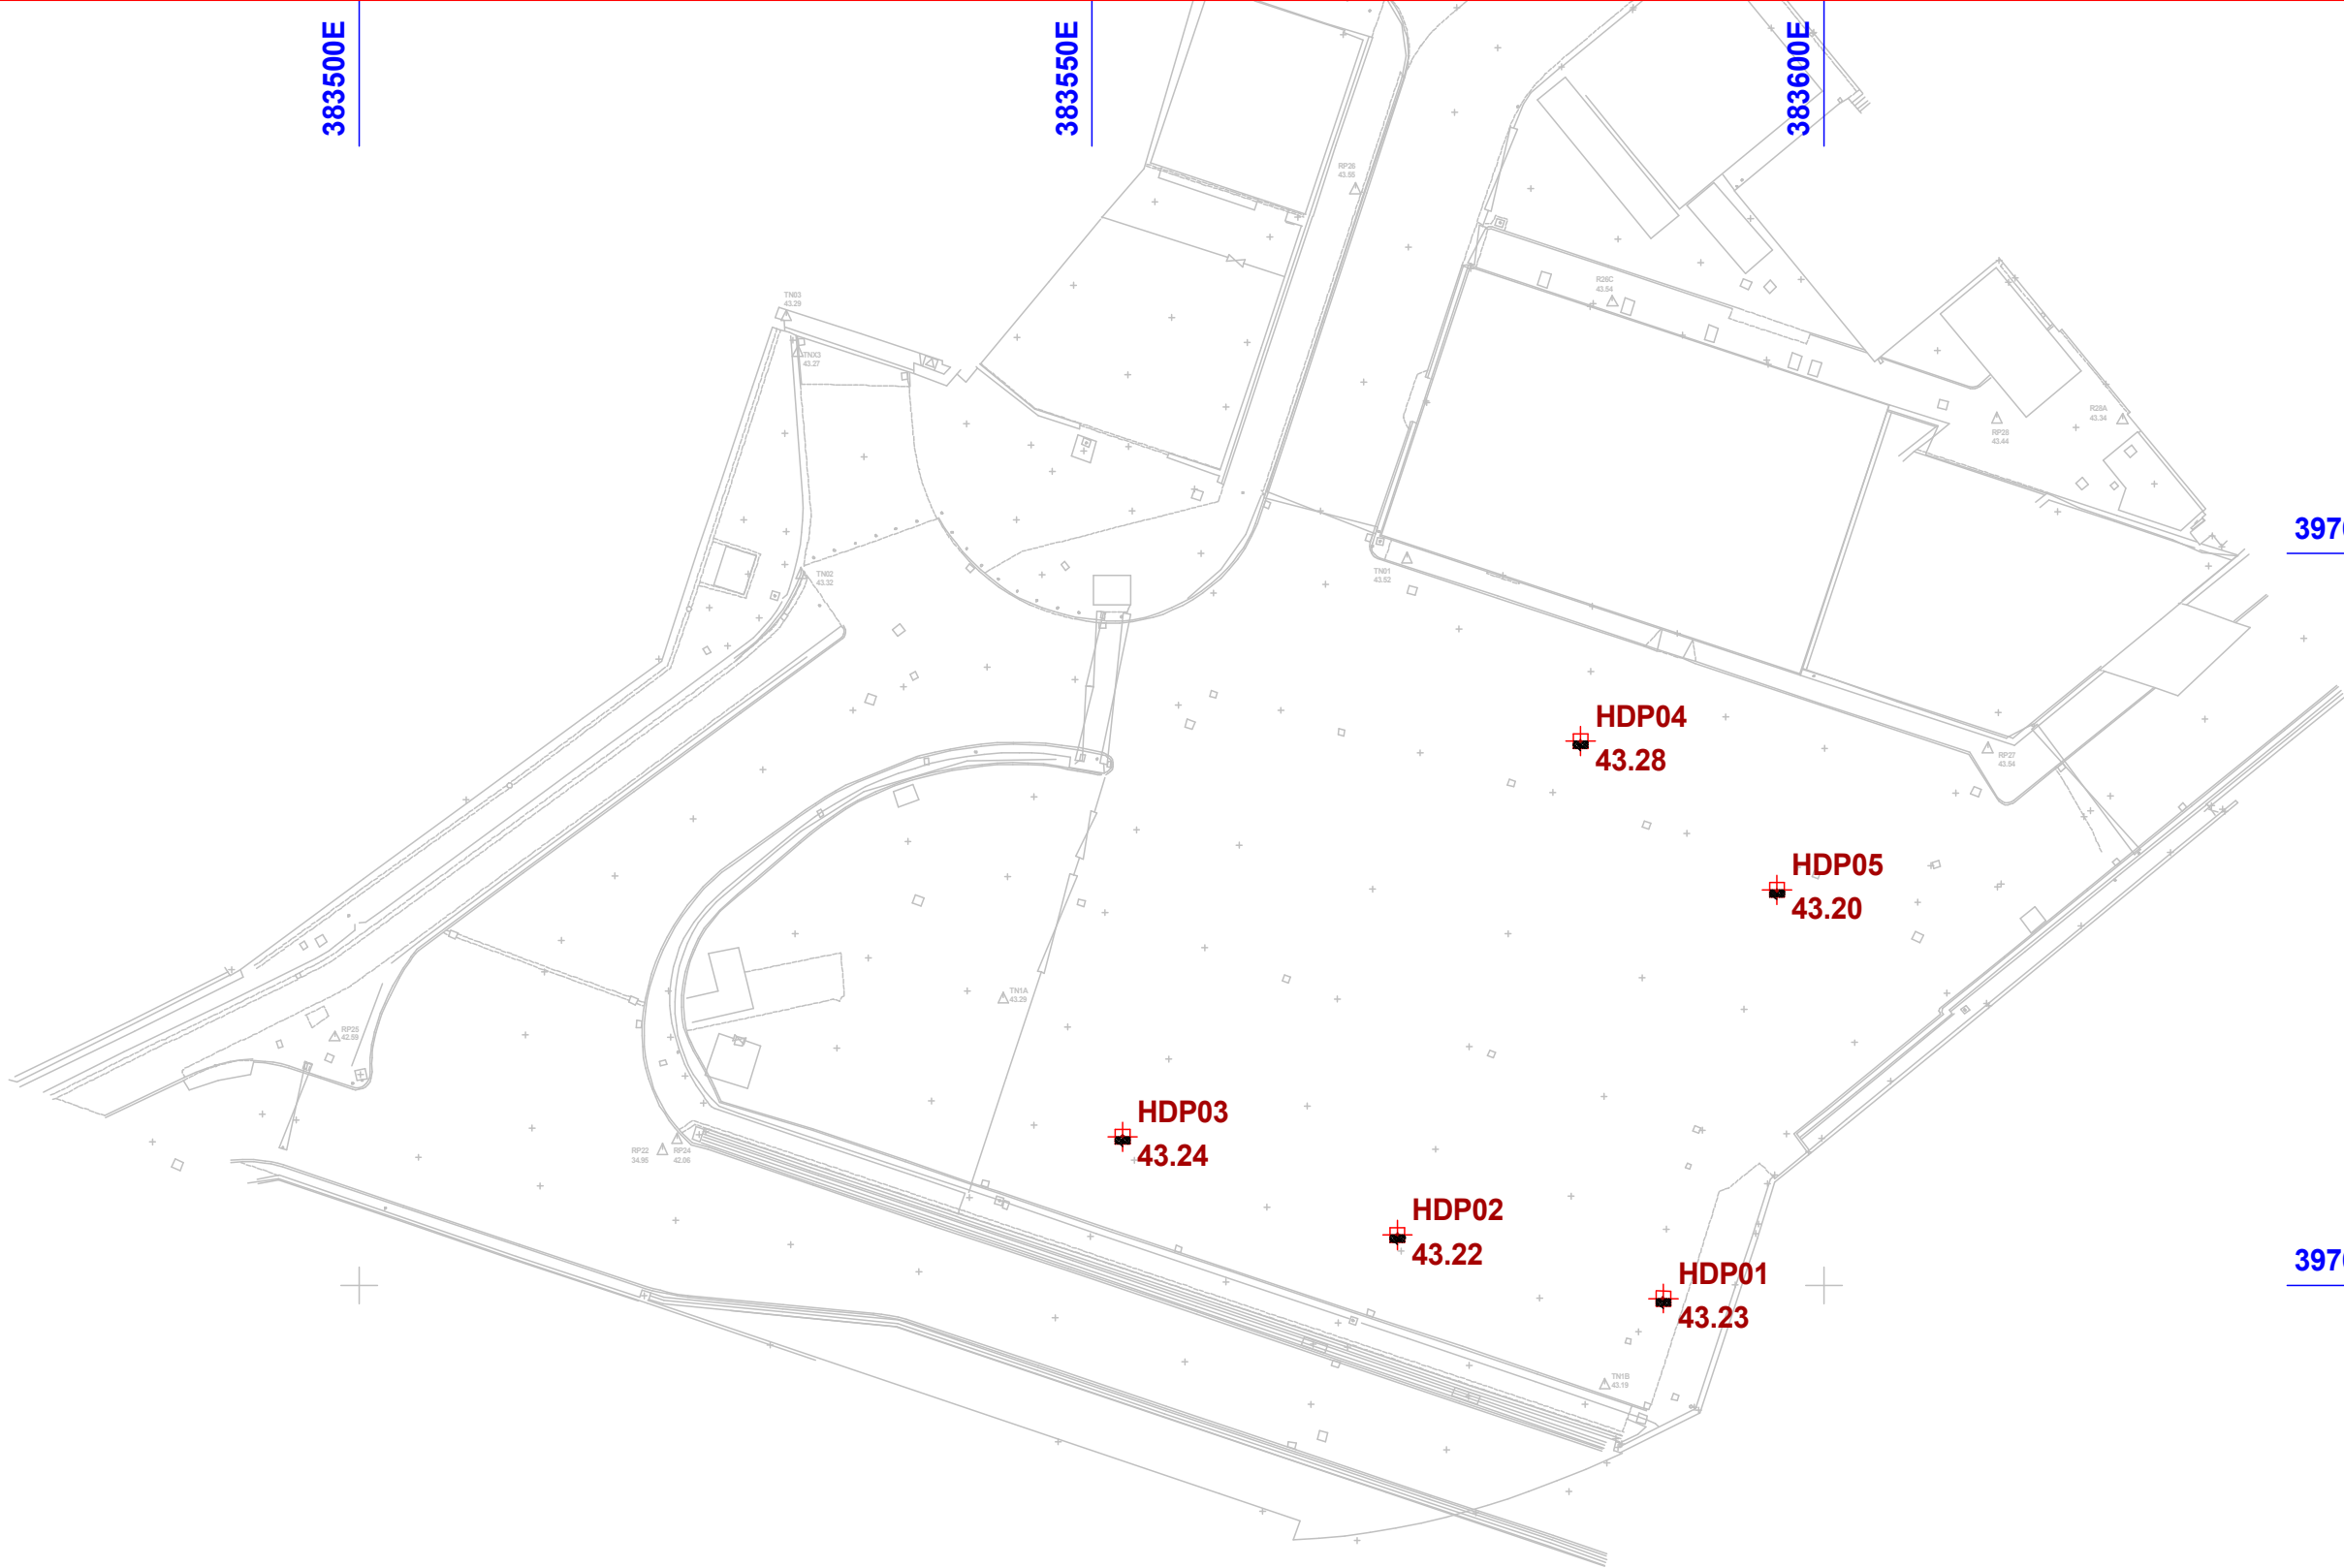
Key: heights refer to code

HP/HDP  
(Hand dug pit)

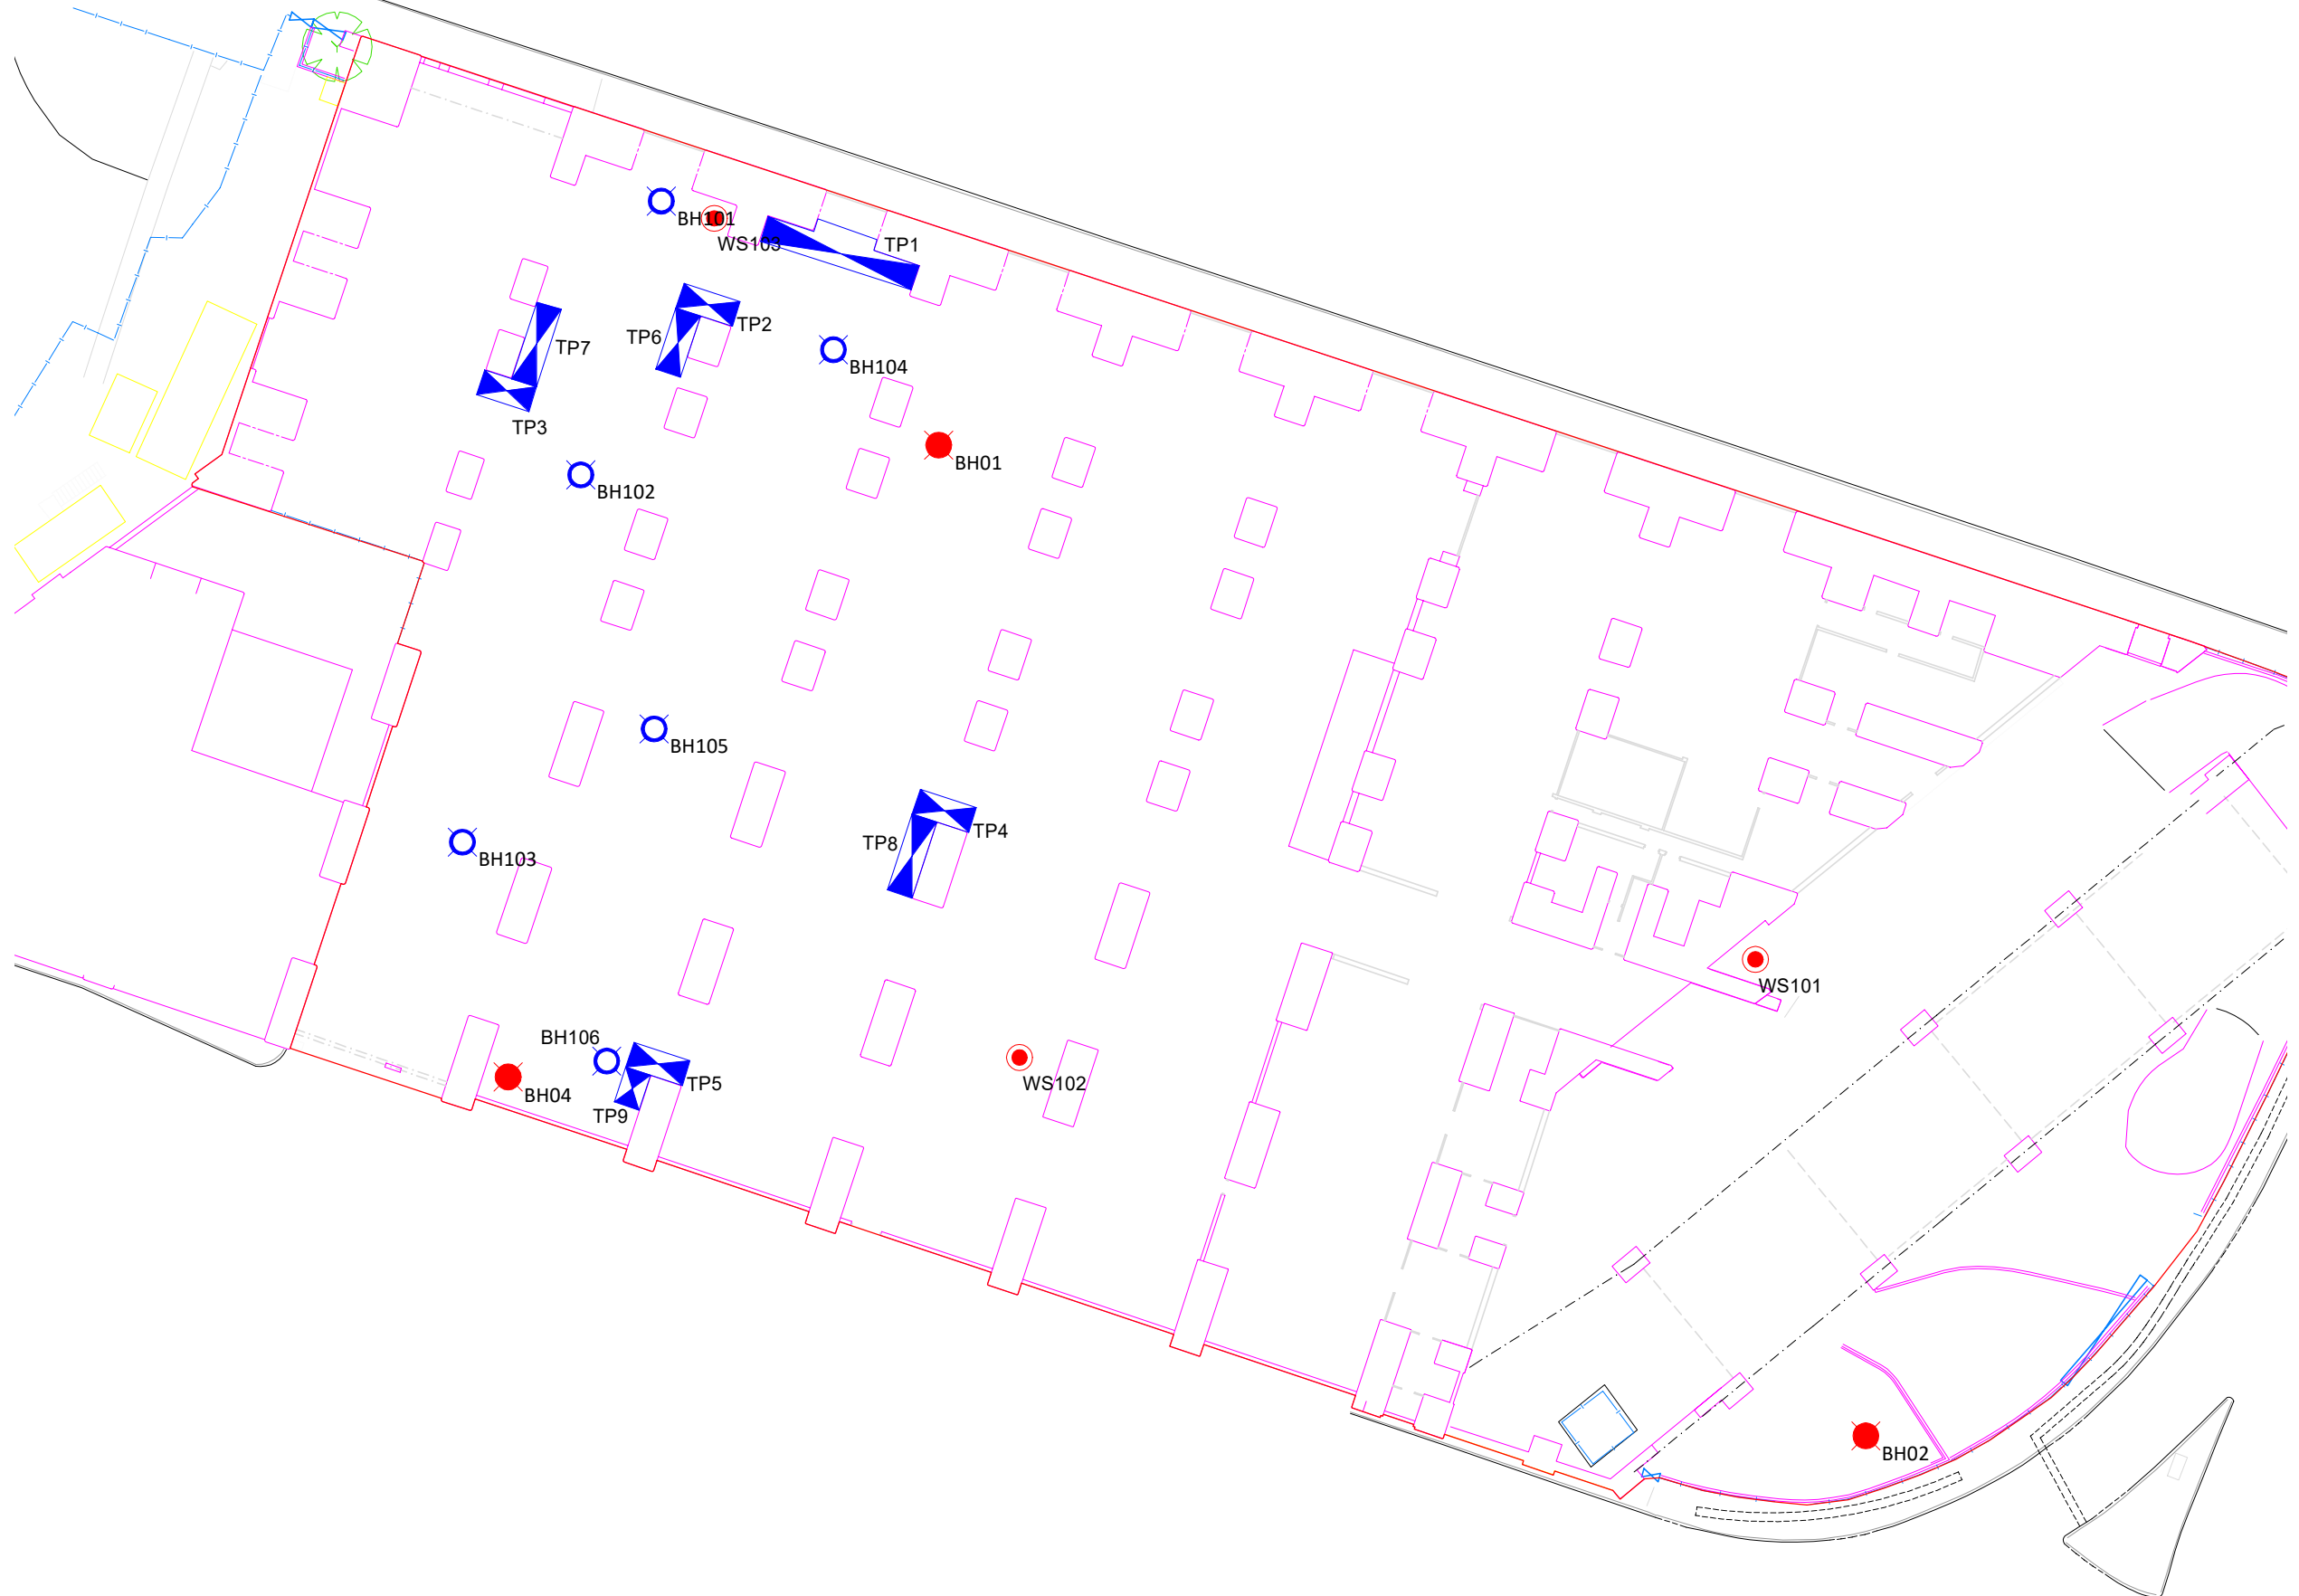
| DRAWING No. | REVISION | SCALE | DATE |
|---|---|---|---|
| C4460/03 | - | NTS | 10/06/20 |

- APPROXIMATE SITE BOUNDARY
- TRIAL TRENCH
- ROTARY CORED BOREHOLE
- WINDOW SAMPLE BOREHOLE (CURTINS CONSULTING LTD, 2016)
- ROTARY CORED BOREHOLE (CURTINS CONSULTING LTD, 2016)

- The scope of the investigation comprised the drilling of 6 No. rotary cored boreholes, 12 No. window sample boreholes and 6 No. trial pits on the Lower Deck across the eastern half of the site for primarily geotechnical purposes, to inform detailed foundation design and detailed settlement analysis for Phase 2 of the Viadux development.

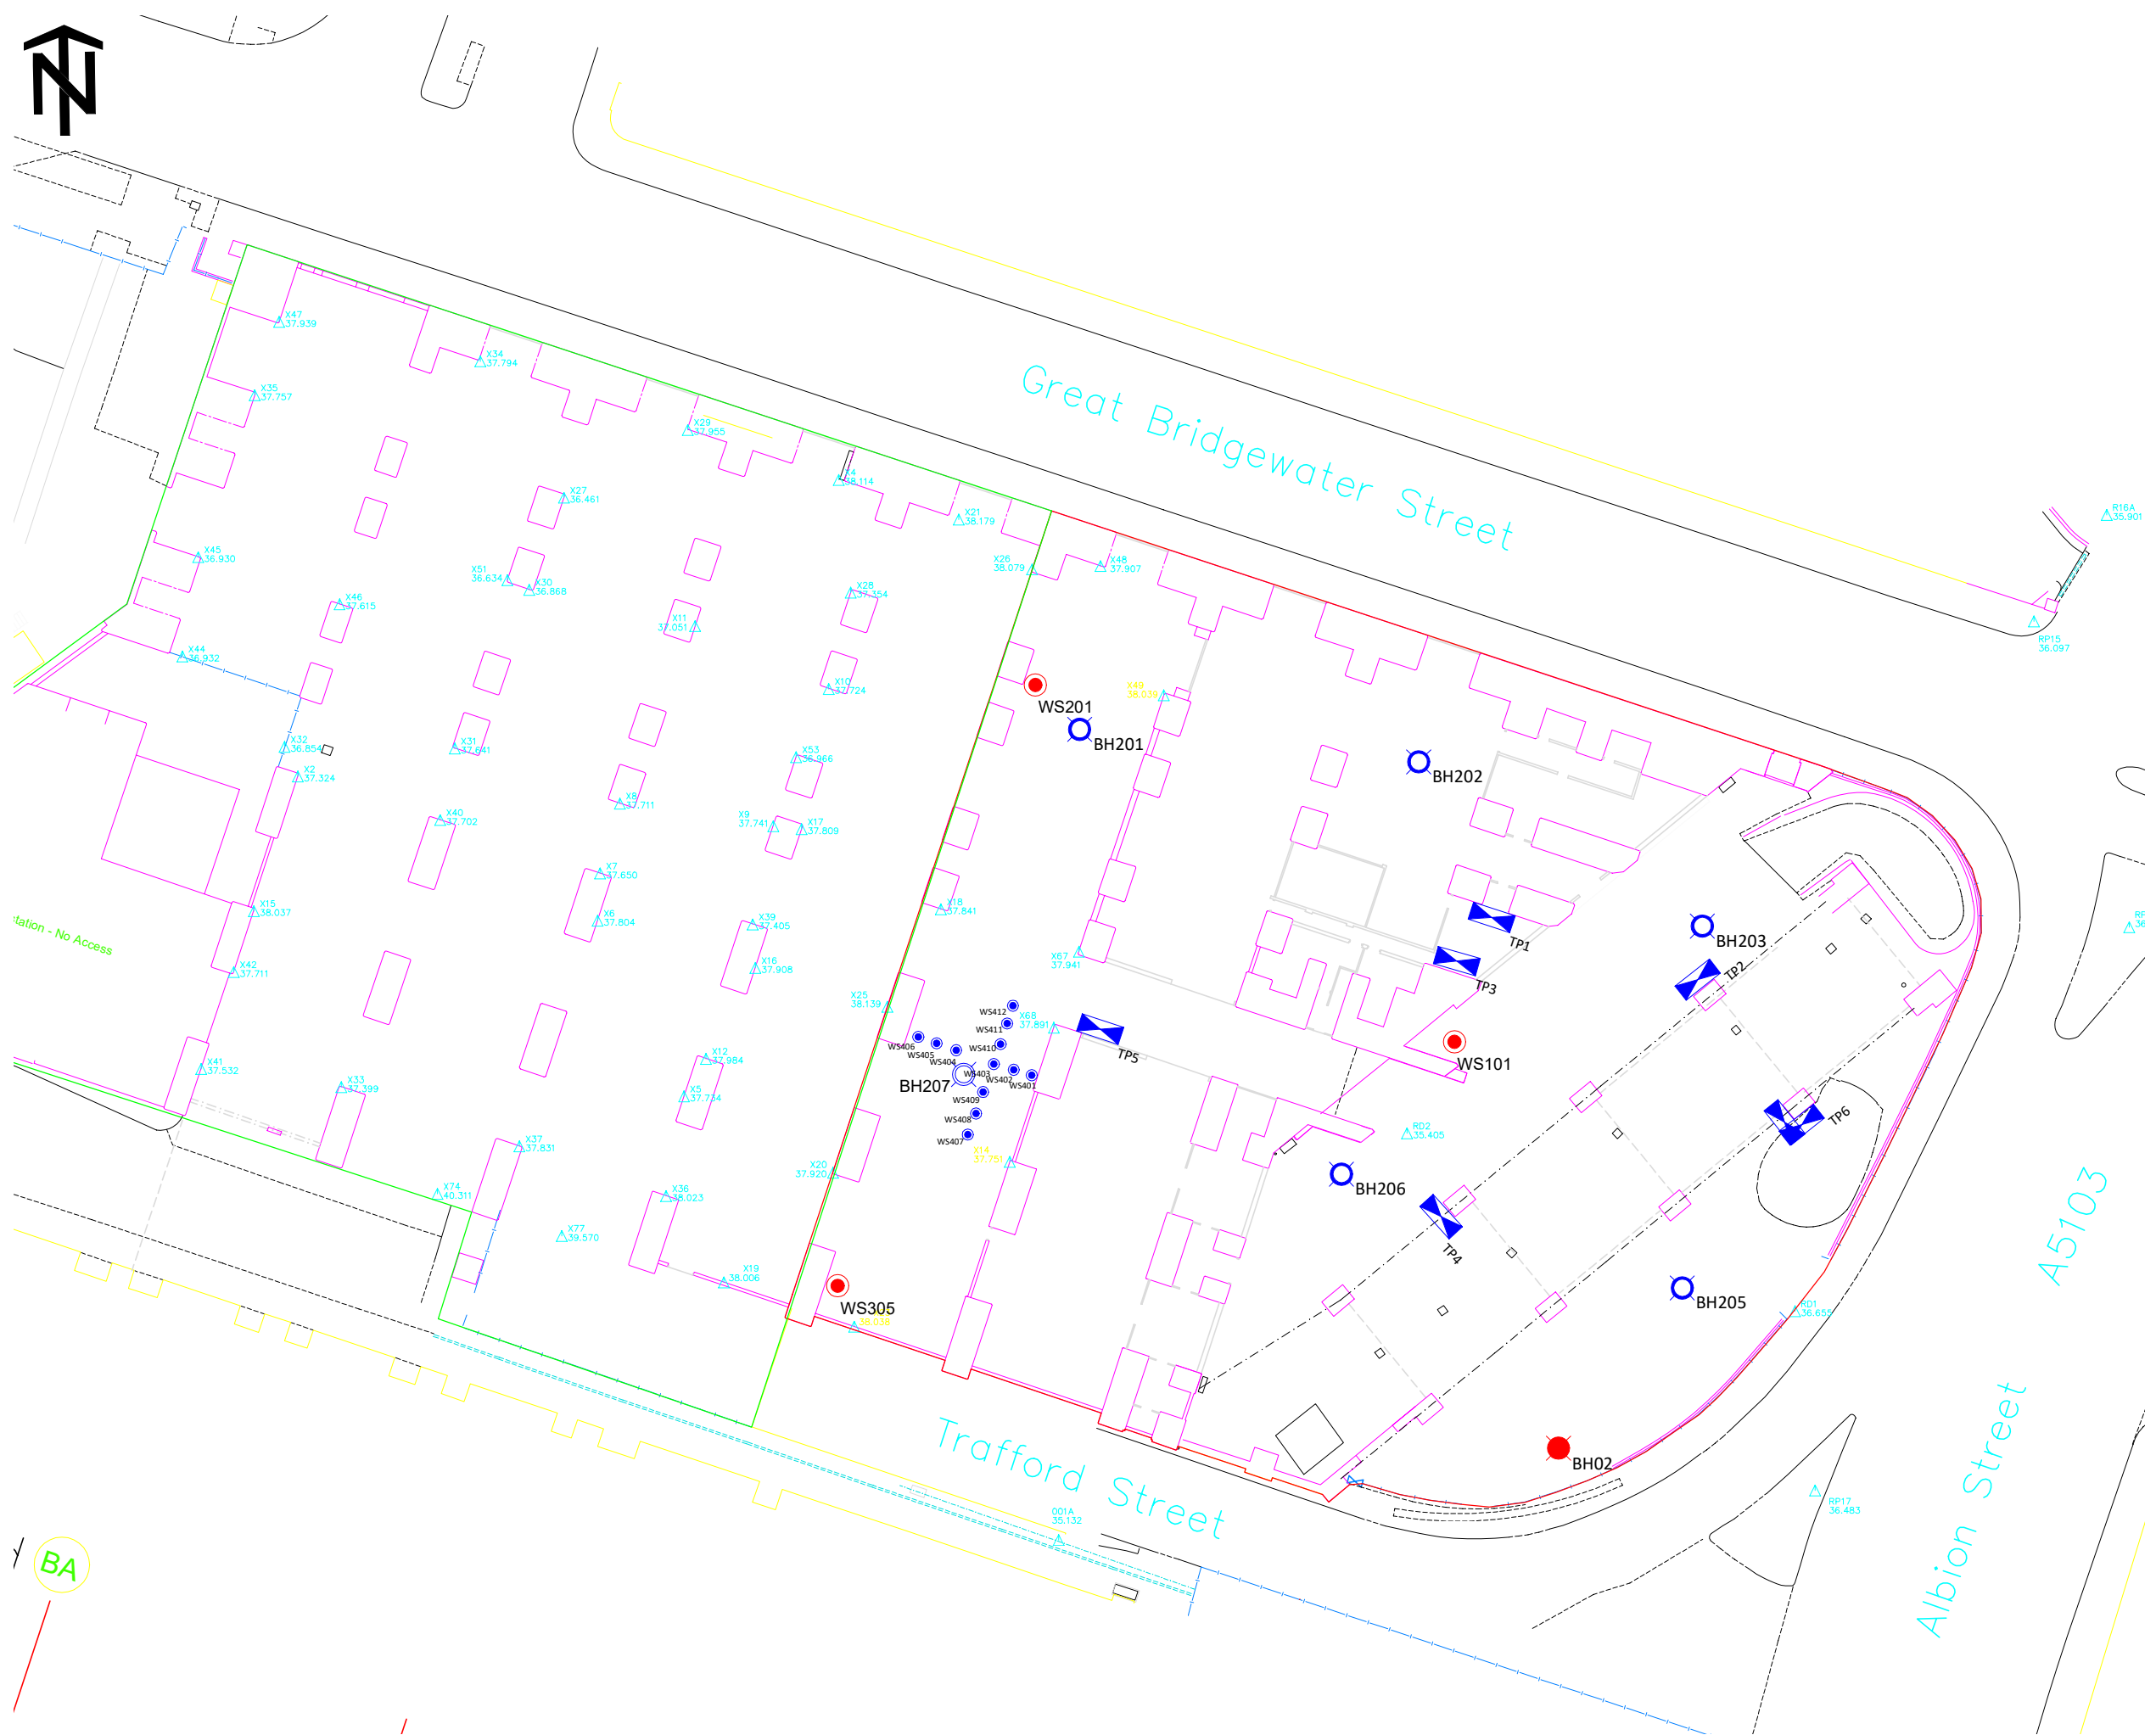
| | APPROXIMATE BOUNDARY OF<br>PHASE 2 DEVELOPMENT AREA |
| | APPROXIMATE BOUNDARY OF<br>PHASE 1 DEVELOPMENT AREA |
