### GAS MEMBRANE VALIDATION – BELLE VUE

**Project Name: Belle Bue Stadium**

**Ground Gas Risk Assessment: Amber 1/ Vapour Proof**

**Plots: 204-207**

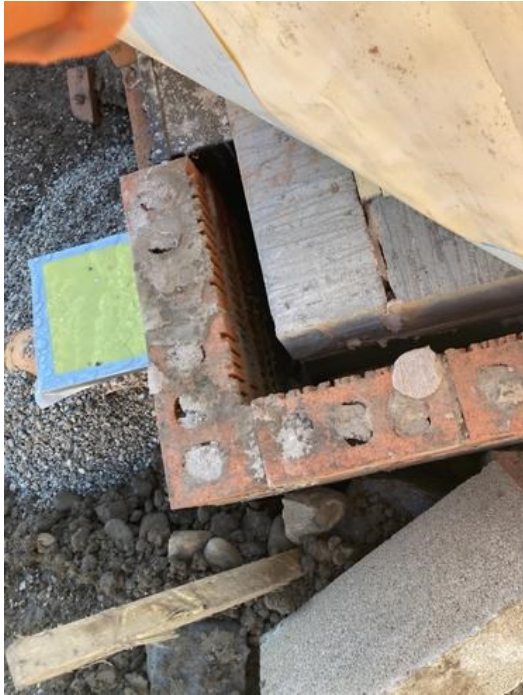
#### Condition of sub-grade and underside of gas membrane: Check that the subgrade does not contain rough/uneven surfaces, is appropriately clean and that there are no hard/sharp objects. That protective sand blinding or geotextile (if specified) is present and meets the design criteria.

Photo 120

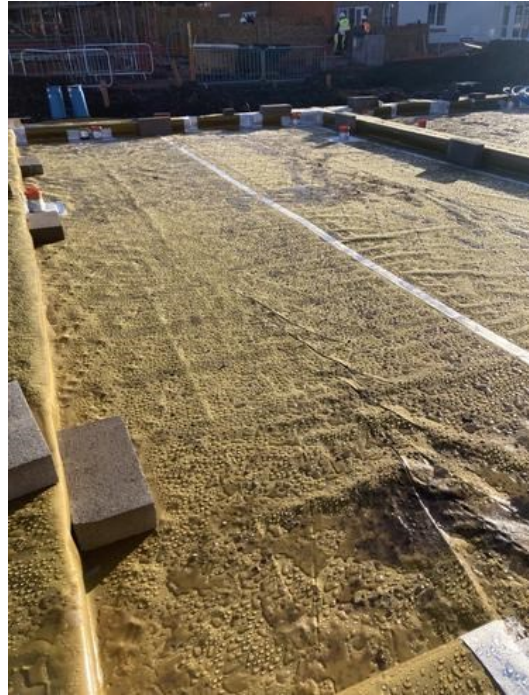
**Slab / membrane condition (is membrane clear of debris or insulation): Can membrane be fully seen and photographed – ask contractor to remove an debris so membrane can be fully seen and inspected – this is a requirement of NHBC and local authorities.**

Photo 121
