| PROJECT<br>96 Ladybarn Lane<br>Fallowfield. | | | CLIENT<br>JH | | PHASE<br>Planning - PL | | DATE<br>11/12/25 | REV<br>- | DATE | REV |
| PROJECT NO<br>188 - | SITE<br>96L - | PHASE<br>PL - | DWG NO<br>HGS1 | | REV<br>- | SCALE<br>1 : 100 | SHEET<br>A4 | | | |
| DRAWING TITLE<br>Existing Grd and Basement. | | | | | | <div><div><div>Sj</div><div>simon james /architect</div></div></div> | | | | |

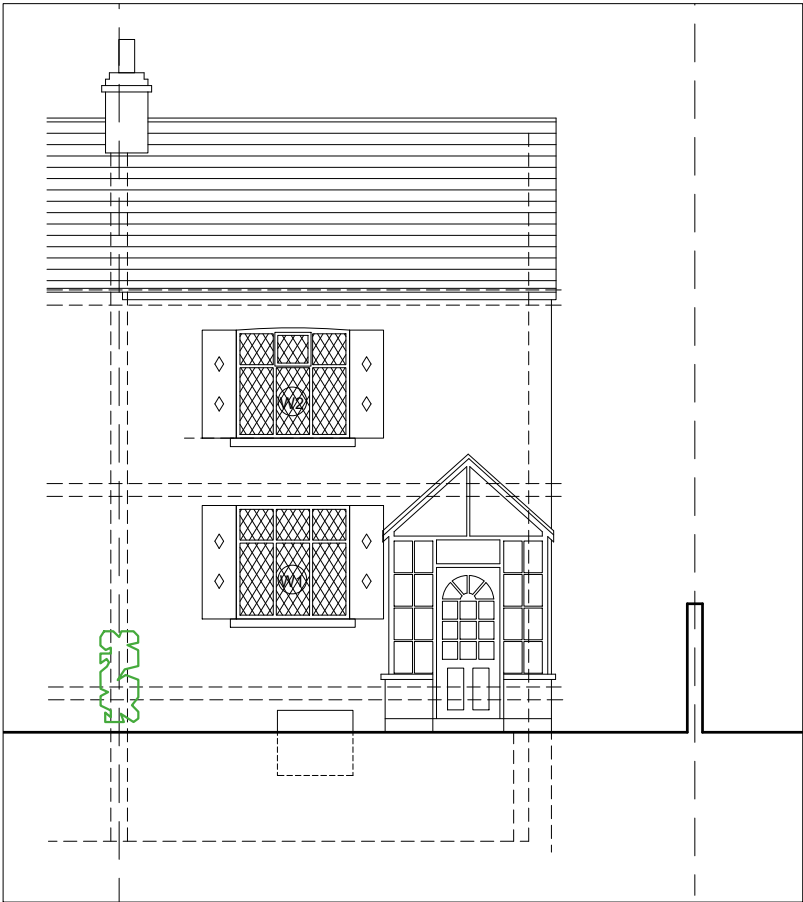
East Elevation

| DRAWING TITLE<br>Existing East & West Elevations | | | | | | | simon james /architect | | | |

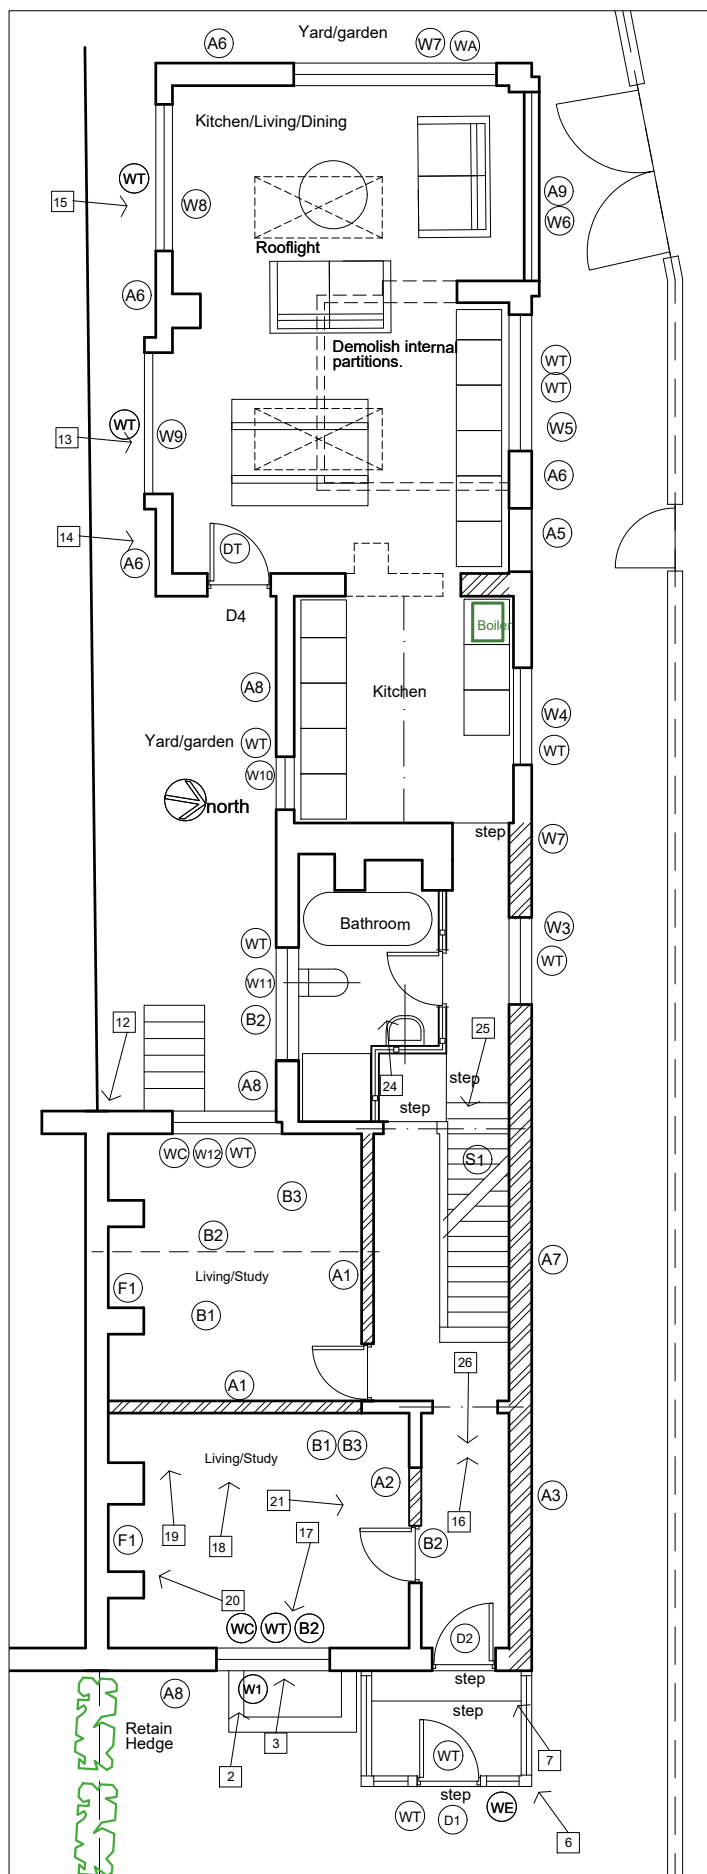
Ground Floor

- WT** Door/window changed by a previous owner. Replace modern poor quality painted timber window/door with a better quality painted timber window. Double glazed, toughened glass as required, PAS24, and installed by FENSA registered company to satisfy current standards.
- WC** Fenestration change to allow for aesthetic changes and or additional openers.
- WE** Existing window frame and glazing refurbished and upgraded.
- WA** New dark grey coloured aluminium sliding door.
- DT** Replace modern poor quality painted timber door with a better quality appropriate heritage, half glazed, painted timber door. Double glazed, toughened glass as required, PAS24, and installed by FENSA registered company to satisfy current standards.

- A1** Rebuild loadbearing wall using reclaimed bricks and introduce correctly sized and specified lintels. Finish with renovating render. Refer to structural engineers details.

- A2** Introduce loadbearing wall using reclaimed bricks to close wall to original opening retain original lintel. Refer to structural engineers details.

- A3** Carry out structural repair work to the gable wall as recommended by the structural engineer.
- A4** Internal wall skin without foundation built to support retaining wall by previous owner to be retained.

- A5** Remove door and replace with externally insulated white painted rendered wall to match main house elevation
- A6** Externally insulated white painted rendered wall to match main house elevation

- A7** If gable wall rebuilt retain as exposed brick with a flemish bond. Brick to be used will the brick taken down and saved. If strapped - render to be repaired with a renovating render and repainted in white as existing.

- A8** Locally repair render with matching renovating render. Paint white to match existing wall. Refer to heritage statement.
- A9** Introduce internally insulated wall to large garage door retain external garage doors as sealed/fixed wall finish to the exterior.

- S1** Reinststate basement stair. Removed by a previous owner.
- F1** Original fireplace removed by a previous owner. Openings made good with renovating plaster.

- B1** Option to avoid rebuilding gable wall. Add structural sheathing to increase shear strength. Add 15mm ply board to floor surface and underside of the existing joists to create diaphragm planes to strengthen the floor and provide a rigid plane to tie the bowed gable wall. Refer to Structural engineers recommendations.
- B2** Undersized, badly damaged or rotting beam or lintel to be replaced. Refer to Structural engineers recommendations.
- B3** In some areas full floor to be replaced, either fully perished or badly damaged and or undersized and poorly tied to the gable. Refer to Structural engineers recommendations.

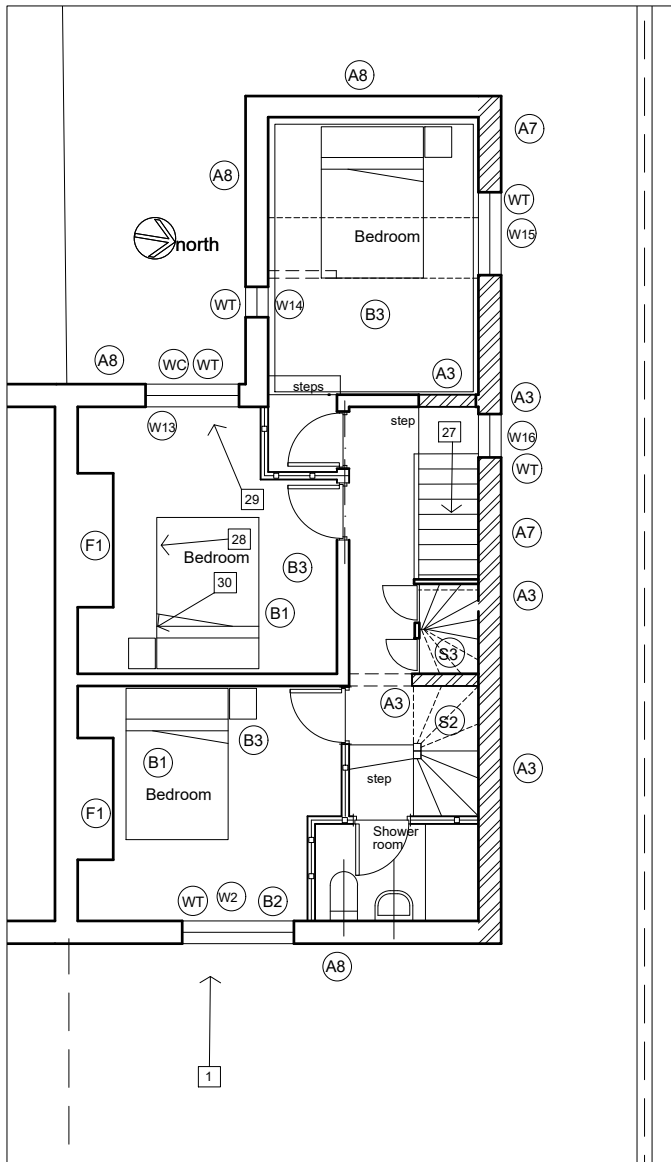
First Floor

- (WT) Door/window changed by a previous owner. Replace modern poor quality painted timber window/door with a better quality painted timber window. Double glazed, toughened glass as required, PAS24, and installed by FENSA registered company to satisfy current standards.
- (WC) Fenestration change to allow for aesthetic changes and or additional openers.

- (A3) Carry out structural repair work to the gable wall as recommended by the structural engineer.
- (A7) If gable wall rebuilt retain as exposed brick with a flemish bond. Brick to be used will the brick taken down and saved. If strapped - render to be repaired with a renovating render and repainted in white as existing.
- (A8) Locally repair render with matching renovating render. Paint white to match existing wall. Refer to heritage statement. Refer to Heritage statement.

- (S2) Additional usable winder stair that will satisfy current building regulations.
- (S3) Refurbish existing winder stair.
- (F1) Original fireplace removed by a previous owner. Openings made good with renovating plaster.

- (B1) Option to avoid rebuilding gable wall. Add structural sheathing to increase shear strength. Add 15mm ply board to floor surface and underside of the existing joists to create diaphragm planes to strengthen the floor and provide a rigid plane to tie the bowed gable wall. Refer to Structural engineers recommendations.
- (B2) Undersized, badly damaged or rotting beam or lintel to be replaced. Refer to Structural engineers recommendations.
- (B3) In some areas full floor to be replaced, either fully perished or badly damaged and or undersized and poorly tied to the gable. Refer to Structural engineers recommendations.

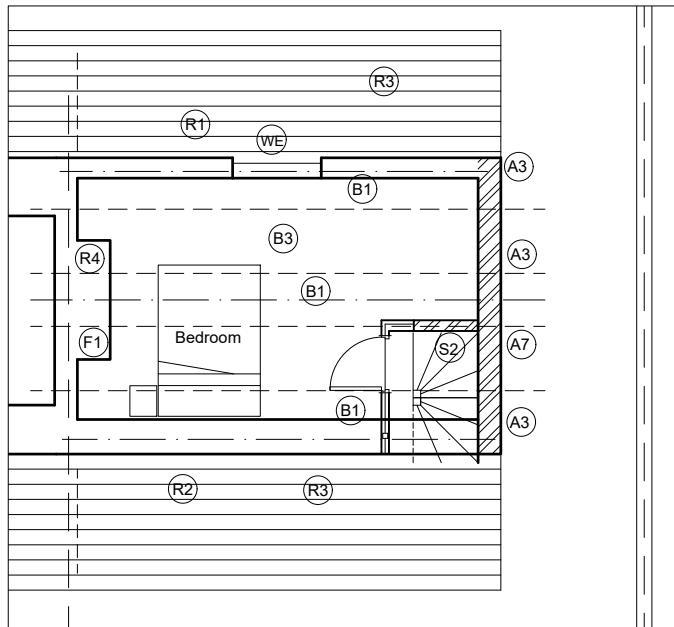
Attic Floor

- (WE) Existing window frame and glazing refurbished and upgrade.

- (A3) Carry out structural repair work to the gable as recommended by the structural engineer.
- (A7) If gable wall rebuilt retain as exposed brick with a flemish bond. Brick to be used will the brick taken down and saved.  
If strapped - render to be repaired with a renovating render and repainted in white as existing.

- (B1) Option to avoid rebuilding gable wall. Add structural sheathing to increase shear strength. Add 15mm ply board to floor surface and underside of the existing joists to create diaphragm planes to strengthen the floor and provide a rigid plane to tie the bowed gable wall. Refer to Structural engineers recommendations.
- (B2) Undersized, badly damaged or rotting beam or lintel to be replaced. Refer to Structural engineers recommendations.
- (B3) In some areas full floor to be replaced, either fully perished or badly damaged and or undersized and poorly tied to the gable. Refer to Structural engineers recommendations.

- (R1) Badly built dormer to remain in place. Repaired and improved with insulation and located on to correctly specified trimmers.
- (R2) Very badly re-built roof to be corrected with properly supported purlin ends, tied rafters, introduction of insulation and adequate ventilation.
- (R3) Recently replaced Roof to remain as existing. Insulation to be inserted between rafters to achieve current building regulations U values.
- (R4) Leaning Chimney to be taken down and rebuilt exactly as existing using the same bricks and pots. Refer to Structural Engineers recommendations.
- (R5) Repair and upgrade roof to be weathered and insulated with a grey single ply rubber roofing system. Replace glazed roof with modern draft proof high U value rooflight

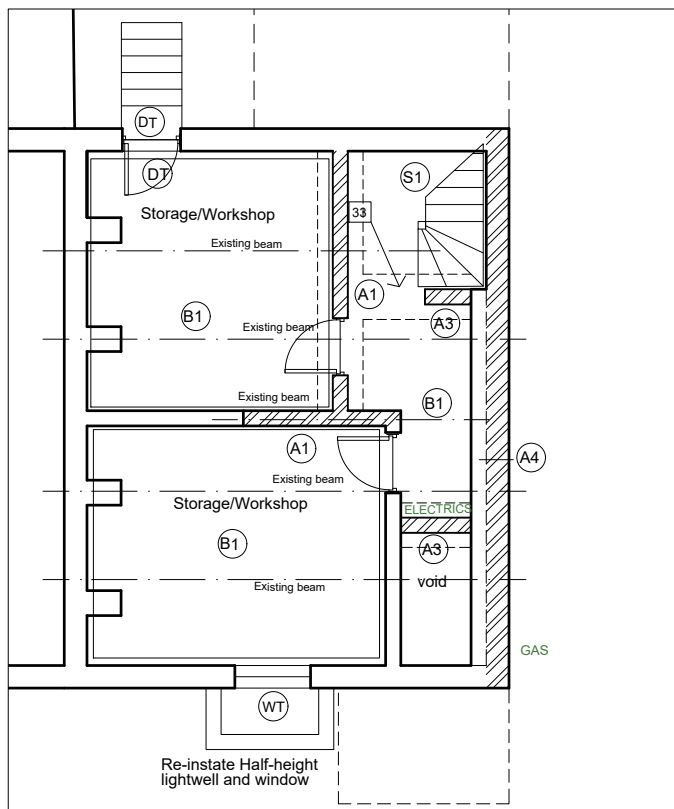
Basement

- (WT) New timber painted window in basement window opening. Original basement opening to be re-opened.  
Double glazed, toughened glass as required, PAS24, and installed by FENSA registered company to satisfy current standards.
- (DT) Replace modern poor quality painted timber door with a better quality appropriate heritage, half glazed, painted timber door.  
Double glazed, toughened glass as required, PAS24, and installed by FENSA registered company to satisfy current standards.

- (A1) Rebuild loadbearing wall using reclaimed bricks and introduce correctly sized and specified lintels. Finish with renovating render. Refer to structural engineers details.
- (A2) Introduce loadbearing wall using reclaimed bricks to close wall to original opening retain original lintel. Refer to structural engineers details.
- (A3) Carry out structural repair work to the gable wall as recommended by the structural engineer.
- (A4) Internal wall skin without foundation built to support retaining wall by previous owner to be retained.
- (A7) If gable wall rebuilt retain as exposed brick with a flemish bond. Brick to be used will the brick taken down and saved.  
If strapped - render to be repaired with a renovating render and repainted in white as existing.

- (B1) Option to avoid rebuilding gable wall. Add structural sheathing to increase shear strength. Add 15mm ply board to floor surface and underside of the existing joists to create diaphragm planes to strengthen the floor and provide a rigid plane to tie the bowed gable wall. Refer to Structural engineers recommendations.
- (B2) Undersized, badly damaged or rotting beam or lintel to be replaced. Refer to Structural engineers recommendations.
- (B3) In some areas full floor to be replaced, either fully perished or badly damaged and or undersized and poorly tied to the gable. Refer to Structural engineers recommendations.

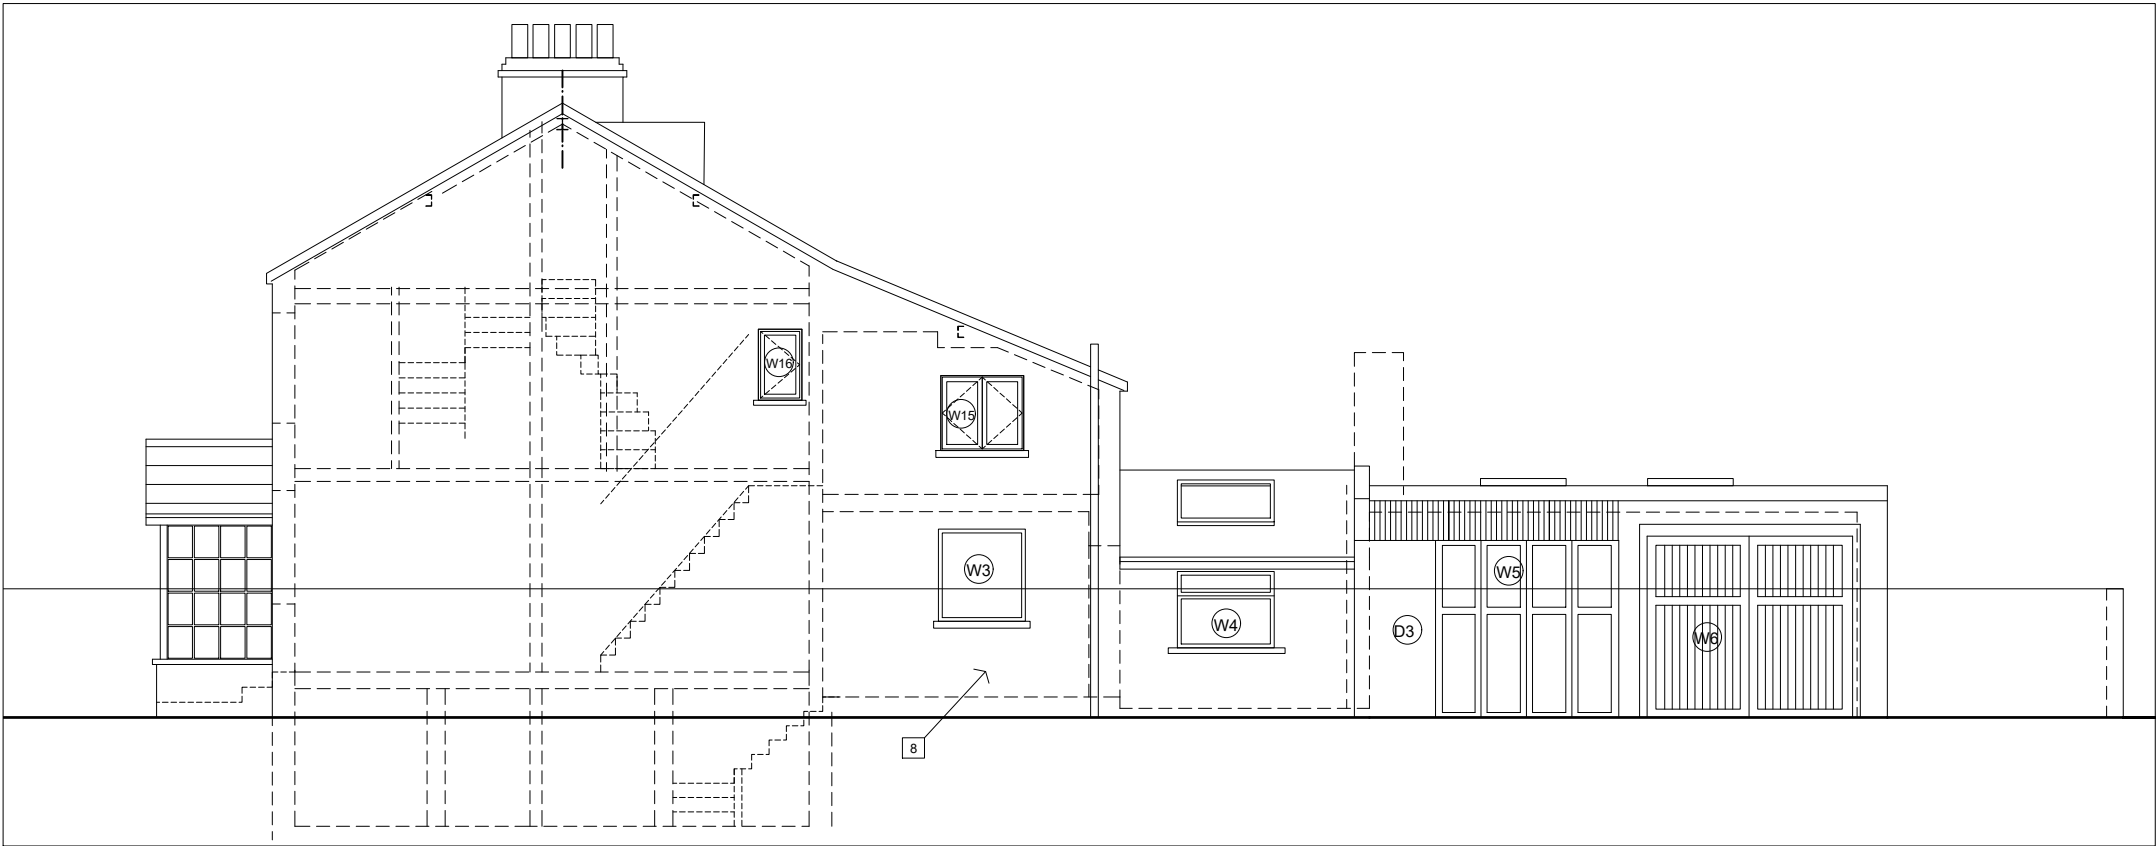
| DRAWING TITLE<br>Proposed North Elevation | | | | | | | <div><div>sj</div><div>simon james /architect</div></div> | | | | |
