### GAS MEMBRANE VALIDATION – BELLE VUE

**Project Name: Belle Bue Stadium**

**Ground Gas Risk Assessment: Amber 1**

**Plots: 157-160 & 228-229**

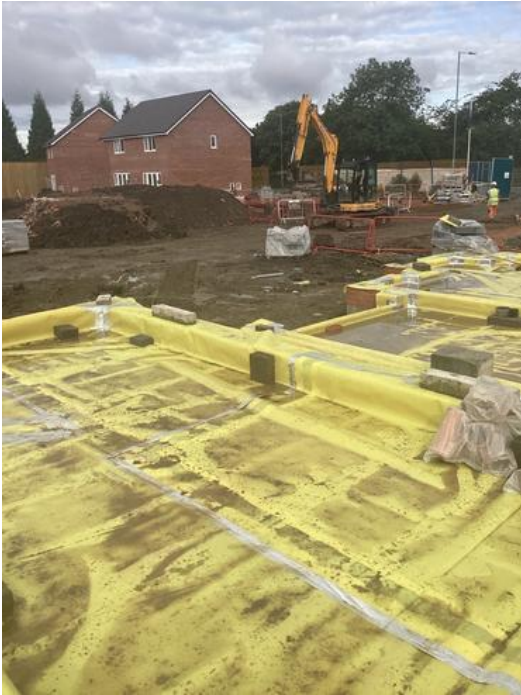
Photo 33

**Condition of sub-grade and underside of gas membrane: Check that the subgrade does not contain rough/uneven surfaces, is appropriately clean and that there are no hard/sharp objects. That protective sand blinding or geotextile (if specified) is present and meets the design criteria.**

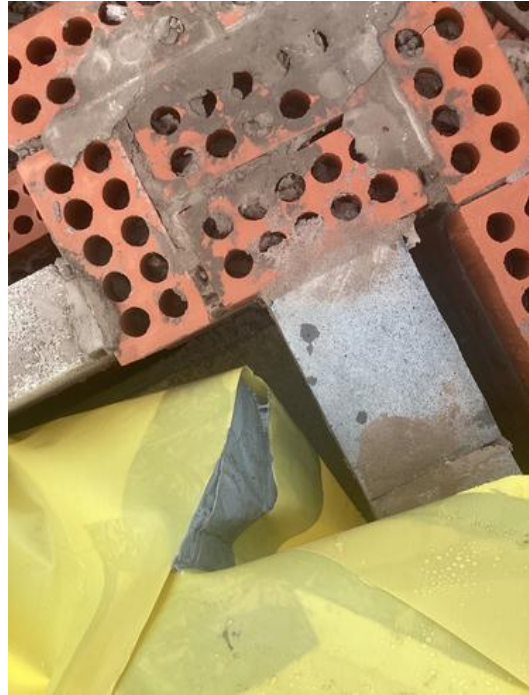
Photo 34

**Slab / membrane condition (is membrane clear of debris or insulation): Can membrane be fully seen and photographed – ask contractor to remove an debris so membrane can be fully seen and inspected – this is a requirement of NHBC and local authorities.**

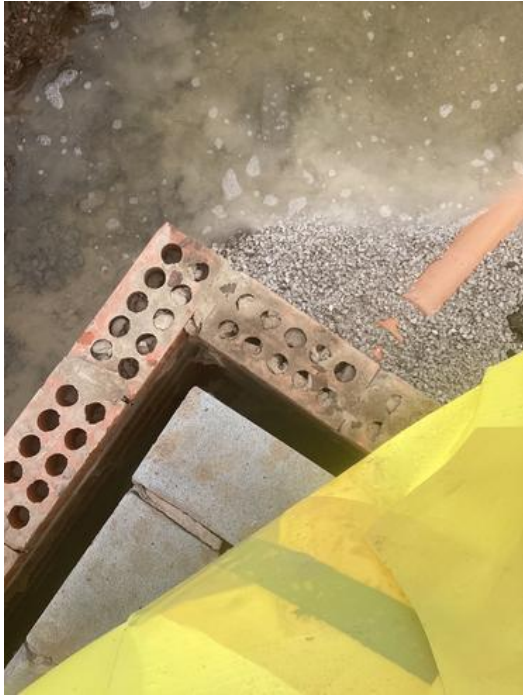
**Condition of sub-grade and underside of gas membrane:** Check that the subgrade does not contain rough/uneven surfaces, is appropriately clean and that there are no hard/sharp objects. That protective sand blinding or geotextile (if specified) is present and meets the design criteria.

Photo 124

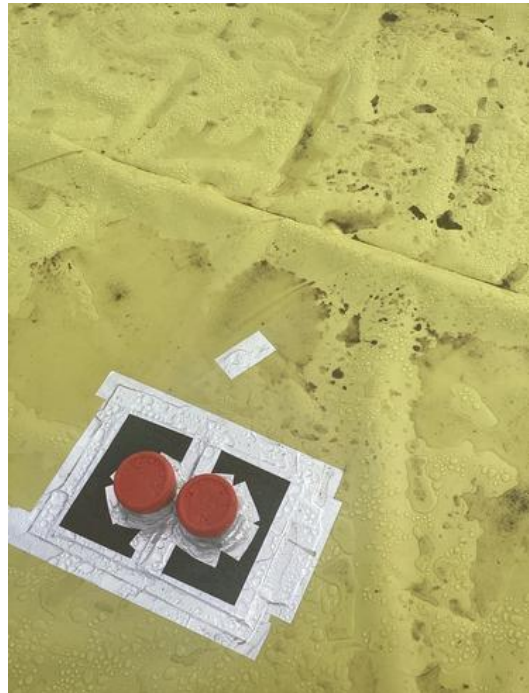
**Foundation Type: Other add note**

Photo 131

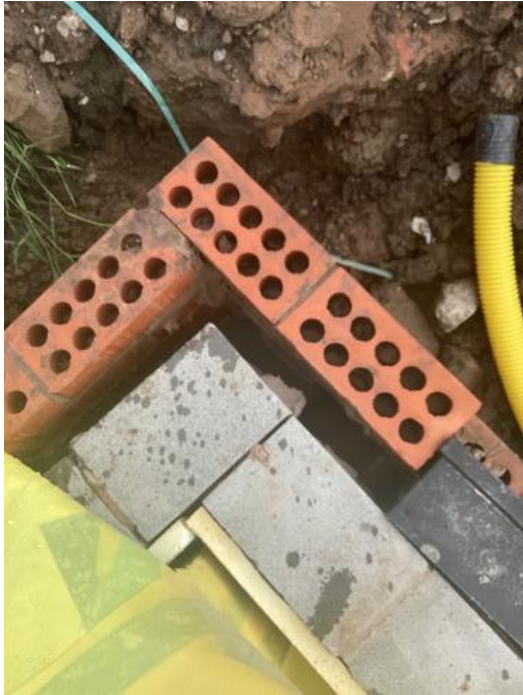
**Condition of sub-grade and underside of gas membrane:** Check that the subgrade does not contain rough/uneven surfaces, is appropriately clean and that there are no hard/sharp objects. That protective sand blinding or geotextile (if specified) is present and meets the design criteria.

Photo 152

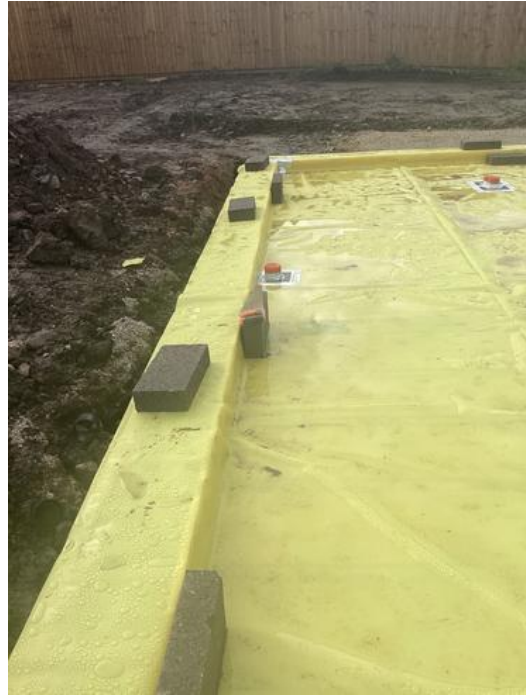
**Slab / membrane condition** (is membrane clear of debris or insulation): Can membrane be fully seen and photographed – ask contractor to remove an debris so membrane can be fully seen and inspected – this is a requirement of NHBC and local authorities.

Photo 153
