# ADDENDUM DESIGN STATEMENT

Change of Use to Upper Floors and Alterations  
to create 46 Bedroom Hotel

1-3 York Street, Manchester

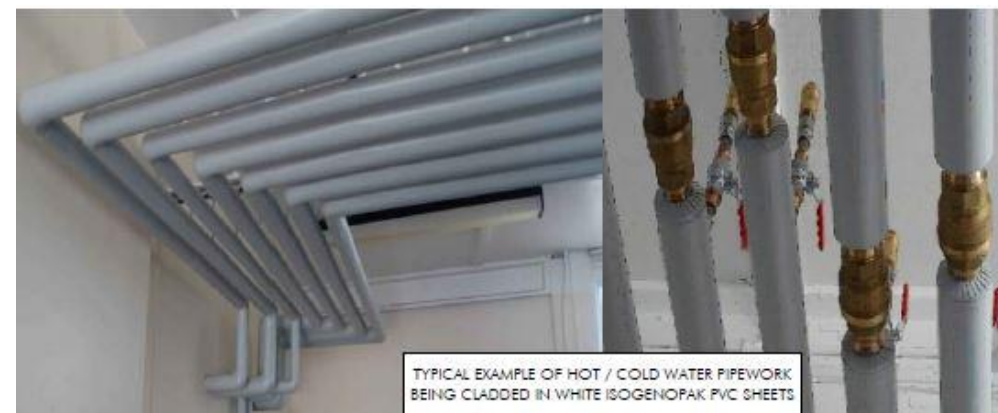
Fig 2: White pipe wrap for exposed water pipework

The main pipe and cable services shall run in ceiling trays with a decorative raft running through the centre of the corridor . This raft can incorporate LED strip lighting to illuminate the volume of the space. All decorative archways at second floor level can now be exposed and the full volume of the original corridor space can be appreciated. Hot and cold water services will run at high level in the upper open space and will be treated with a white wrap product (illustrated below) to improve the appearance where they may be visible either side of the central raft.

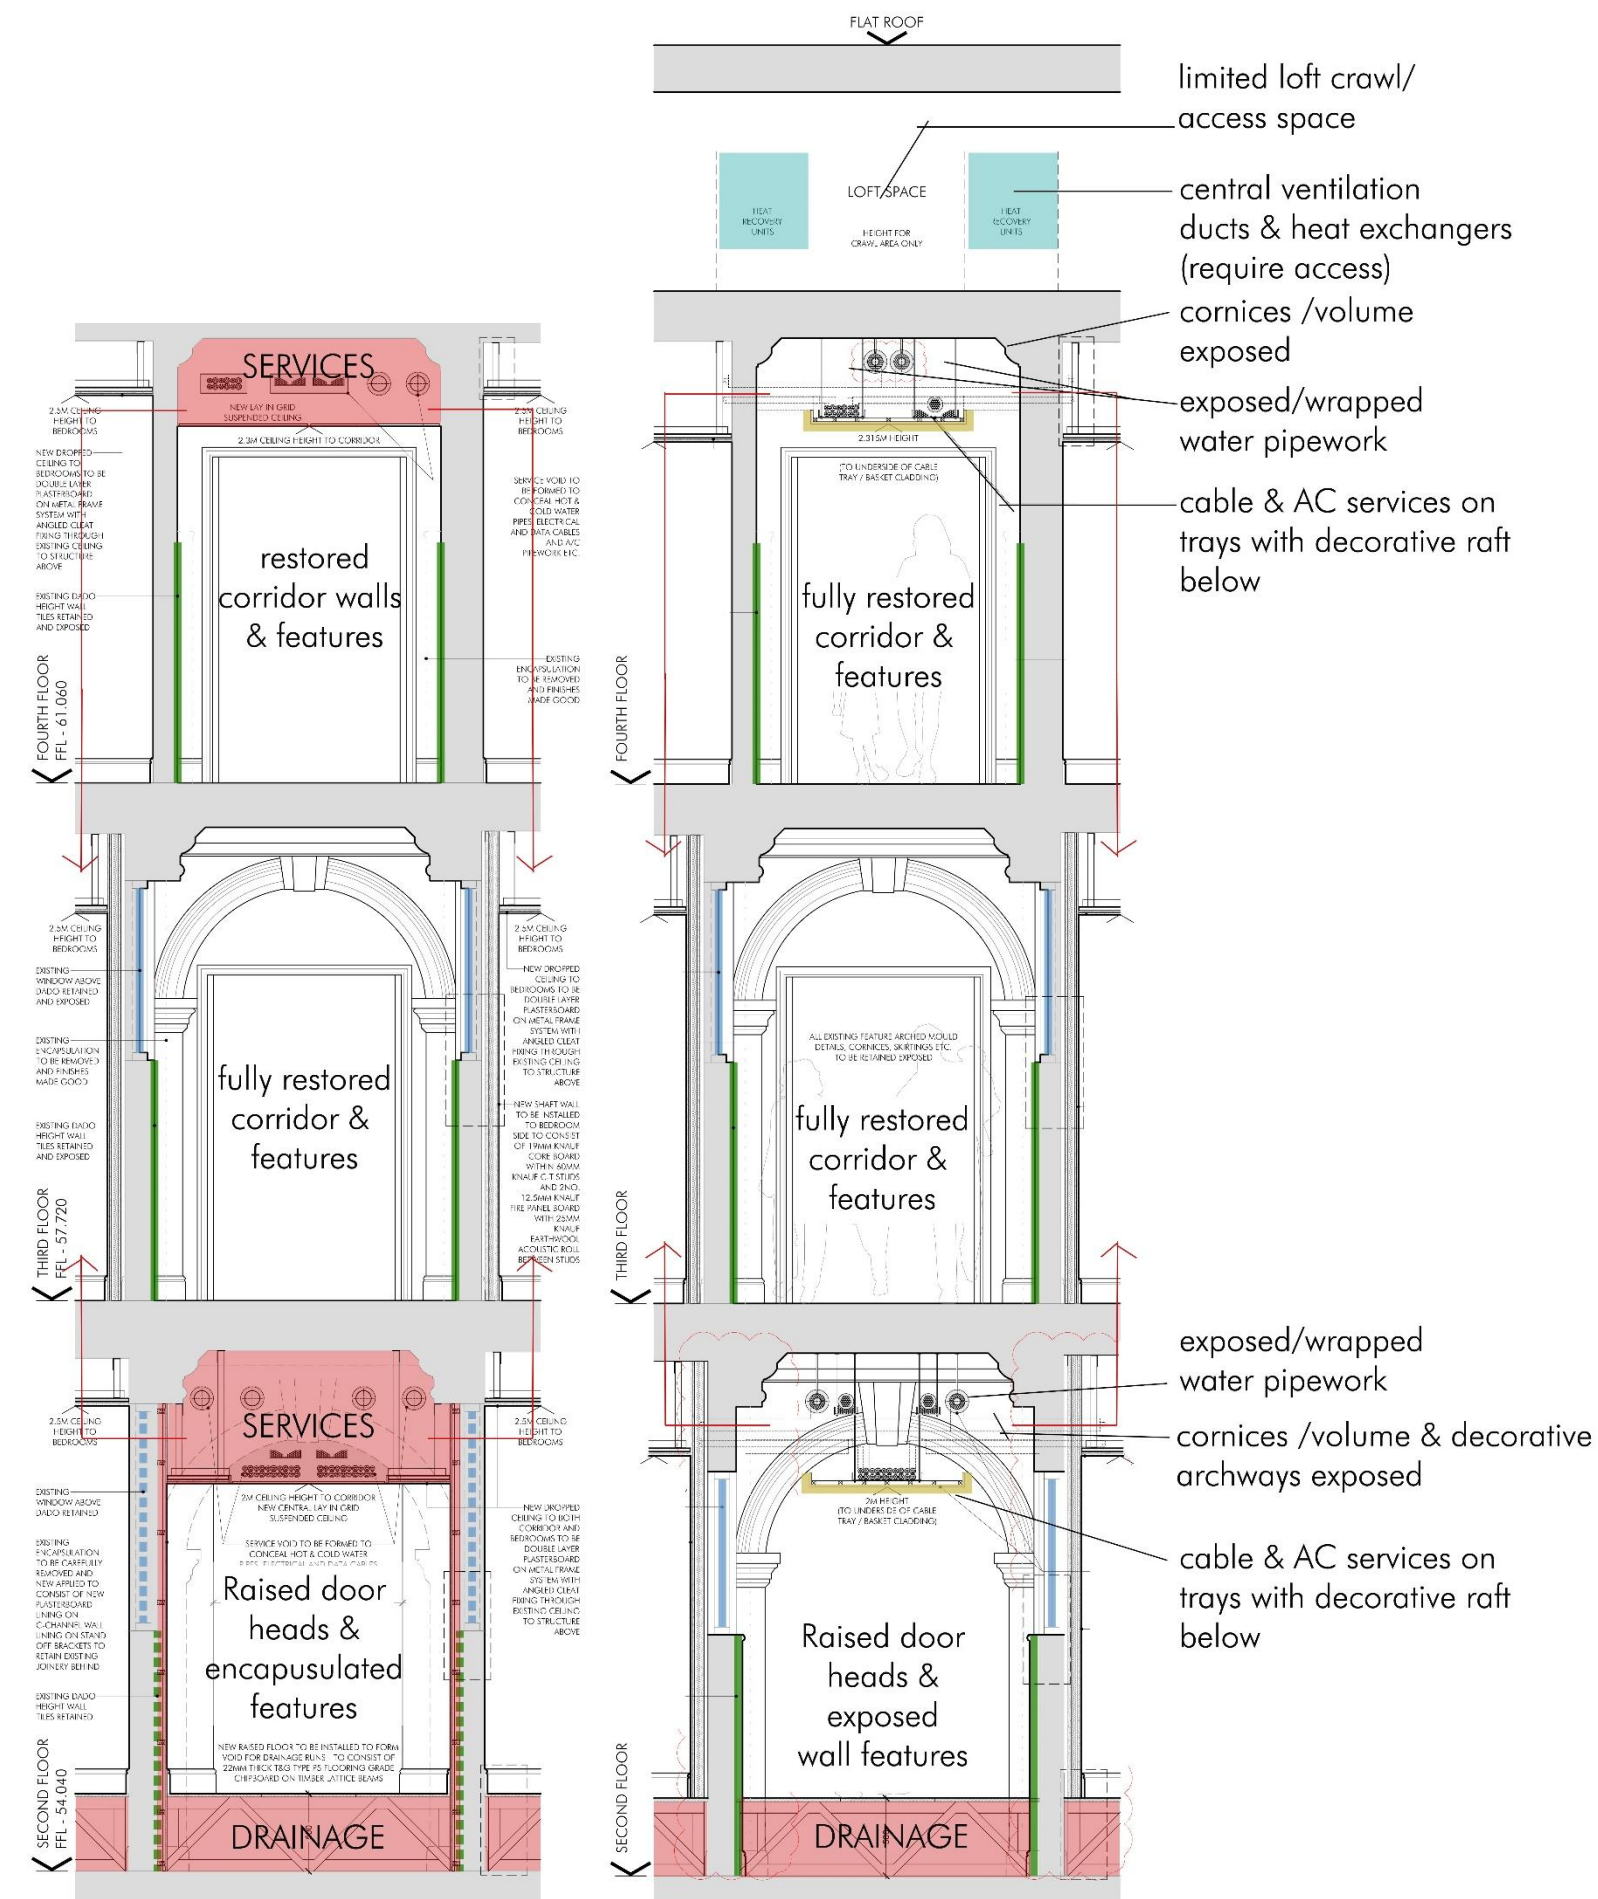
Fig 3: LEFT: previous corridor services strategy; RIGHT: Proposed services strategy introducing corridor ceiling rafts. Void spaces are highlighted in red.

Following detailed consideration, we have redesigned the services distribution within the corridor ceilings to achieve the requested principle of carrying services on 'rafts' rather than boxing-in the full ceiling zone. The illustrations (opposite) show clearly the difference between the original approach and this revised proposal. The fundamental distribution principles for the whole building have not changed – services are concentrated at second and fourth floor level with vertical feeds through the bedrooms to enable the corridors at third floor level to be fully restored.

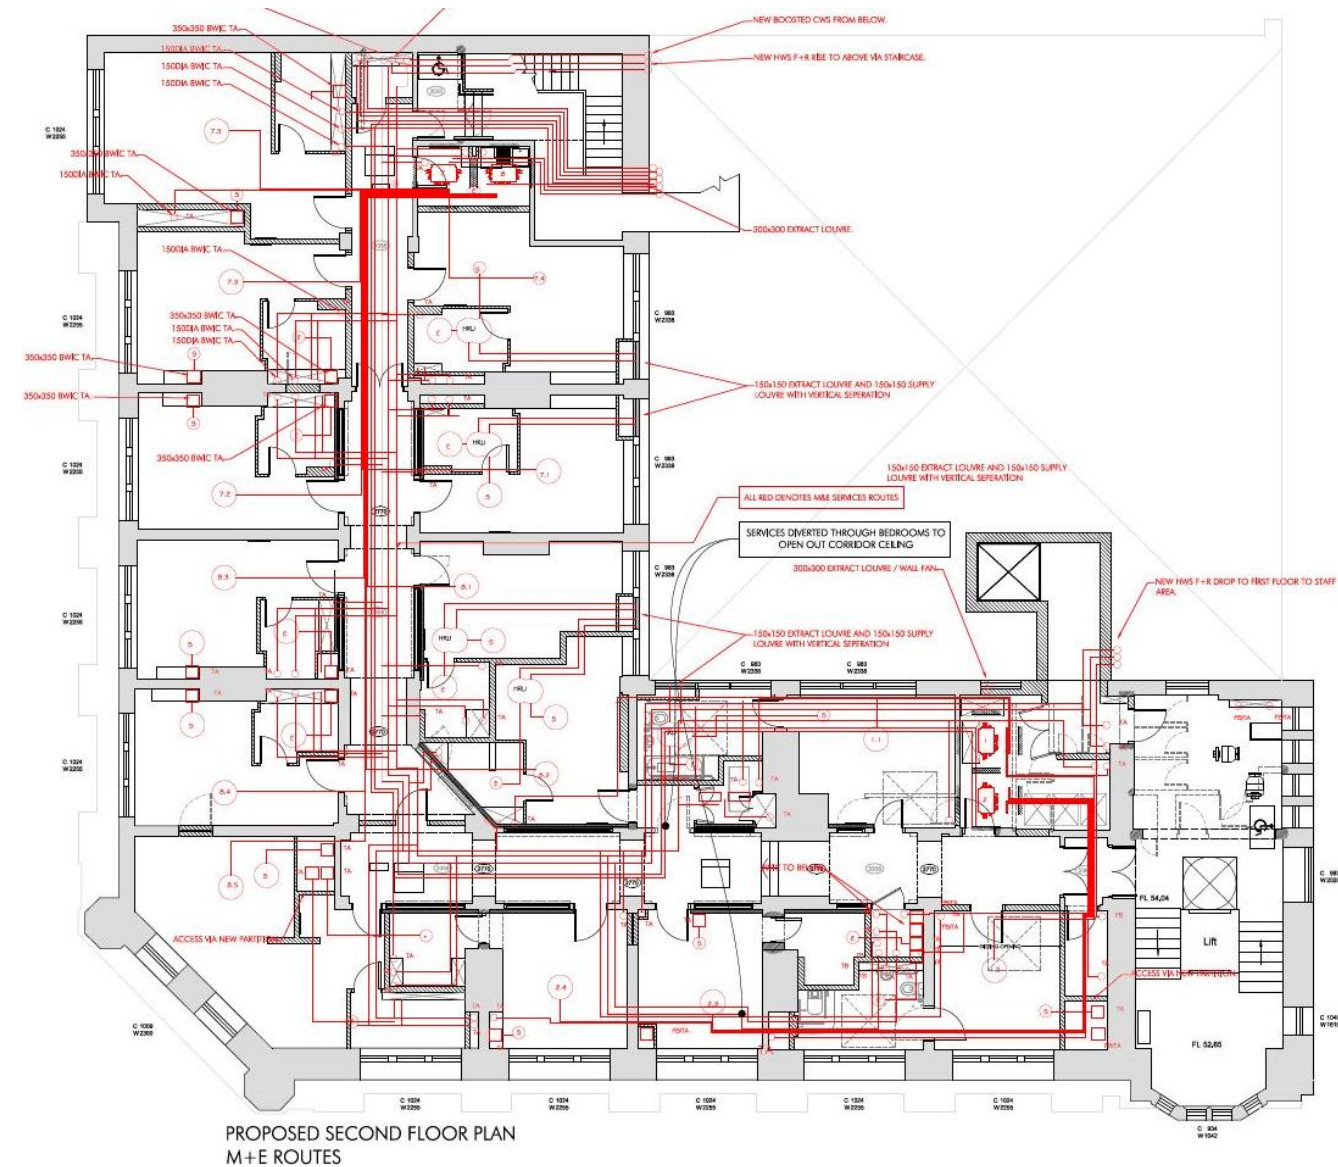
Fig 4: Plan extract showing M&E services (in red) diverted around section of corridor.

The only exception to this general principle of corridor ceiling services rafts is at second floor, to the initial section of corridor directly accessed from the proposed reception area. This area does not require a raised floor therefore, as in the original application drawings, we are proposing to fully restore that section of corridor, including the tiled walls full height, by routing services through the rooms to either side of it. This results in a larger section of bulkhead ceiling in those few side rooms, however there is a clear benefit to the user experience of the building by allowing that section of corridor to be restored. The restored section of the corridor is more 'on show' to the general public, being both a general access corridor and immediately adjacent to, and visible from, the reception area.

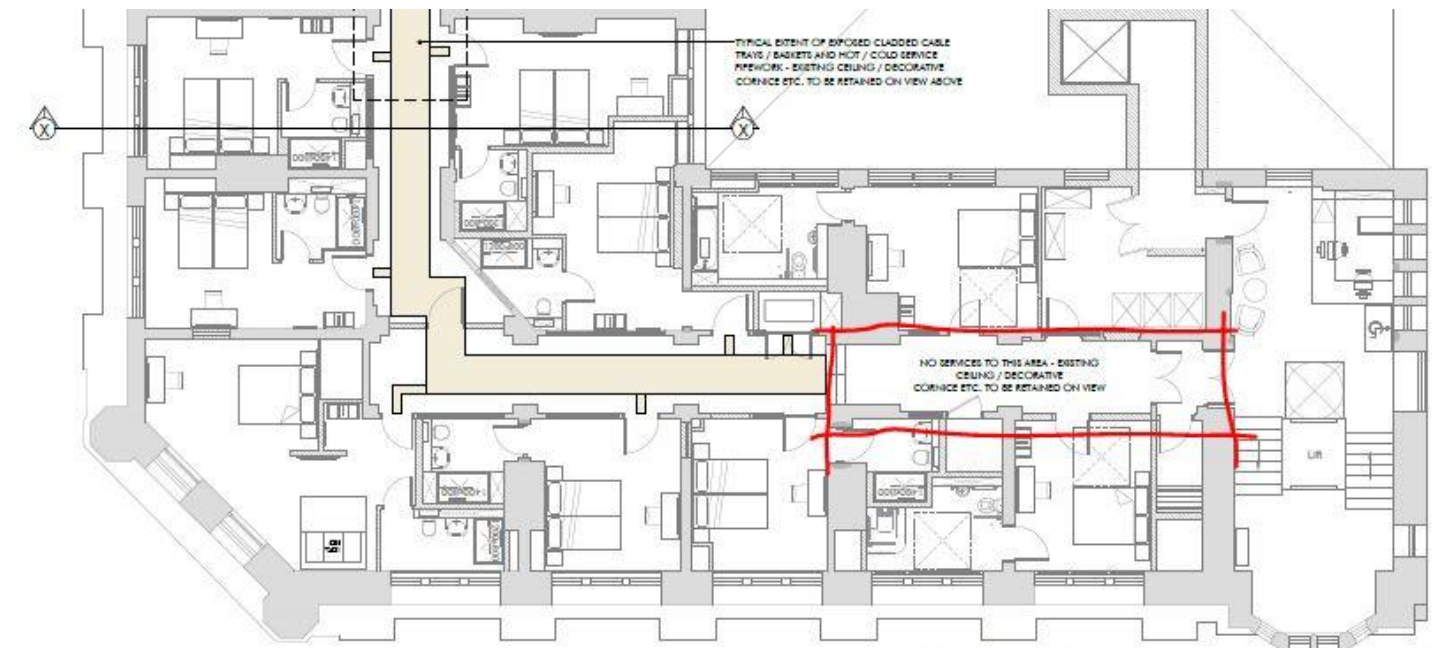
Fig 5: Location of fully exposed existing corridor ceiling with no raft – located directly off the proposed reception.

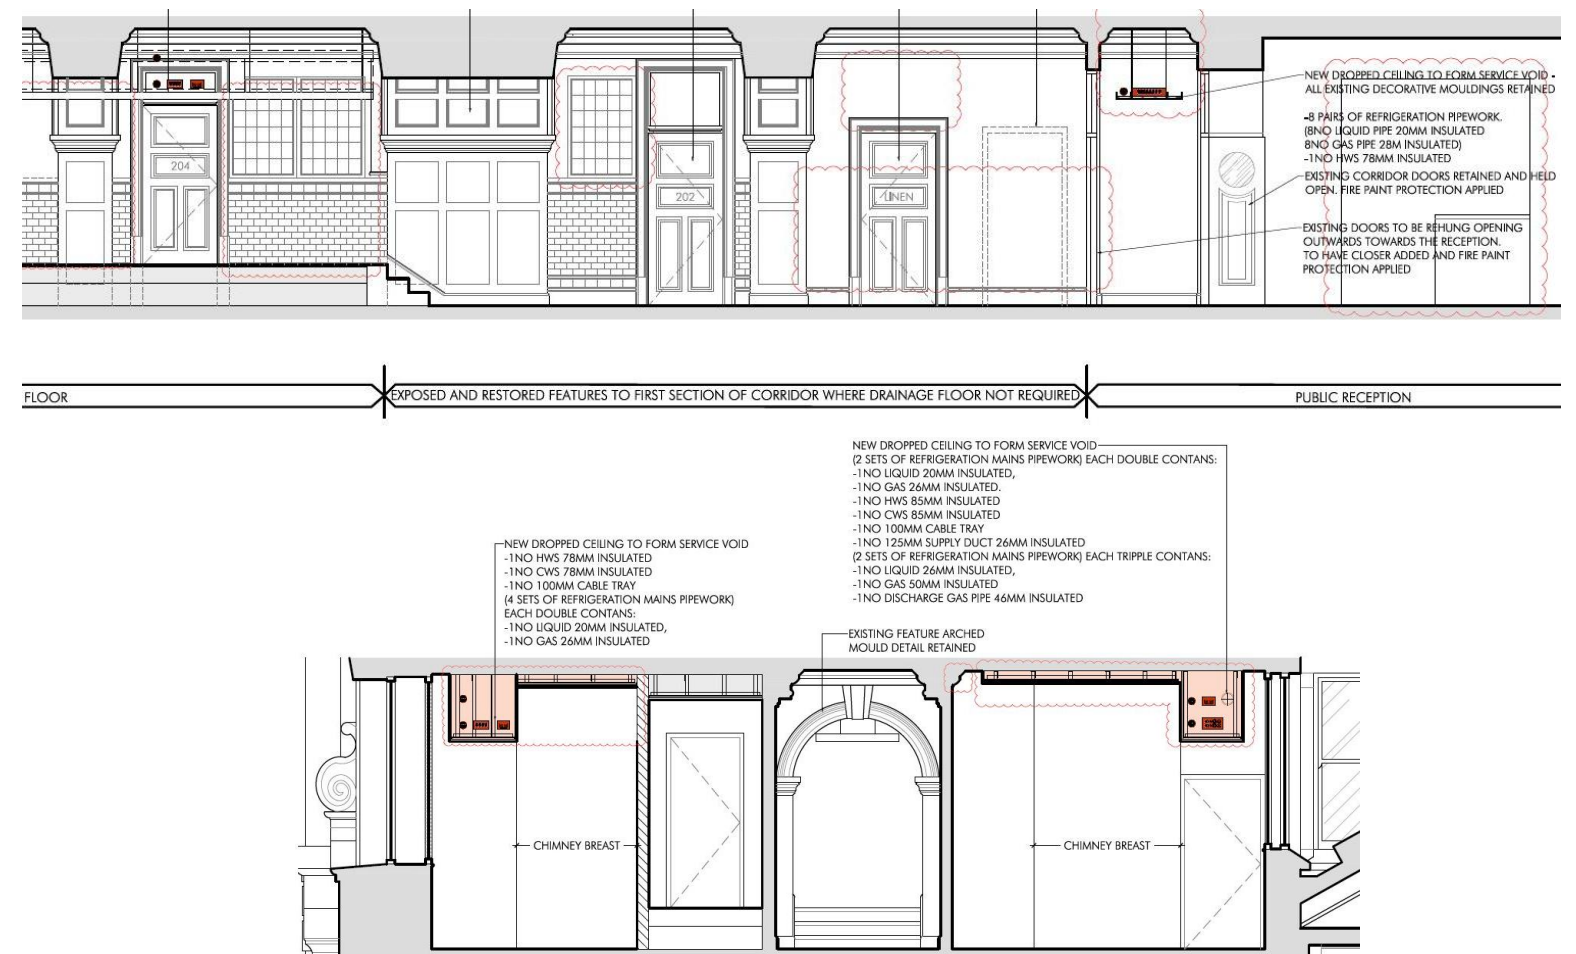
Fig 6: Internal elevations and cross section showing area at second floor with no raised floor or raft to ceiling.

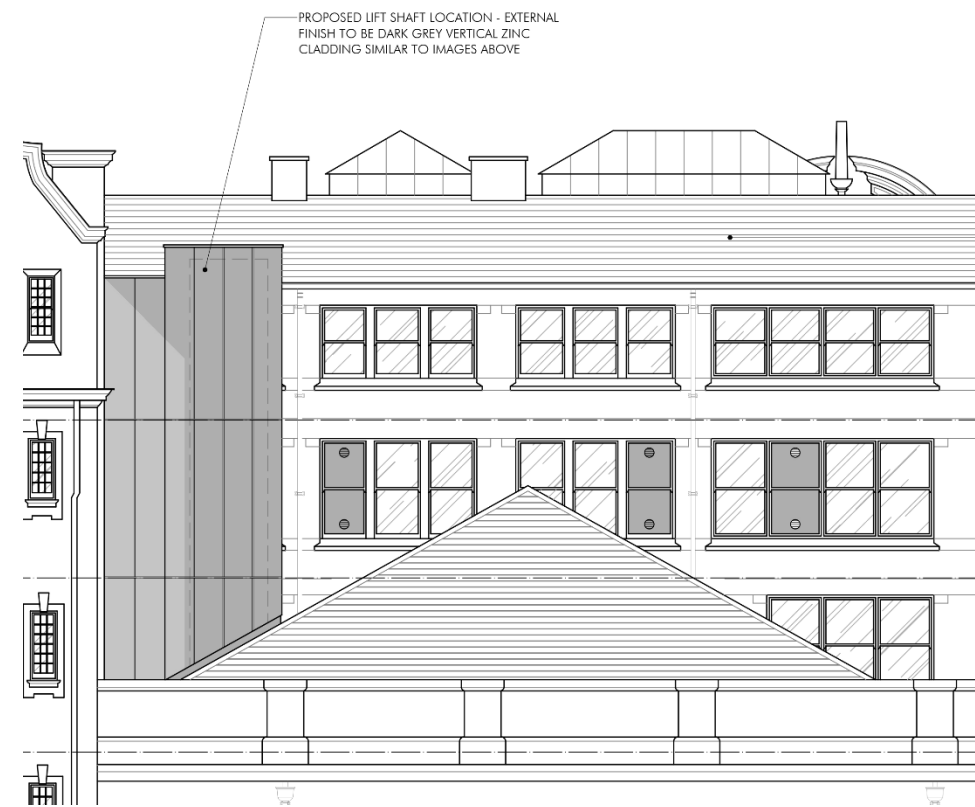
Fig 7: LEFT: Extracts from D&AS Section 2.14; ABOVE extract from rear elevations drawing; RIGHT detailed section through sash windows. \*

In order to achieve the required ventilation within the windowpanes with minimal visual impact to the rear, we are proposing to re-glaze the existing sashes with an opaque grey ceramic spandrel glass, with individual cut-outs for single air vents. As before, the affected windows are entirely obscured from view at street level by the courtyard pyramid roof, and mostly obscured by the pyramid roof when viewed from the adjacent office buildings. Using a glazed-in method, the existing sash windows can be retained or refurbished and the impact on the building fabric is limited and easily reversible.

Although the above opinion on the reversible and inobtrusive nature of this proposal was supported by the Planning Case Officer, further Conservation Officer comments have suggested openings drilled through brickwork would be preferable, and that we should show in detail why this is not possible. This is illustrated in the D&AS section 2.14 (page 13) – part reproduced below – demonstrating that there is insufficient depth at window head to 2<sup>nd</sup> & 3<sup>rd</sup> floors and a clash with roof structure at second floor cill level. The photograph to the right, also taken at second floor, and highlighted plan extract shows there is generally insufficient width of masonry at the window jambs to accommodate a core drill hole (about 125mm diameter would be needed, while leaving masonry surrounding it to maintain structural stability).

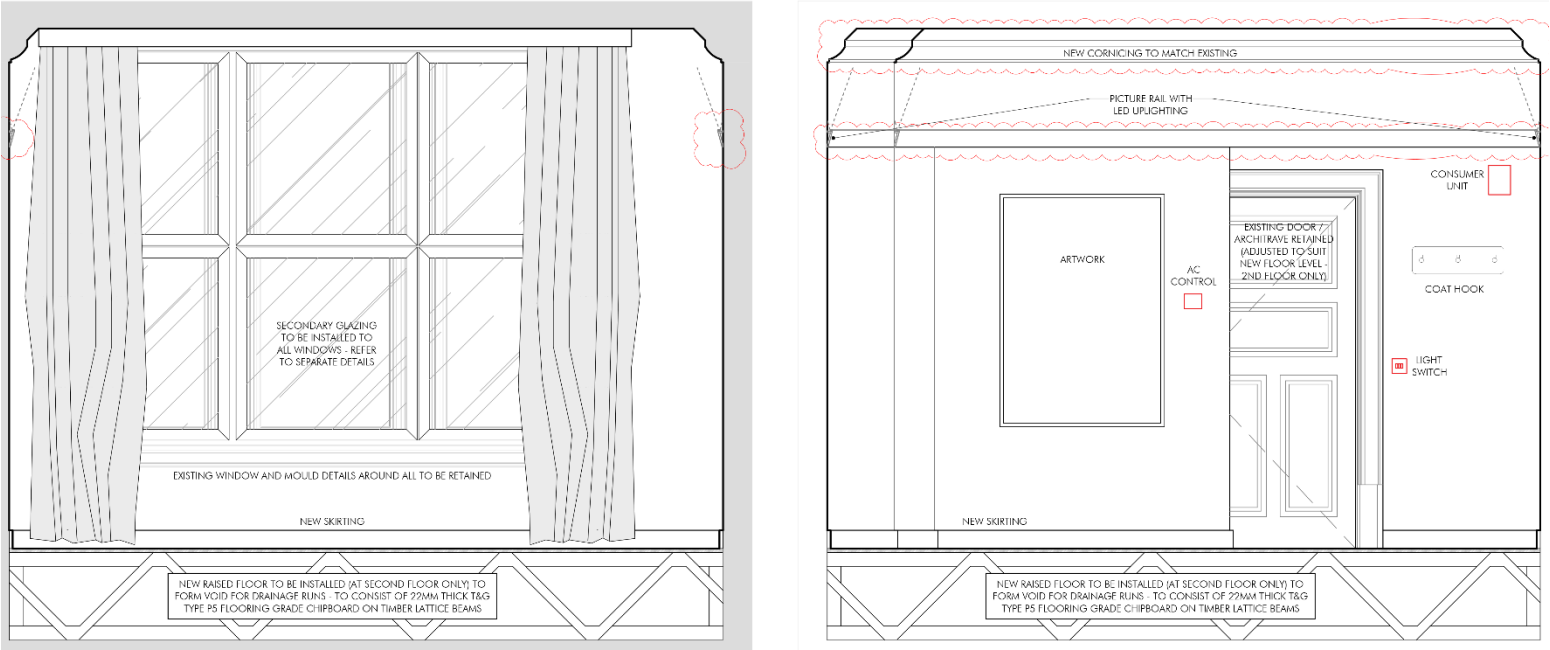
Fig 9: Extract from bedroom detail drawing at second floor level showing extent of ceiling raft in main bedroom area.

The proposed building sections have been updated to show in greater detail the extent and impact of dropped ceilings in bedrooms. The existing floors are solid concrete construction, so there is no floor void to distribute services into the space. To better highlight the existing room volumes, the previously proposed ceiling raft in the main part of the bedroom has been omitted. Instead, the design will enhance the original cornicing with LED picture rails, providing uplighting to celebrate these historic features.

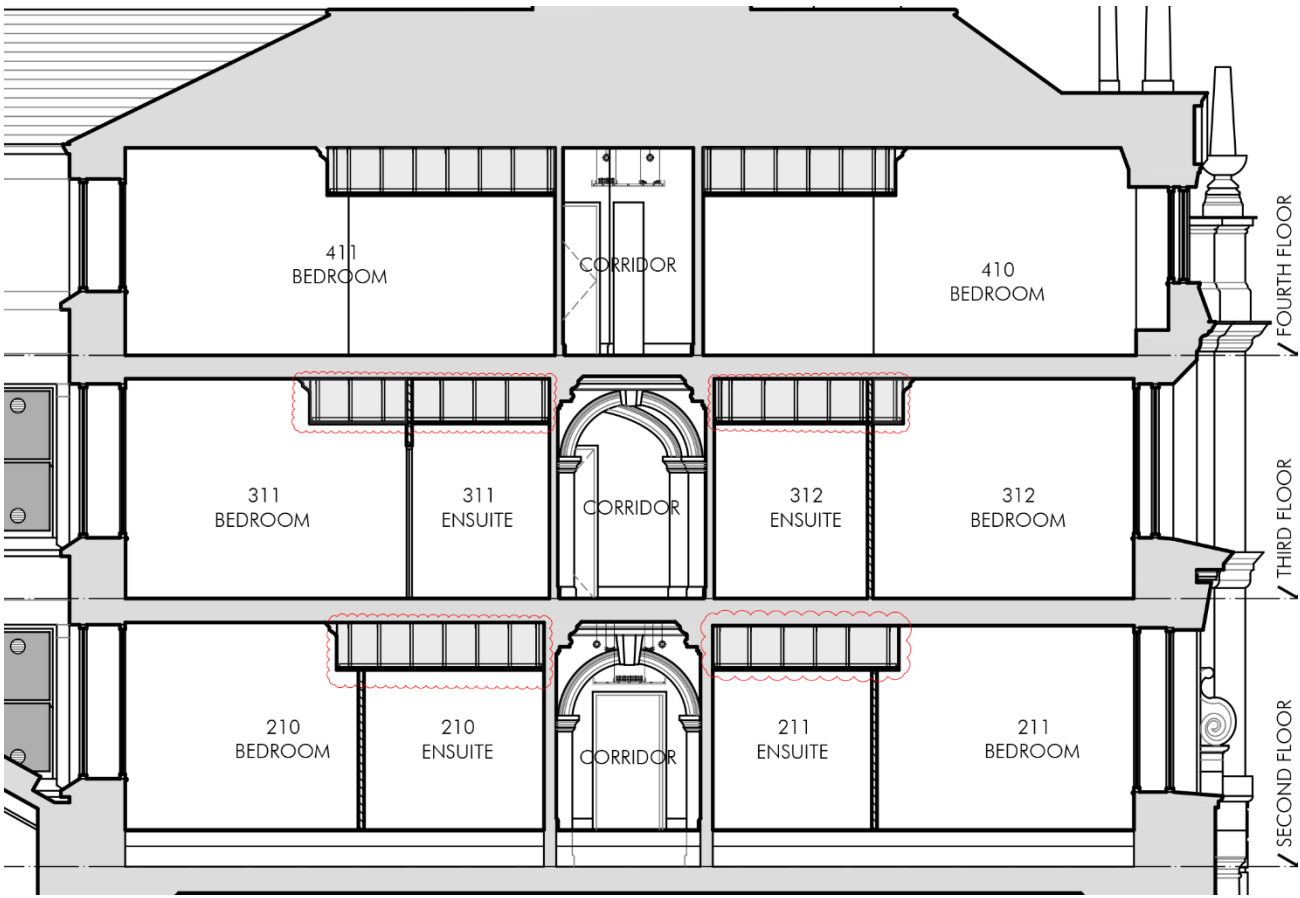
Fig 8: Extract from sectional drawing showing ceiling rafts to bedroom area.

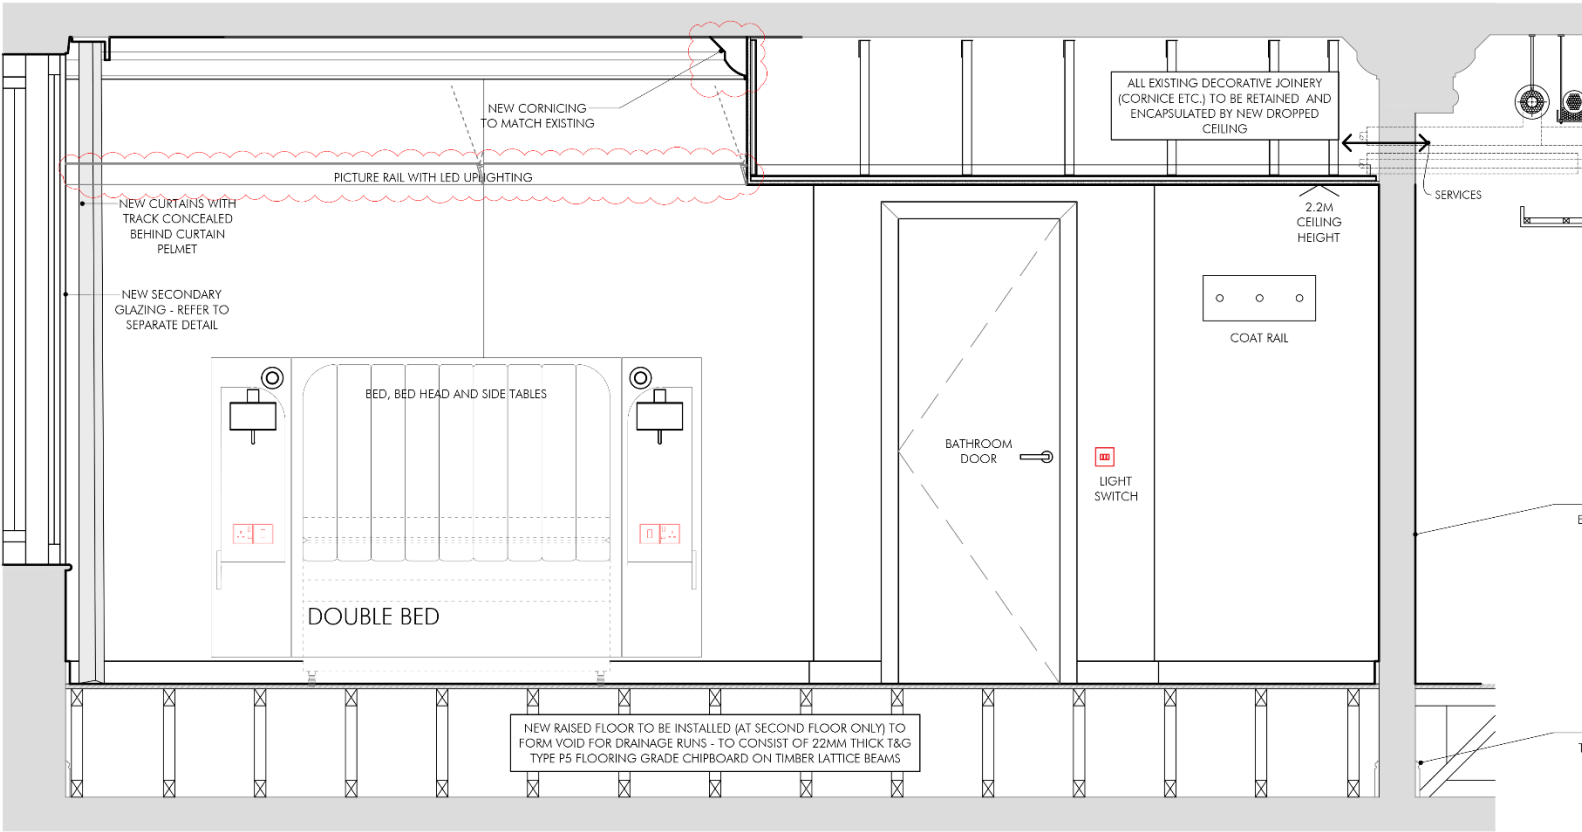
Fig 10: Extract from bedroom detail drawing at second floor level showing space for pipe and cable services in bedroom lobby area with depth to allow for installation of air conditioning cassette.

Where services (electrics, water and air conditioning pipework) enter the room adjacent to the corridor, an area of dropped ceiling will need to be provided low enough to allow these services to penetrate and pass through the wall below cornice level. This lower dropped ceiling will be a minimum of 350mm deep, low enough to also conceal a built-in air conditioning cassette unit.

Hot and cold-water services and ventilation ductwork will need to be concealed in this lower ceiling that will also extend over the ensuite shower room where ventilation grilles will terminate.

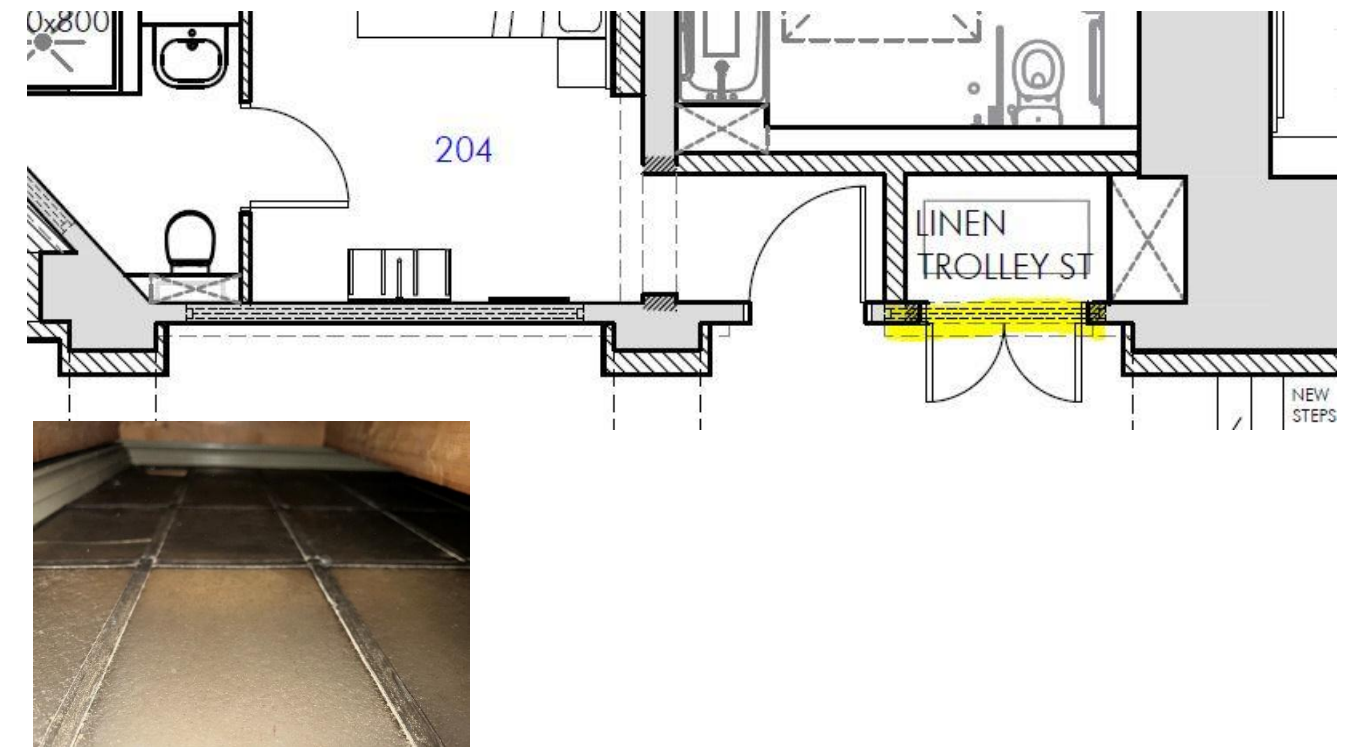
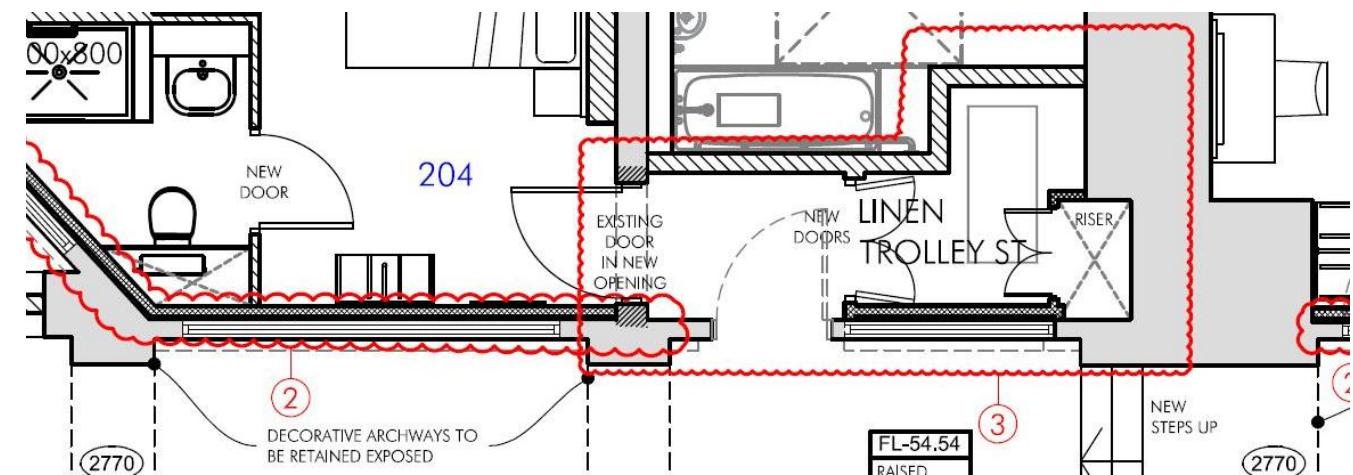
Fig 11: Top: Previous proposal to provide linen trolley store with removal of 'borrowed light' window at second floor level.

Inset: photograph confirming presence of glazed leaded borrowed light window

Bottom: Revised re-design to alter access to linen trolley store to allow for retention of the borrowed light window, to be exposed on the corridor side.

An example of redesign to retain the borrowed light windows is given opposite, where the entrance to a linen trolley store has been relocated to allow the internal window to be exposed on the corridor side.

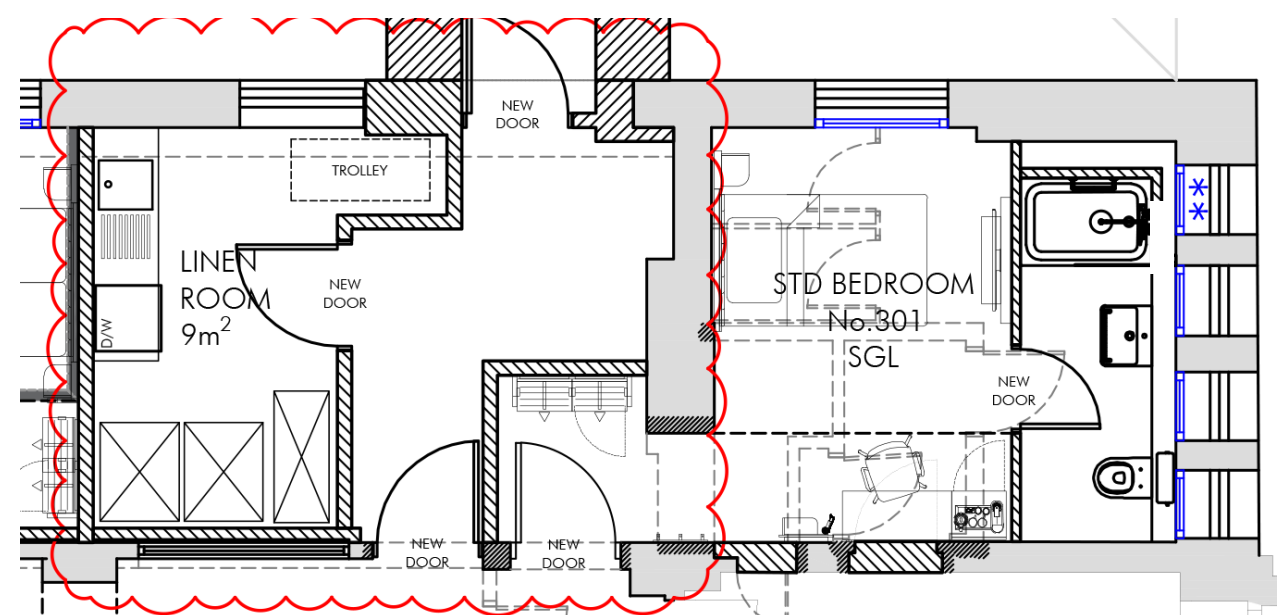
Fig 14: Left: Proposal for room 301 layout. Right: attempt to redesign room 301 to retain corridor borrowed light, highlighting reduced space to room 301. \*

The design changes outlined on the previous two pages have allowed the retention and exposure of 'borrowed light' windows in all areas of the building, with only one exception. The drawing extracts, pictured below, show: (left) the proposal to access room 301 and the adjacent linen room, borrowing some space from the linen store to accommodate a bedroom wardrobe, freeing-up space in room 301; and (right) an alternative re-design to avoid a reduction in the borrowed light window hidden in the corridor wall.

We have highlighted in red the resulting reduced space around bedroom furniture, and we do not consider this to be a viable arrangement, being too tight to comfortably operate as a hotel room. Also, the resulting staggered access into/out of the linen store would make the existing corridor doorway liable to significant damage from the wheeling in and out of laden linen trolleys.

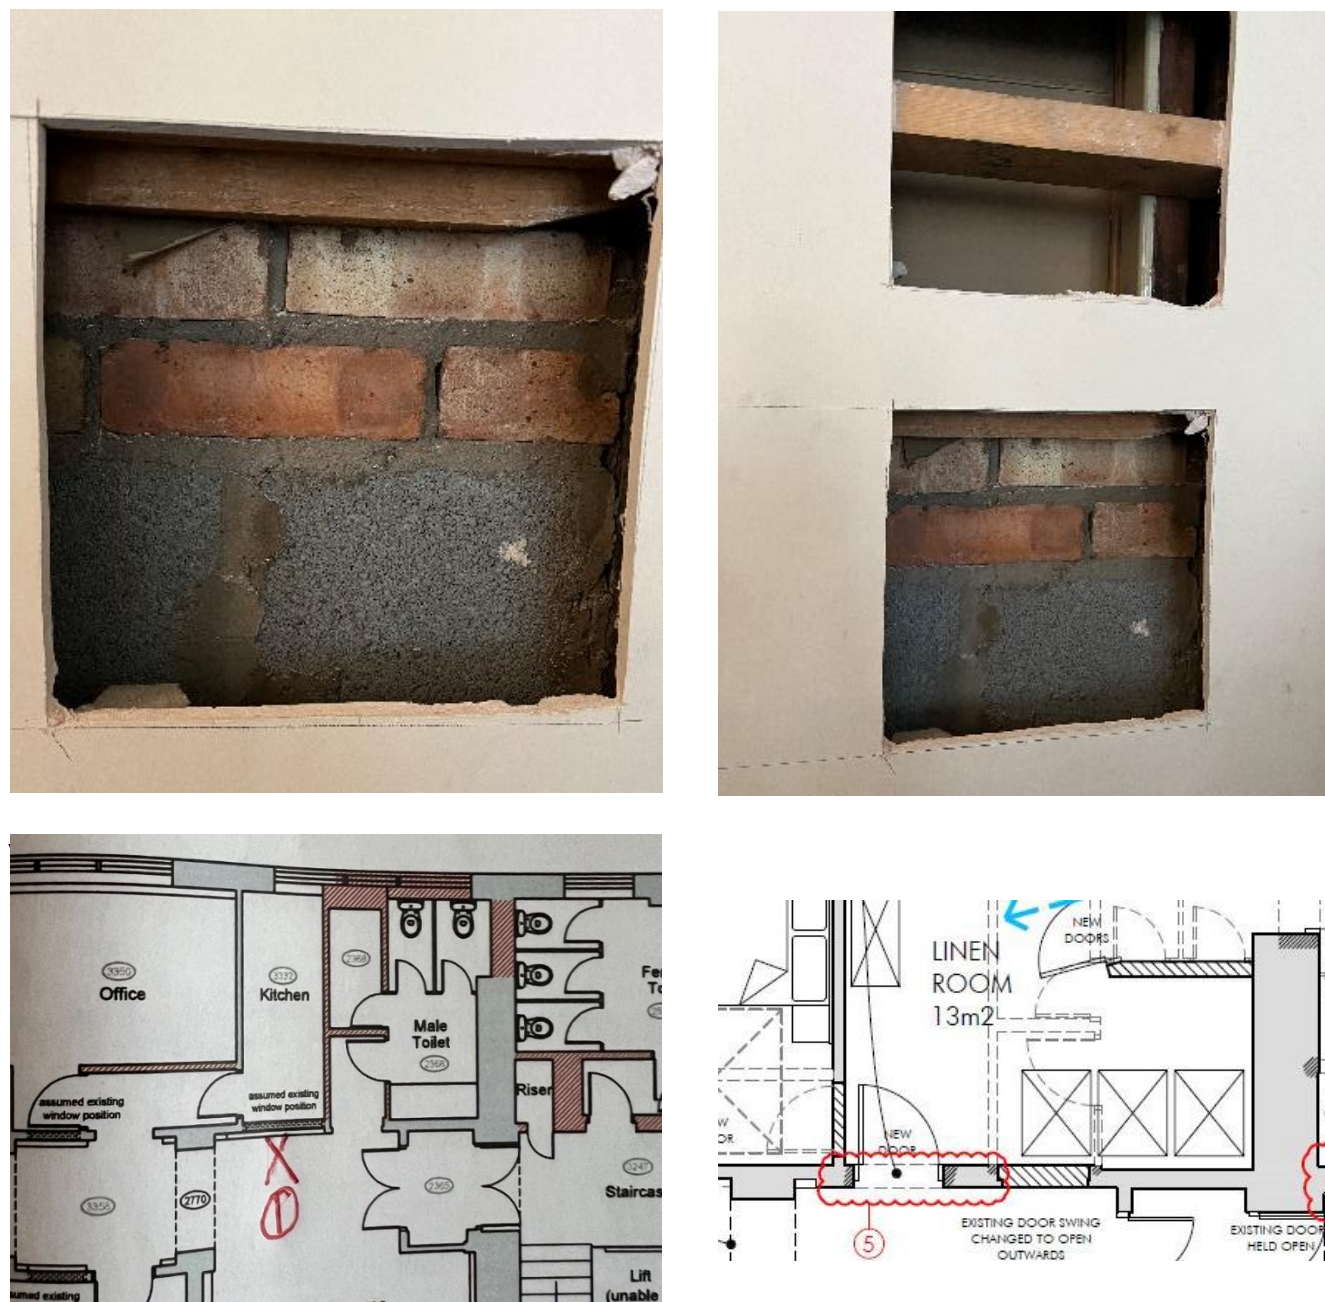
Fig 15.1: Photographs showing modern brick and blockwork infill where a previous opening has been filled-in to location of proposed doors to 2<sup>nd</sup> floor linen store (proposed plan extract on the right).

Further photographic evidence has been requested to show the lack of harm caused by new openings at 2<sup>nd</sup> floor (new linen store doorway) and to 4<sup>th</sup> floor (room 401 & linen store doorways). This is provided below:

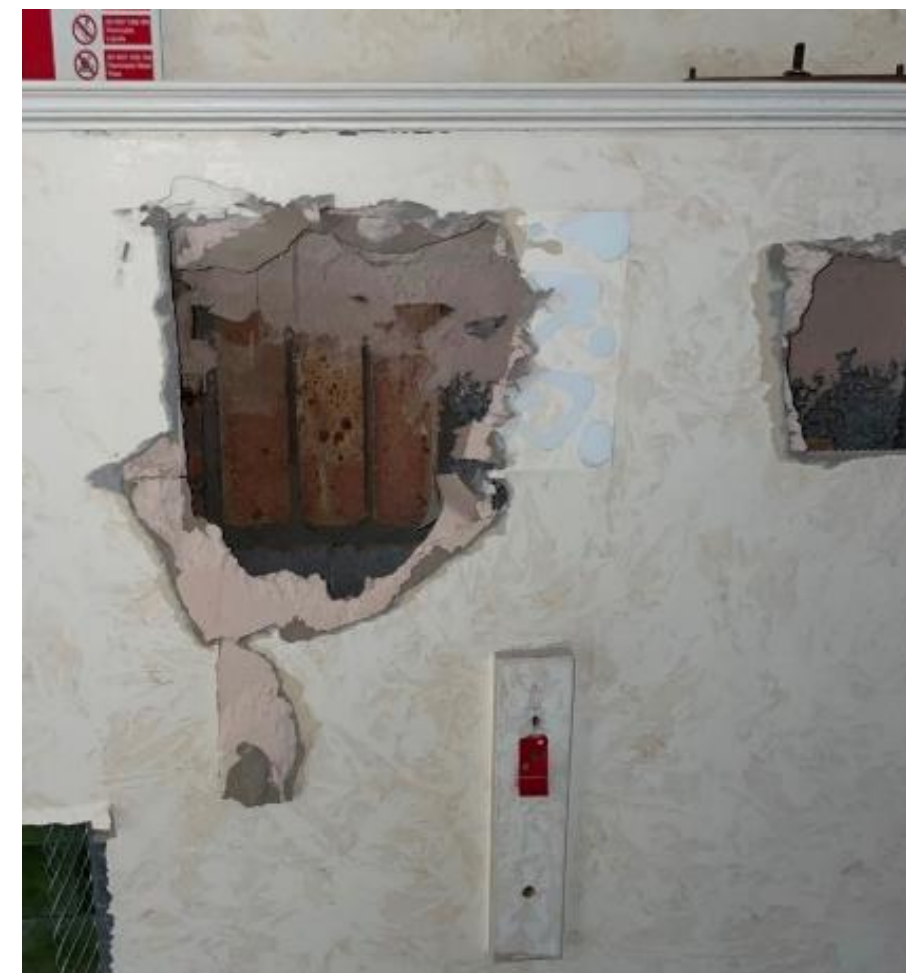
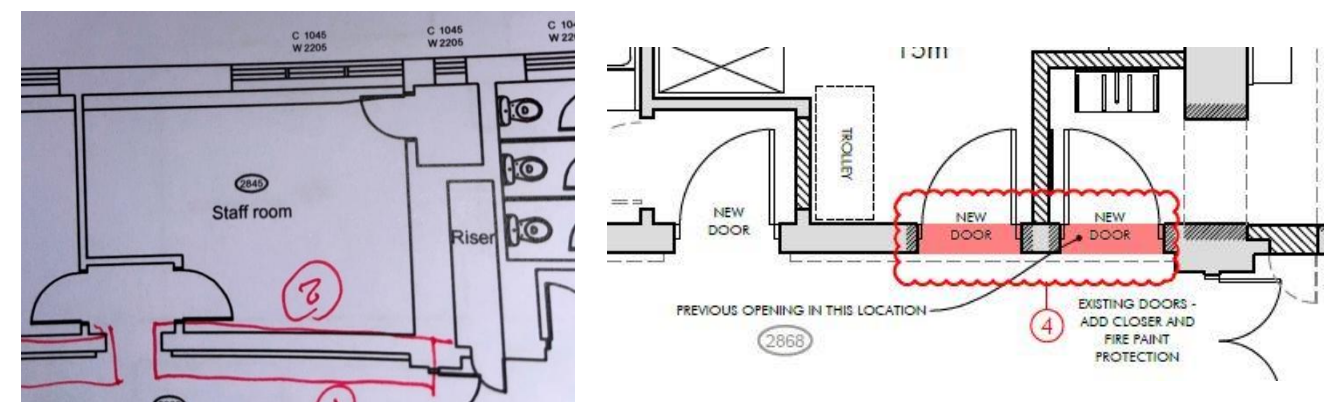
Fig 15.2: Photograph showing modern brick infill where a previous opening has been filled-in to location of proposed doors to 4<sup>th</sup> floor linen store/bedroom 401 (proposed plan extract on the right).

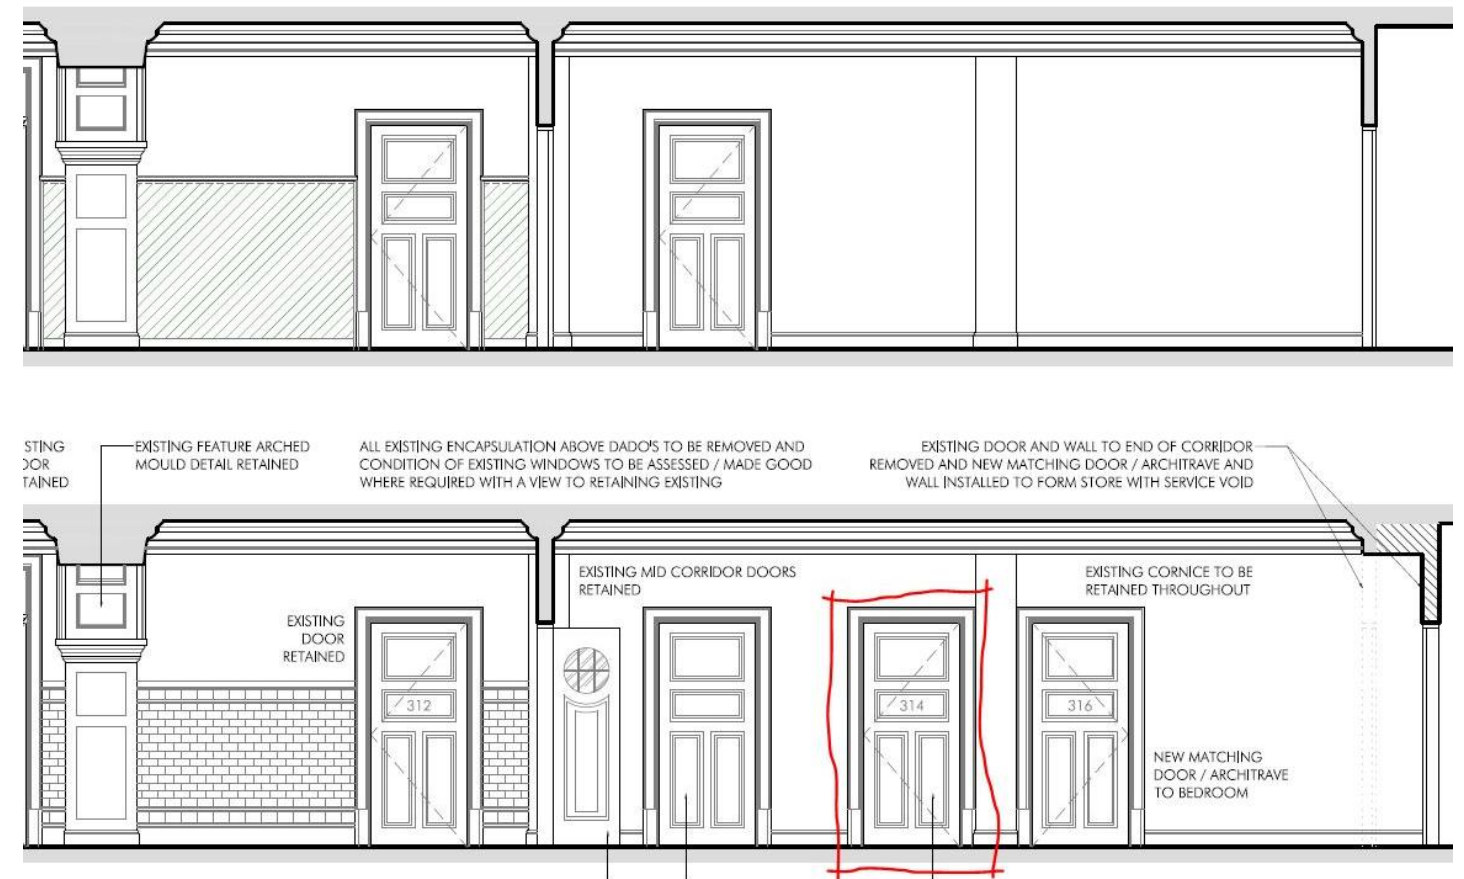
Architectural drawings for three rooms (412, 314, 212) showing floor plans, elevations, and sections. Room 412 includes a 'NEW DOOR' and 'EXIST. ADD 1 PAIR'. Room 314 includes a 'NEW DOOR' and 'DOOR TO BE RETAINED AND FIXED SHUT'. Room 212 includes a 'NEW DOOR' and 'EXISTING DOOR REHUNG'. The drawings show various fixtures like sinks, toilets, and shelves, along with dimensions and material callouts like SVP 11, SVP 12, and IC.

From the floor plans it is evident that the rooms above and below 314 have the same 'hand' of layout. This determines the bathroom position and the bedroom layout. The bathrooms require vertical drainage services, and also central ventilation extraction is routed to the bathroom side. If the handing was switched on 3<sup>rd</sup> floor, boxing in would be required within the rooms for these vertical services, plus additional vertical services for the new bathroom position would be required and similarly require boxing-in on 2<sup>nd</sup> floor. Weighing up the resultant harm, we have selected a design of least harm to the existing building fabric. The door to 314 is to remain in place, shut and boarded on the bathroom side, thus no original fabric is removed. In the corridor outside room 314, there is no wall tiling that would be damaged by the insertion of a new door. As can be seen on the illustration below, a new matching door for room 314 (and also for room 316) will be inserted into the existing wall with no damage or removal of tiling features.

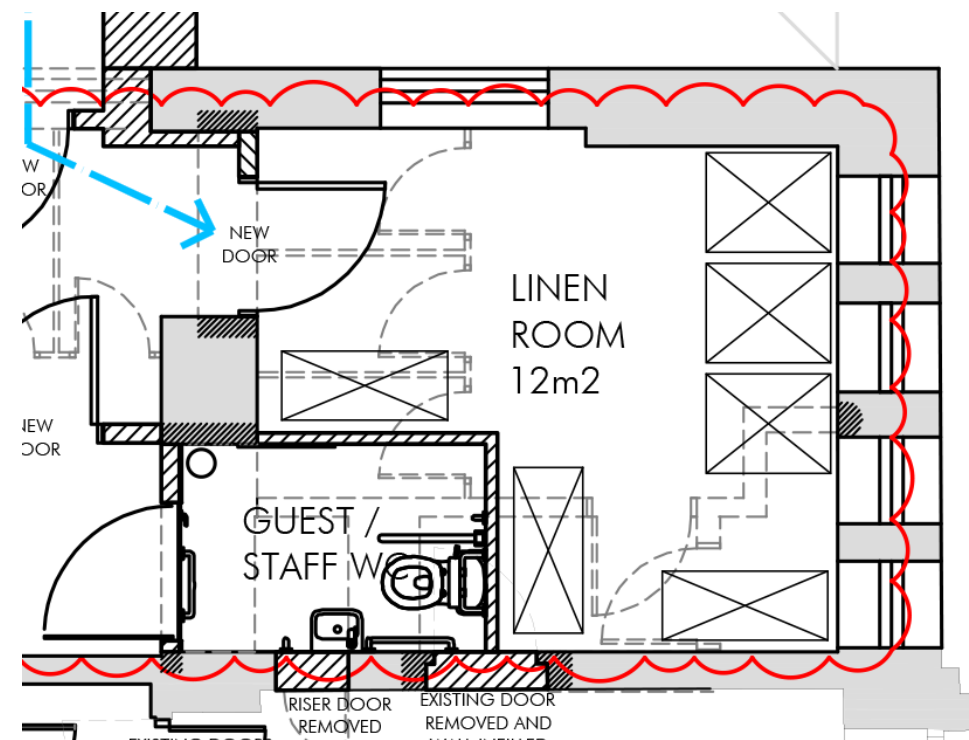
Fig 16: Linen room formed in the area of former communal office toilets. Legibility of the group of four windows to the side wall retained. \*

- On the second floor, it was previously proposed that the wall be partially removed. We are now proposing that this wall be retained in full, with the existing doors removed and infilled to form a guest/staff WC and linen room.
- Where showers abut one of the existing window openings, these have been amended to reinstate the fourth window opening (which will have frosted secondary glazing applied) so that the group of four windows in that space remain legible.
- As requested, boxing around the shower has been reduced, the boxing to the rear of the shower must remain for vertical services to the shower – wastewater, H&C water and ventilation.
