# ADDENDUM DESIGN STATEMENT

Change of Use to Upper Floors and Alterations  
to create 46 Bedroom Hotel

1-3 York Street, Manchester

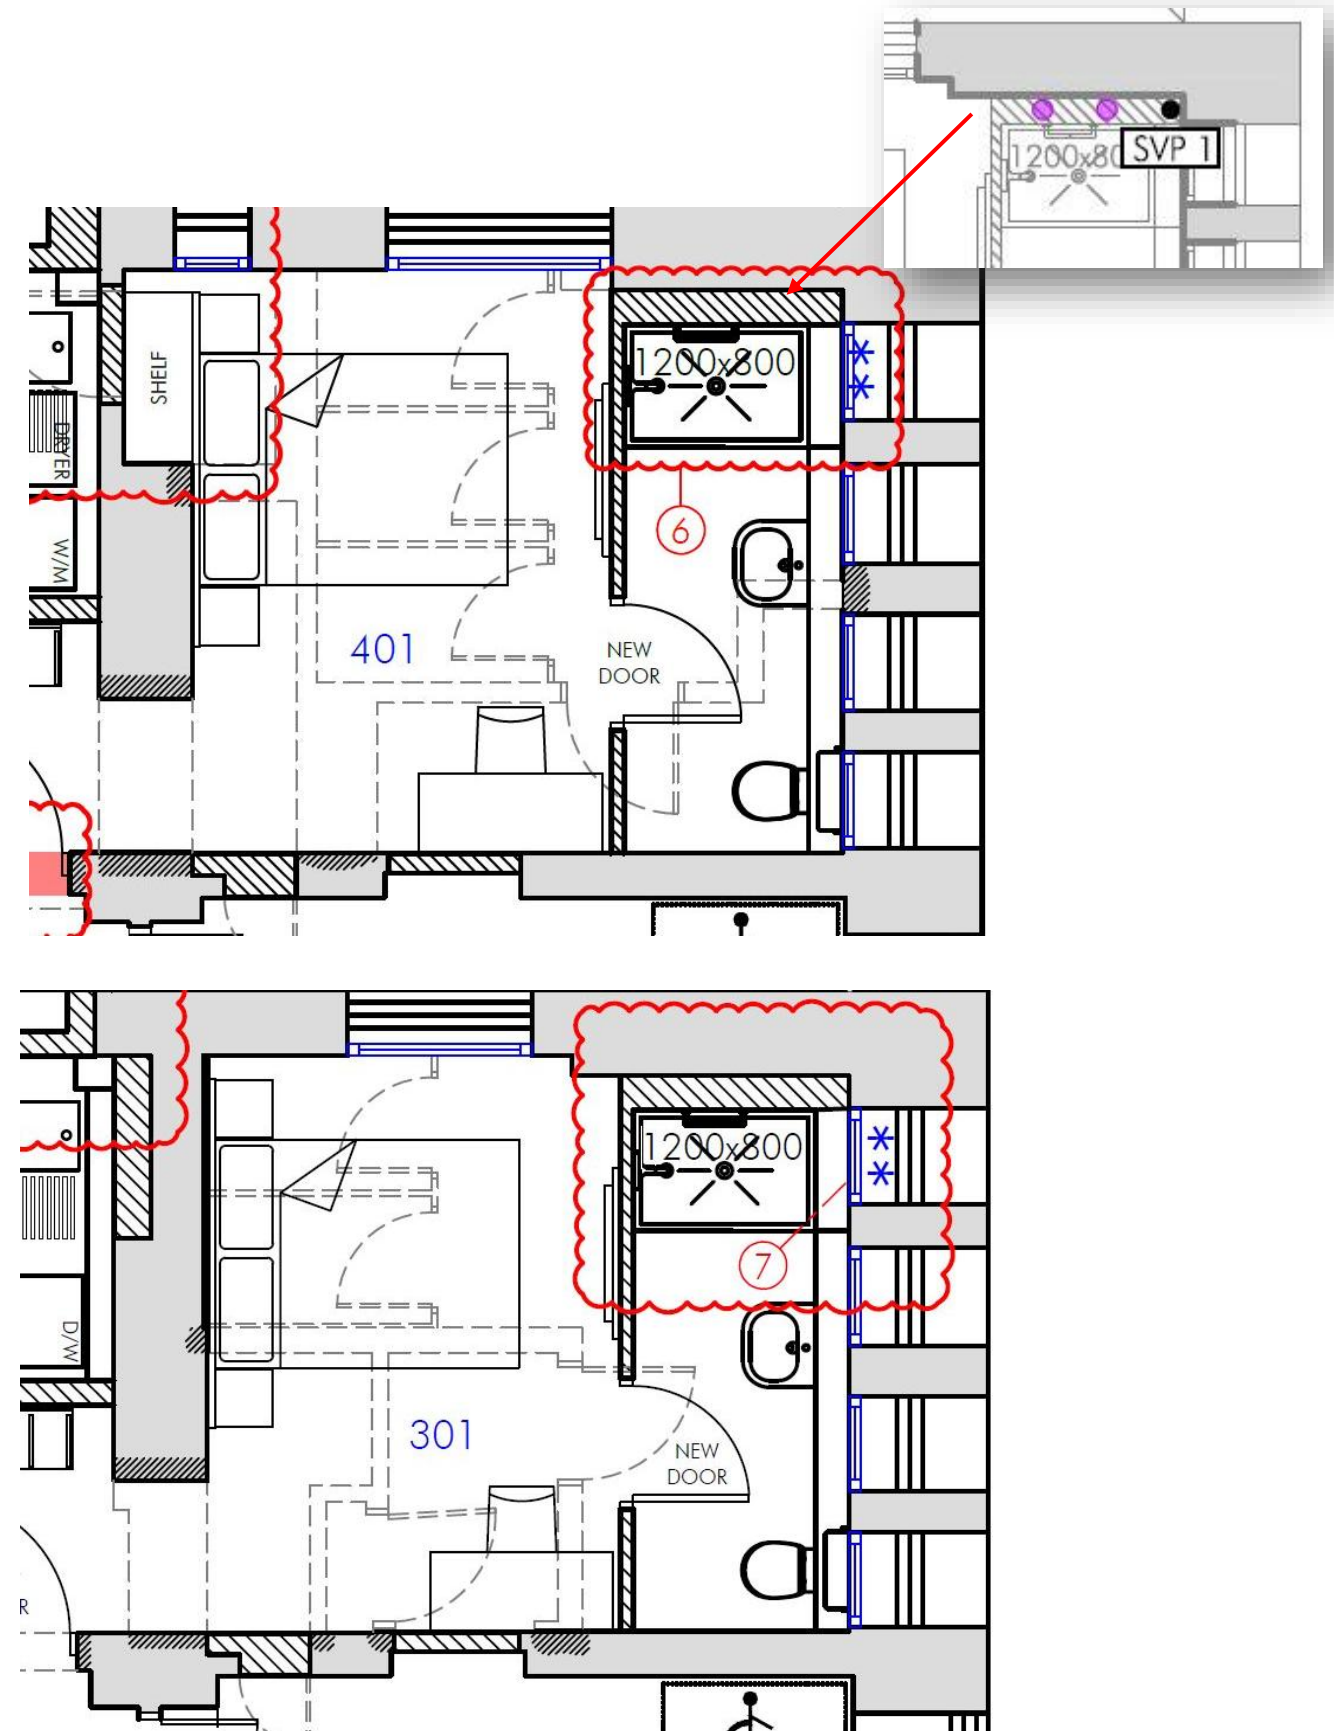
Fig 17: Upper floor bedrooms inserted into former communal office toilets area, retaining the legibility of the group of four windows to the side wall (inset: vertical services to riser boxing behind shower)

- On the second floor, it was previously proposed that the wall be partially removed. We are now proposing that this wall be retained in full, with the existing doors removed and infilled to form a guest/staff WC and linen room.
- Where showers abut one of the existing window openings, these have been amended to reinstate the fourth window opening (which will have frosted secondary glazing applied) so that the group of four windows in that space remain legible.
- As requested, boxing around the shower has been reduced, the boxing to the rear of the shower must remain for vertical services to the shower – wastewater, H&C water and ventilation.

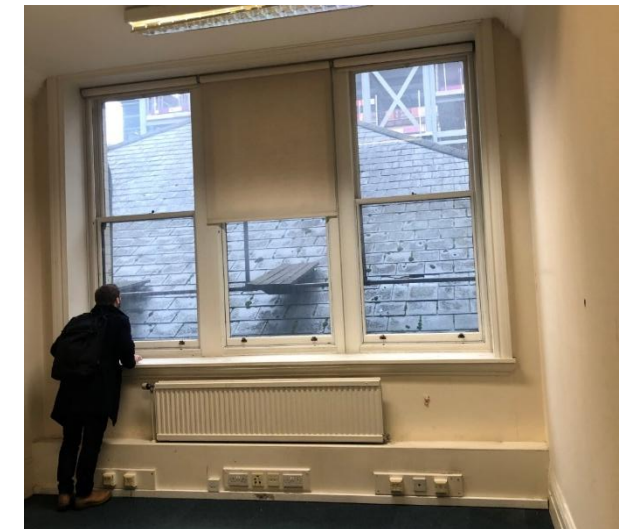
Fig 19: Typical window showing wide mullion sections between sash casements, and radiator & services boxings to be removed.

- All bedrooms throughout the building necessitate a level of subdivision to insert an ensuite shower room into each room. In that context, some level of subdivision of original internal volumes will be necessary to bring the building into continued use.
- The existing timber sash windows include a wide mullion, giving a suitably wide surface to enable the subdivision of the windows between the two spaces.
- The subdivision is not legible externally and the lower two floors are hidden externally behind the courtyard pyramid roof and cannot be seen at close proximity from outside.
- Existing radiators and wall mounted boxings concealing pipework and cabling shall be removed (see inset photo)

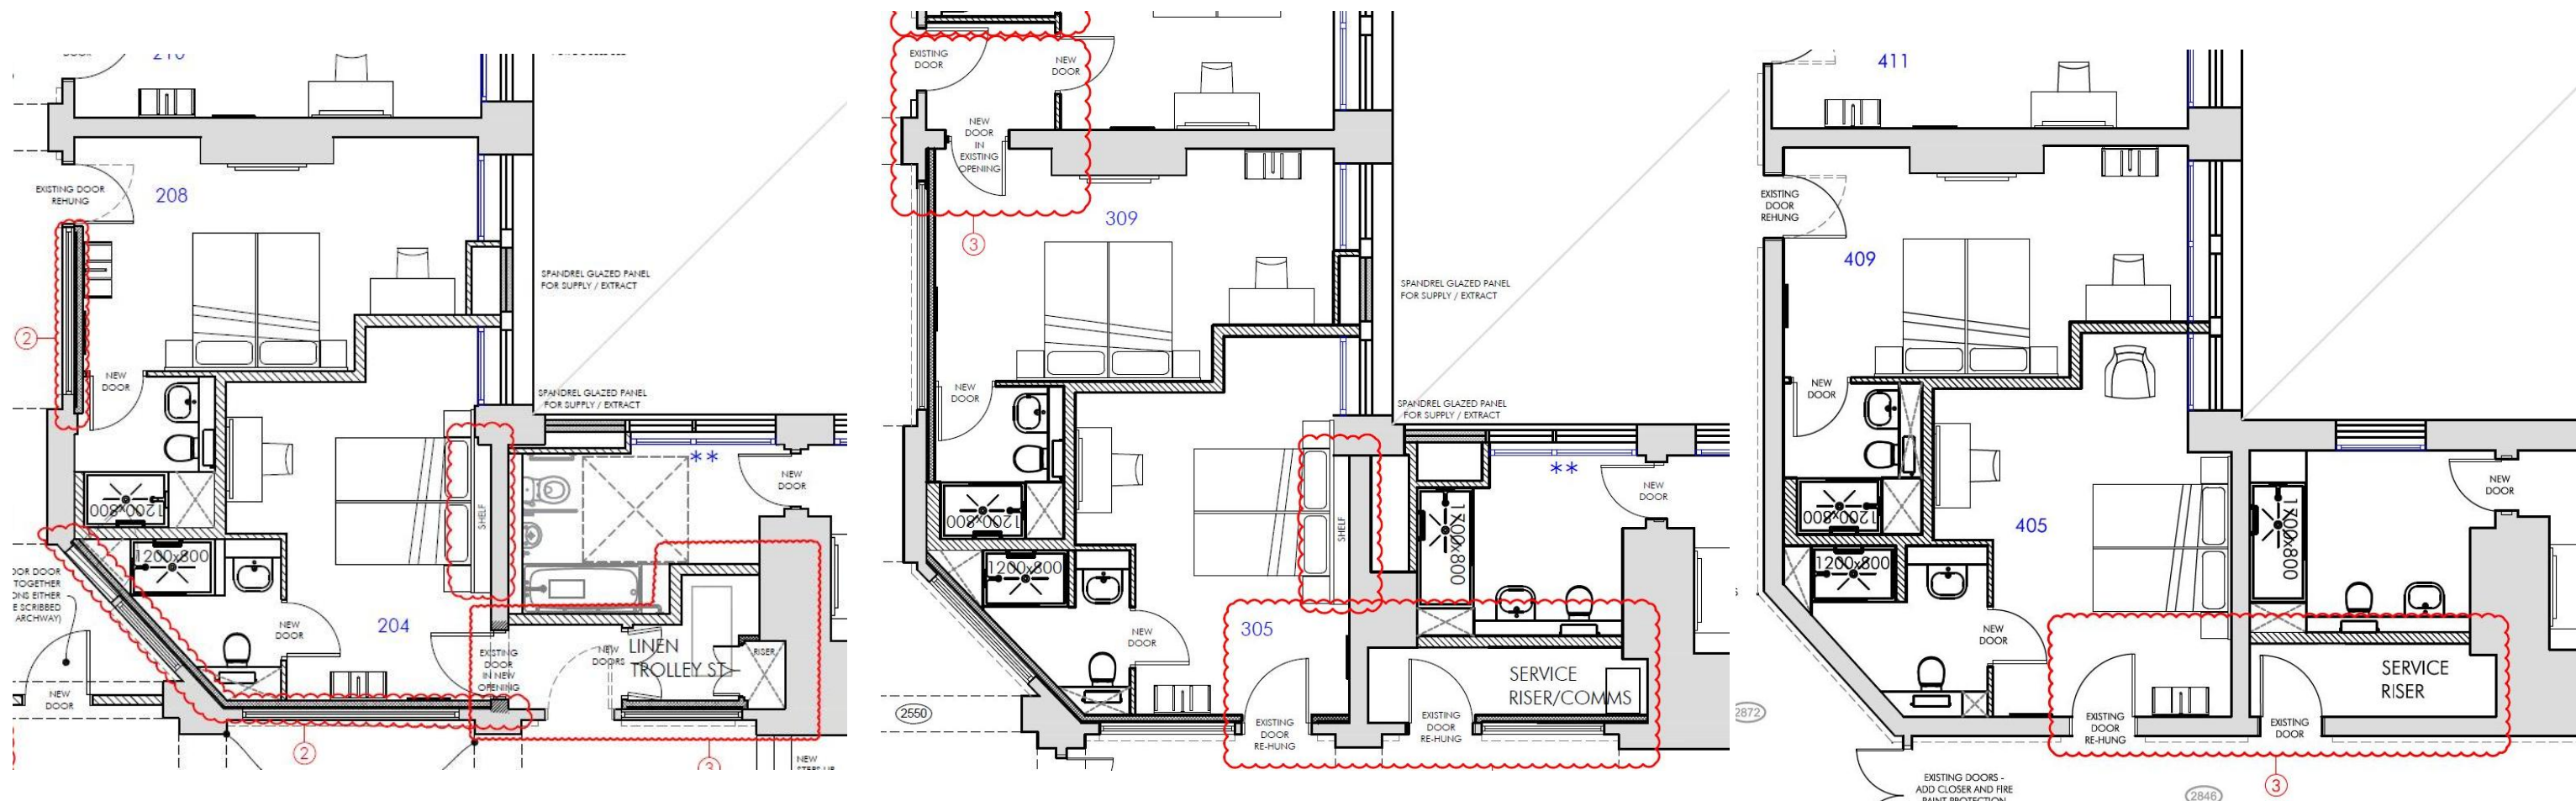
Fig 18: Floor plan layouts of internal corner bedrooms at 2<sup>nd</sup>, 3<sup>rd</sup> & 4<sup>th</sup> Floors.

- The layout has been reconsidered to ensure that no new door openings into the spaces are required and they can function as two separate rooms without the need to form any new doorways in the existing fabric.
- The layout has been reconsidered to also ensure that any 'borrowed light' windows can be retained completely intact, and an internal lining added so they can remain restored and on view from the public hotel corridors.

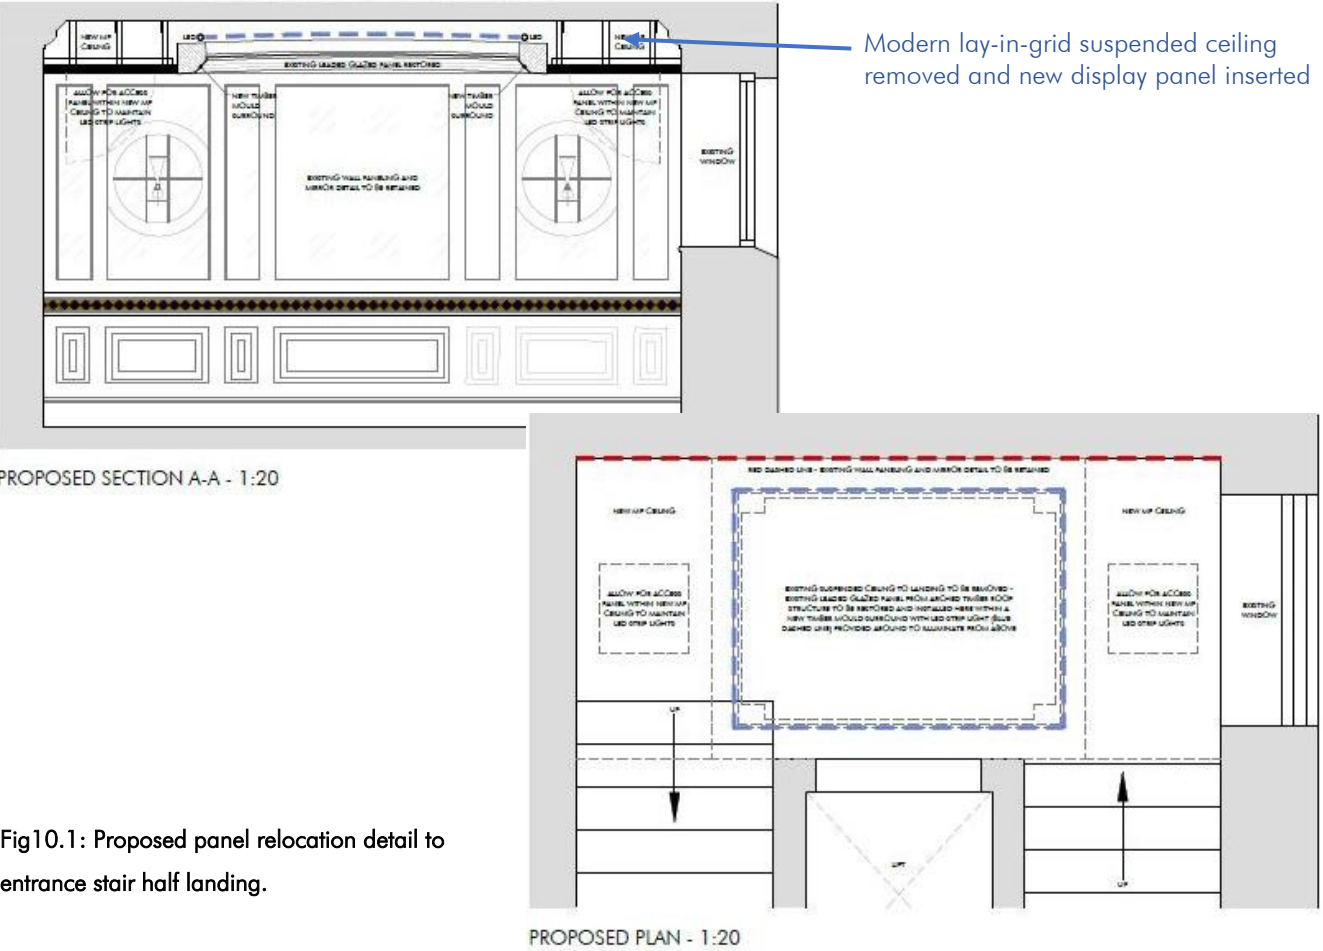
Fig10.1: Proposed panel relocation detail to entrance stair half landing.

In addition, we have submitted a drawing AP41 'Proposed Glazed Light Relocation Detail'. Although final details would be welcome as a planning condition, this detail has been prepared to demonstrate that the stairwell mid-half landing ceiling are of sufficient size to enable a reconstruction of a single glazed panel, clamped in a new timer frame and top-lit as a feature. This may be in conjunction with an information/interpretation panel to relate the feature to the history and origin of this almost entirely eradicated piece of the banking clerks' hall and its history.

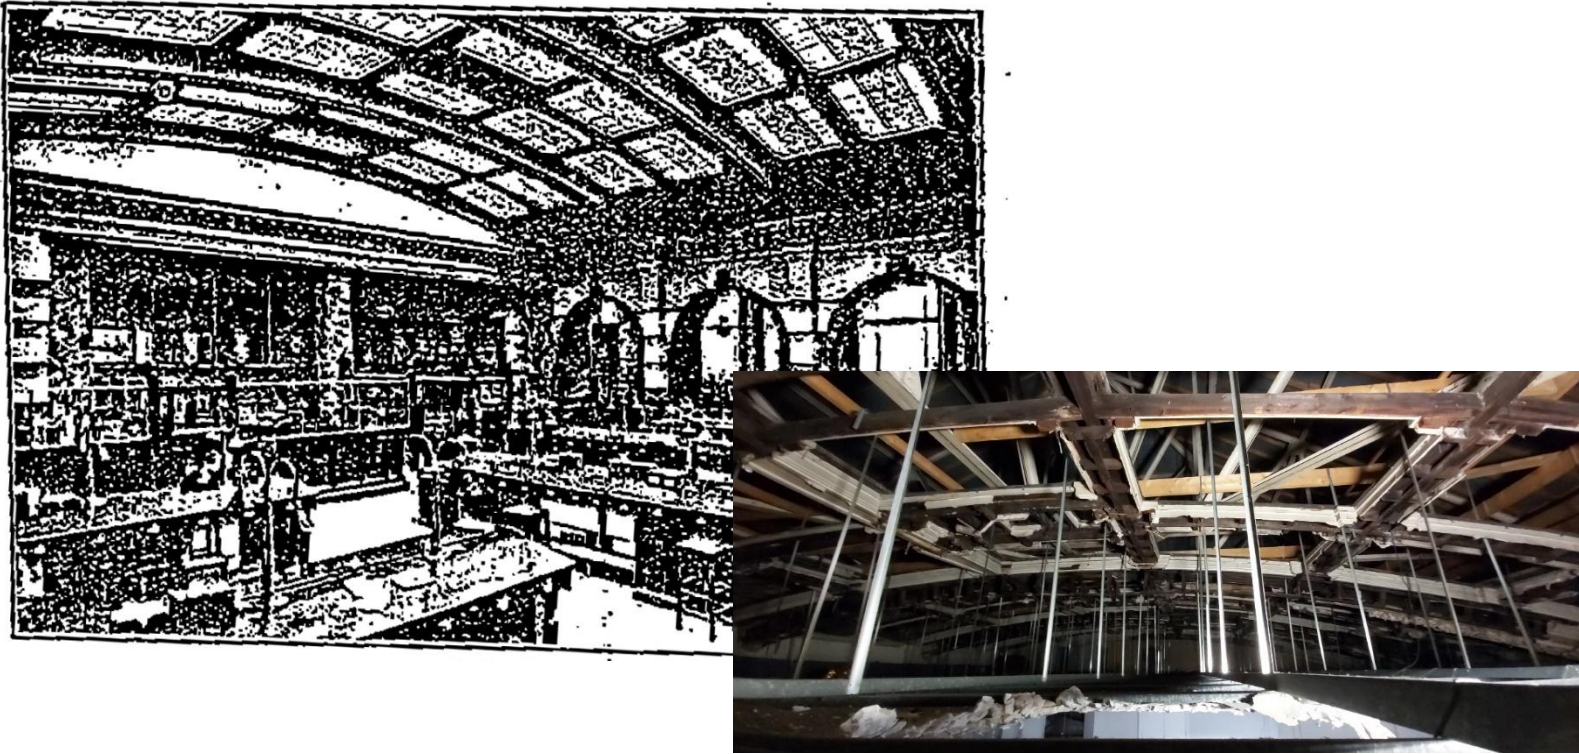
Fig 9: LEFT The only record photograph of the former clerk's hall, from The Builder's Journal 1907; RIGHT photograph taken looking across the current ceiling void showing only the timber primary ceiling structure still in place.

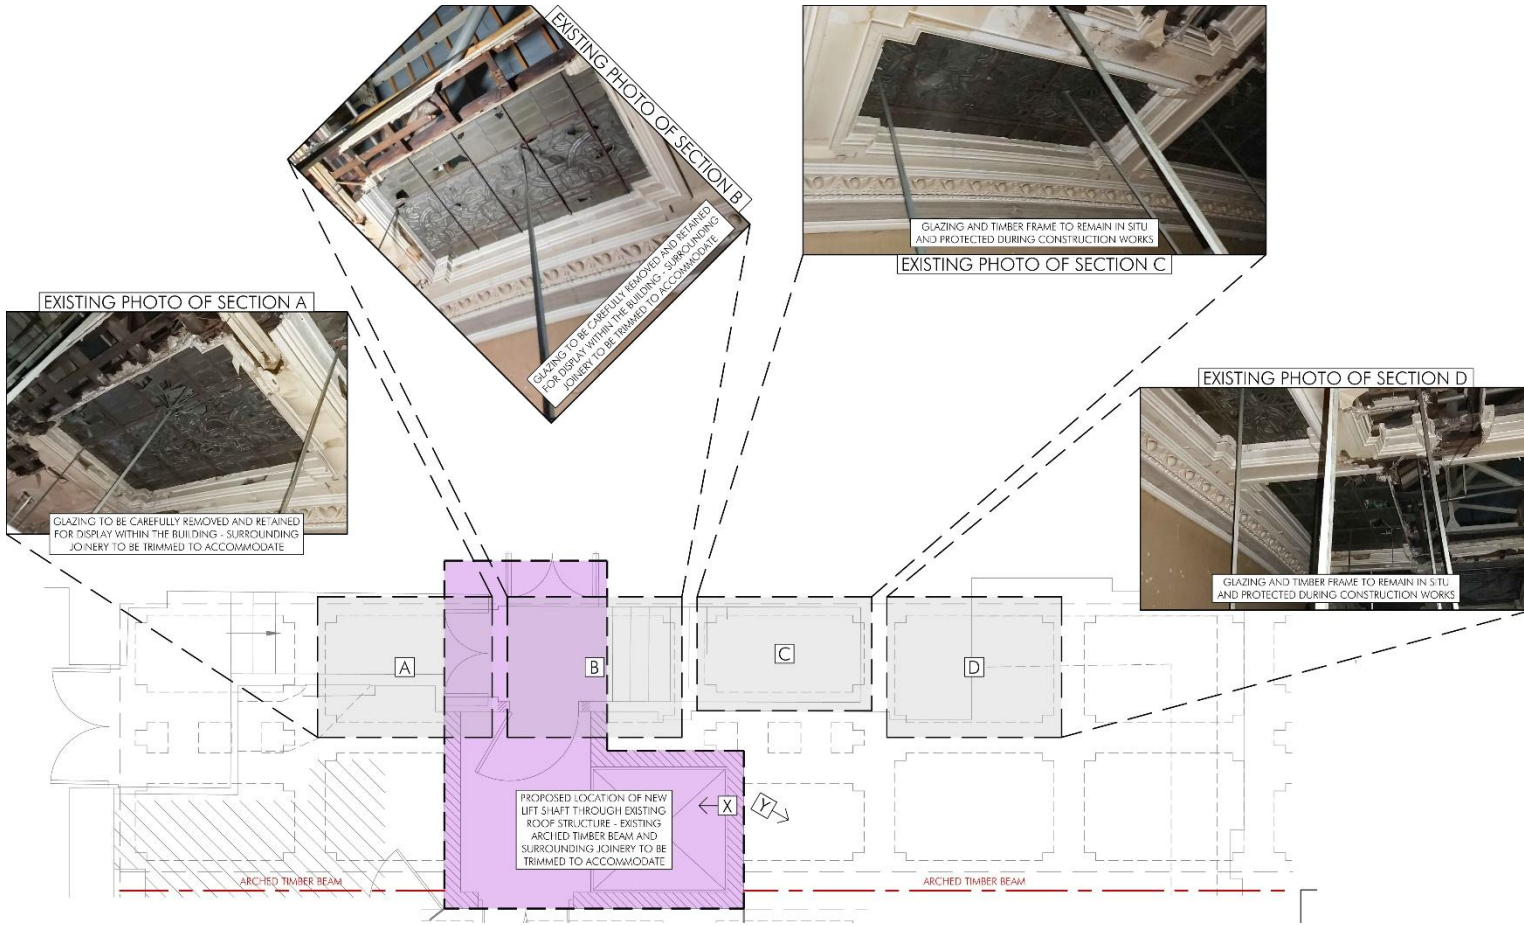
Fig 10.2: the proposed lift location (purple) in relation to remaining section of ceiling glazing (part reflected ceiling plan)

When inserting the necessary service lift for hotel use, its location is governed by the existing roof structure – a combination of steel and timber roof construction. The necessary location of the new lift is shown in purple on the illustration opposite. This location conflicts with the remaining small areas of glazing. Therefore we propose to retain two of the panes insitu, to be protected during construction; and we propose to carefully remove the other two panels for specialist conservation repairs and cleaning. The two restored panels shall be displayed in the public areas of the hotel – for example in the main stairwell on a landing between ground floor and reception – along with some information/interpretation. The panels can be back-lit as a wall feature or mounted in the ceiling – the final detail for this installation can be agreed by Planning Condition if required.

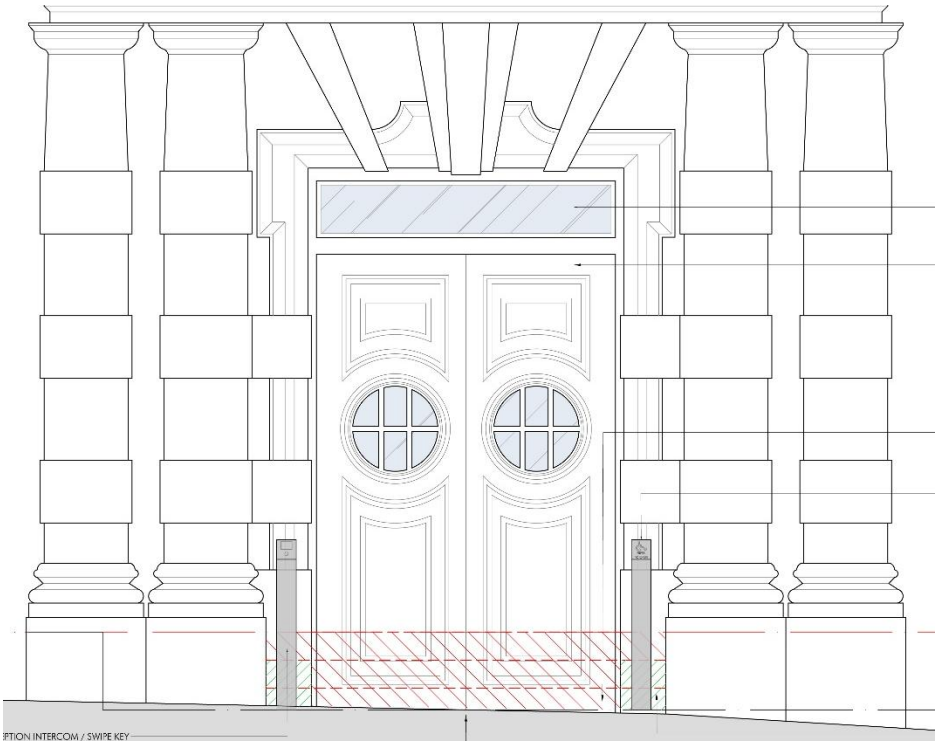
Fig 10: External elevations, showing existing doors relocated with fanlight above, and door controls/voice communication points provided on freestanding external stainless steel posts

Further details for the treatment of the entrance lobby, following the lowering of the structural floor for level access, has been provided on drawings AP.51 (internal) & AP.32 (external). Externally, plinth stonework shall be made good, the existing doors re-used and fitted with power assisted automation, and a new fan light added above it. Rather than fixing to the building, door activation and voice communication for nighttime use will be provided on free-standing stainless steel posts located within the recess of the external portico.

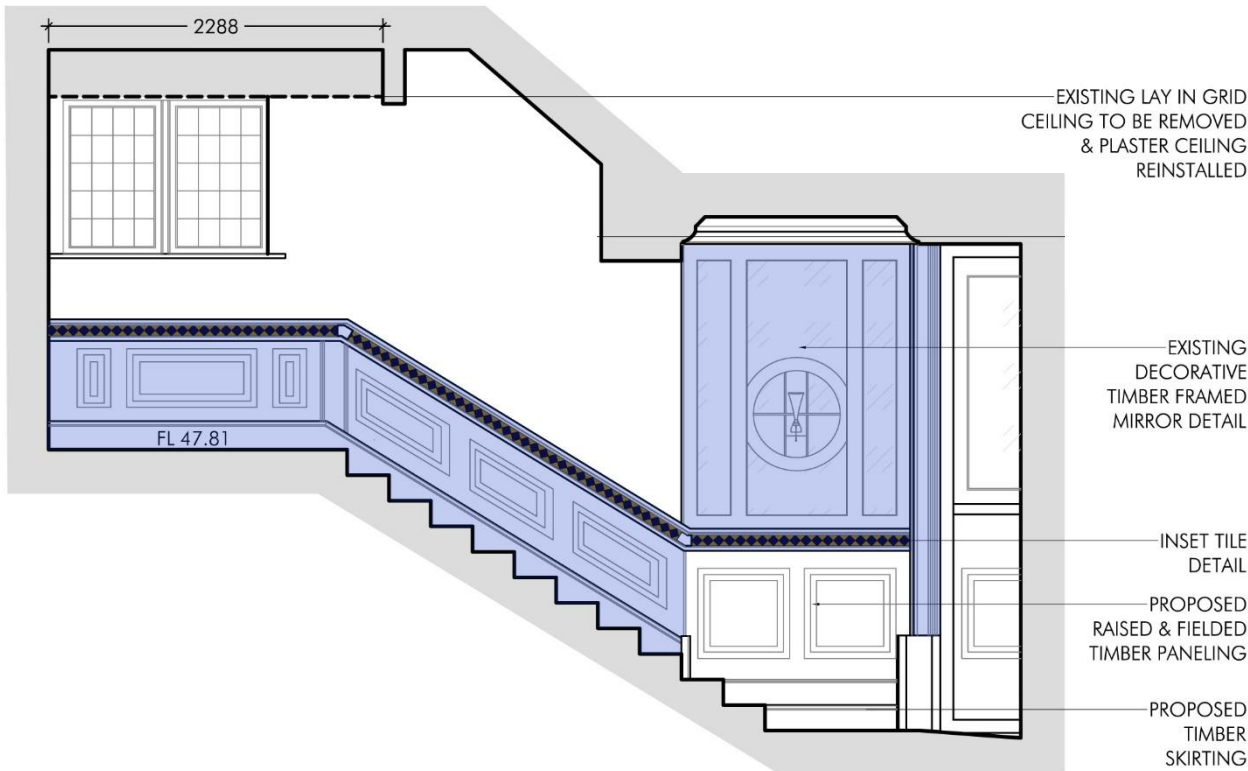
Fig 10: Part section detail with retained existing panelling highlighted in blue

Internally, where the floor is to be structurally lowered, stair panelling and lobby panelling above dado height (including the decorative dado inlay) shall be retained and protected during the works. 1:10 scale details of the proposed new lower-level panelling have been provided on drawing AP.51. the existing modern wallpaper above dado level to the perimeter walls and around the lift shaft shall be removed and the plaster finish made good and painted.

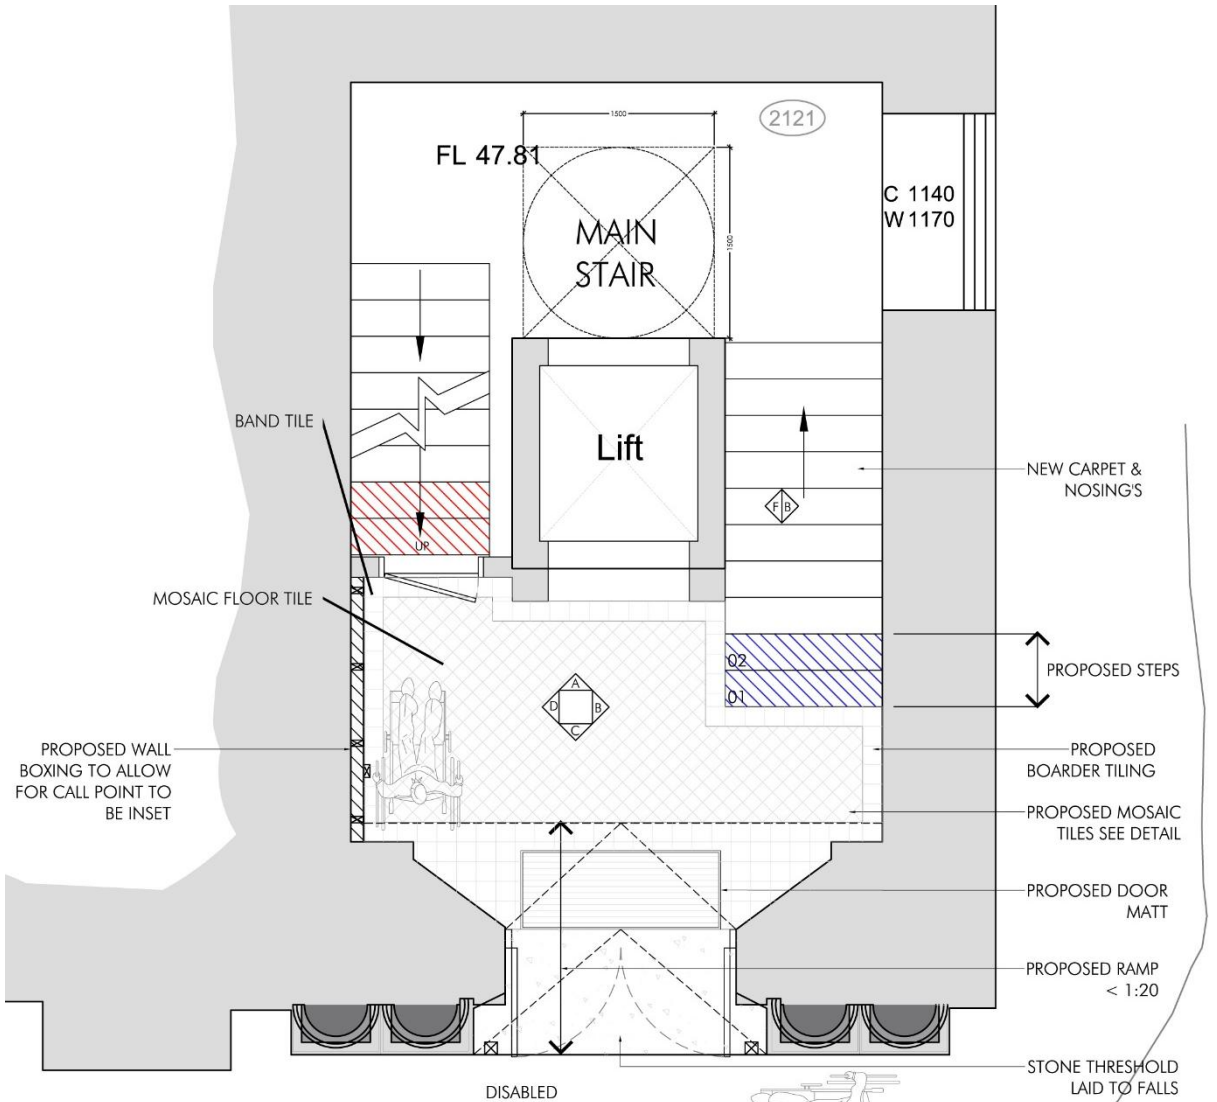
Fig 10: Plan extract identifying proposed floor finishes details

The floor tiles, if bedded in a lime- or sand-based compound, shall be removed and cleaned for re-use. As the building dates from 1902 and incorporates a structural concrete floor, it is possible that the existing ceramic floor tiles will be bedded in a cement-based screed, making it impossible to take up the existing floor tiles for re-use. If this is the case, they shall be replaced with new Victorian-style fired matt ceramic mosaic and band tiles in a similar patterning/rationale to the existing flooring.

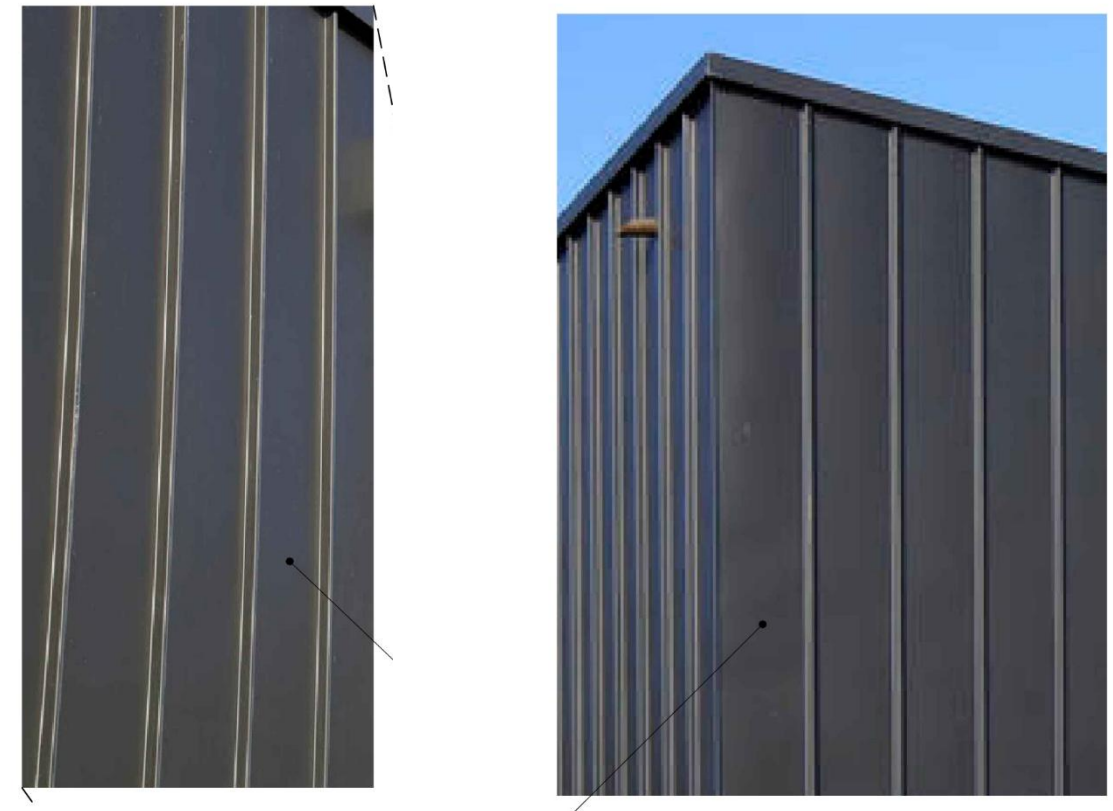
Fig 12: Images showing typical dark finish coated zinc cladding.

Although not formally noted, on separate site visits both the Conservation Officer and Planning Officer noted that the proposed timber cladding to the new lift shaft would be better suited to a material with longer lifespan than the timber cladding illustrated. Therefore, we have amended this to be clad in a seamed zinc cladding in a very dark grey/black finish. This material is both sympathetic to the listed building and also contrasts - making clear the new intervention.

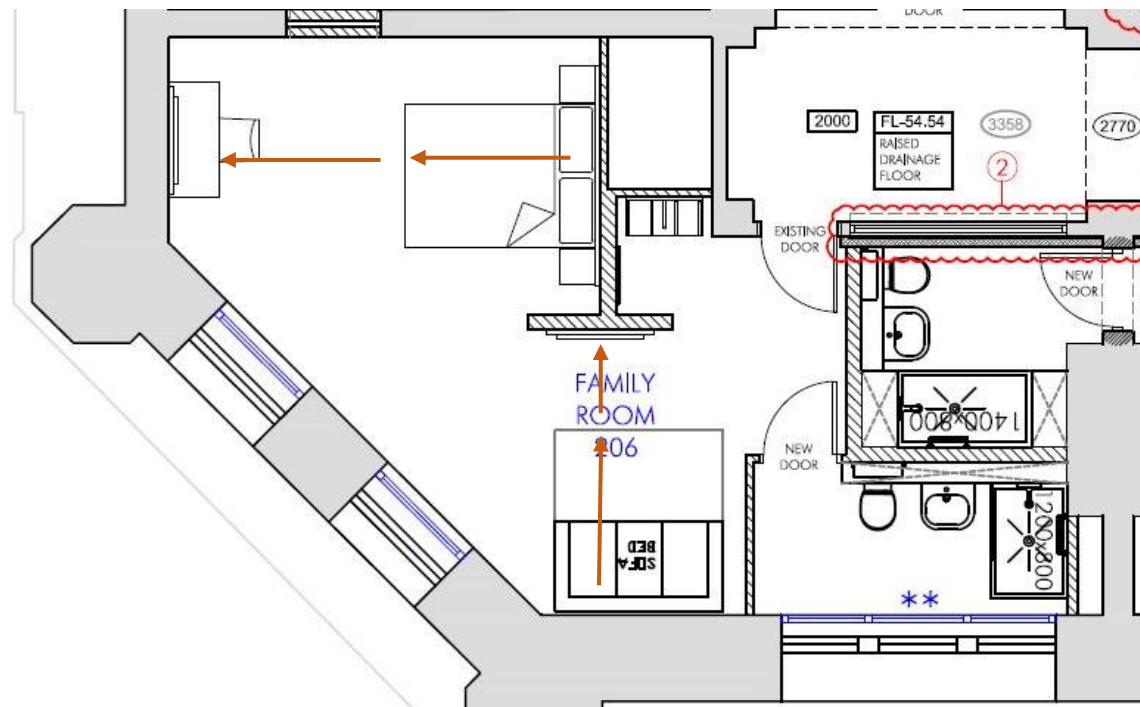
Fig 13: Room 206 – PREVIOUS HOTEL-LED APPROACH

Rooms 206 & 307 are large 'family' rooms formed in a larger corner volume. The Conservation Officer has requested that we "Remove the proposed 'boarding-out' of the wall in the proposed family rooms 206 and 307". Here we compare the previous proposal with the new, to show we have prioritised the heritage preference to retain as much original uninterrupted volume of the spaces as possible. In room 307 a previous subdivision partition wall has been removed to recreate this volume.

The previous designs were 'hotel'-focused – e.g., having a TV directly facing the beds and no more than a further bed-length away from the bedhead for ease of viewing. Instead, we have now taken a heritage-led approach to restore the room volume and compromise on the room amenity.

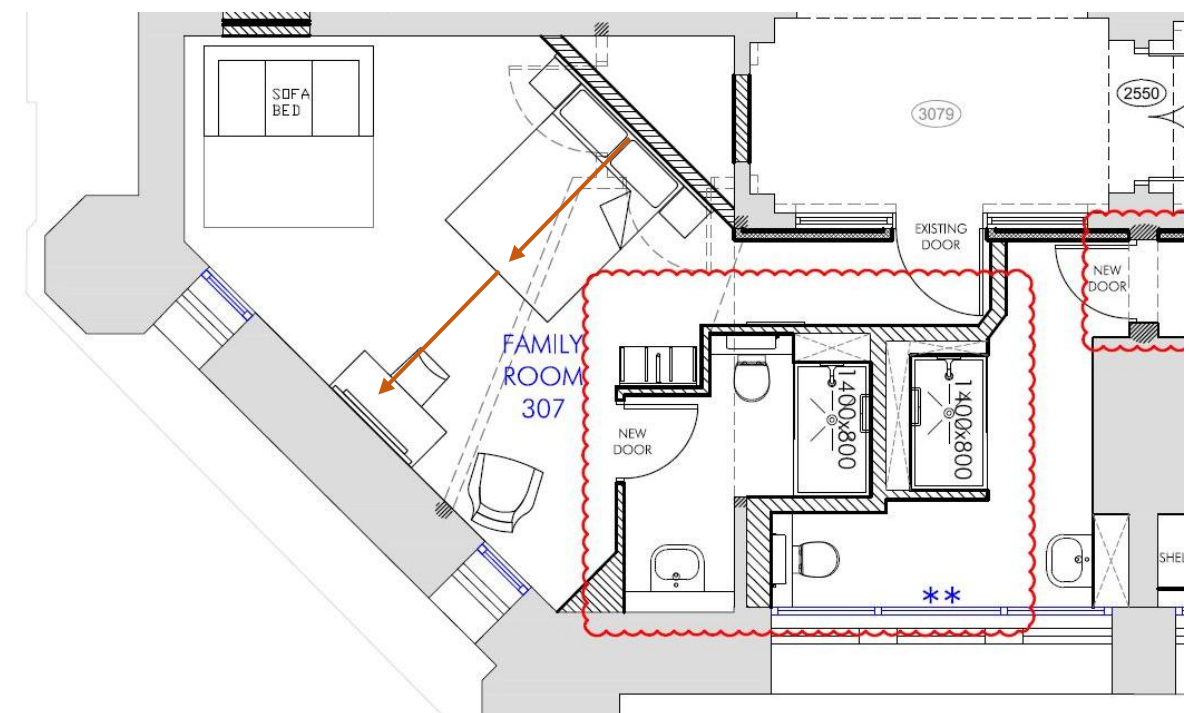
Fig 15: Room 307 – PREVIOUS HOTEL-LED APPROACH

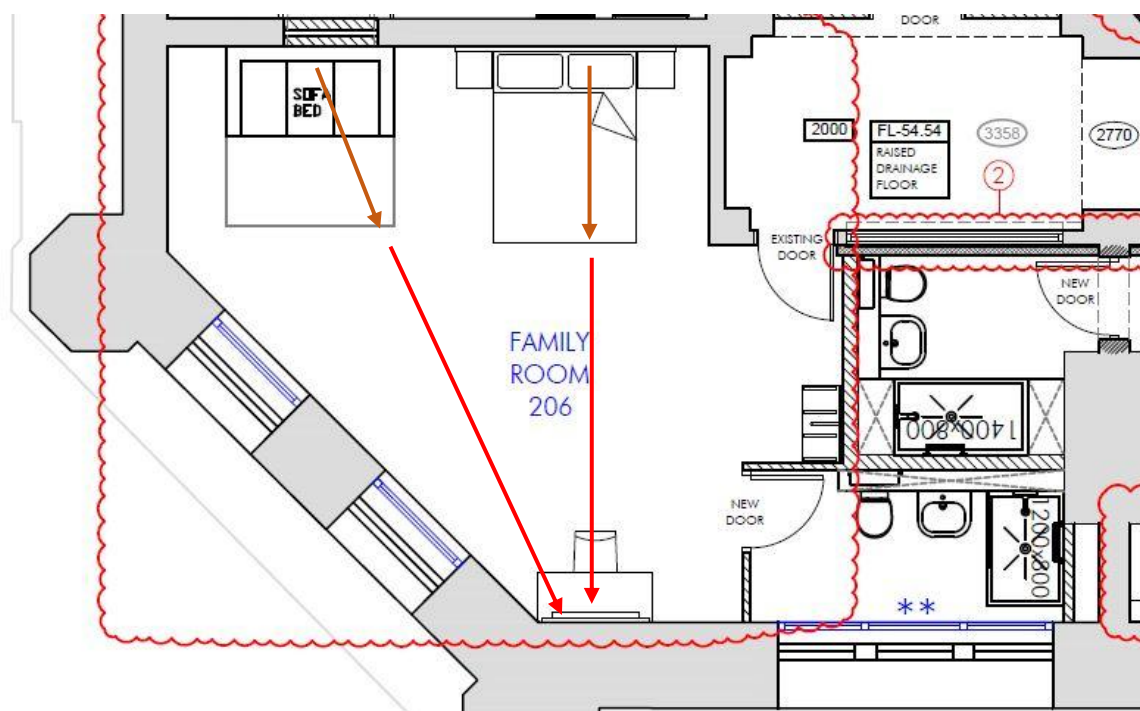
Fig 14: Room 206 – PROPOSED CONSERVATION-LED APPROACH

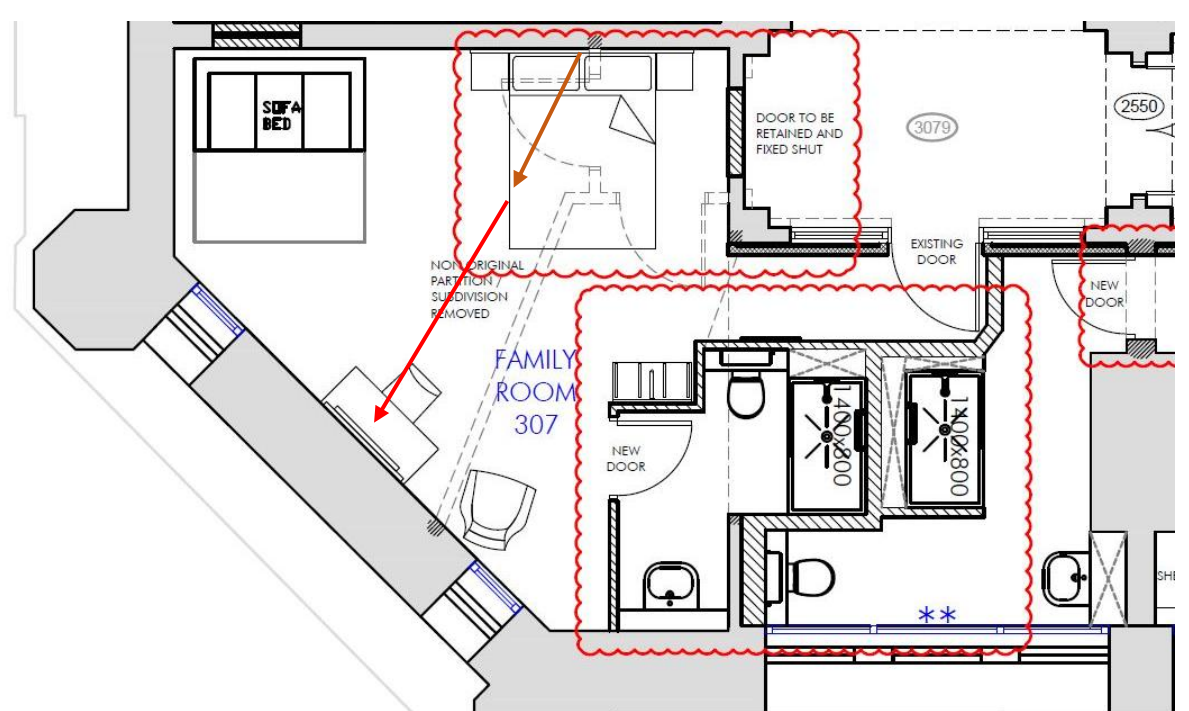
Fig 16: Room 307 – PROPOSED CONSERVATION-LED APPROACH

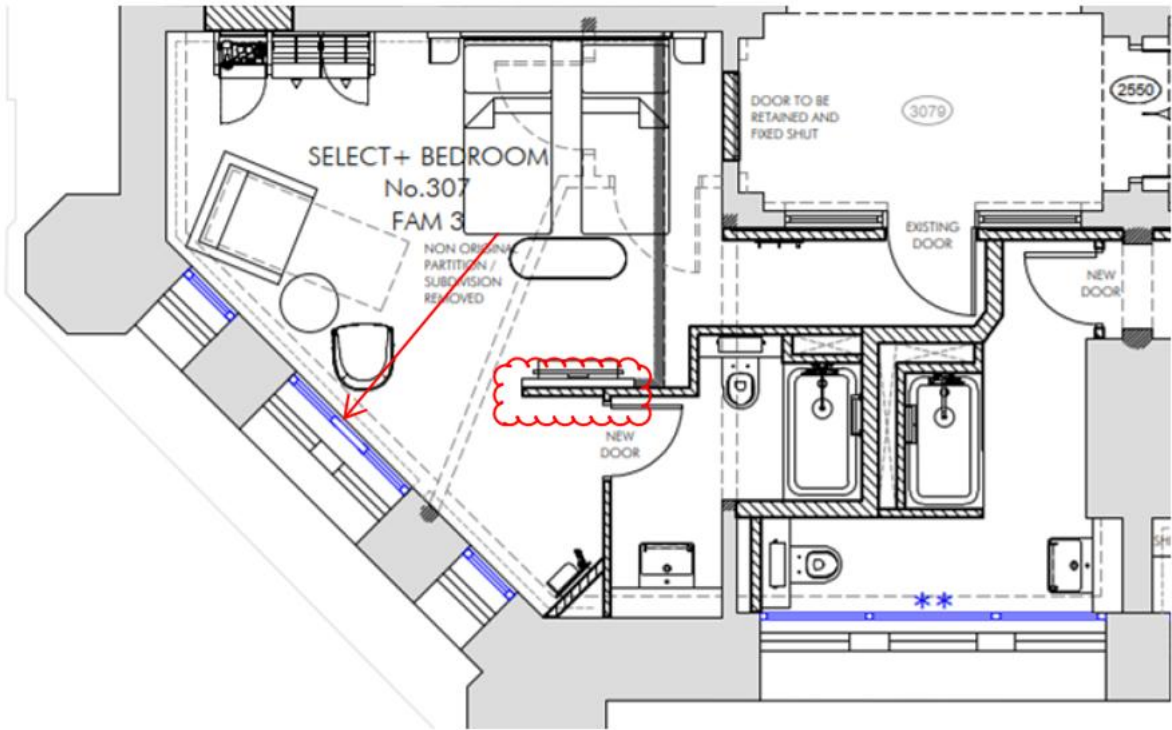
A small section of new wall has been added to Room 307 to provide an area for a TV to be displayed. We believe that this small section of new partition doesn't detract from the original room volume.

Fig 17: Room 307 – UPDATED PROPOSED CONSERVATION-LED APPROACH
