## Coal Mining Risk Assessment

Ebsworth street

Monton

**Report No. A7202/25/CMRA**

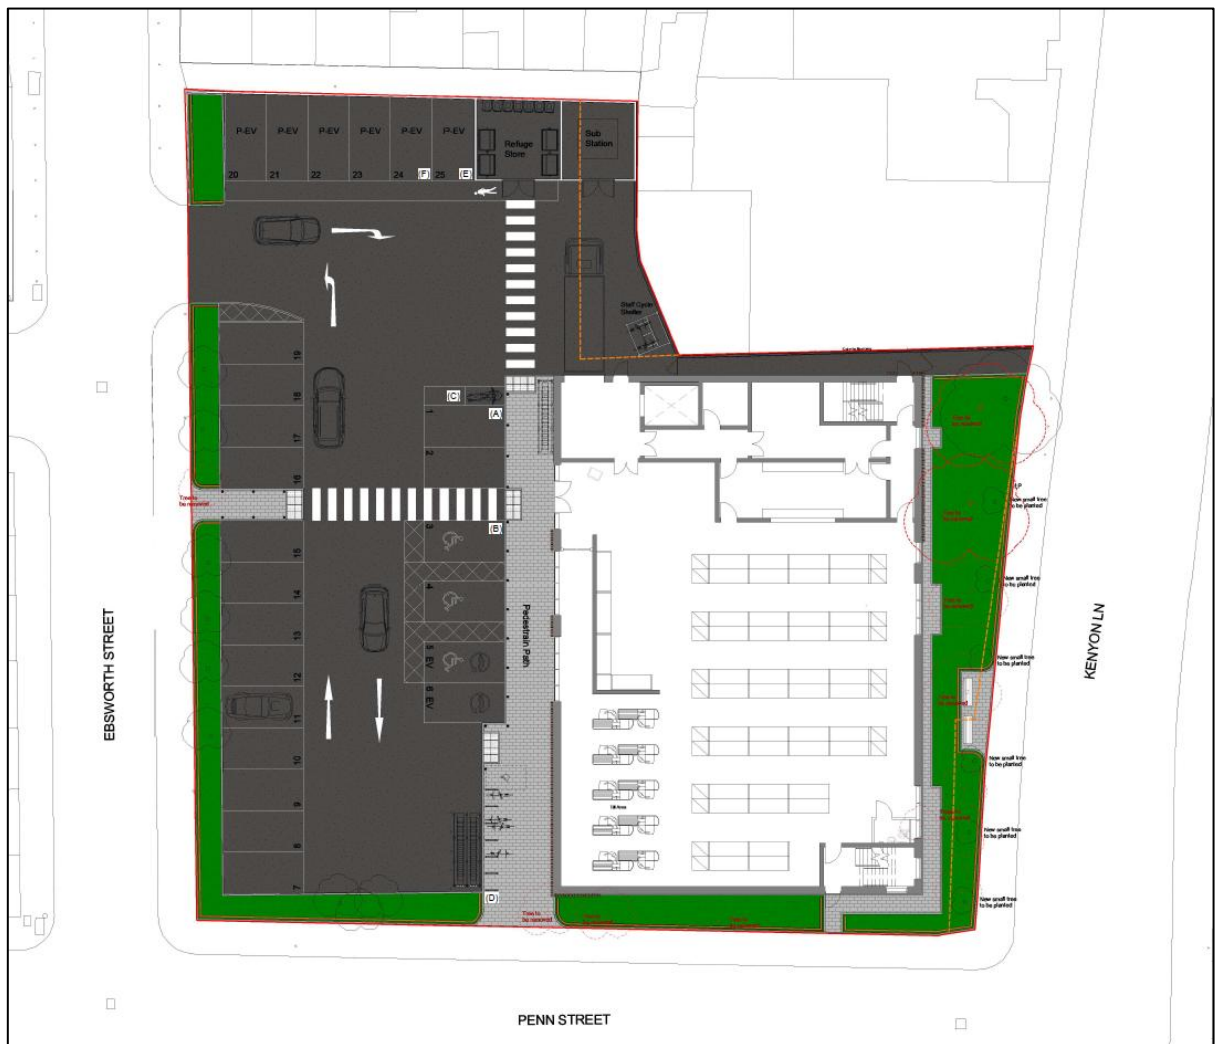
**Figure 1 Proposed Development Plan**

- 1.2 It is understood that the client intends to construct a Moston Superstore with associated car parking and areas of soft landscaping within a residential development area.
- 1.3 A proposed development plan for the site is shown in Figure 1, overleaf.
