2.2 RECOMMENDATIONS (Hutton + Rostron Roof Report):

2402-RBUM-ARC-XX-RL-DR-A-2402 "GA PLAN LEADWORK & GUTTERS"

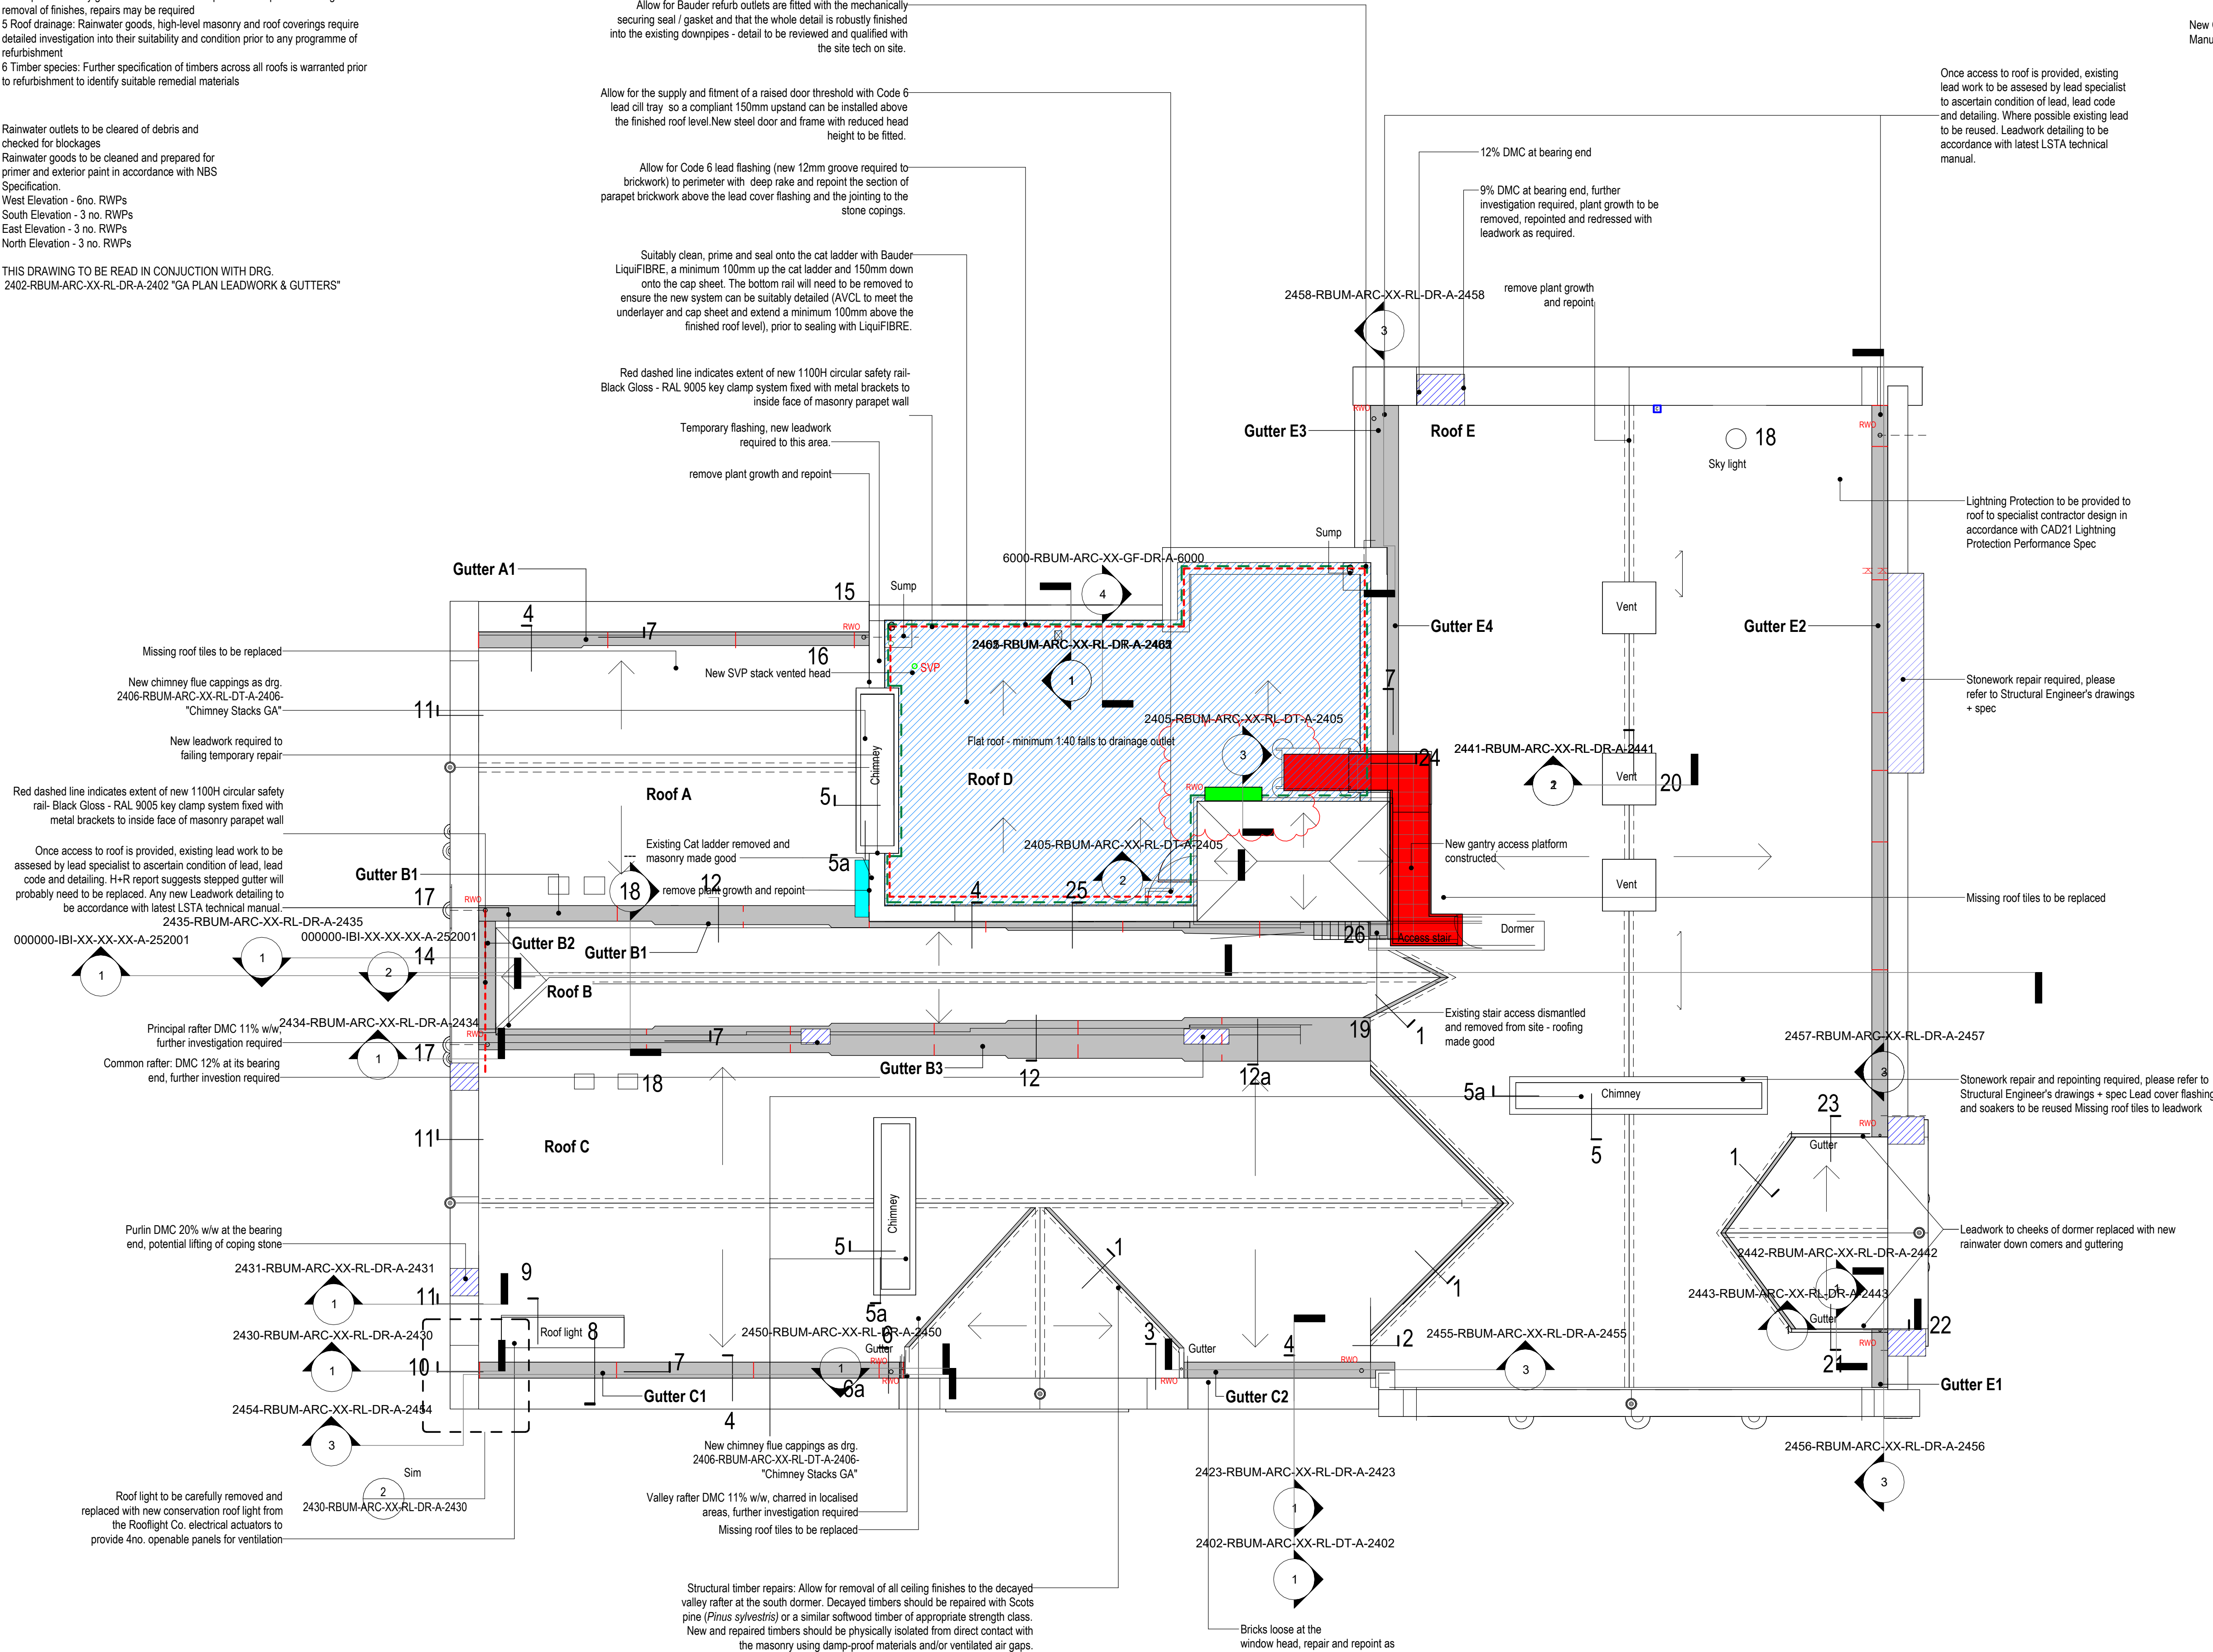
Rainwater outlets to be cleared of debris and checked for blockages

Rainwater goods to be cleaned and prepared for primer and exterior paint in accordance with NBS Specification.

THIS DRAWING TO BE READ IN CONJUNCTION WITH DRG.

1 Water penetration: Gutters and rainwater goods should be cleared of any debris and require detailed investigation. Leadwork should be renewed where necessary to an improved standard. Moisture sources should be eliminated prior to any refurbishment

5 Roof drainage: Rainwater goods, high-level masonry and roof coverings require detailed investigation into their suitability and condition prior to any programme of refurbishment
