## GAS MEMBRANE VALIDATION

| <b>Site Name:</b> Belle Vue | <b>Project Number:</b> 12-123 |
| <p><b>Overview:</b><br/>The membrane comprised a Visqueen low permeability gas membrane (Yellow) resistant to radon, carbon dioxide and low levels of methane. E3P can confirm there were no holes or rips at the time of inspection. Upon being laid the membrane is to be covered with a Celotex (closed Cell) floor insulation material which is considered to provide a high degree of protection.</p> <p>All external joints were inspected and E3P can confirm that the membrane was overlapped and double taped to external and internal gas resistant DPM. The membrane was taped to the gas resistant DPM using a double-sided jointing tape. All the overlaps were then additionally taped using foil backed girth tape.</p> <p>Each unit has a service duct located to the front and outer edge of the property. E3P inspected each one and can confirm that the top-hats have been adequately sealed against the membrane.</p> <p>Based on the information provided within this report, the site inspections and validation checklists, E3P can confirm that <b>Plots 181-183 have</b> been installed with gas protection measures in

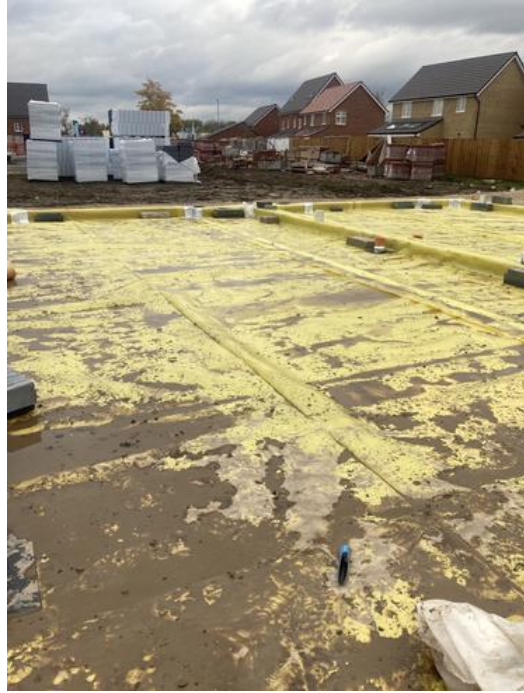
Photo 2

| Gas Membrane Condition: Open punctures, tears, rips, stretching, Presence of debris, Repairs, Signs of weakness such as raised or sunken indentations, Protection plan in place to restrict access to lain gas membrane? IF FAIL DESCRIPTION IN ACTIONS AND PHOTOS REQUIRED | Pass |
