## MCFC Project Taverna

### Coal Mining Risk Assessment

For: Manchester City Football Club

| <b>Report Reference:</b> | | <b>4490-02A</b> |

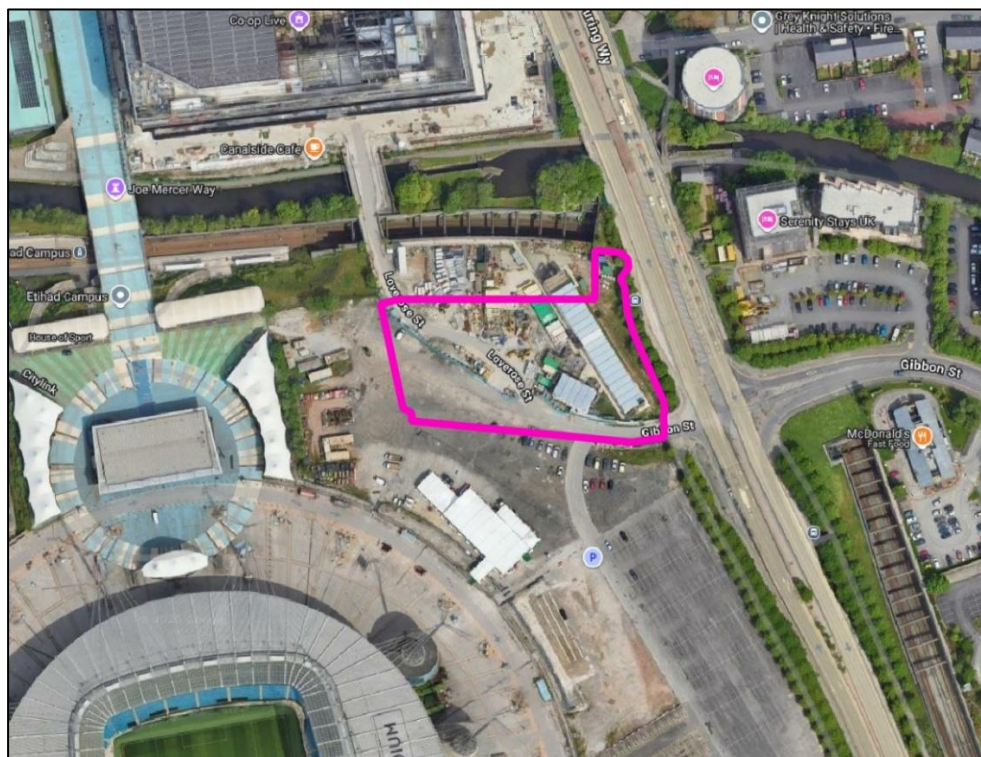
Figure 1: Aerial image of the site dated April 2023.

The site currently comprises an open area of hardstanding with Loverose Street crossing the site in the southwest. The site is currently partially used as a site compound for the north stand extension. The site is bound by a Metrolink cutting to the north with Ashton Canal and the Co-op Live Arena beyond to the North, Alan Turing Way to the east, Gibbon Street to the south and Loverose Street to the west. Access to the site is via Gibbon Street off Alan Turing Way. An aerial photo of the site is included below, and A site location plan is contained in Appendix 2.

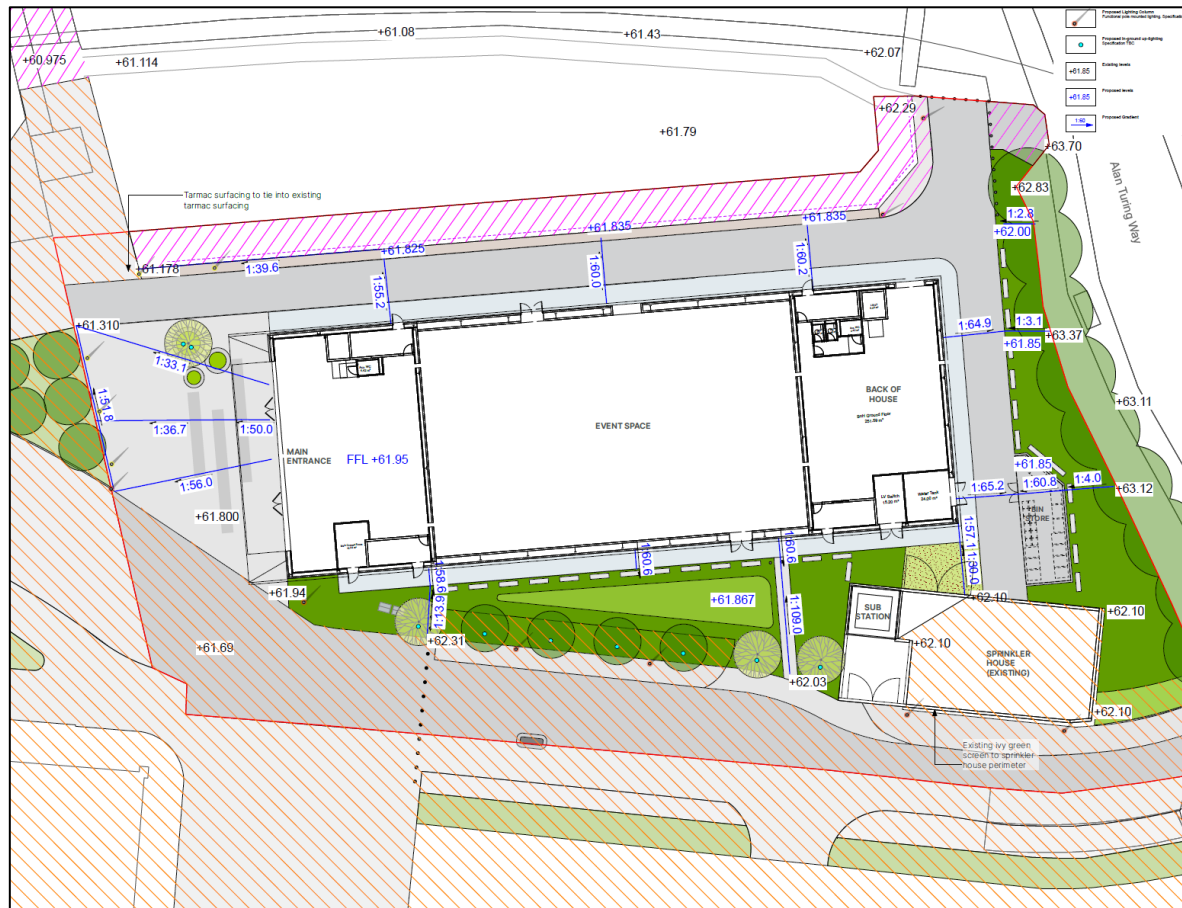
Figure 2: Extract of the proposed development plan

The proposed development plan is contained in Appendix 2 with an extract below:

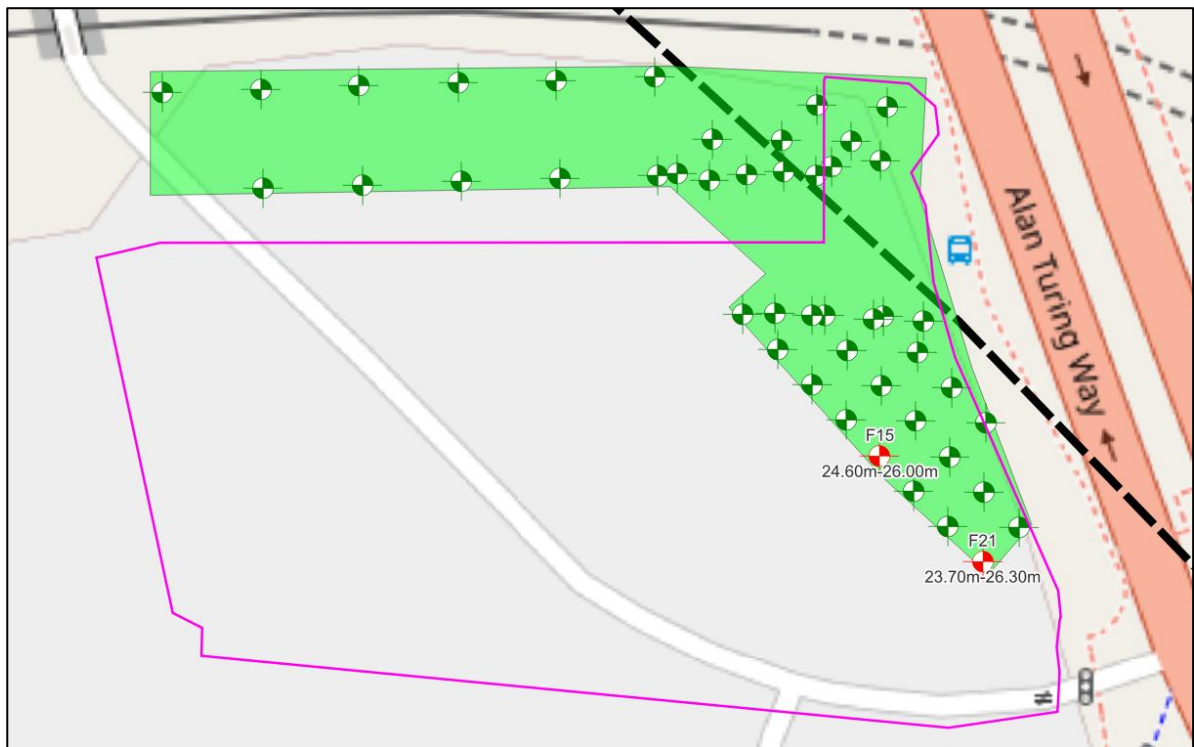
The location of the drill & grout boreholes carried out in 2001 and 2010 along with drill holes F15 and F21 in relation to the site boundary are shown below:

Figure 7: Location of historical drill & grout holes.

The majority of the drill holes encountered intact coal. However, broken ground combined with a loss of flush was identified in two boreholes (F15 and F21) at depths of 24.60m to 26.00m and 23.70m to 26.30m bgl, respectively. The thickness of broken ground / lost flush on these holes is greater than the intact seam thickness recorded elsewhere. There is the potential for further broken ground west of these boreholes as they were located on the edge of the treatment area as shown in Figure 7, below.

Each hole was backfilled with grout upon completion of drilling, with the majority of holes taking no more than 0.3 to 0.4 tonnes, with the average grout take being recorded at 0.33 tonne per hole. The 2 No. boreholes with identified broken ground (F15 and F21) took 0.7 tonne and 0.4 tonne, respectively.

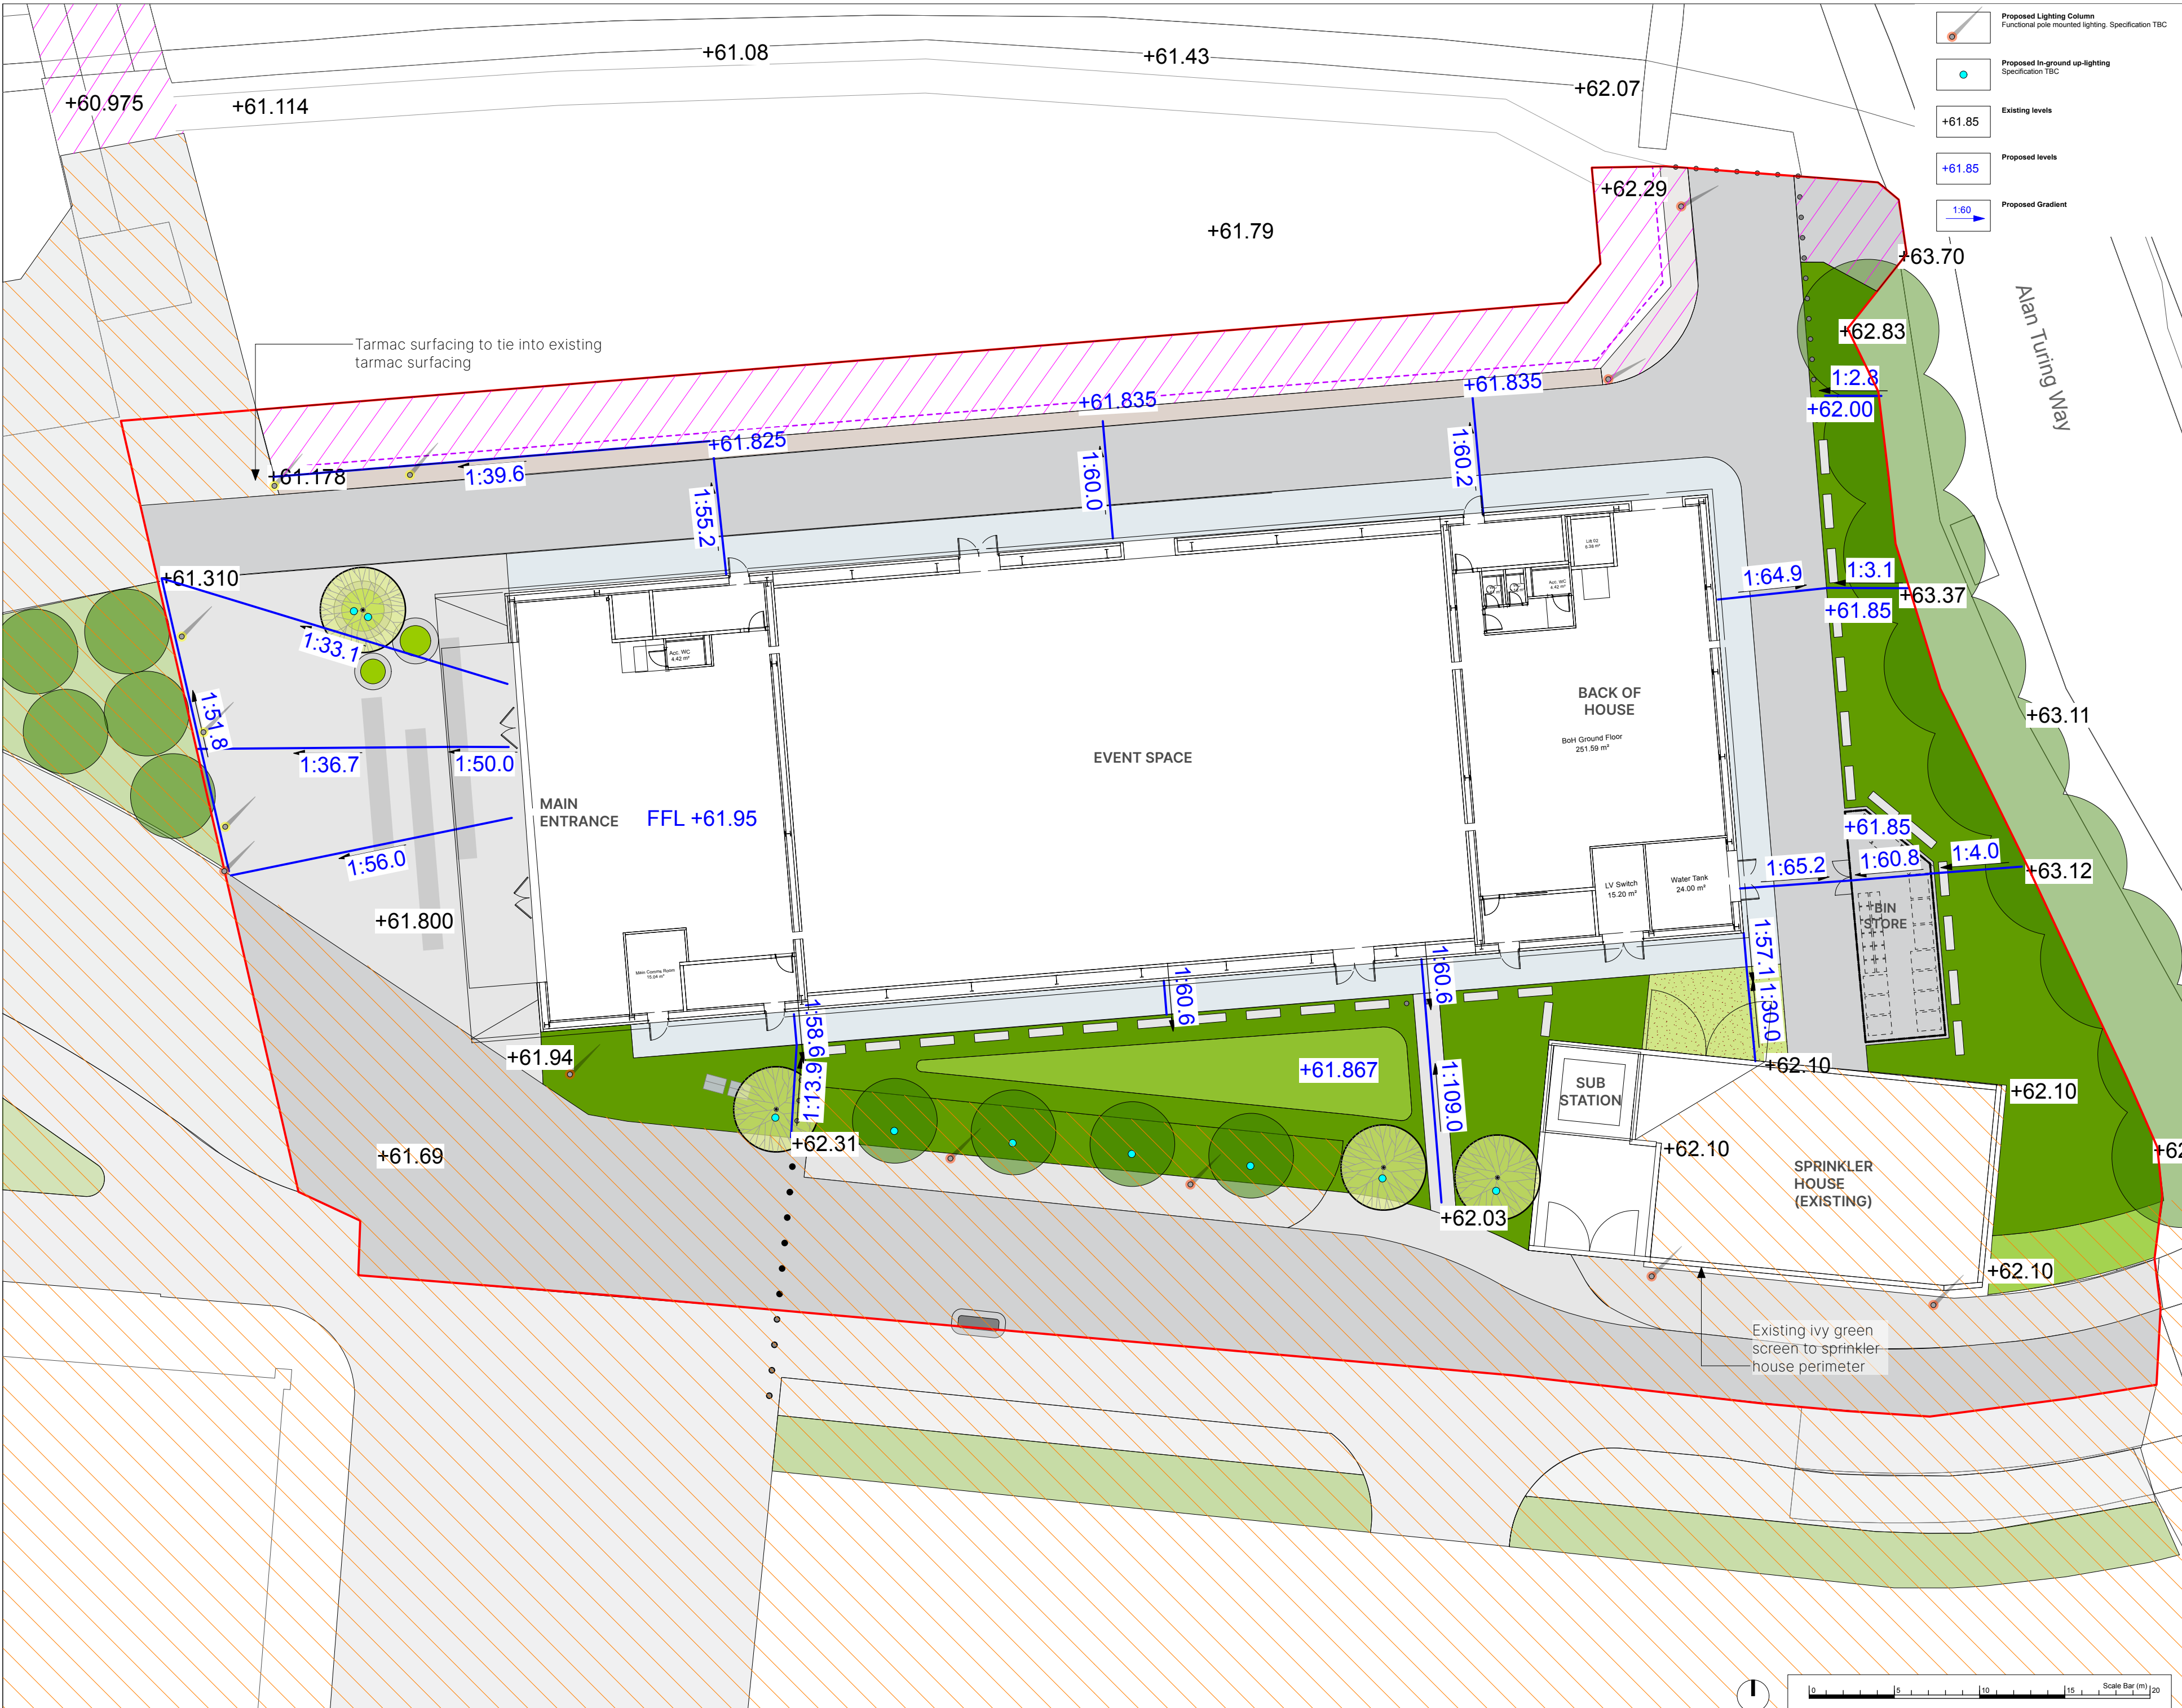
**Drg No.** 3679.3-PLA-XX-XX-DR-L-0001  
**Suitability Revision** S2 P05  
© Plant I.E. Limited

**Proposed Lighting Column**  
Functional pole mounted lighting. Specification TBC

**Proposed In-ground up-lighting**  
Specification TBC

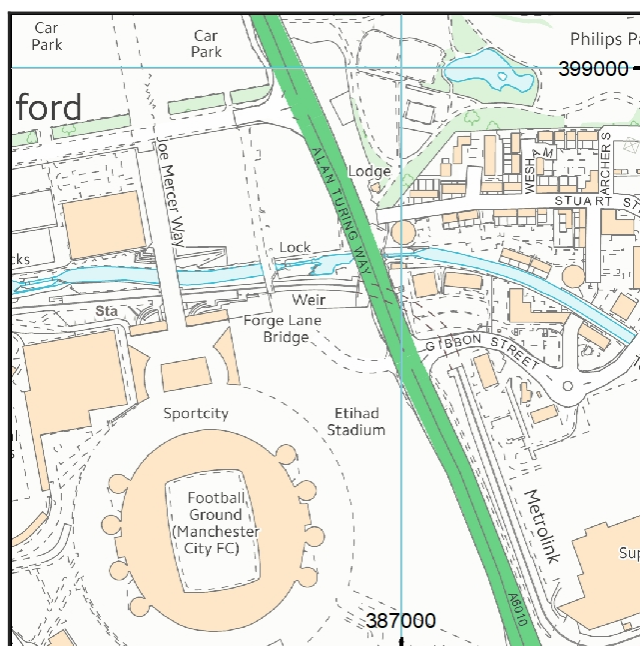
Approximate position of property

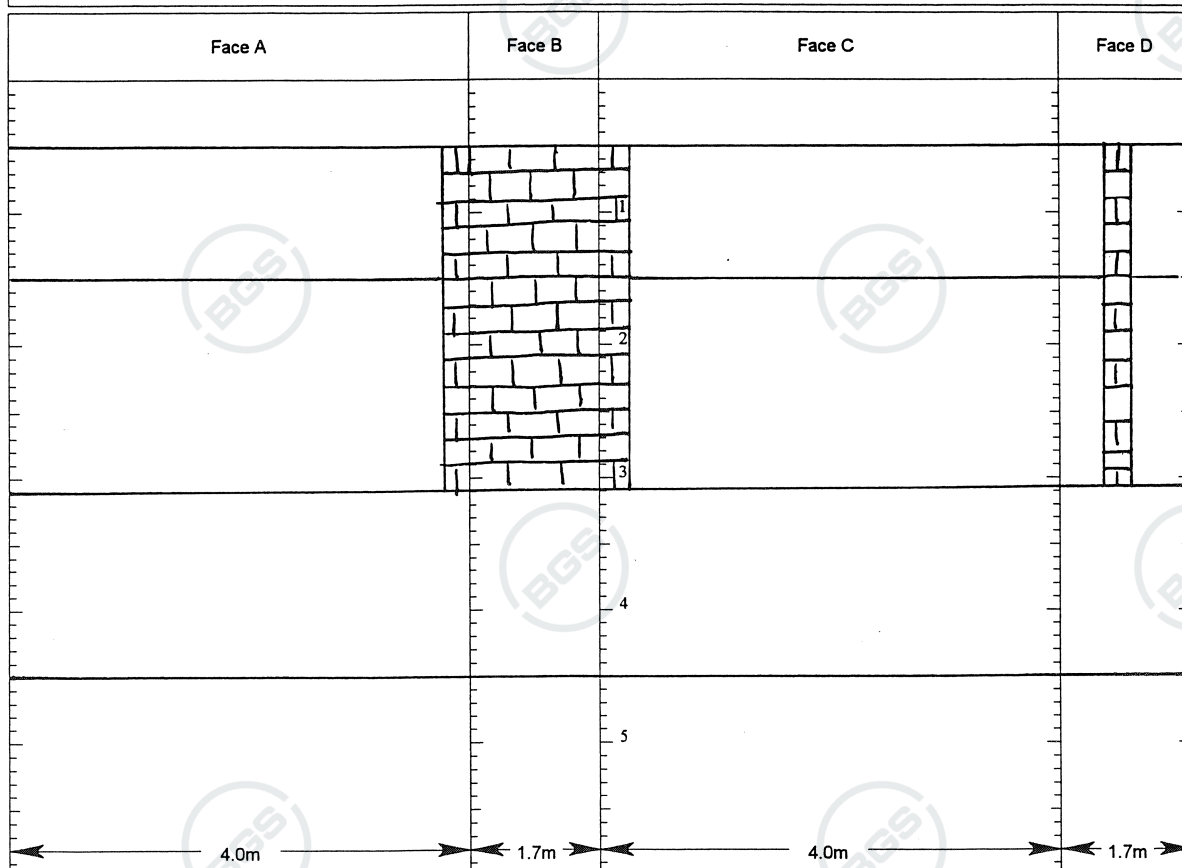
See main log for strata descriptions and sampling details.

NB Sketch is not to scale.
