# ARBORICULTURAL IMPLICATIONS ASSESSMENT

NEW SMITHFIELD MARKET  
MANCHESTER

Author: C. Salisbury  
Date: 14 February 2022  
Ref: TRE/BRM/Rev C

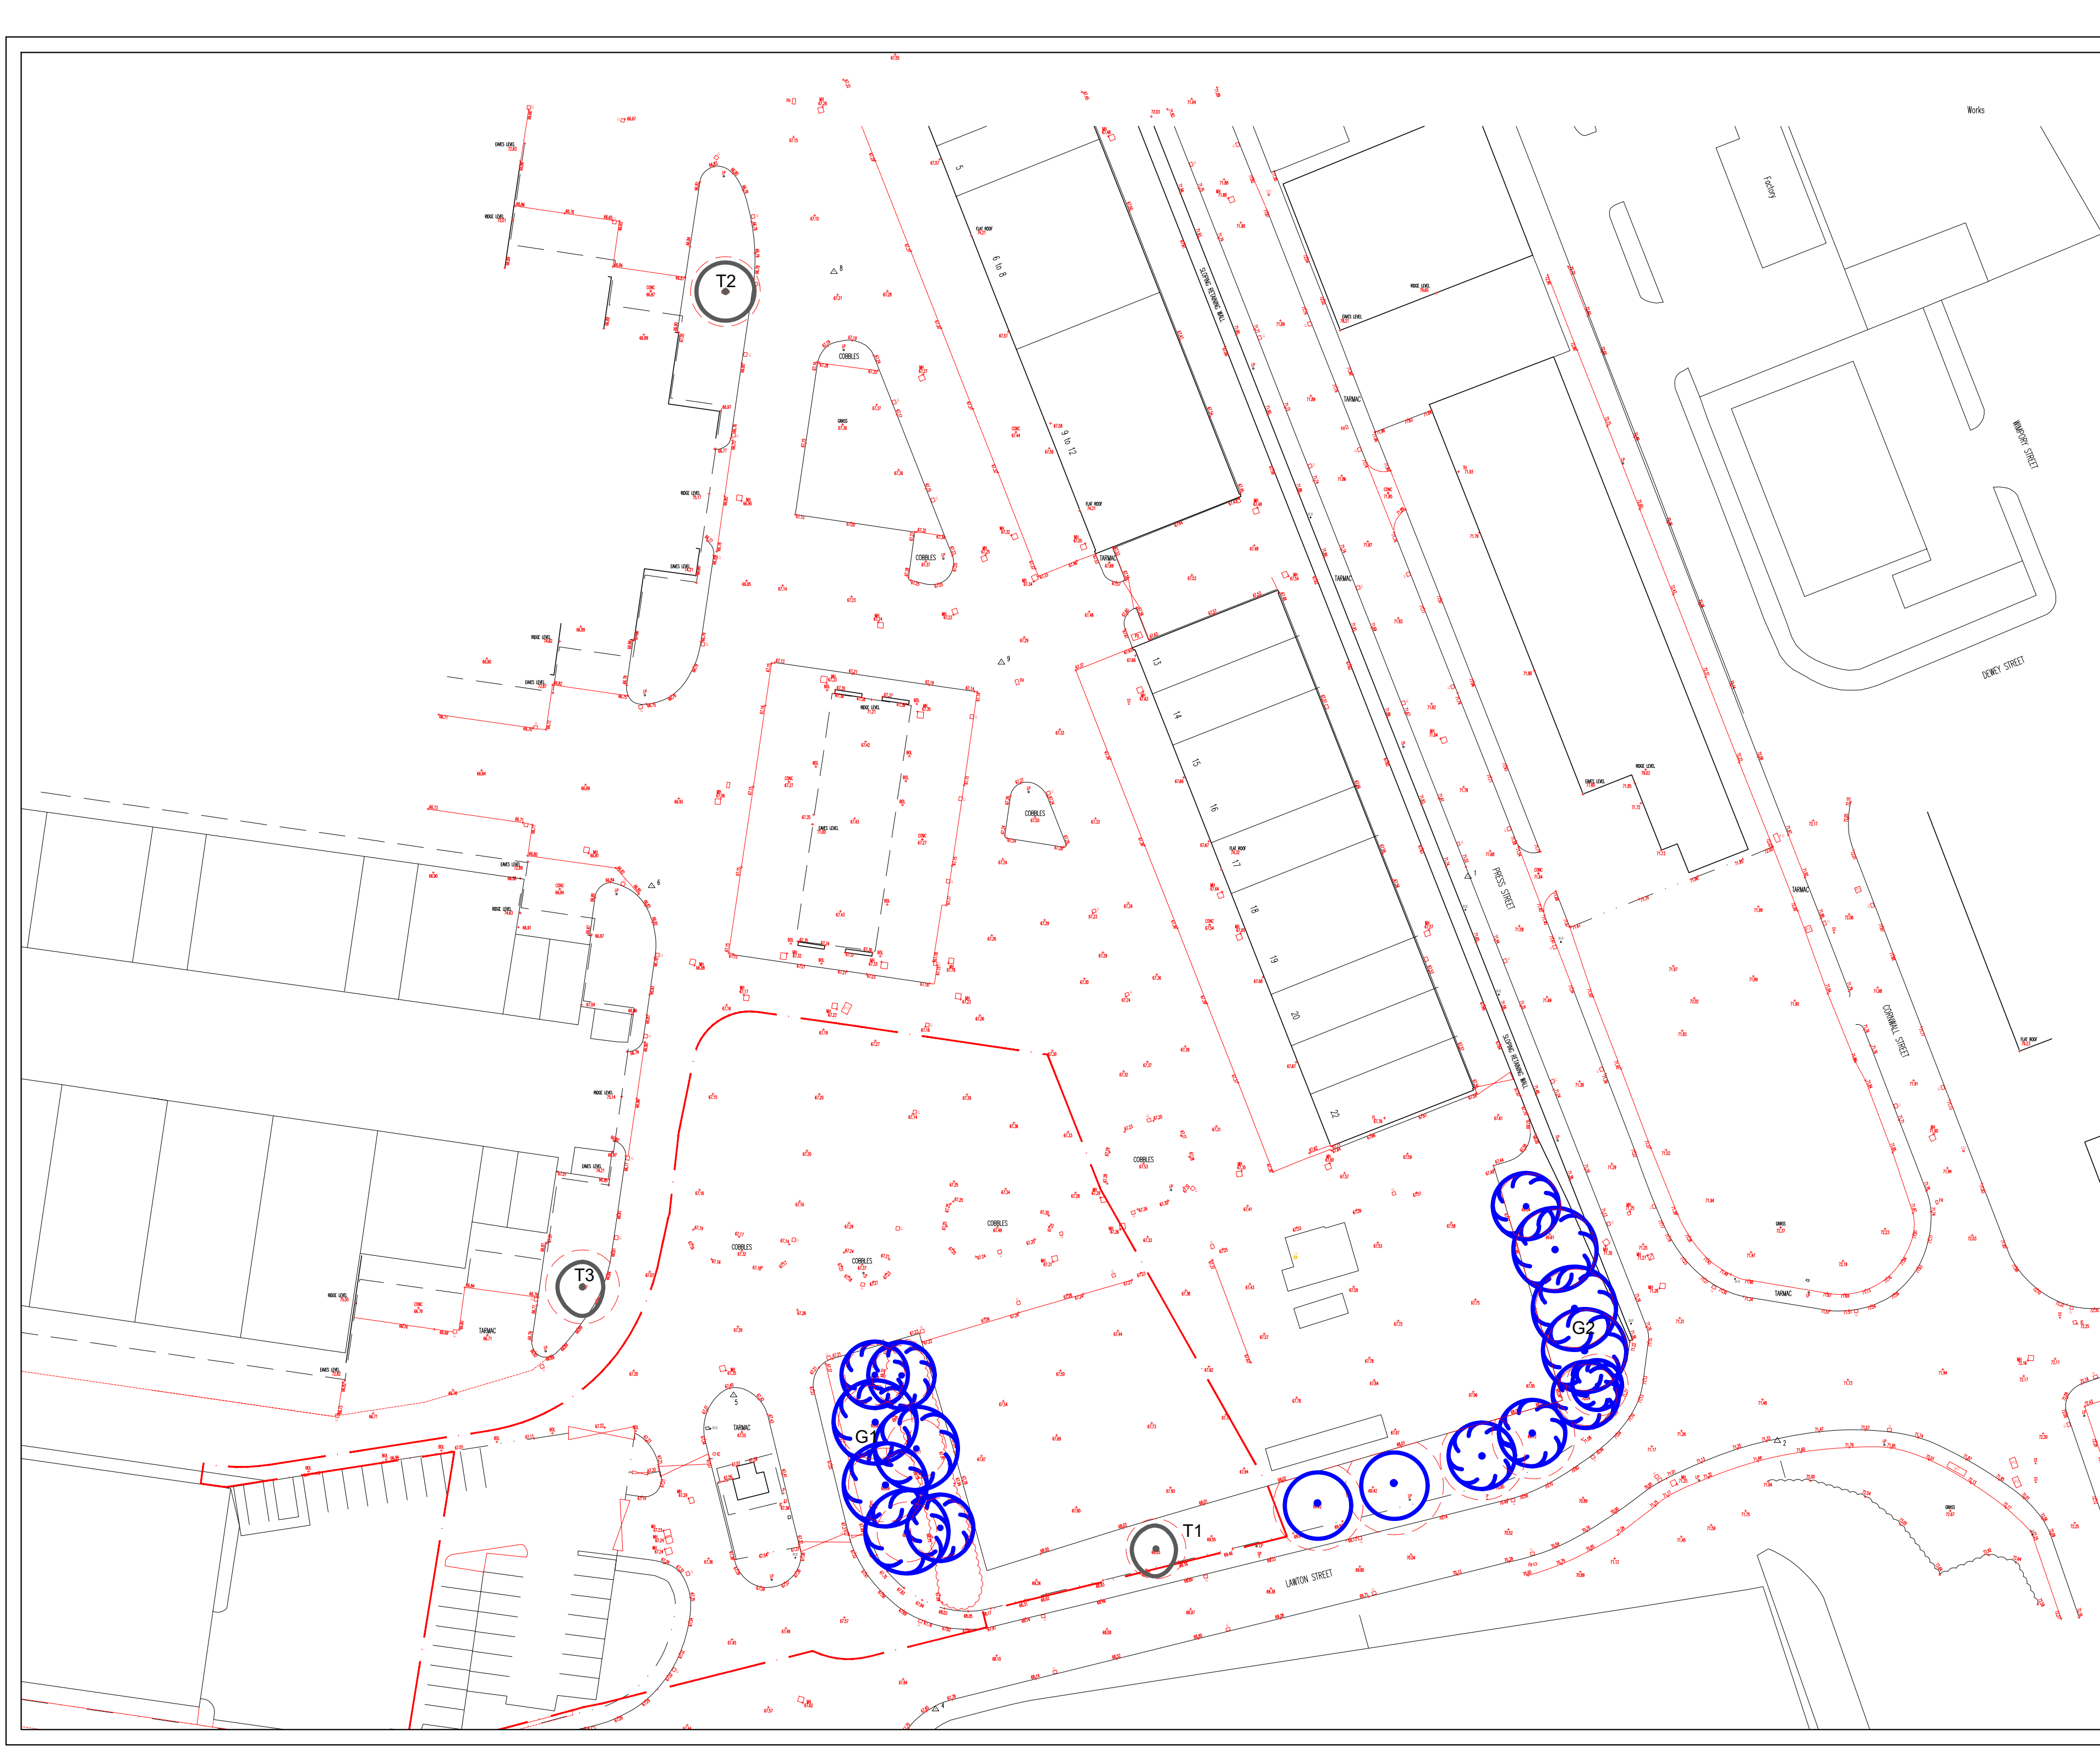
Drawing No:  
BRM/BS/01 Rev. B

- 2.1 The trees were surveyed (prefixed T, or G for group) and recorded in the tree schedule in appendix one. Where groups are recorded, average height and diameter at breast height (DBH) of the trees in the group are reported. Where access to the base of any trees was limited, stem size was estimated.
- 2.2 All the trees were assessed using: a grading A to C (retention) and U (removal); condition and age class as defined in appendix two.
- 2.3 Where appropriate, canopy spread for each tree was recorded at four cardinal points in order to reproduce an accurate representation of the crown shape of the tree on the tree plan in appendix three.
- 2.4 The survey included all trees within the proposal area and trees near to the proposal.

Drawing Title:  
BS5837 Plan

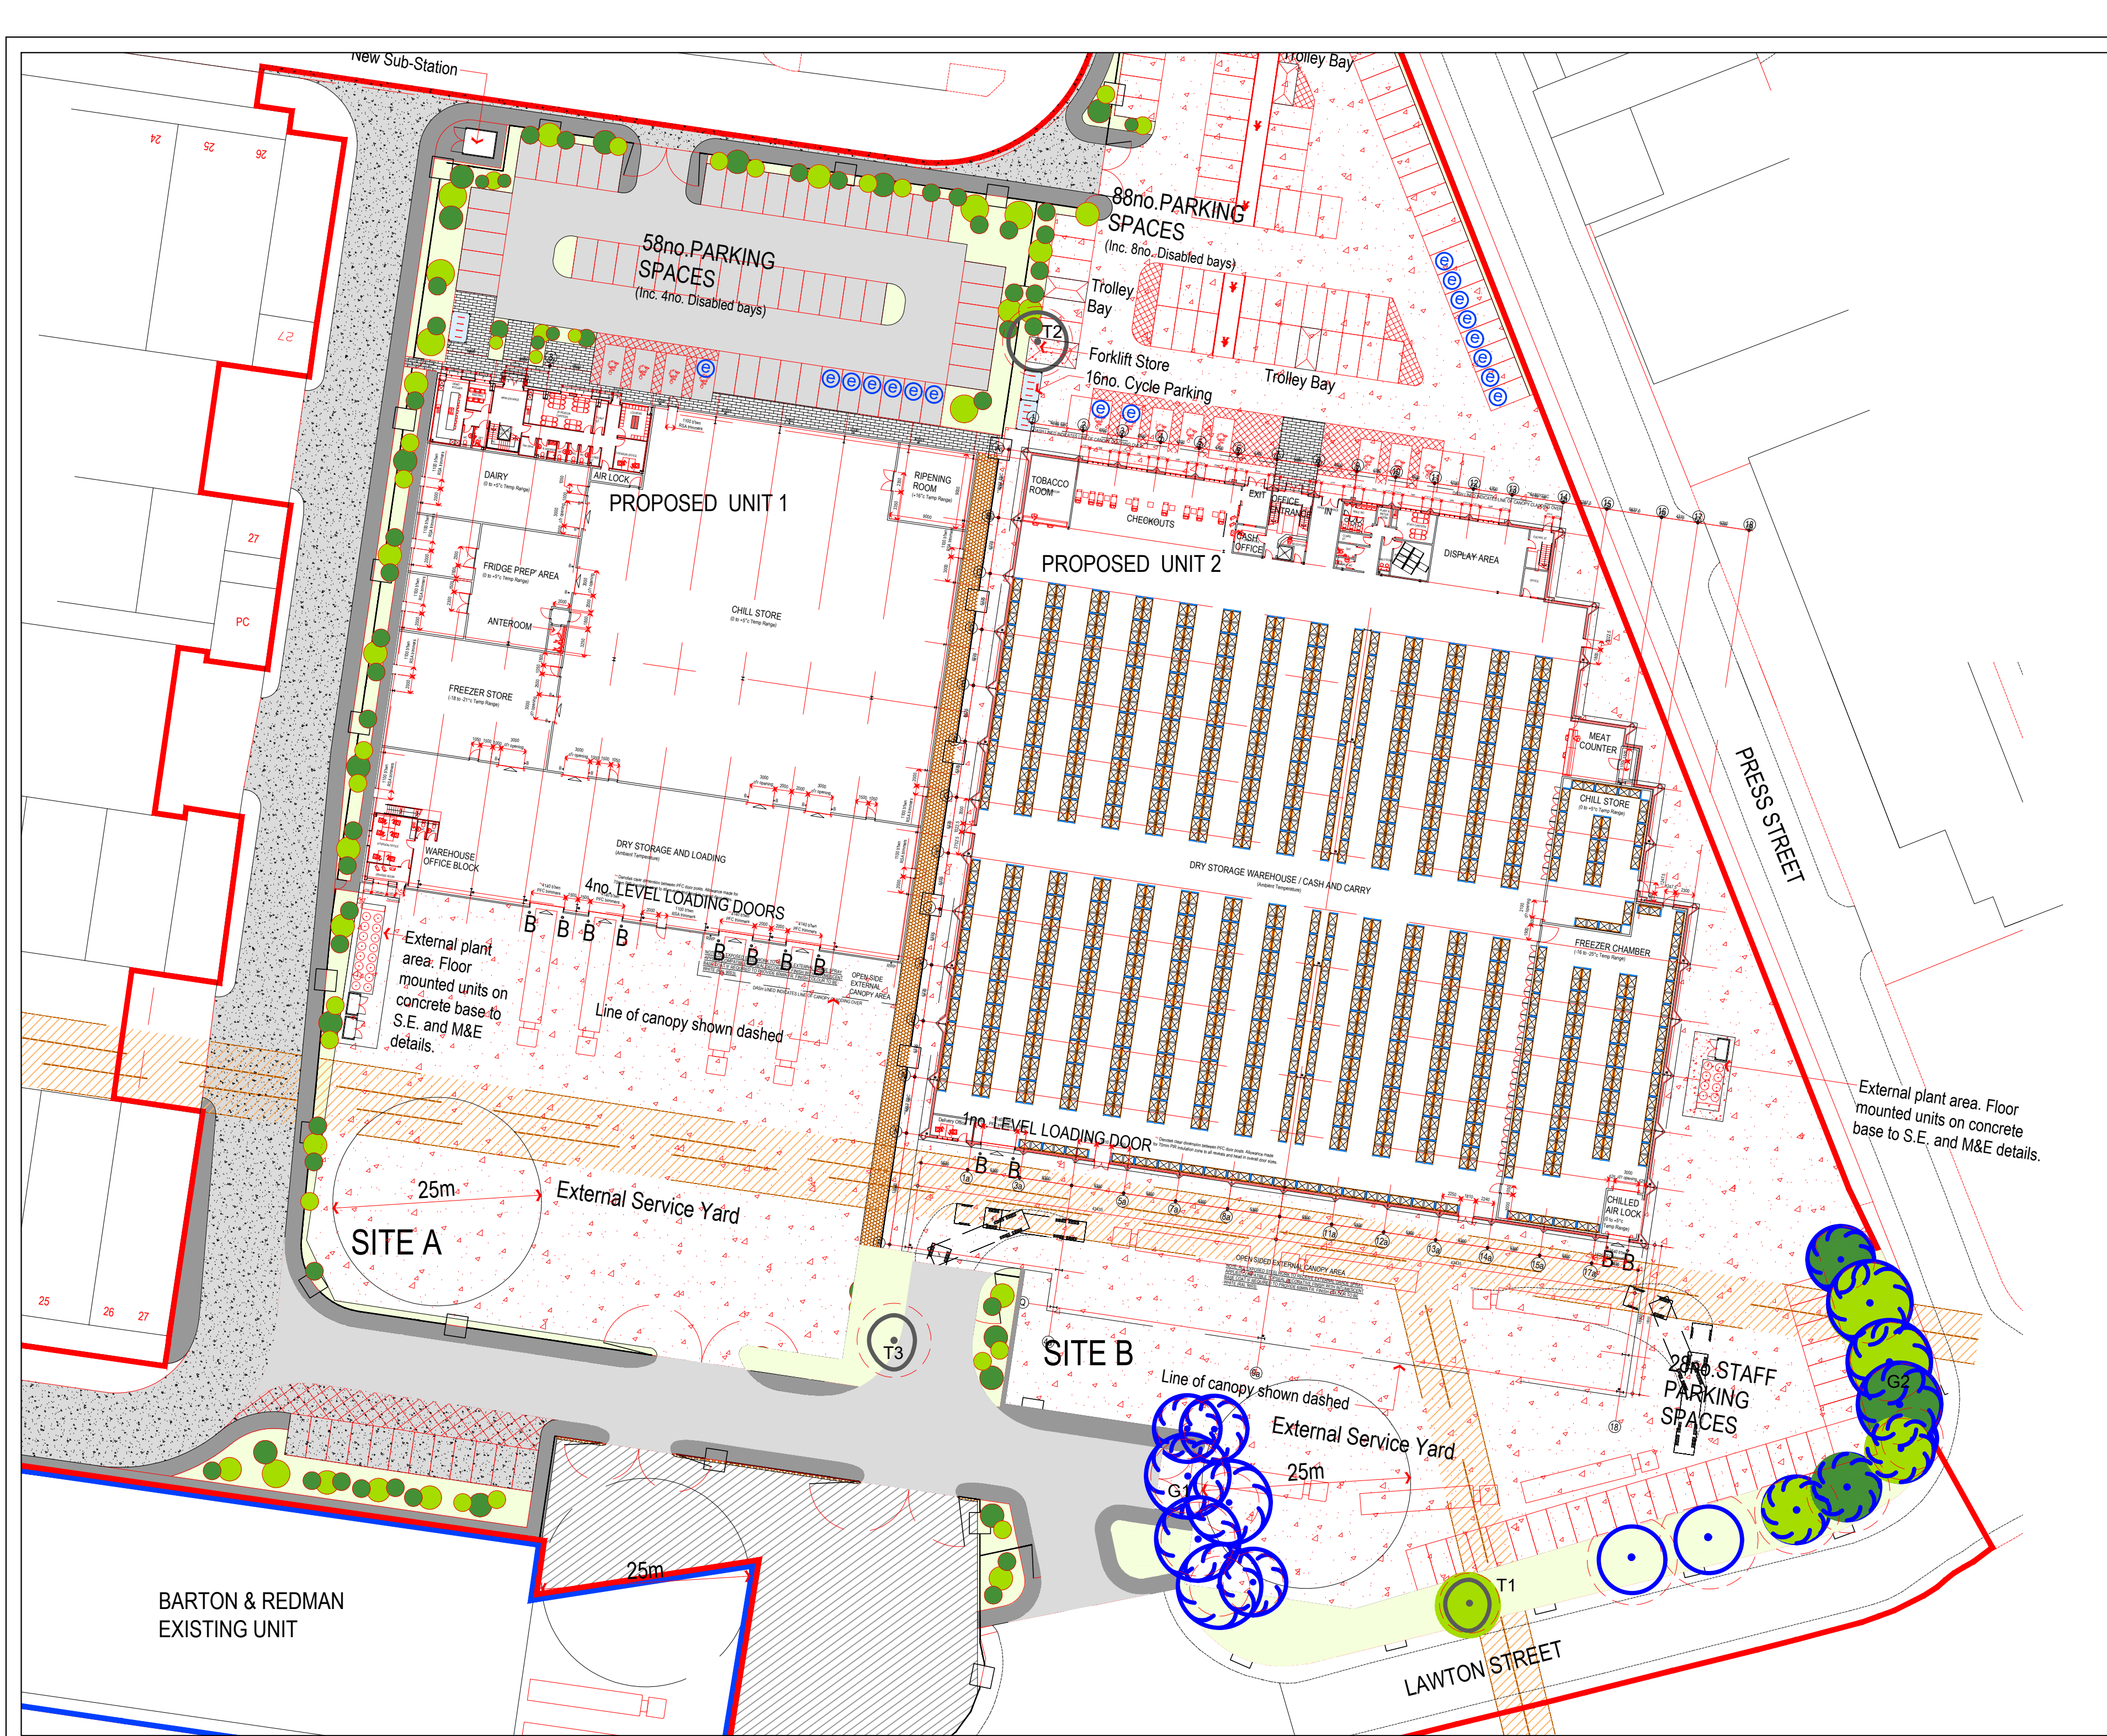
Drawing No:  
BRM/AIS/01 Rev. C

- 3.1 Due to the proposed development and its associated infrastructure there are a number of locations where the proposals are in close proximity to the trees surveyed. The Site Layout Plan within appendix three identifies the trees in relation to the proposed development.
- 3.2 In order to fully assess the impact of the proposals an Impact Table has been created detailing each tree, which shows the proximity of the associated works to the tree.
- 3.3 This can then be assessed in accordance with BS 5837:2012 to determine whether the development will have a detrimental impact on the health of each tree. Once this has been determined remedial measures can be detailed to reduce the impact the proposals will have on the treescape.

Drawing Title:  
AIS Plan
