# Arboricultural Impact Assessment (AIA)

**Arcadia Library and Leisure Centre**

| <b>Title:</b> | Arboricultural Impact Assessment | | | |
| <b>Document Type:</b> | BS 5837 | | | |

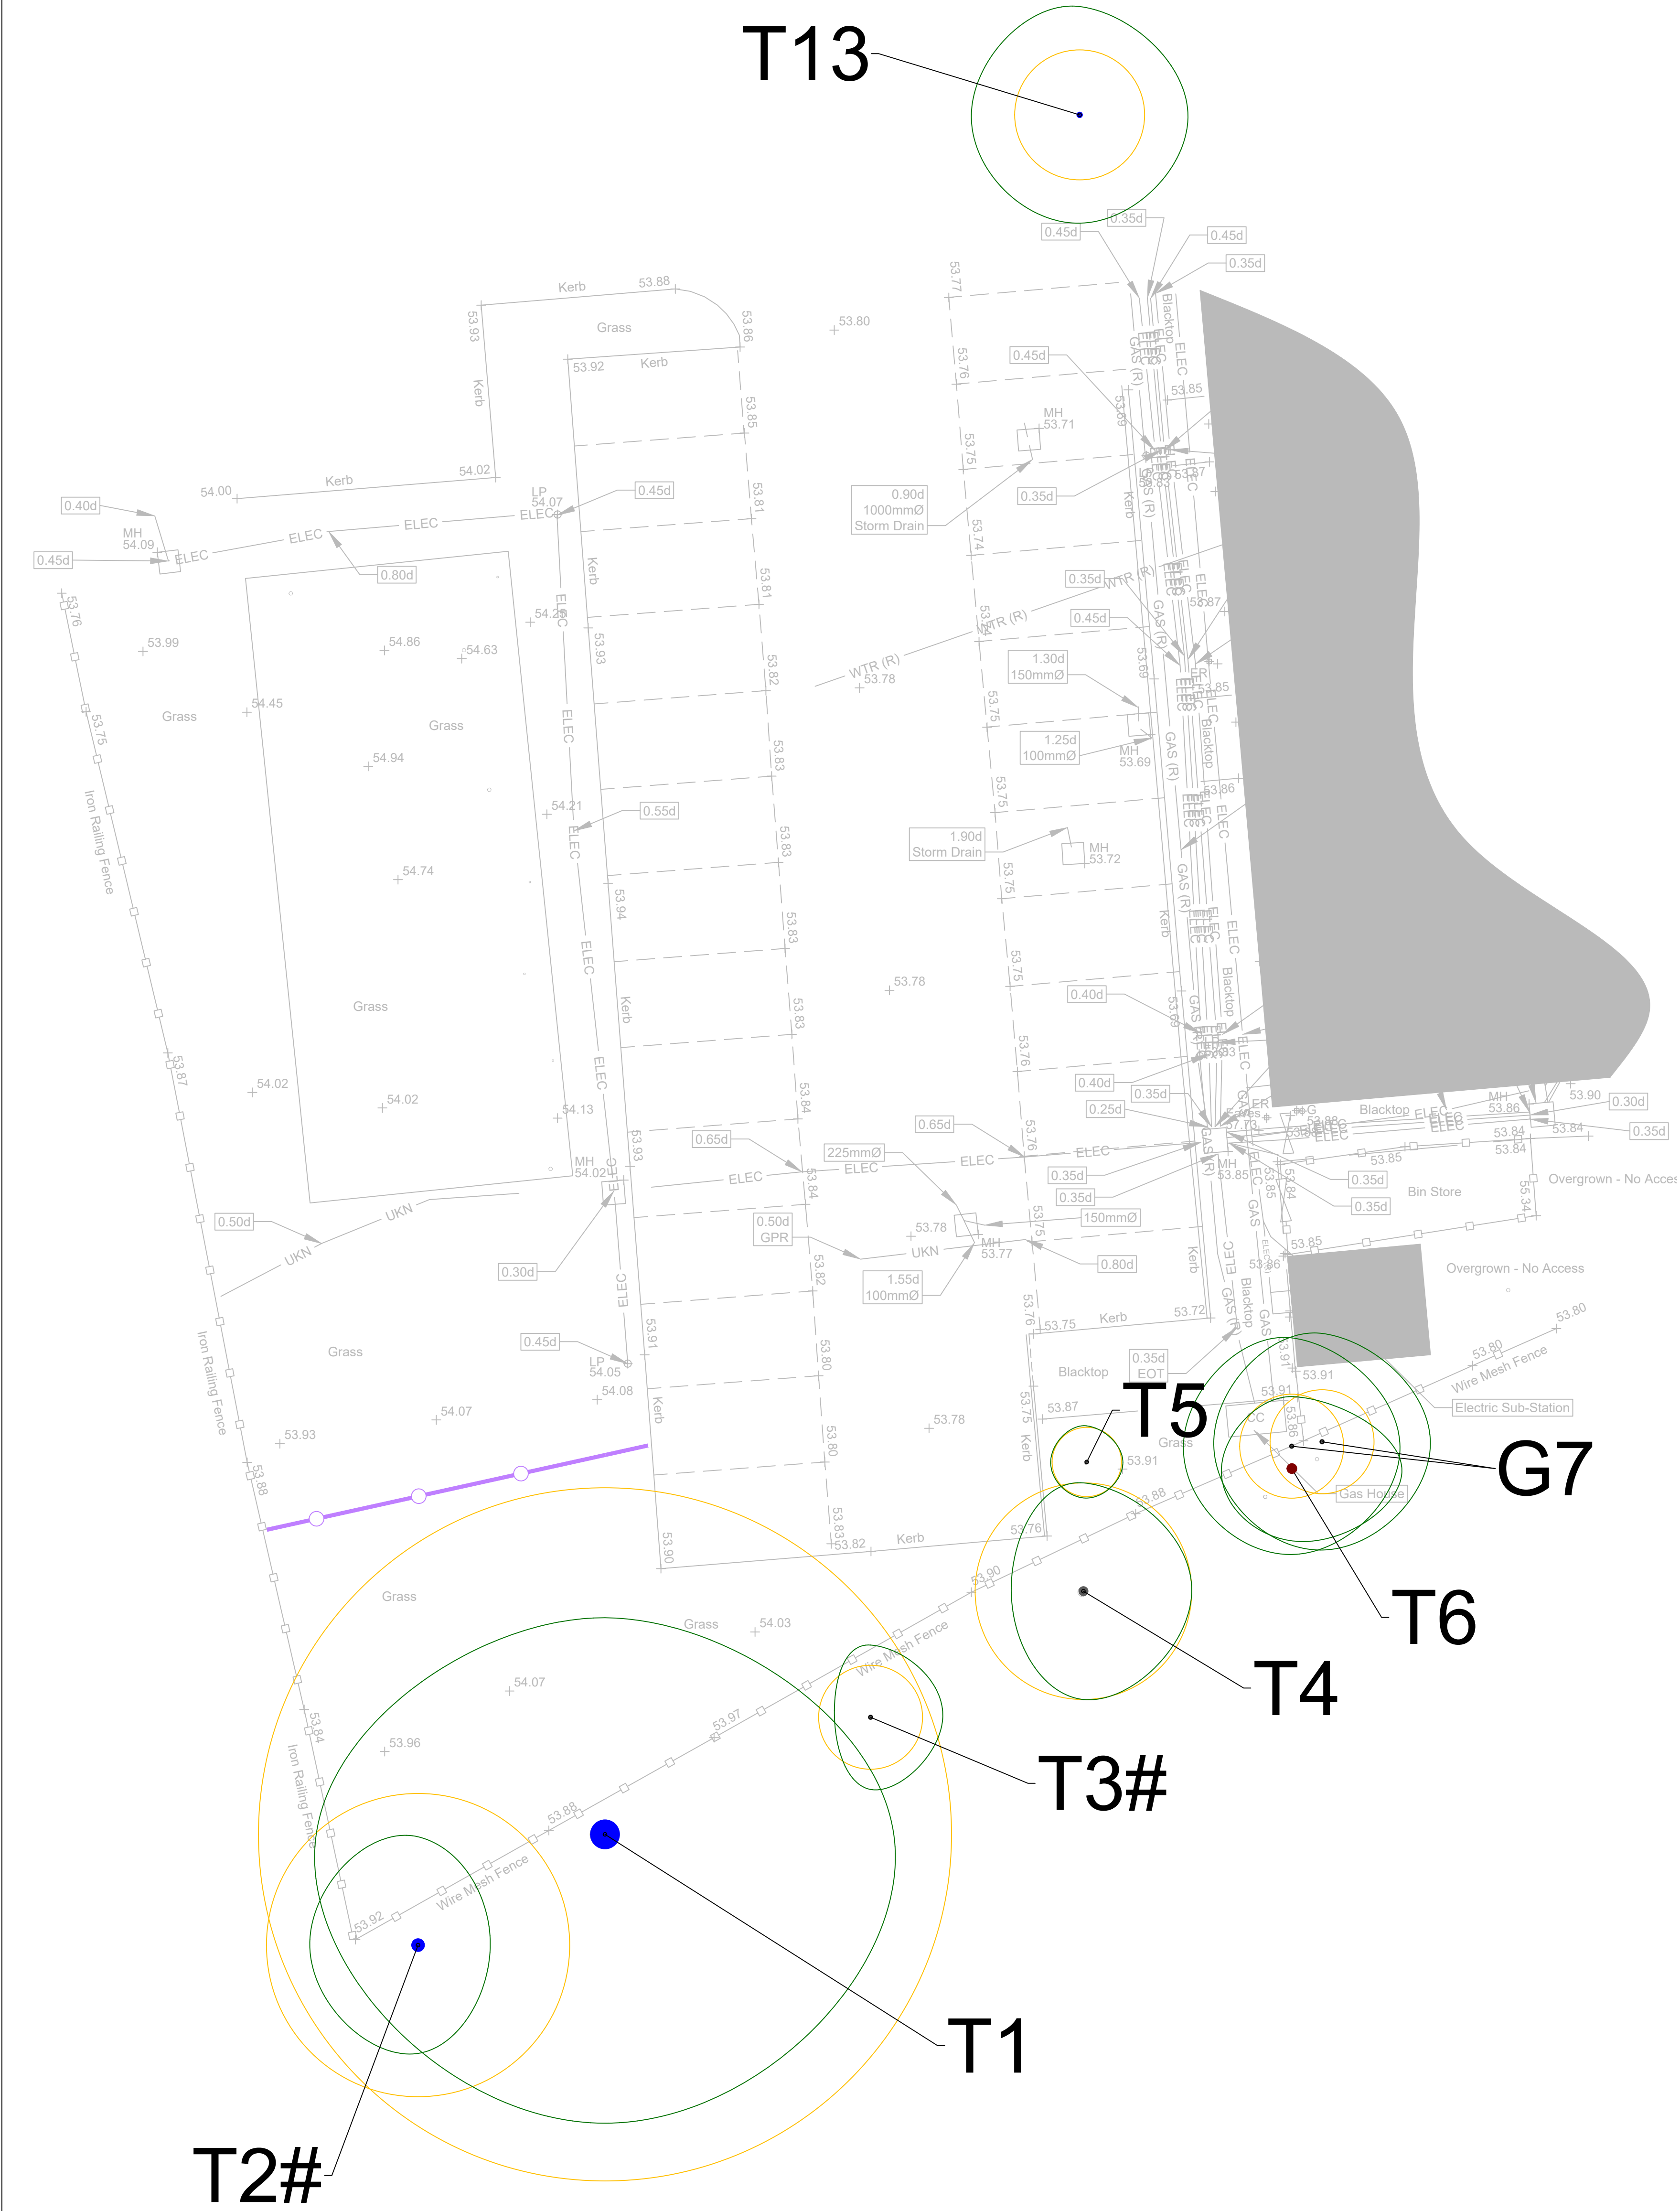
- Category A tree, group or hedge
- Category B tree, group or hedge
- Category C tree, group or hedge
- Category U tree, group or hedge
- Retained tree
- Root Protection Area (RPA)
- # Position estimated on site
- Protective fencing ( See Insert 1 & Insert 2)

- 4.6.1. Temporary protective fencing will need to be installed at the alignment indicated on the Tree Protection Plan in Appendix 4, prior to the commencement of any construction activities on site including the delivery of materials and site facilities.

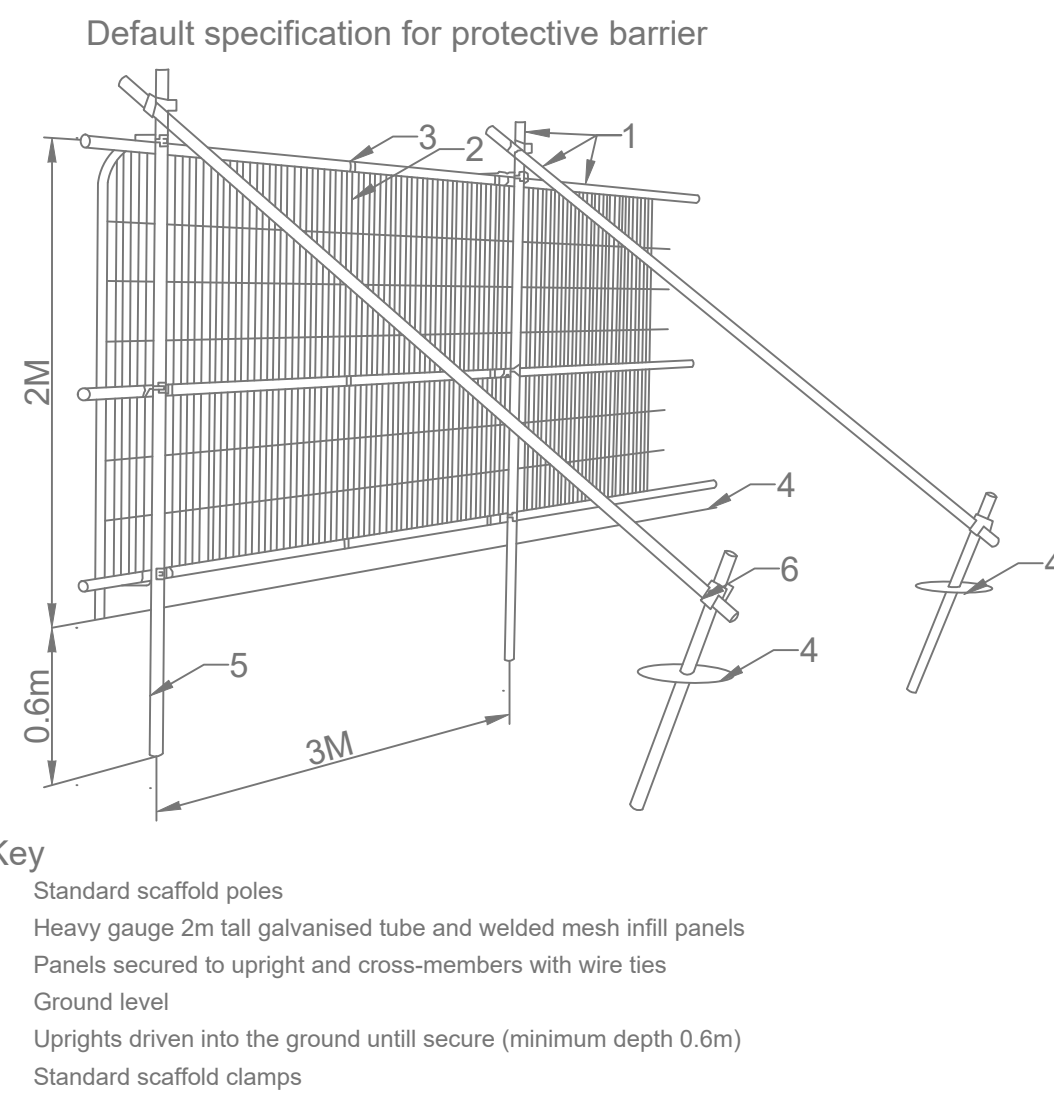
Insert 1: Tree protective fencing specification

- 4.6.3. The required specification for protective fencing is illustrated in the Tree Protection Plan (Insert 1).
- 4.6.4. The 'in-ground' system involves driving vertical scaffold poles approximately 0.6m into the ground onto which are affixed horizontal scaffold poles and bracing struts. 2m high anti-climb weldmesh panels are then wired to the scaffold framework. The vertical scaffold poles should be at a maximum of 3m apart.

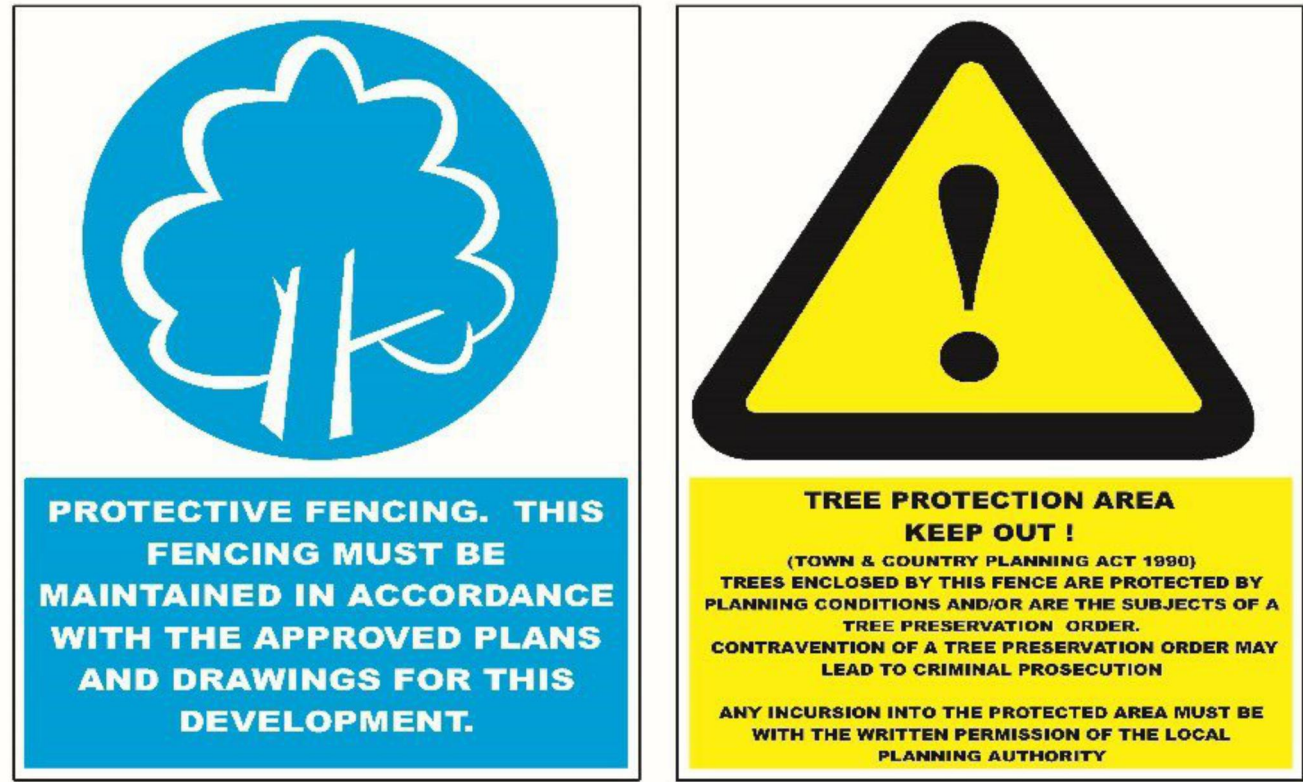
Insert 2: Tree protection notice

- 4.6.5. No fixing shall be made to any tree and all possible precautions shall be taken to prevent damage to the tree roots when locating uprights.
- 4.6.6. A 600mm x 300mm warning sign reading "TREE PROTECTION AREA KEEP OUT" shall be fixed to every 10m of protective fencing, as illustrated on the Tree Protection Plan (Insert 2).
