# MANCHESTER COLLEGE CAMPUS

## REMEDIATION STRATEGY

**Job Number:** CLR 19 1016

**Client:** Wilmott Dixon Construction Ltd

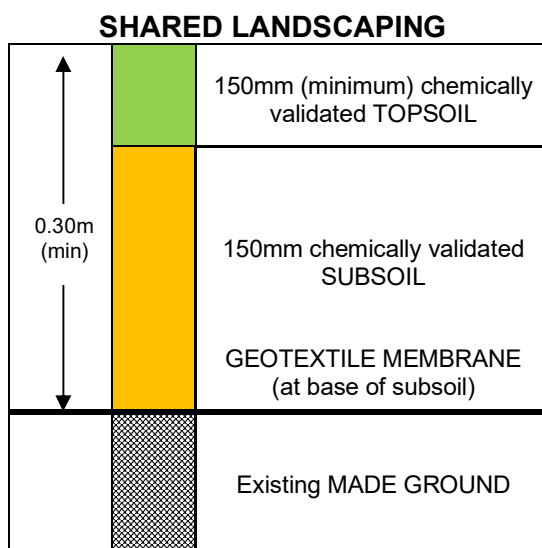
An environmental cover layer is required in all soft landscaping areas. A cover layer should comprise a depth of at least 300mm in shared landscaping areas. A typical construction detail is provided below (the subsoil layer can be omitted in favour using topsoil):

| Phase | Remediation Requirements | Validation Requirements |
|---|---|---|
| Build Phase | <u>Environmental Cover System</u><br><br><b>Shared Landscaping: 300mm thick environmental cover system comprising:</b><br><b><u>Either</u></b> 100mm physical break layer (MOT type 1 material, 20-30mm, minimal fines) and at least 200mm comprising clean inert fill and sufficient topsoil for a growing medium.<br><b><u>Or</u></b> geotextile membrane and at least 300mm comprising clean inert fill and sufficient topsoil for a growing medium.<br><br>The subsoil layer can be replaced by additional topsoil. | Photographic evidence of natural strata.<br>Chemical validation of imported/ site-won soils.: See Table 3-1. |
