## **GROUND INVESTIGATION REPORT**

**FOR  
OLD MARKET STREET,  
MANCHESTER,  
M9 8HY**

**REPORT NO. 7268A  
NOVEMBER 2021**

**SUB SURFACE NORTH WEST LIMITED**

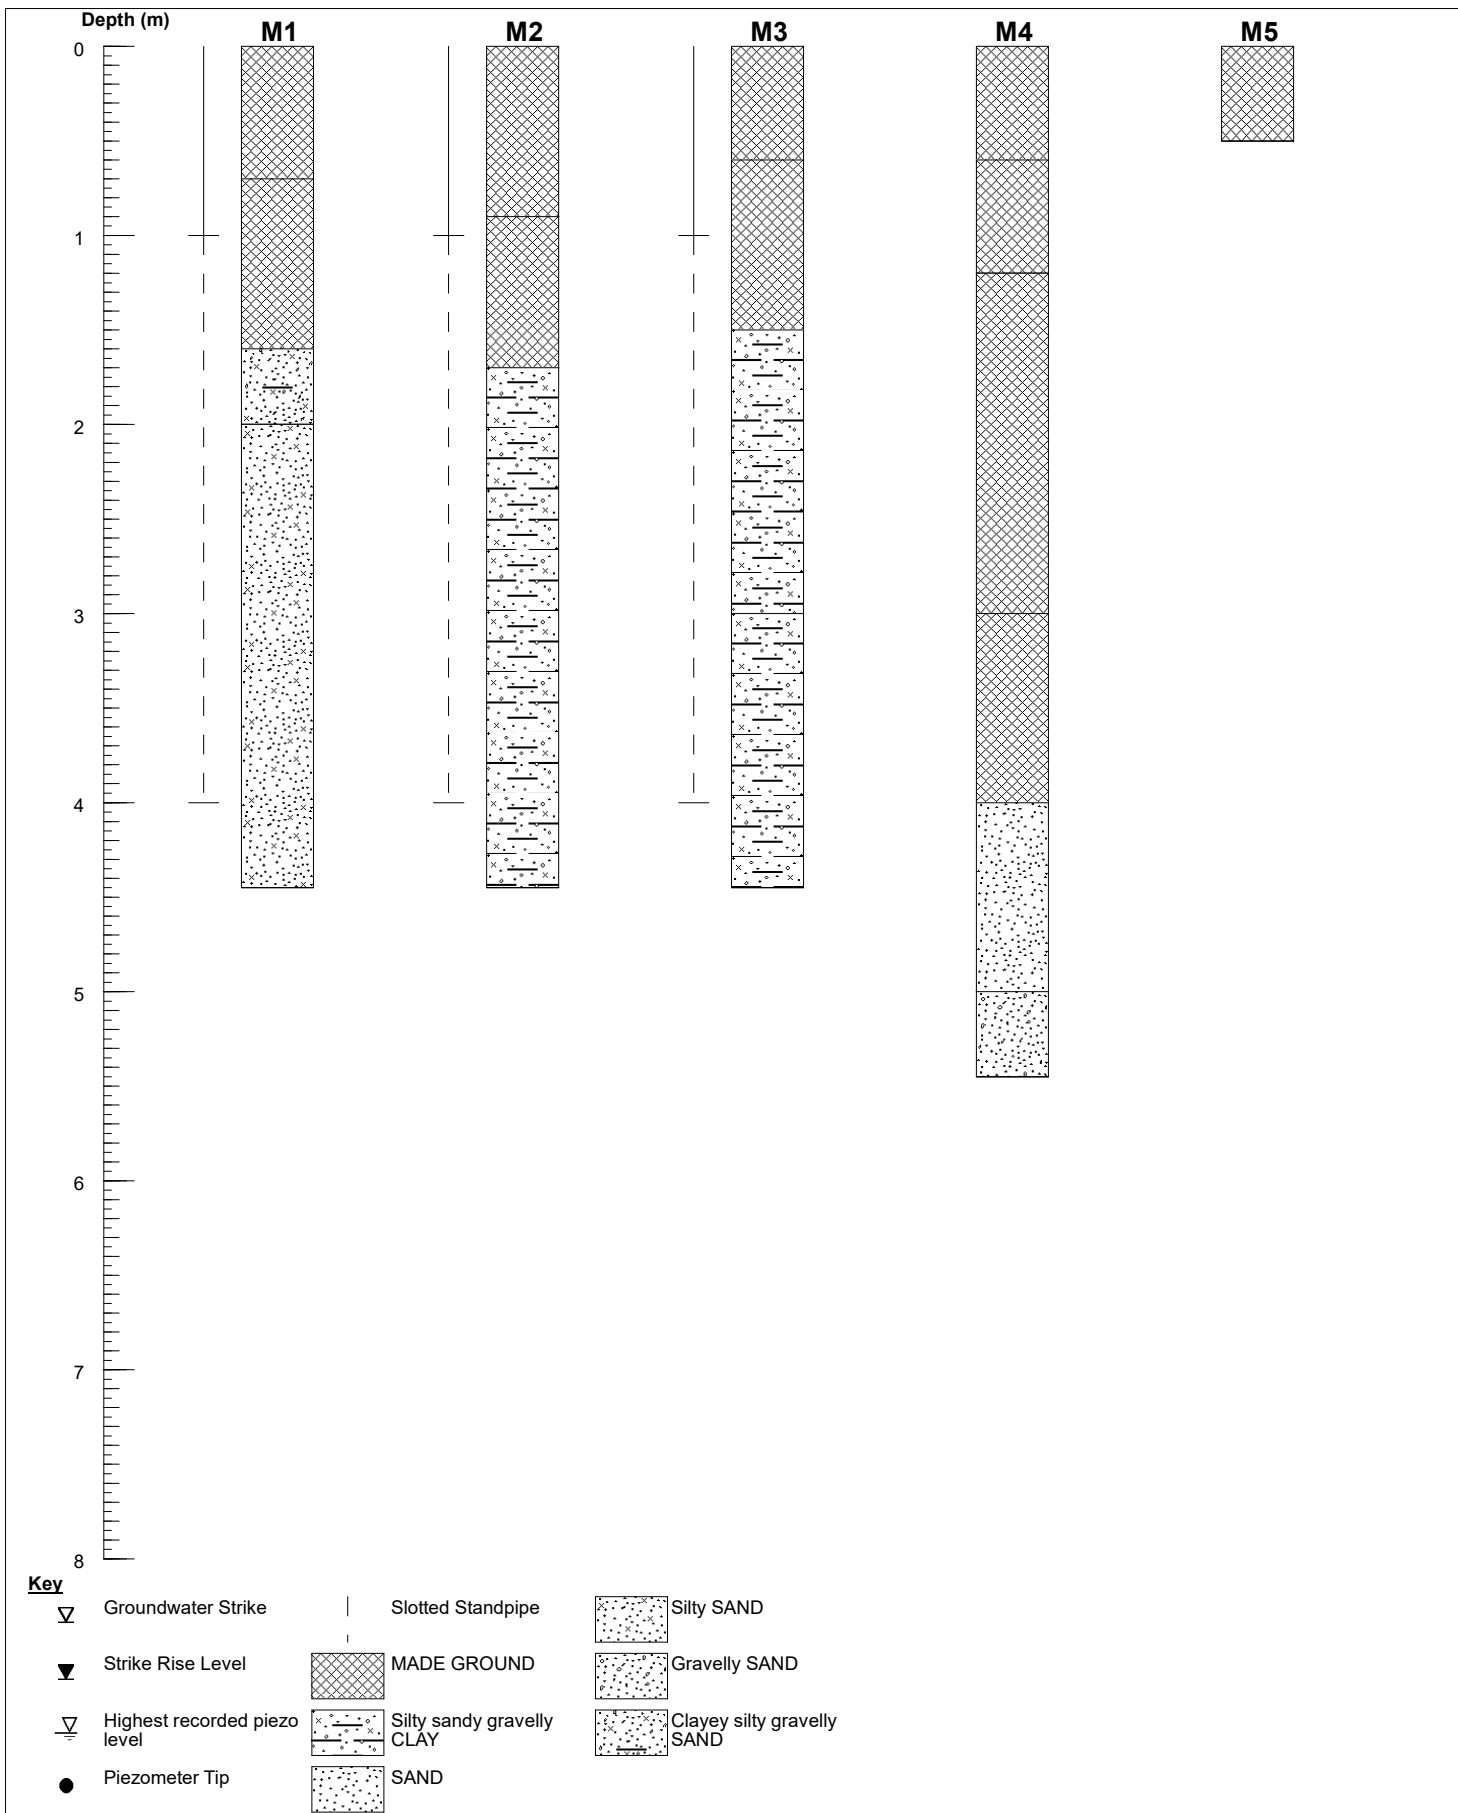
| | | | <b>Scale</b><br>1:40[V] | <b>Figure No.</b><br>7268.1 |

| <b>SS SUB SURFACE</b><br>SITE INVESTIGATION SPECIALISTS, GEOTECHNICAL & ENVIRONMENTAL CONSULTANTS<br>3 Peel Street, Preston, Lancashire, PR2 2QS. Tel: (01772) 561135 Fax: (01772) 204907 | | <b>Nominal Section</b> | | |

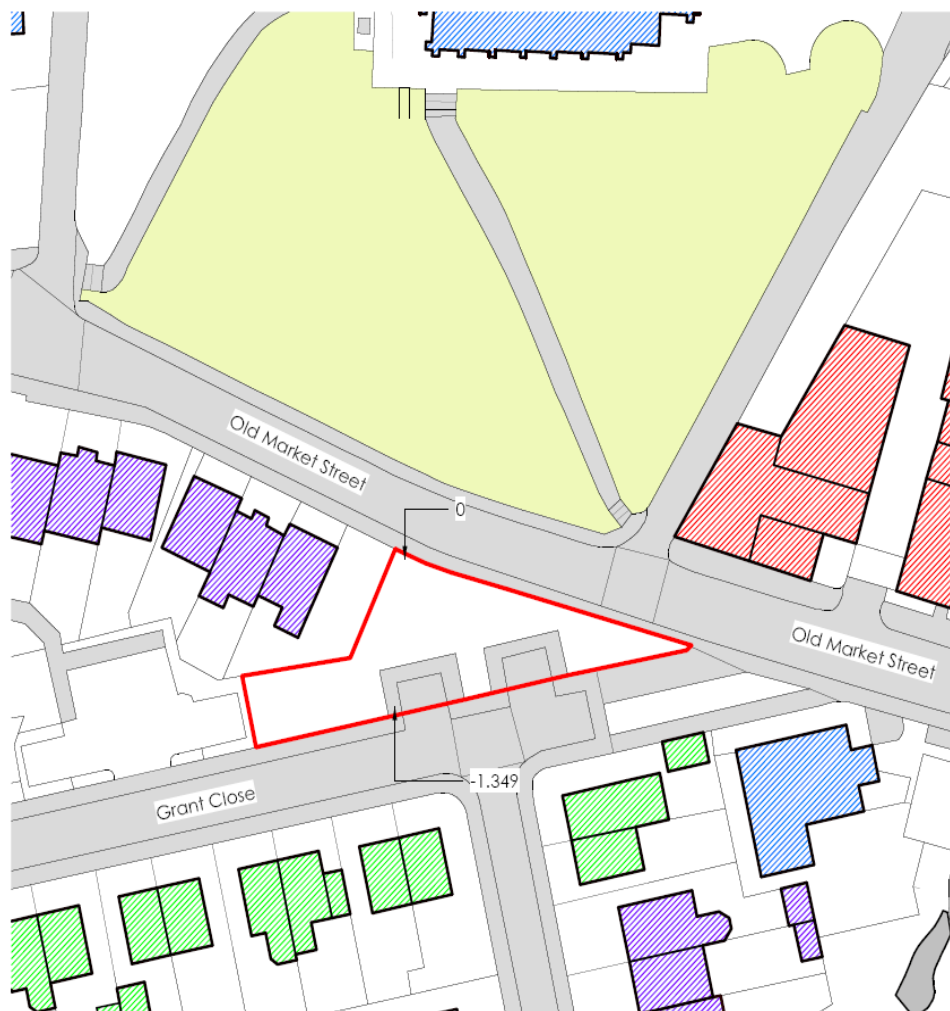
3

We understand that it is proposed to construct a single residential bungalow with associated car parking and gardens as shown on Figure 3.

We understand that it is proposed to construct a single residential bungalow with associated car parking and gardens as shown on Figure 3. However, at the time of writing this report no specific details regarding the proposed foundations and design loadings were available and consequently the recommendations given are in general terms only.
