## Robinsons Preservation Ltd.

### **Re: Power Room Manchester Science & Industry Museum Manchester**

Further to the discovery of Dry rot to the valley beams to the central valley, we carried out an inspection during our visit on Monday 20<sup>th</sup> December 2021. The following beams were discovered to be affected by decay as follows:-

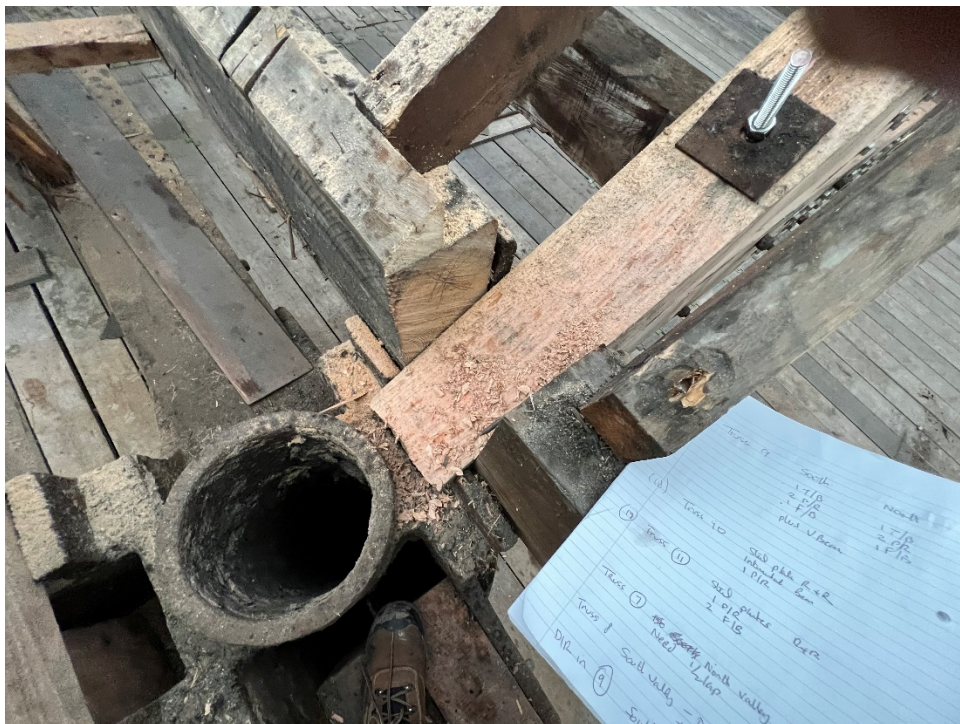
#### **Between Trusses 9 and 10 Valley Beam South Side**

The repairs to the truss end revealed dry rot attack to the bearing end of the valley beam to the south side entering truss 9. Allowances should be made for additional 1/2 repairs as per schedule of repairs

| Trusses 9 and 10 Valley Beam South Side | ½ lap repair |

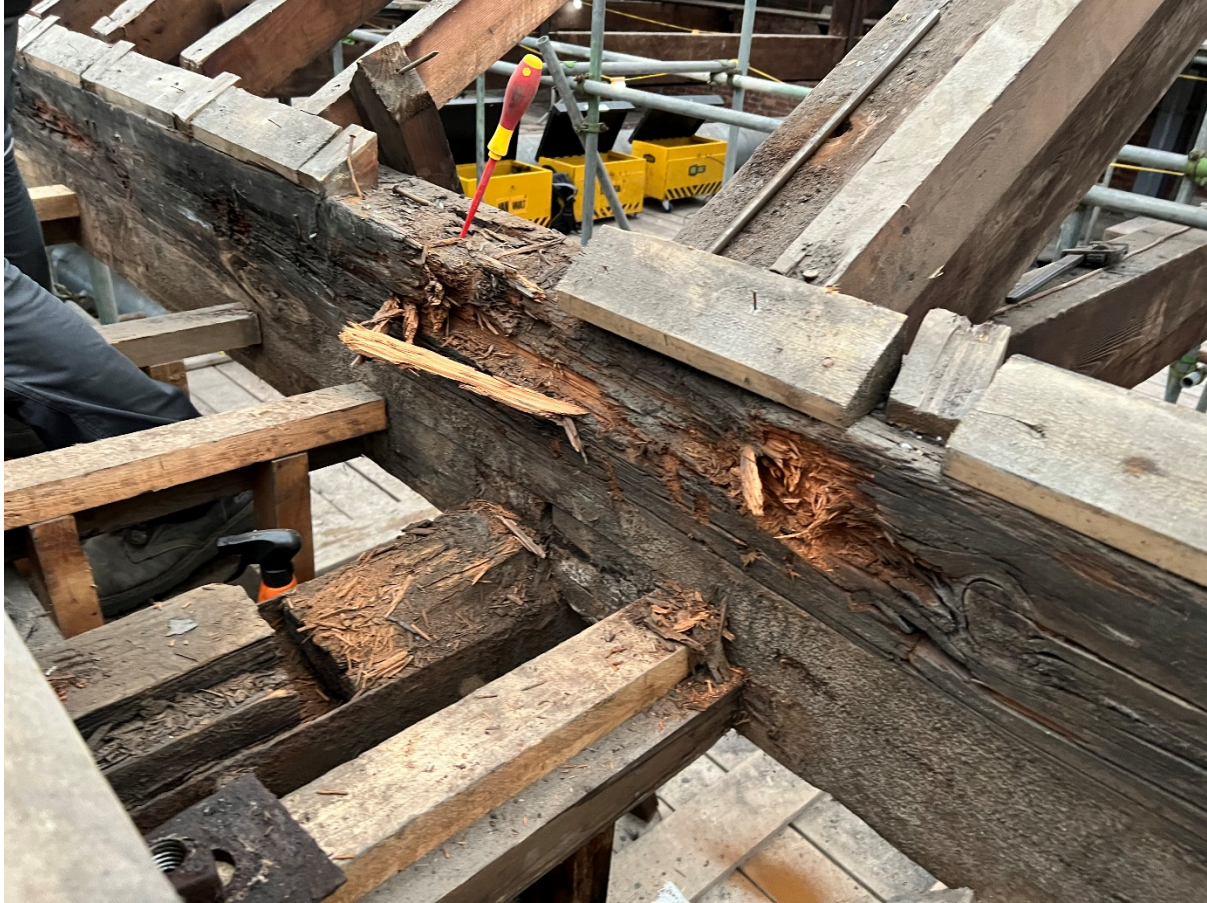
**Truss 12 Valley Beam South Side**

Rot to both bearing ends of the valley beam entering the truss 12. Additional ½ repair to the valley beam between trusses 11 and 12. The beam between trusses 12 and 13 to be fully replaced (cost neutral) with ½ repair already allowed for valley beam entering truss 13 on south side

| Trusses 11 to 12 Valley Beam South Side | ½ lap repair |

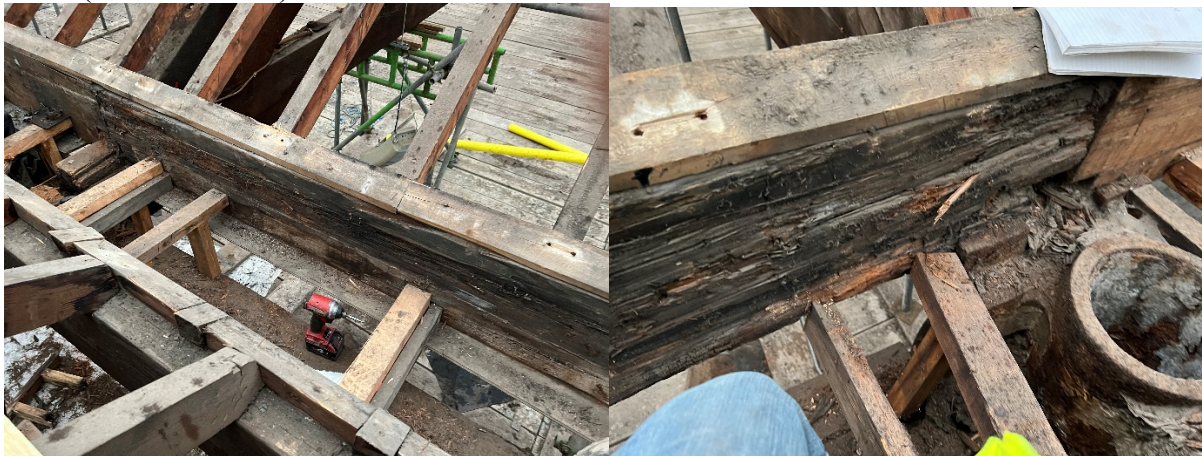
**Trusses 12 to 13 Valley Beam North Side**

Rot to full length of beam. No allowance made previous for repairs. Allowance to full renew beam (additional cost)

| Trusses 12 to 13 Valley Beam North Side | Full Beam |

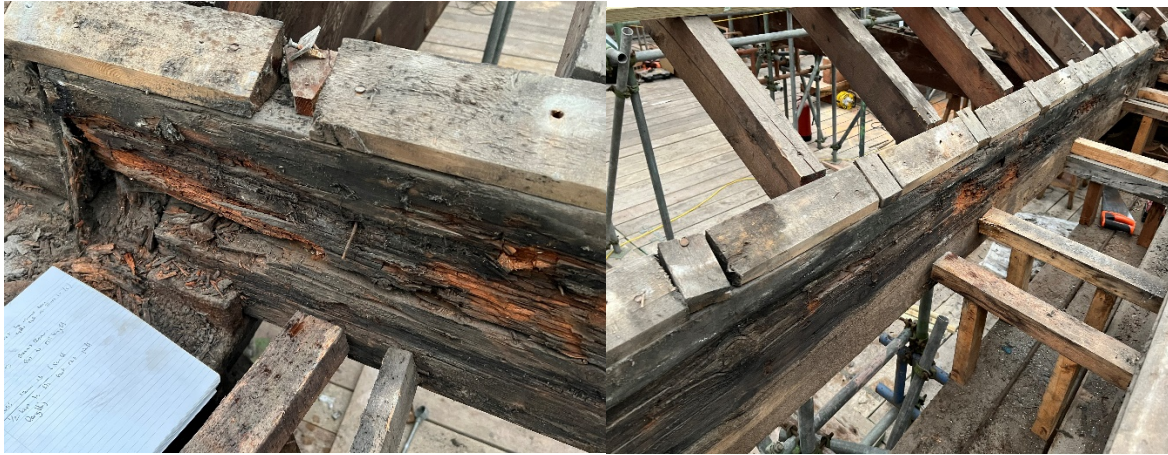
**Trusses 12 to 13 Valley Beam South Side**

Allowances already made for ½ entering the truss 13. Rot discovered the full length of beam between 12 and 13. Allowance should be made to fully renew beam (additional costs)

| Trusses 12 to 13 Valley Beam South Side | Full beam |

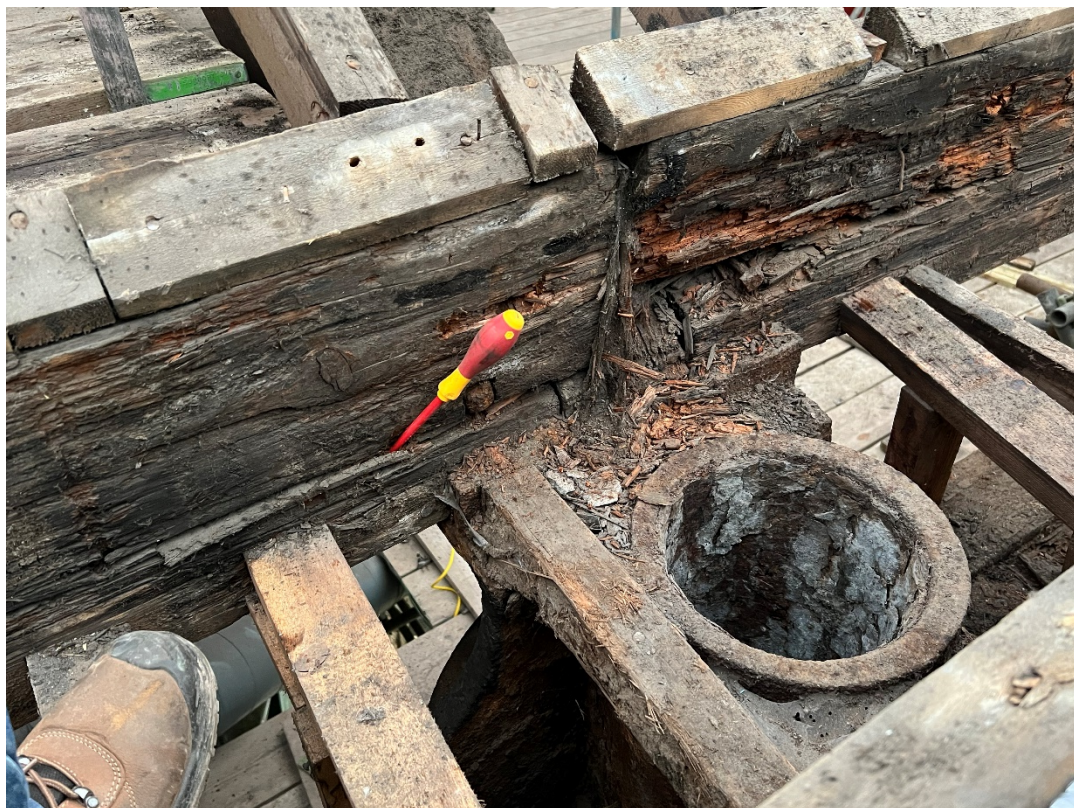
#### **Trusses 14 to 15 Valley Beam South Side**

Rot discovered in both ends of beam. Allowances have already made for repair entering truss 15. Recommend full beam renewed. Cost neutral.

| Trusses 14 to 15 Valley Beam South Side | Full beam |

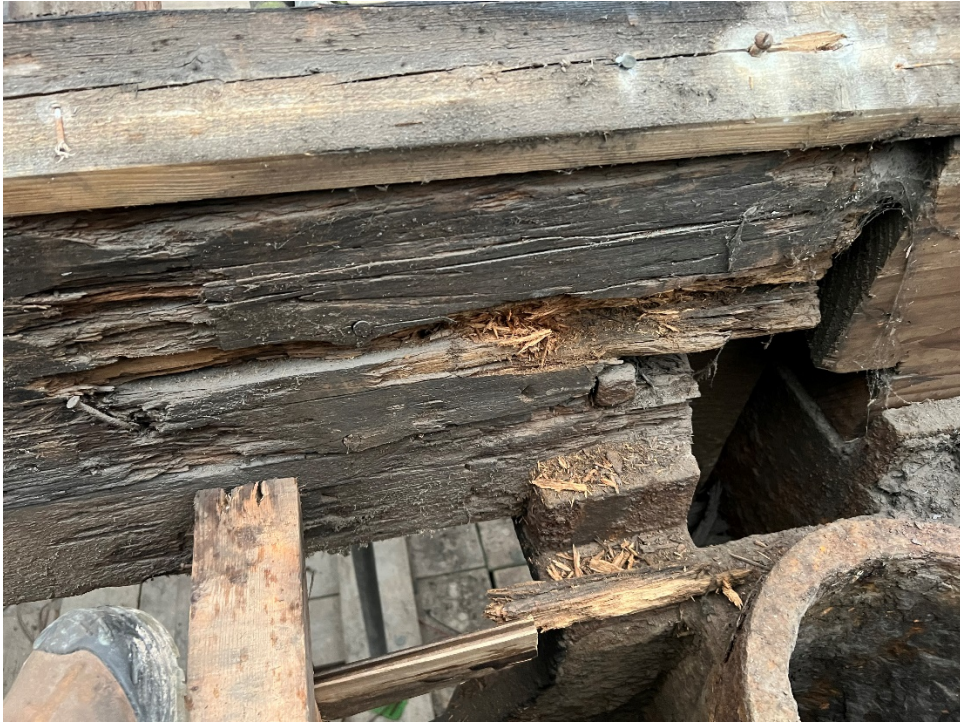
#### **Trusses 16 to 17 Valley Beam North Side**

The full length of the beam is affected by wet rot. Allowances should be made for full renewal of the beam (additional cost)

| Trusses 16 to 17 Valley Beam North Side | Full Beam |

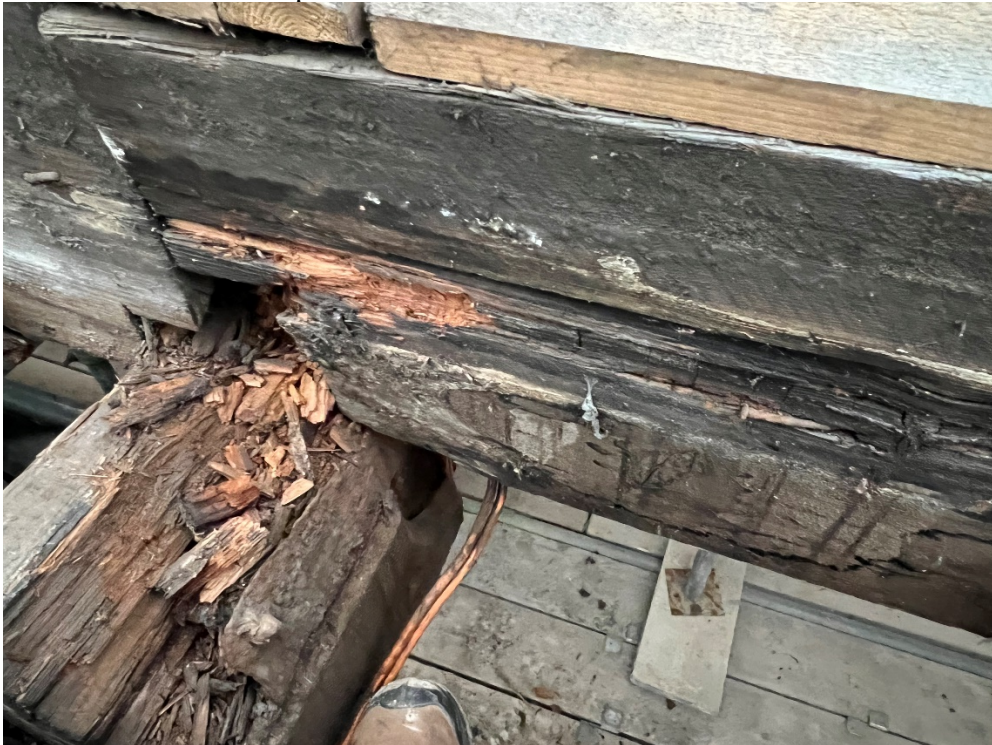
#### **Truss 19 Valley Beam South**

Dry rot attack to the bearing end entering truss 19 (between truss 19 and 18). Additional works recommended with ½ repair

| Truss 19 Valley Beam South | ½ lap repair |

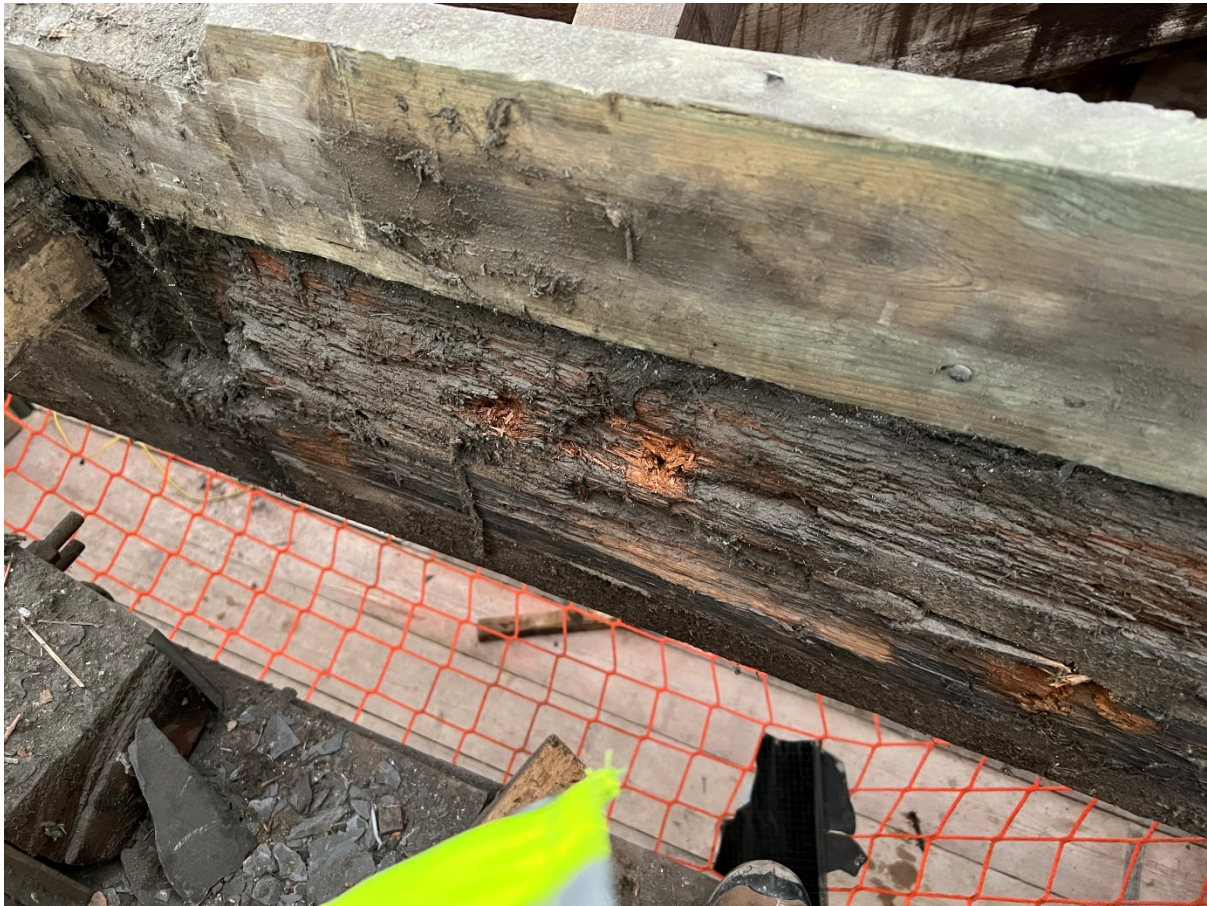
#### **Truss 21 North Valley Beam**

Signs of surface decay to beam end opposite truss 21. Robinson recommend the surface is de-frassed free from decay to assess if repairs are required

| Truss 21 North Valley Beam | TBC |
