| | | <h1>Inspection Report</h1> | | 40 Francis Road<br>Irlam<br>Manchester<br>M44 6AY | |
| Section:<br><b>MH 01 UPSTREAM</b> | Date:<br><b>2021-11-25</b> | Job Number:<br><b>32 M21 9LA</b> | Weather:<br><b>No rain or snow</b> | PLR: | |

| Place:<br>Road:<br>Location: | <b>HAPMTON ROAD<br/>Gardens</b> | Direction:<br>Catchment:<br>Total Length:<br>Pipe Length: | <b>Upstream</b> | Start ref:<br>Start depth:<br>End ref:<br>End depth: | <b>MH 01<br/>HEAD OF LINE</b> |
| Use:<br>Year Laid:<br>Purpose:<br>Lining:<br>Comments: | <b>Combined<br/>Sample survey to determine asset condition of a sewer system</b> | | Pipe Shape:<br>Width / Height:<br>Flow Control:<br>Pipe Material: | <b>circular<br/>? / 150mm<br/>vitrified clay</b> | |

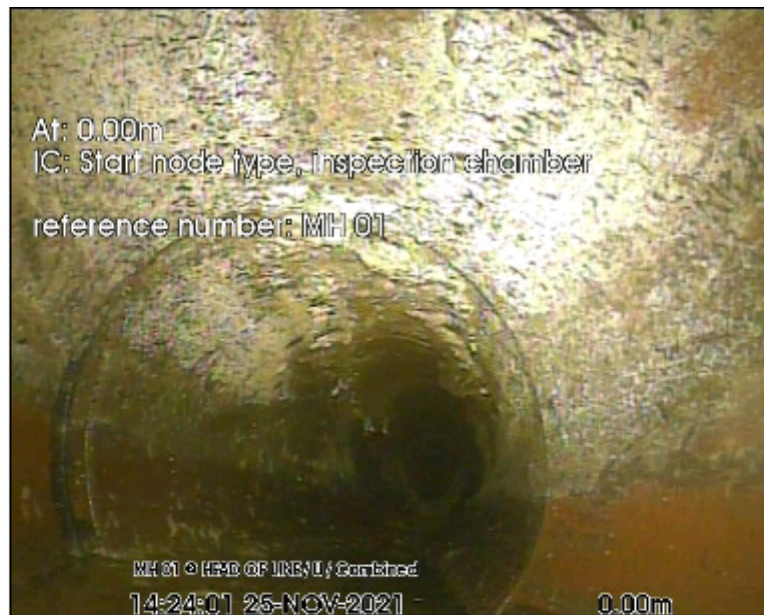
| | Meterage | CD | Code | Observation | Video | Pic. |
|---|---|---|---|---|---|---|
| | 0.00m | | IC | Start node type, inspection chamber reference number: MH 01 | 00:00:01 | (1) |

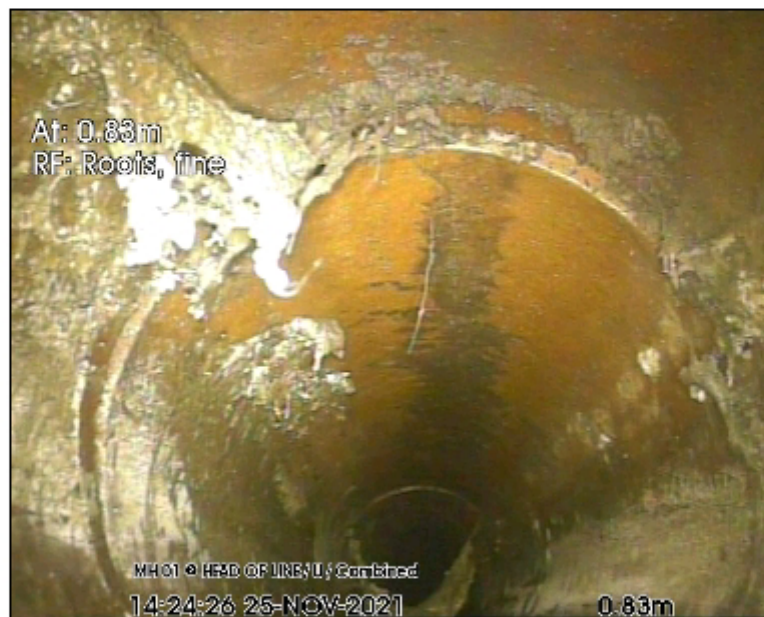
| | Meterage | CD | Code | Observation | Video | Pic. |
|---|---|---|---|---|---|---|
| | 0.83m | | RF | Roots, fine | 00:00:15 | (2) |

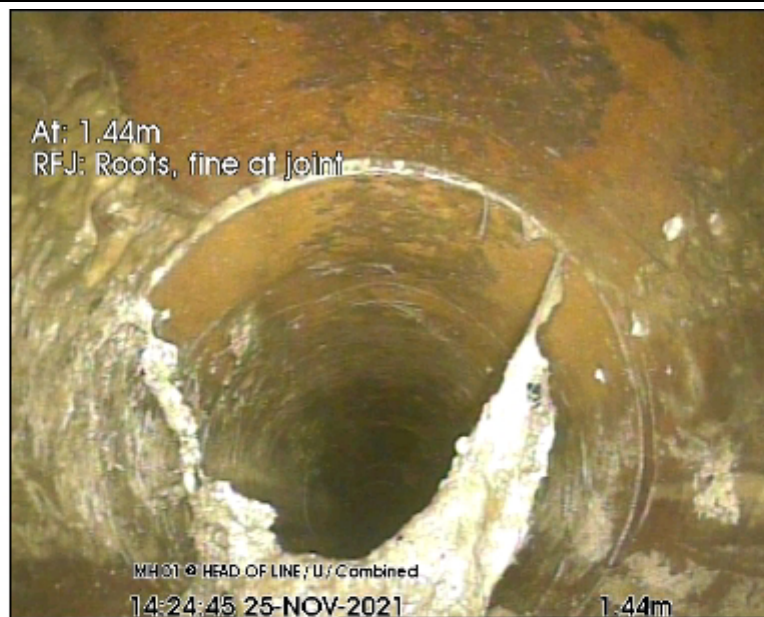
| | Meterage | CD | Code | Observation | Video | Pic. |
|---|---|---|---|---|---|---|
| | 1.44m | | RFJ | Roots, fine at joint | 00:00:23 | (3) |

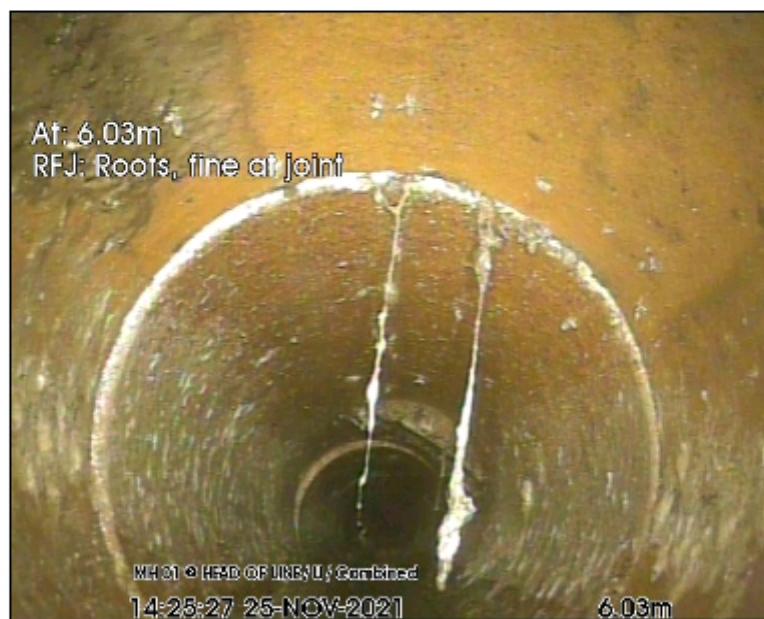
| | Meterage | CD | Code | Observation | Video | Pic. |
|---|---|---|---|---|---|---|
| | 6.03m | | RFJ | Roots, fine at joint | 00:00:55 | (4) |

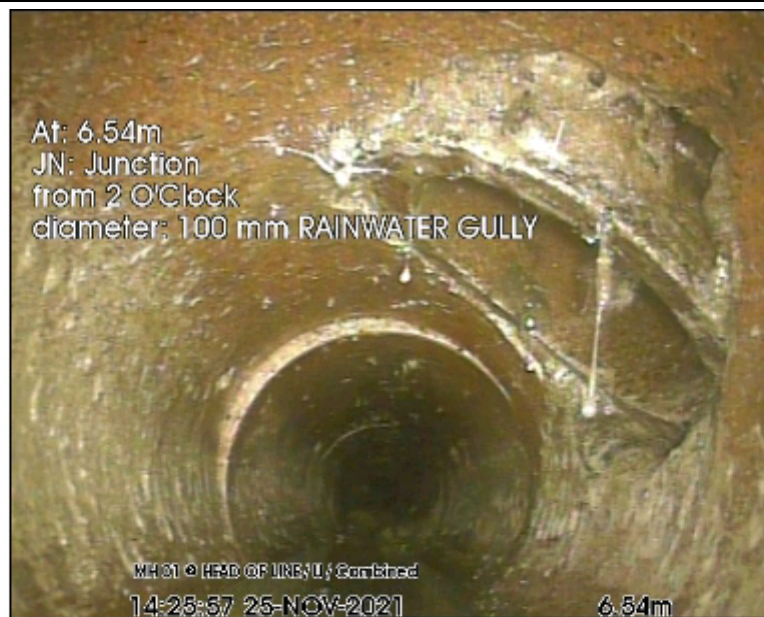
| | Meterage | CD | Code | Observation | Video | Pic. |
|---|---|---|---|---|---|---|
| | 6.54m | | JN | Junction from 2 O'Clock diameter: 100 mm RAINWATER GULLY | 00:00:58 | (5) |

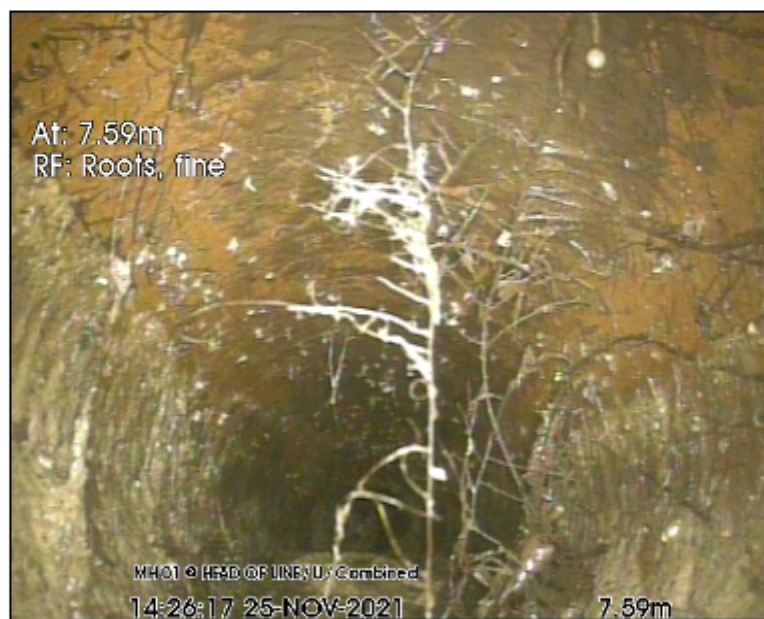
| | Meterage | CD | Code | Observation | Video | Pic. |
|---|---|---|---|---|---|---|
| | 7.59m | | RF | Roots, fine | 00:01:04 | (6) |

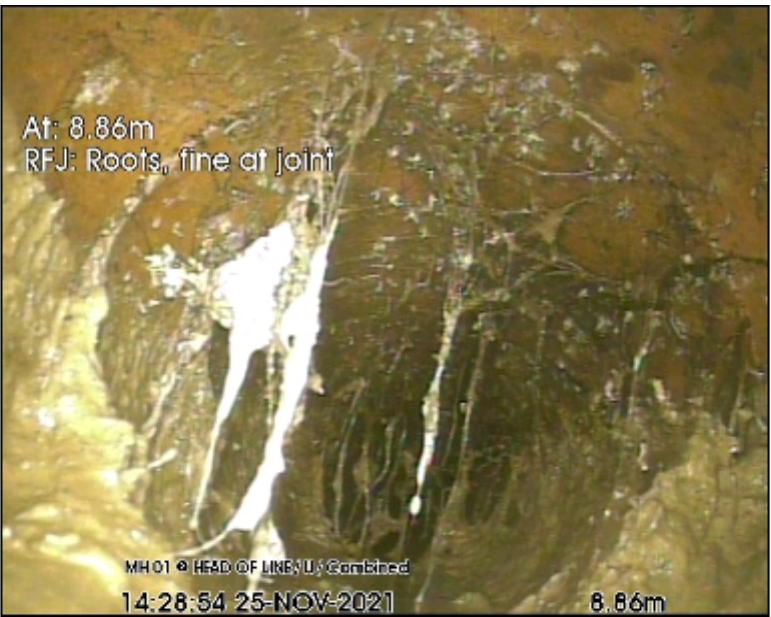
| | Meterage | CD | Code | Observation | Video | Pic. |
|---|---|---|---|---|---|---|
| | 8.86m | | RFJ | Roots, fine at joint | 00:03:31 | (7) |

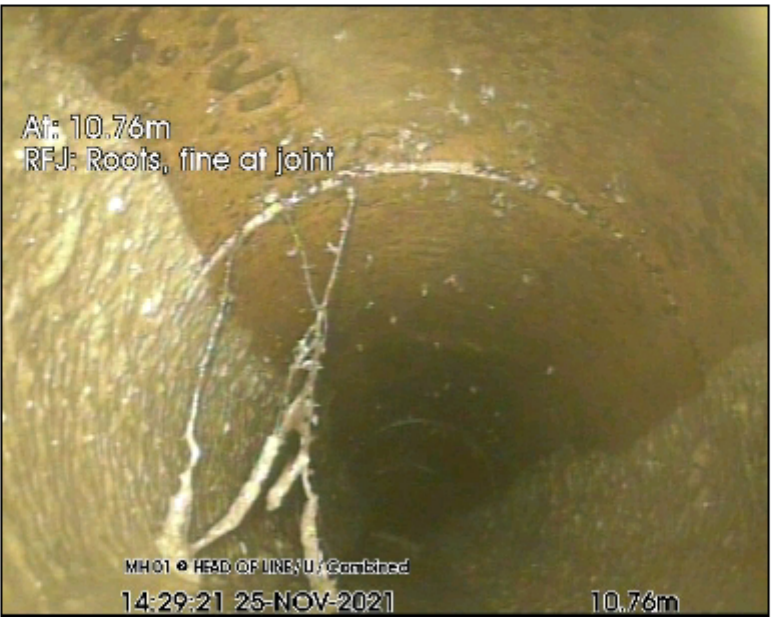
| Meterage | CD | Code | Observation | Video | Pic. |
|---|---|---|---|---|---|
| 10.76m | | RFJ | Roots, fine at joint | 00:03:48 | (8) |

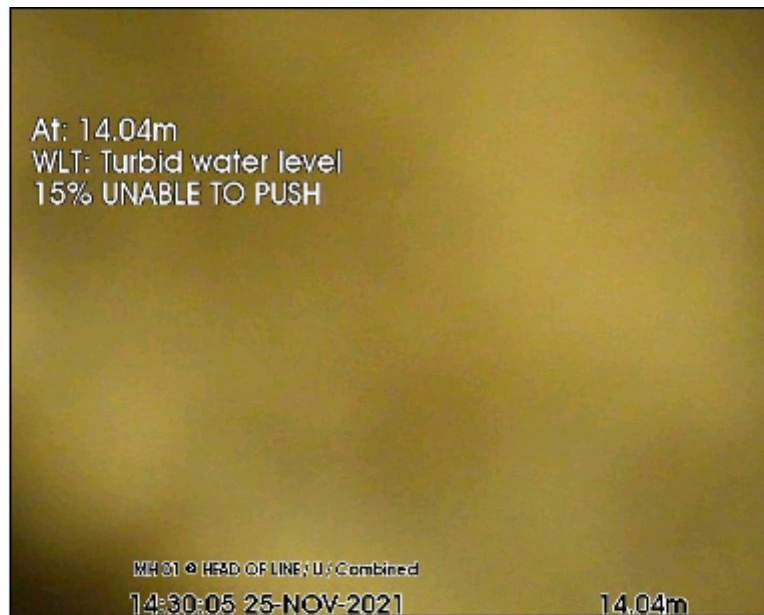
| Meterage | CD | Code | Observation | Video | Pic. |
|---|---|---|---|---|---|
| 14.04m | | WLT | Turbid water level 15% UNABLE TO PUSH | 00:04:13 | (9) |

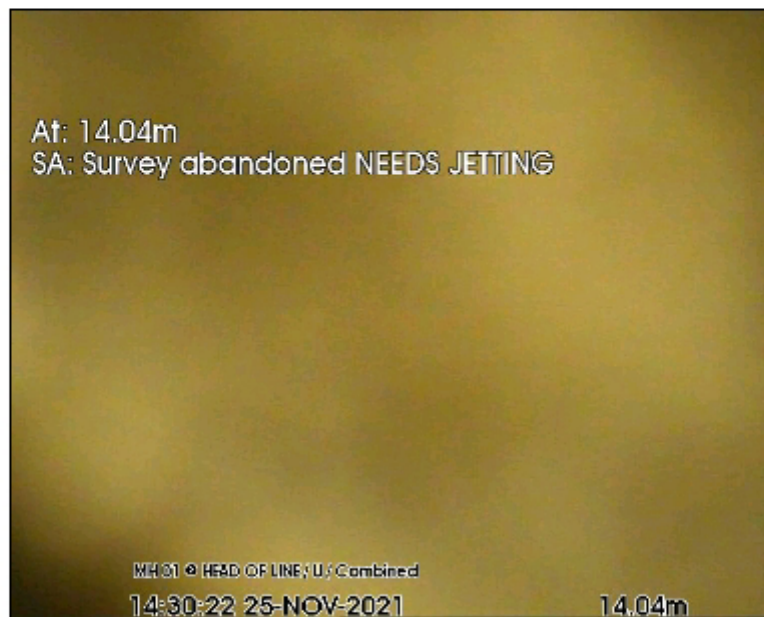
| Meterage | CD | Code | Observation | Video | Pic. |
|---|---|---|---|---|---|
| 14.04m | | SA | Survey abandoned NEEDS JETTING | 00:04:15 | (10) |
