| Project:<br><b>47 PETER STREET,<br/>MANCHESTER</b> | | | | |
| Drawing Title:<br><b>UPPER FLOOR DETAILS<br/>(SHEET 2 OF 2)</b> | | | | |
| Status:<br><b>STAGE 4</b> | | | | |
| PSM-REN-ZZ-ZZ-DR-S-00315-T03 | | | | |

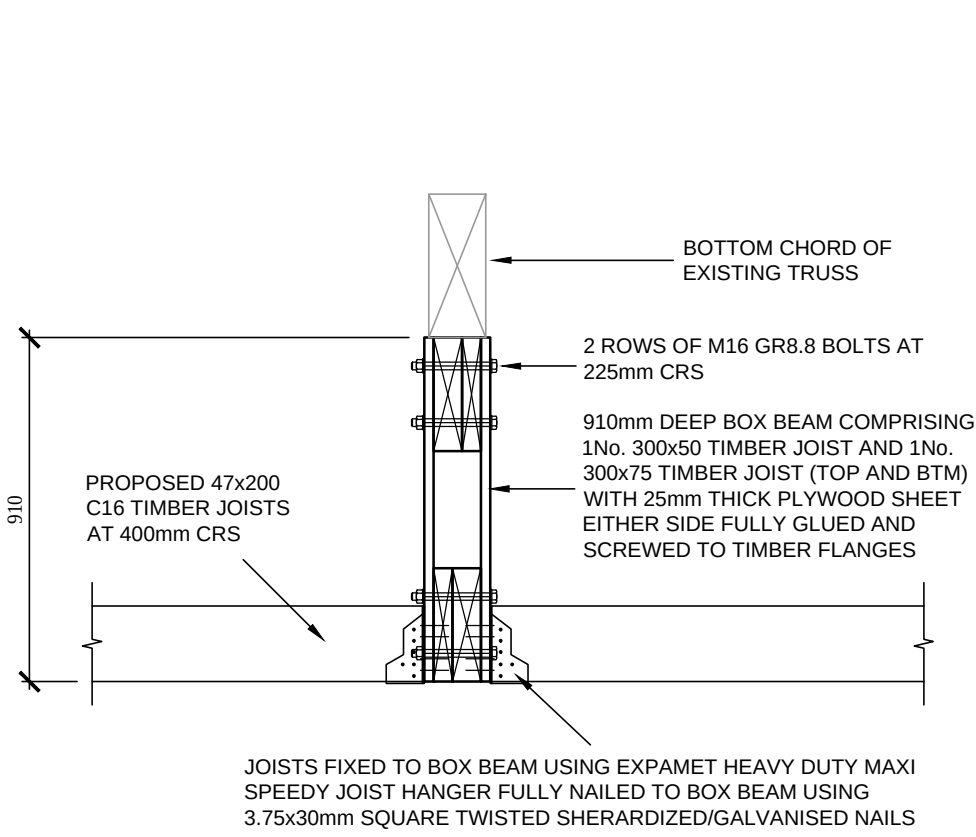
**DETAIL 108**  
TYPICAL SECTION THROUGH BOX BEAM  
AT 3RD FLOOR MEZZANINE LEVEL  
SCALE 1:20

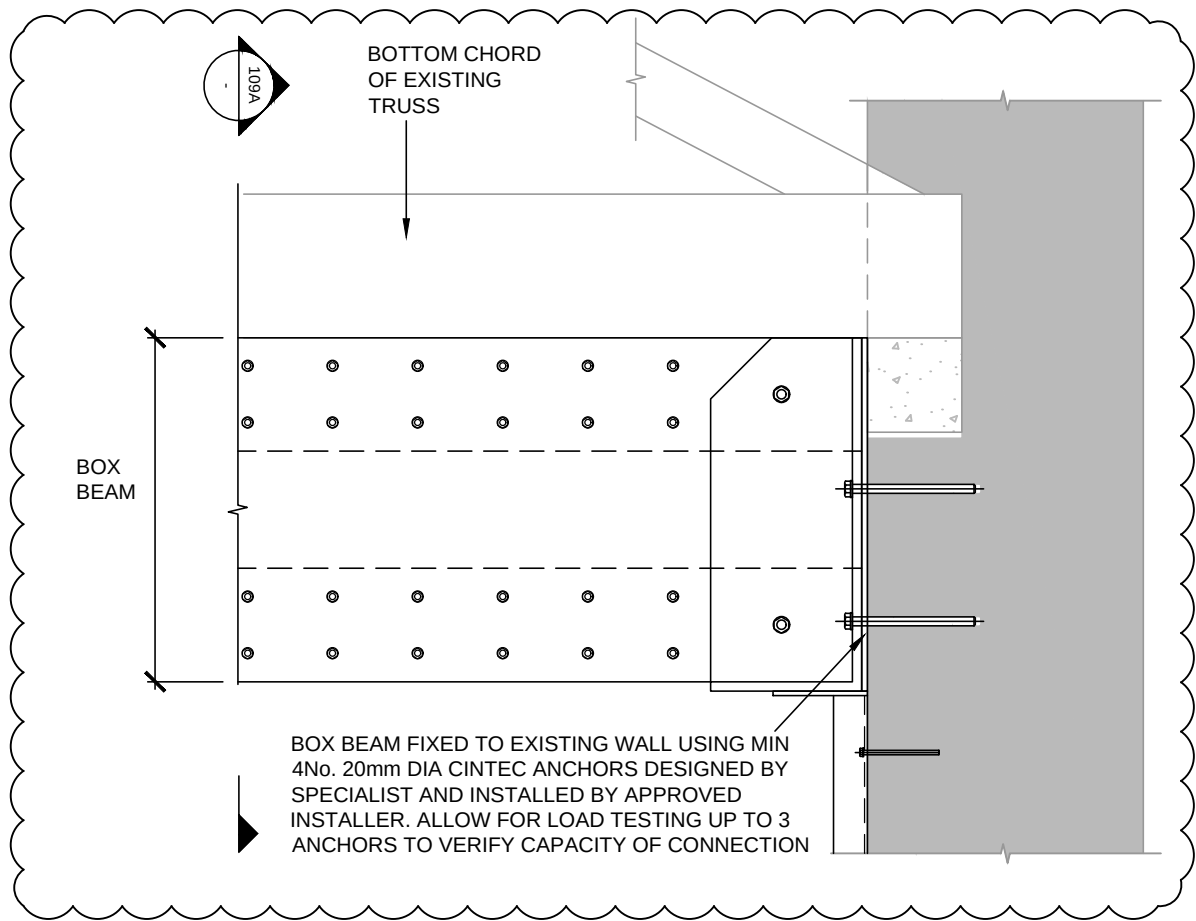
**DETAIL 109**  
TYPICAL EXISTING MASONRY TO BOX BEAM CONNECTION  
SCALE 1:20

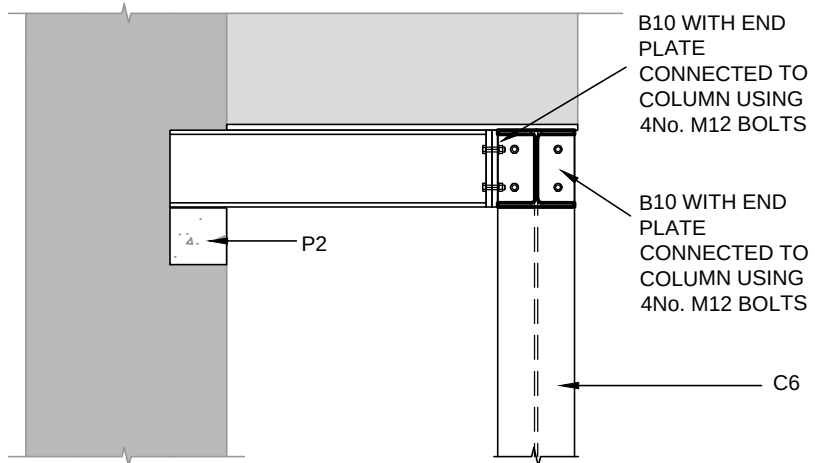
**DETAIL 110**  
SECTION THROUGH CHIMNEY SUPPORT  
GRILLAGE STEEL  
SCALE 1:20

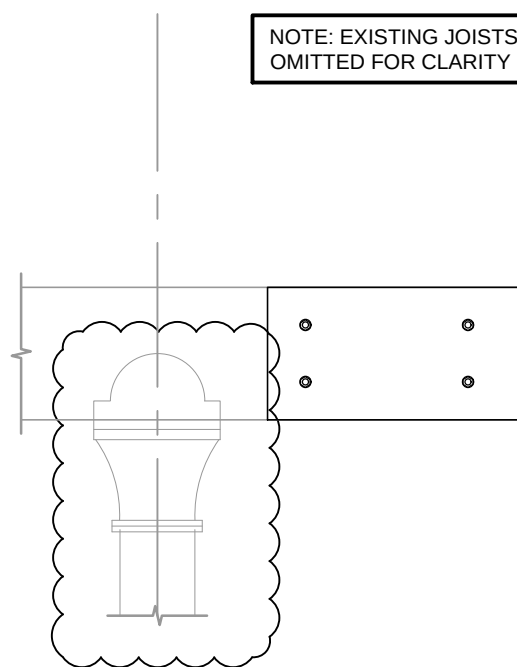
FIRE DAMAGED TIMBER TO BE REMOVED AND SECTION BUILT BACK UP AS ORIGINAL PRIOR TO PLACEMENT OF FLITCH PLATES TO EACH SIDE

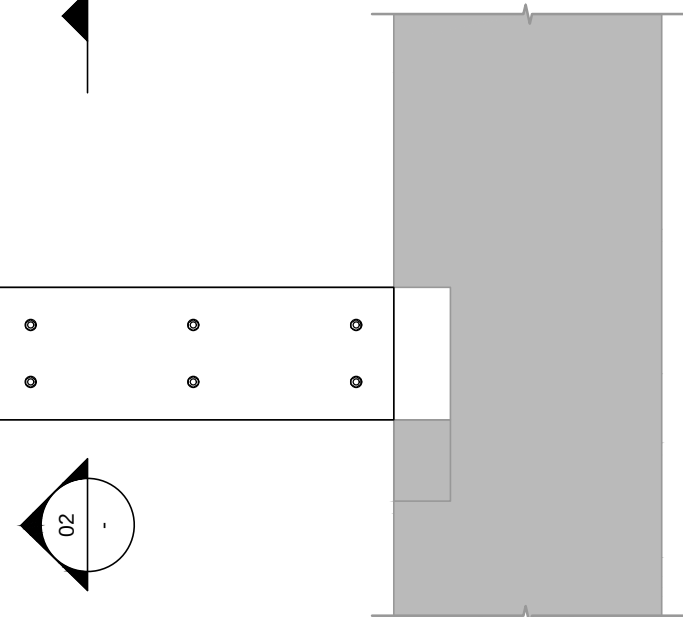
**DETAIL 113**  
SCALE 1:20

FIRE DAMAGED TIMBER TO BE REMOVED AND SECTION BUILT BACK UP AS ORIGINAL PRIOR TO PLACEMENT OF FLITCH PLATES TO EACH SIDE

2 No. 8mm x 300mm (TBC) S355 CONTINUOUS PLATES

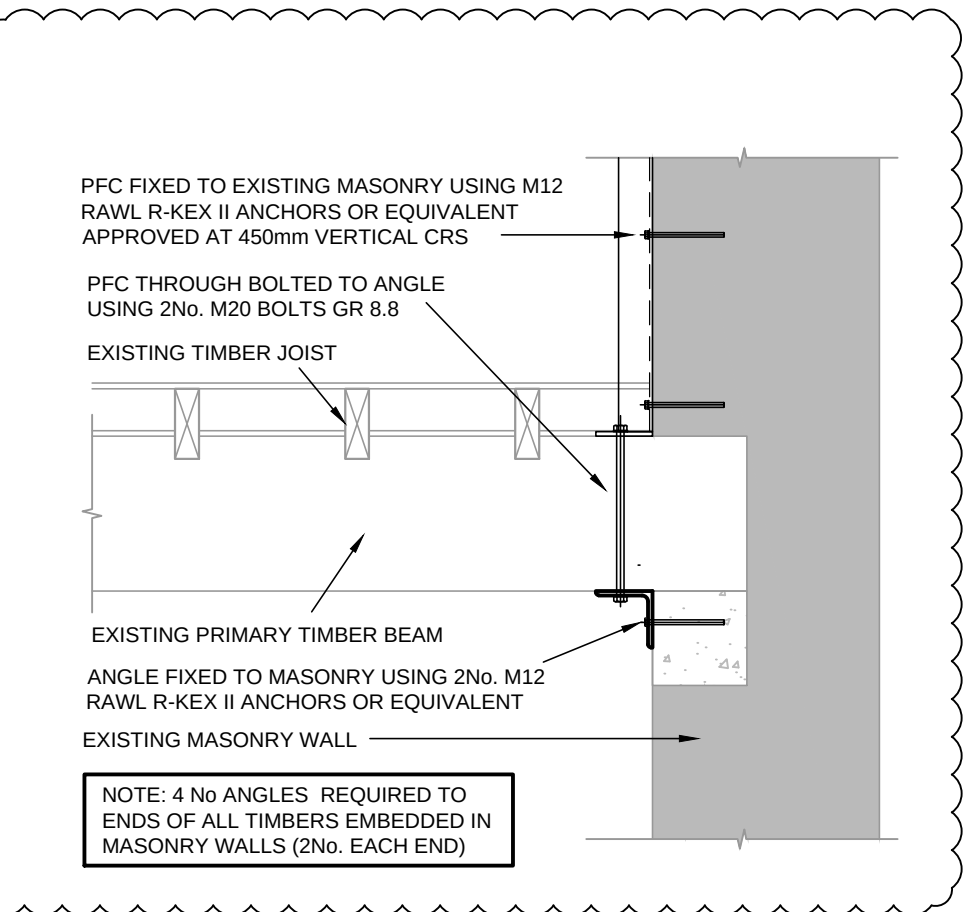
**DETAIL 114**  
TYPICAL PFC TO EXISTING TIMBER BEAM  
CONNECTION AT 3RD FLOOR LEVEL  
SCALE 1:20

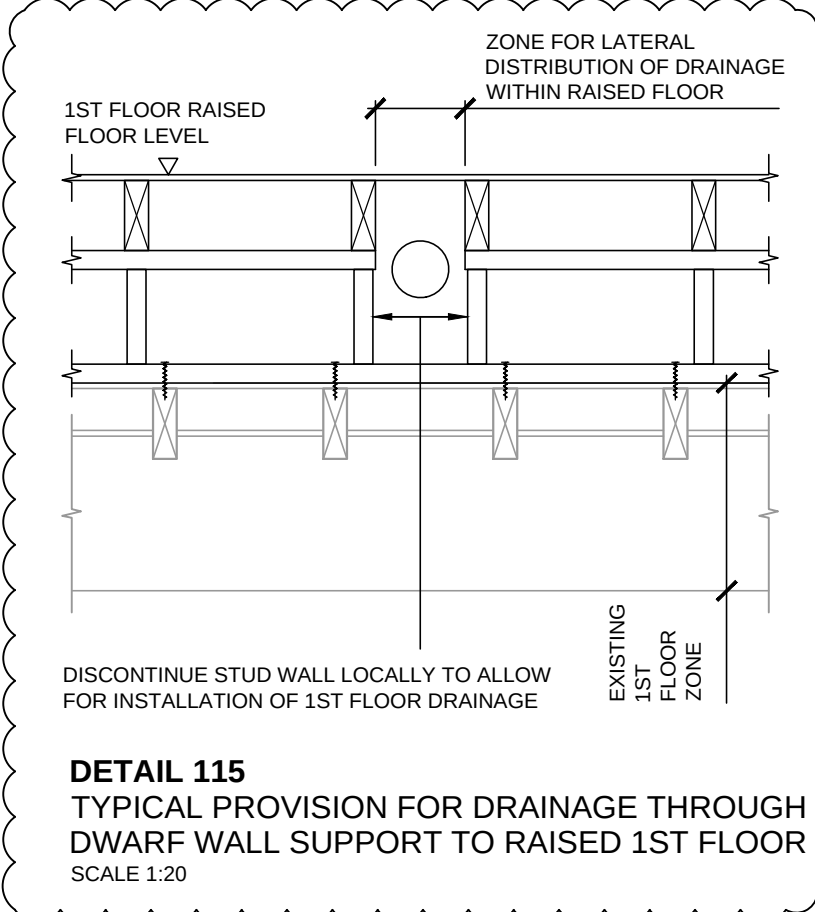
**DETAIL 115**  
TYPICAL PROVISION FOR DRAINAGE THROUGH  
DWARF WALL SUPPORT TO RAISED 1ST FLOOR  
SCALE 1:20

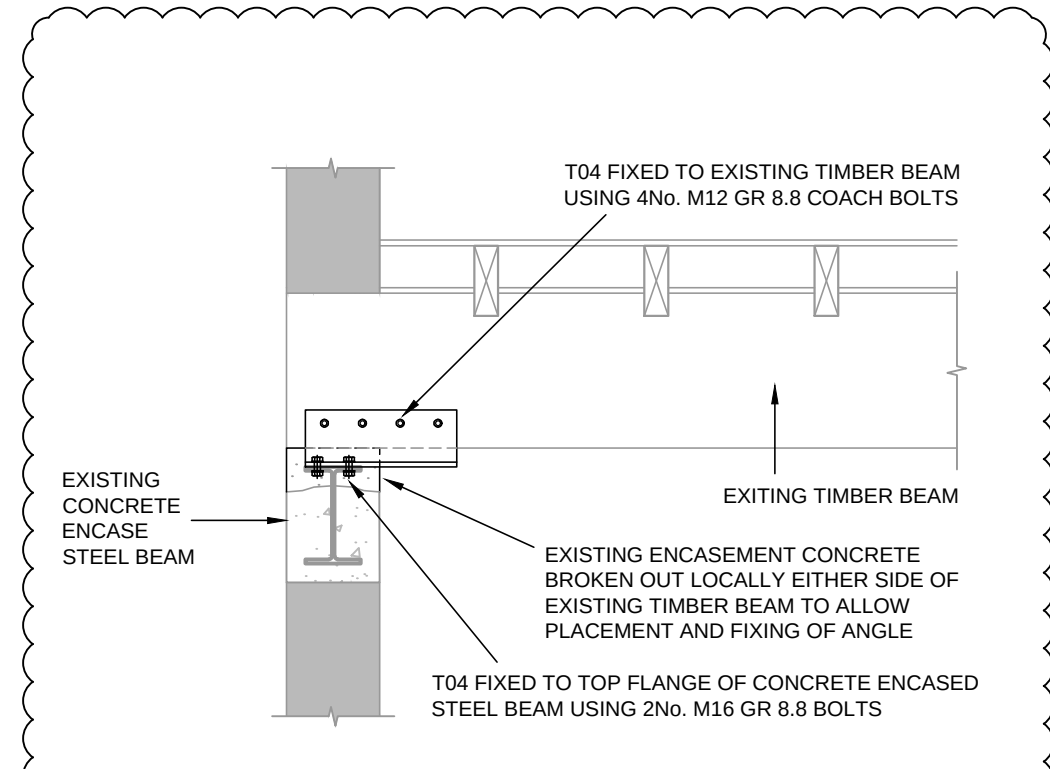
**DETAIL 116**  
TYPICAL T04 DETAIL  
SCALE 1:20

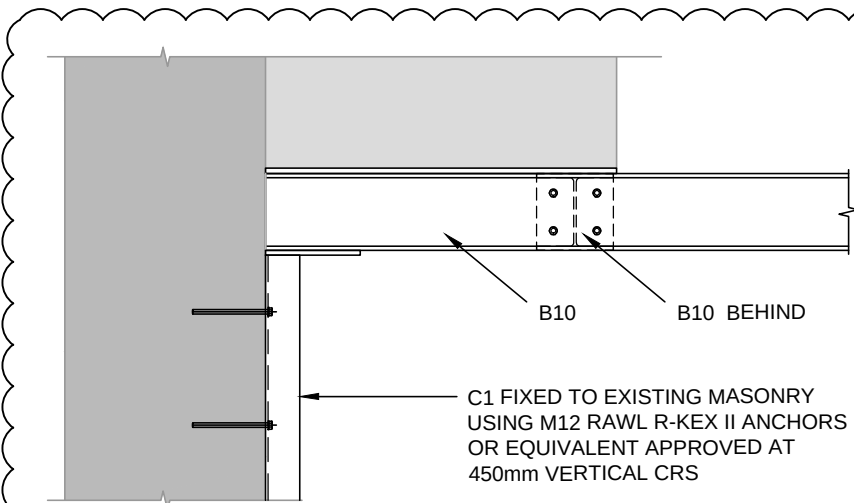
**DETAIL 118**  
SECTION THROUGH CHIMNEY SUPPORT  
GRILLAGE STEEL  
SCALE 1:20
