# ARBORICULTURAL IMPLICATIONS ASSESSMENT

PROPOSED DEVELOPMENT

CHAIN ROAD  
BLACKLEY  
M9 6QX

Author: C. Salisbury  
Date: 3 October 2021  
Ref: TRE/CR/Rev A

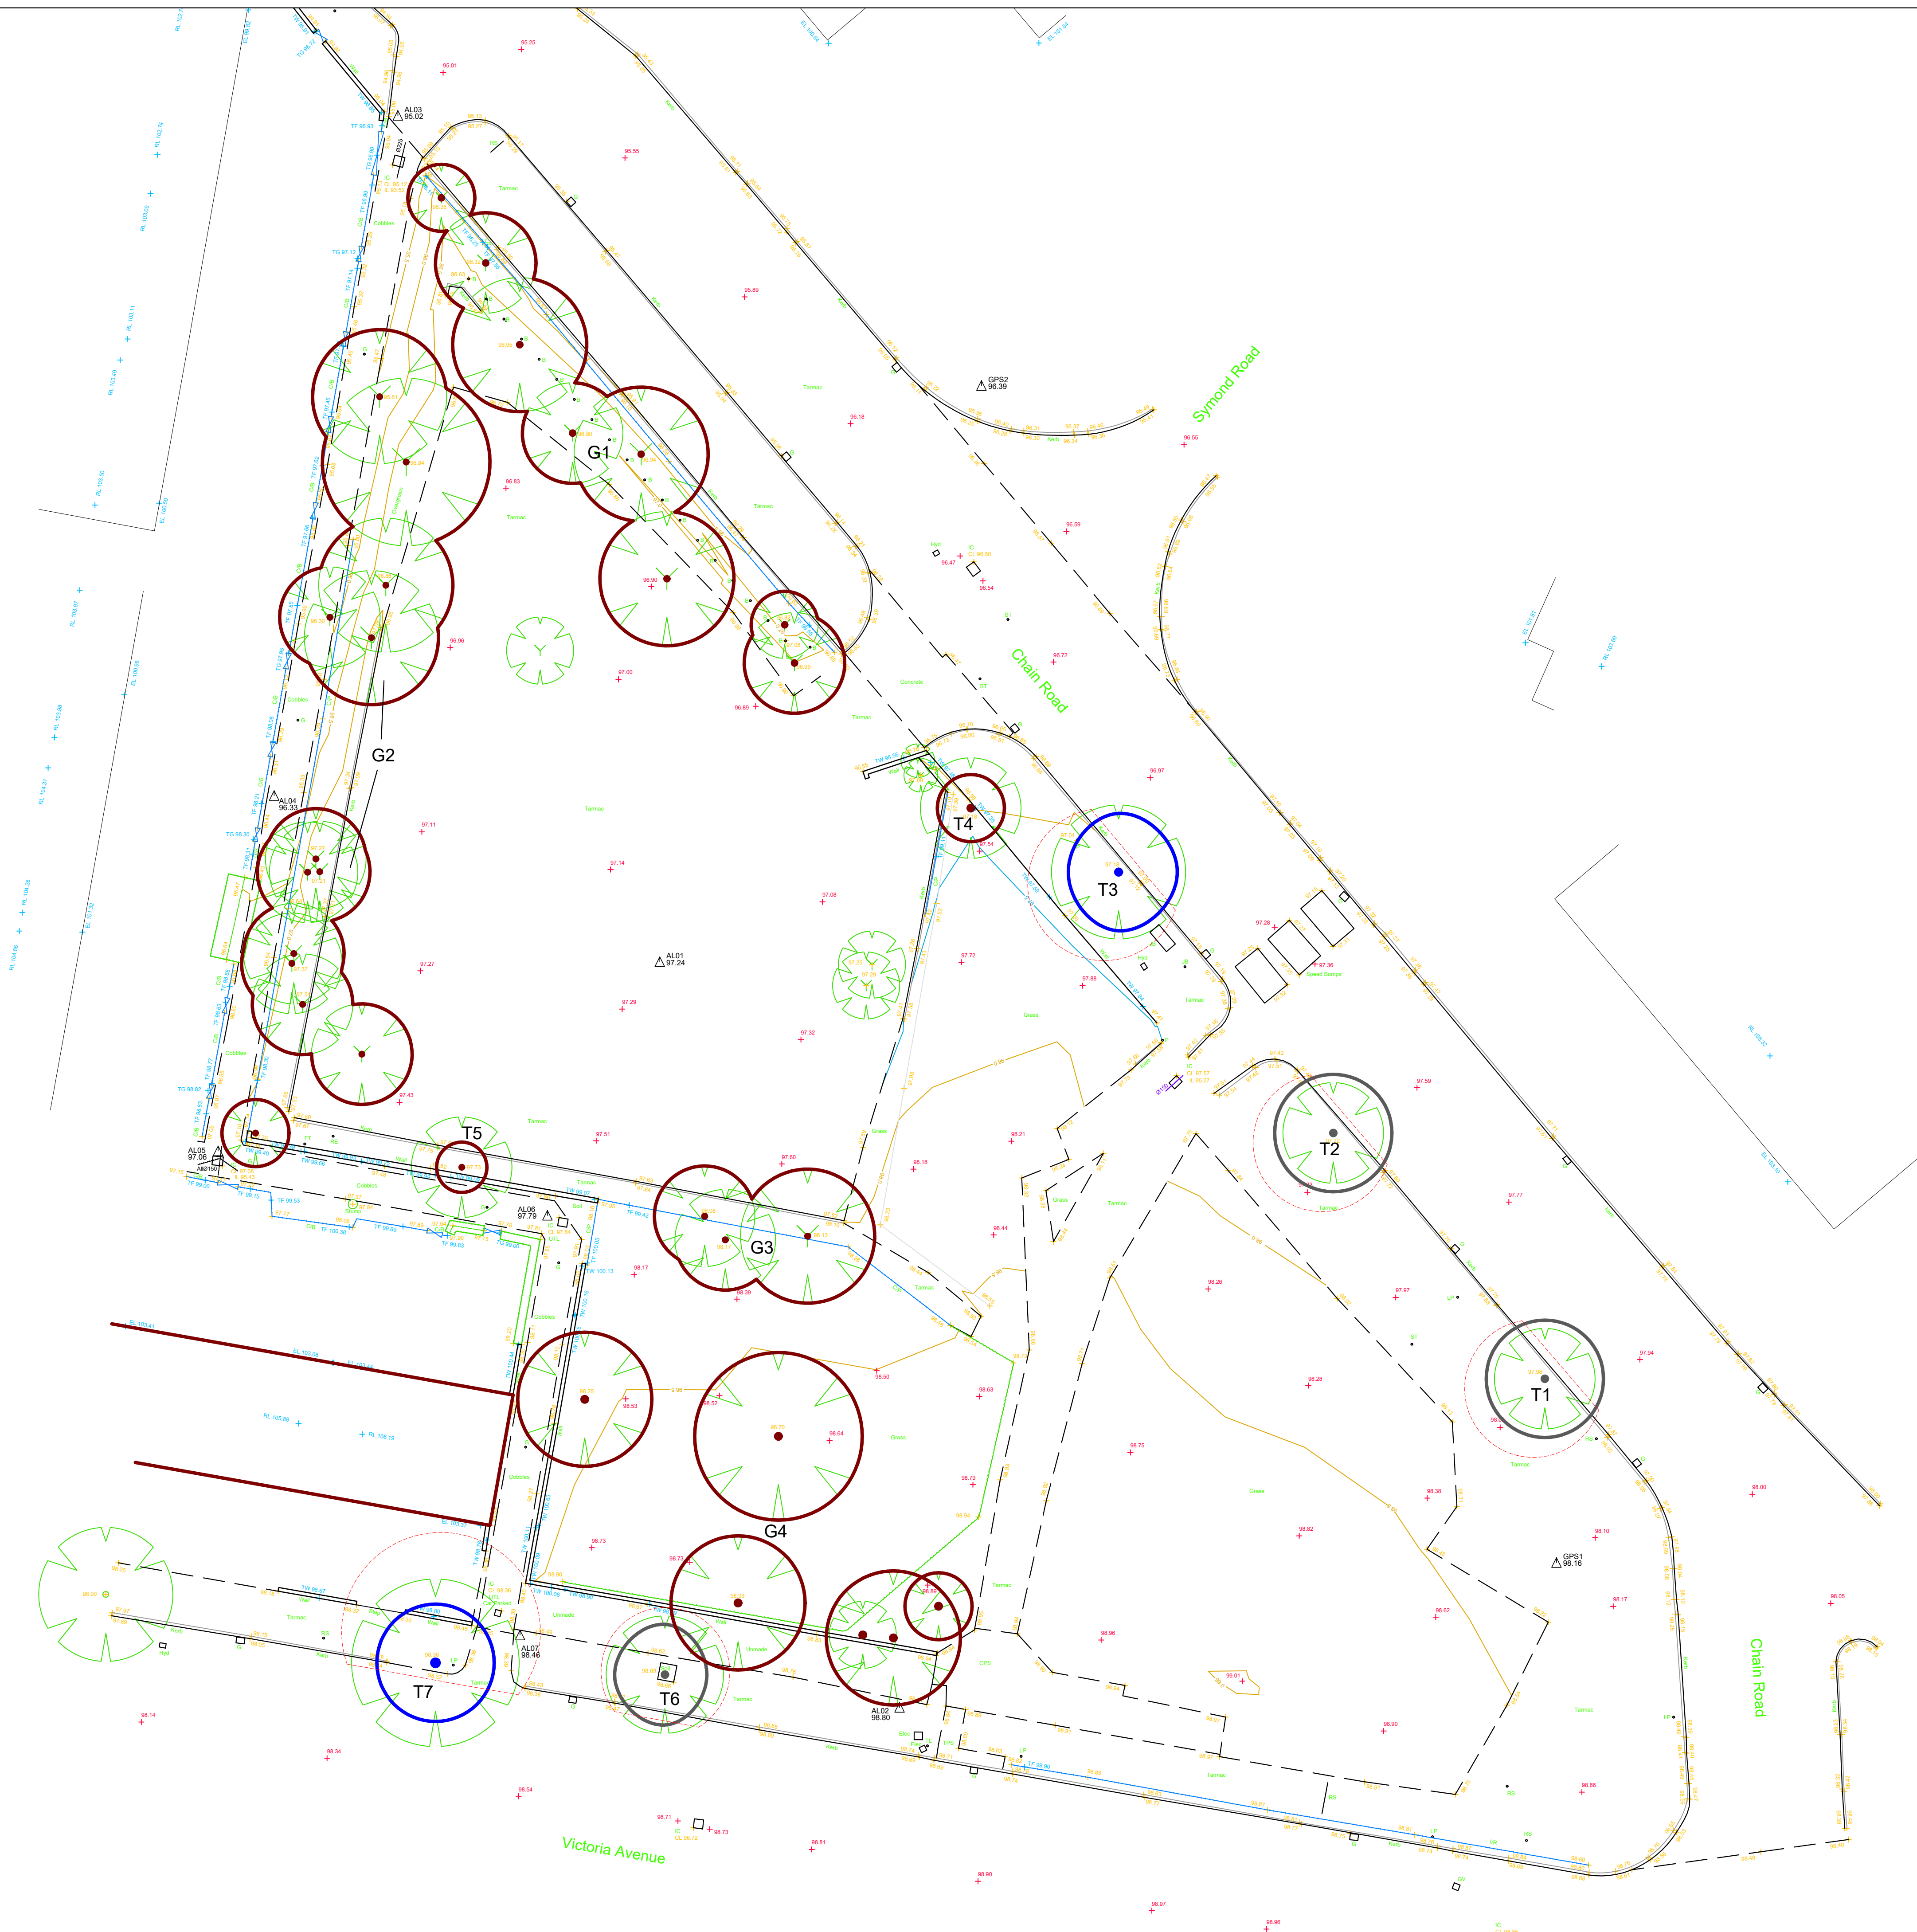
Drawing No:  
CRB/BS/01

Drawing Title:  
BS5837 Plan

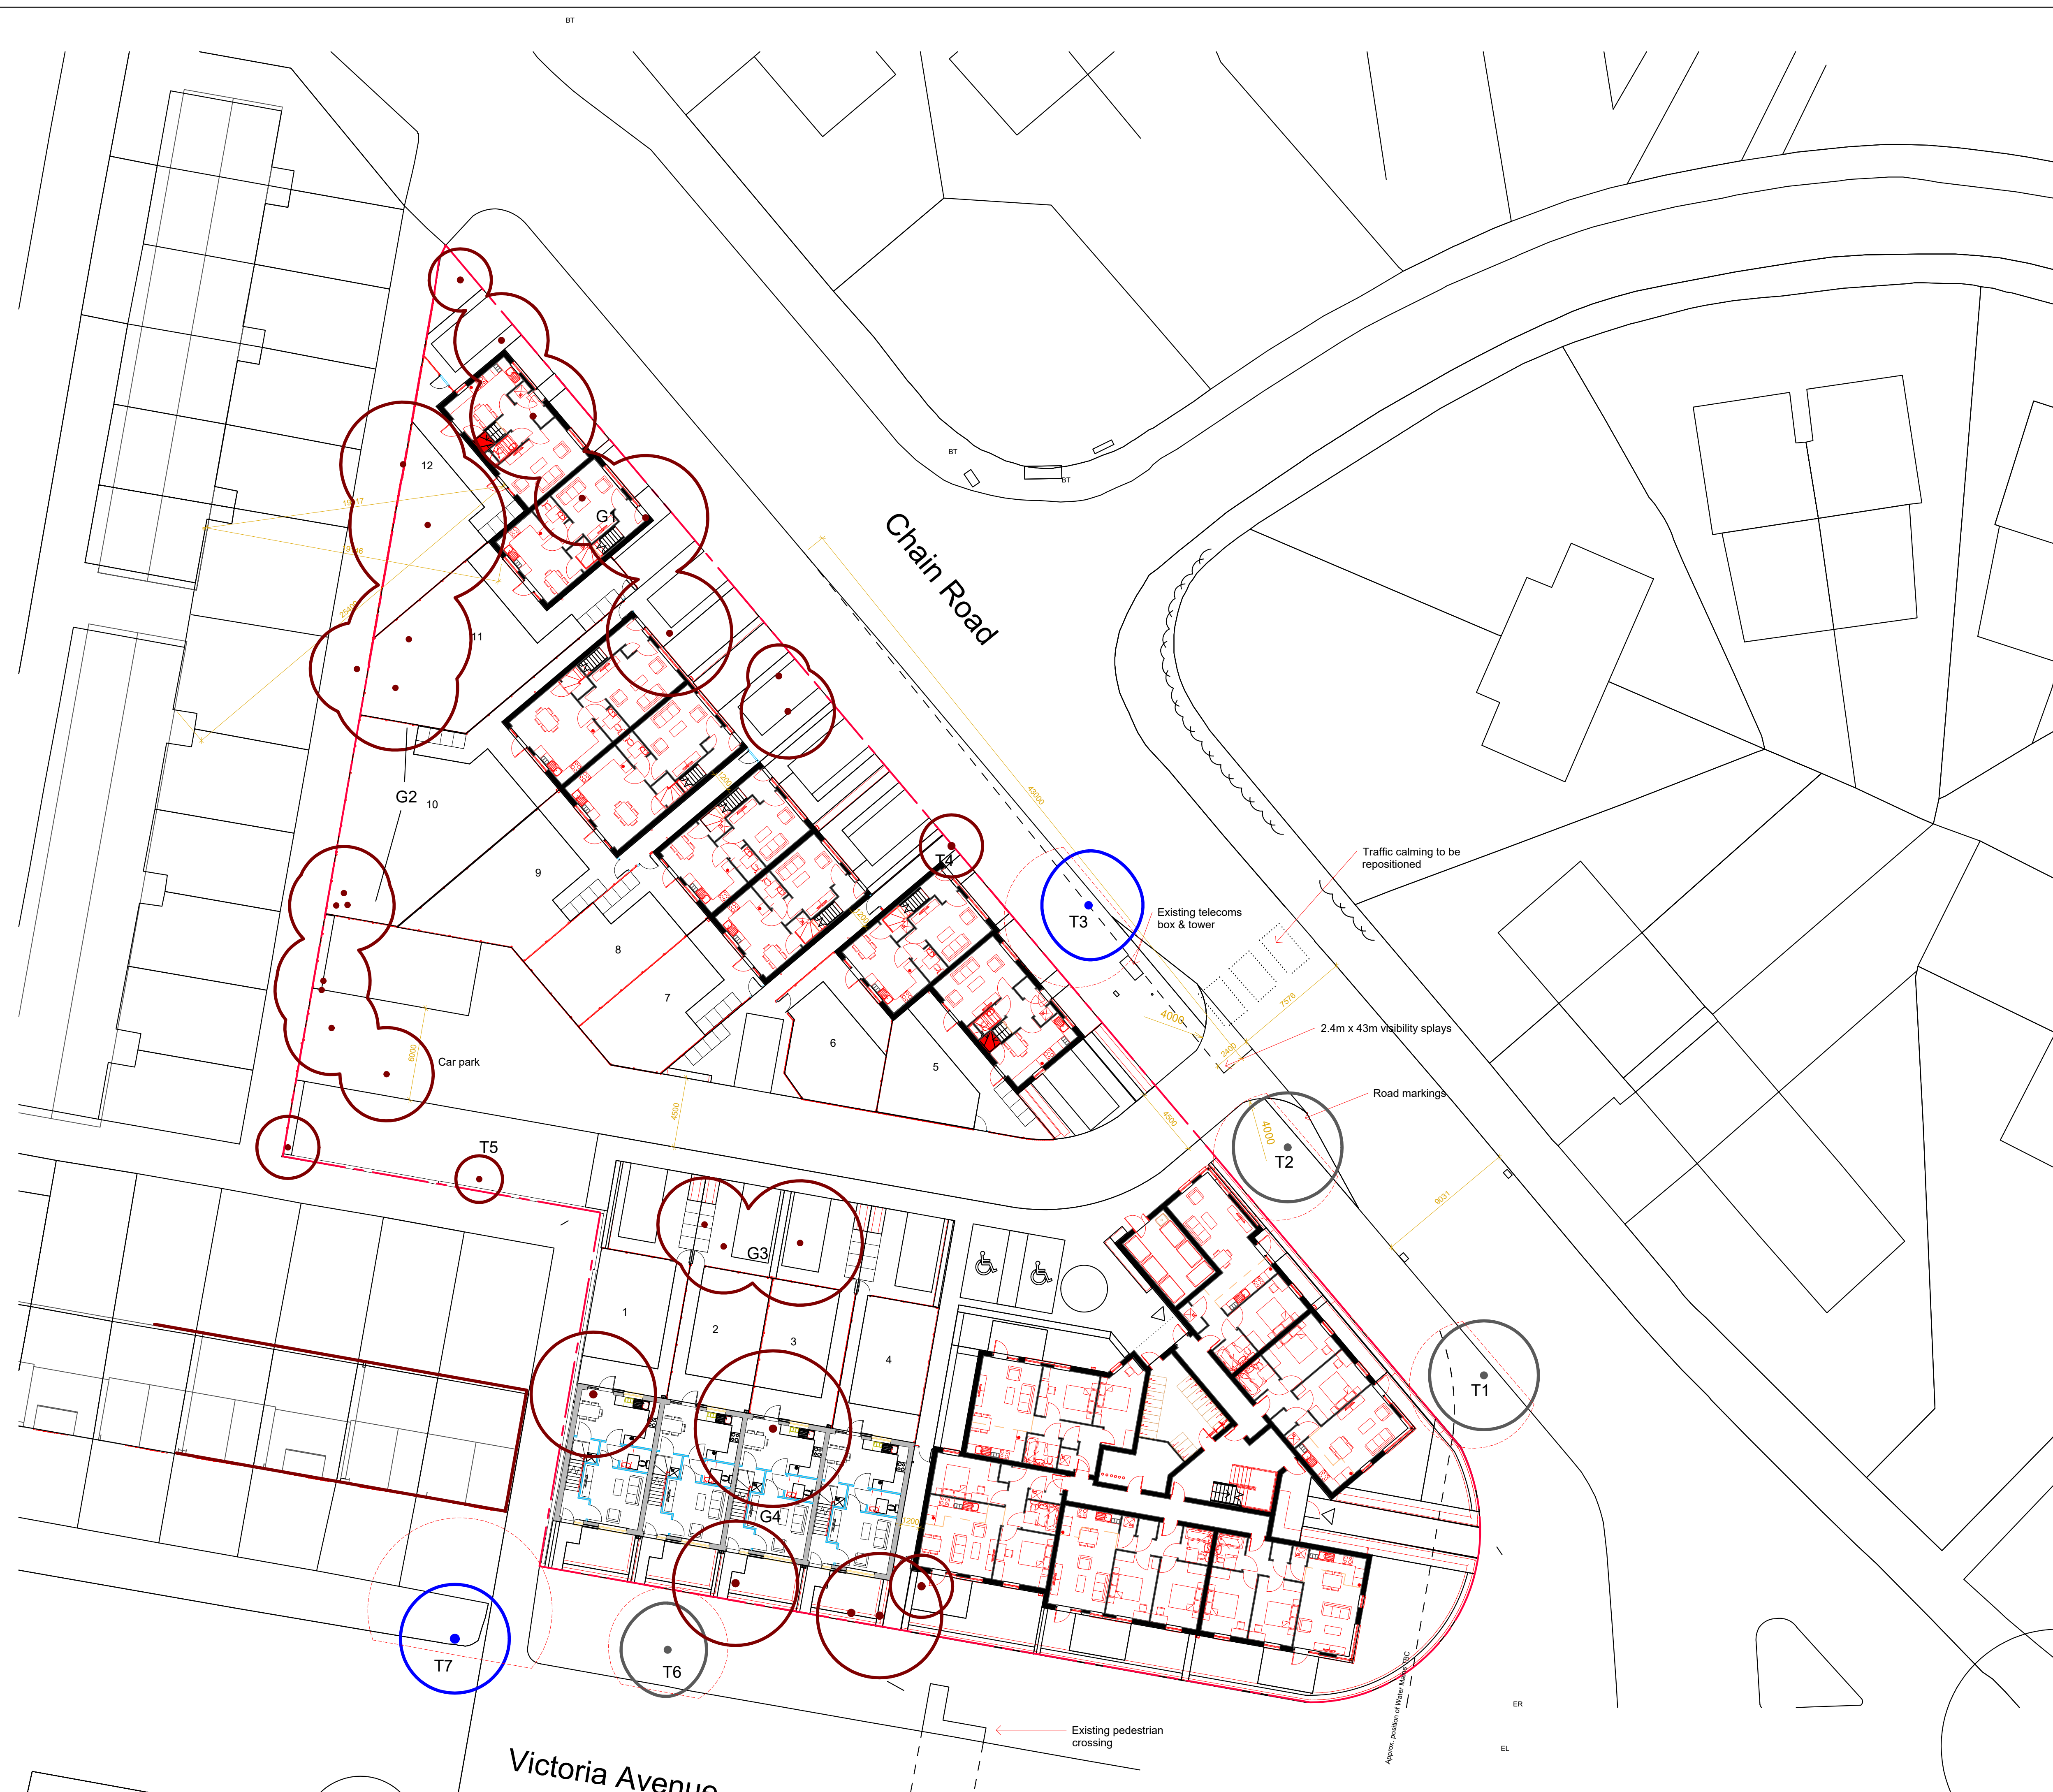
Drawing No:  
 CRB/AIS/01 Rev. A

- 3.1 Due to the proposed development and its associated infrastructure there are a number of locations where the proposals are in close proximity to the trees surveyed. The Site Layout Plan within appendix three identifies the trees in relation to the proposed development.
- 3.2 In order to fully assess the impact of the proposals an Impact Table has been created detailing each tree, which shows the proximity of the associated works to the tree.
- 3.3 This can then be assessed in accordance with BS 5837:2012 to determine whether the development will have a detrimental impact on the health of each tree. Once this has been determined remedial measures can be detailed to reduce the impact the proposals will have on the treescape.

Drawing Title:  
 AIS Plan

- 5.2.1 The impact table below shows the proposed development having a minor encroachment into the root protection area of T2. It is felt that due to the species, condition and limited extent of encroachment the proposal will not have a detrimental impact on the safe useful life expectancy of these trees.
- 5.2.2 Section 7.5.3 of BS 5837:2012 advises that where a slab or minor structure is to be formed within the RPA it should not exceed 20% of any existing unsurfaced ground. The table below details the amount of encroachment within the RPA.

- 5.3.1 The impact table below shows the proposed car parking having a minor encroachment into the root protection area of T2. It is felt that due to the species, condition and limited extent of encroachment the proposal will not have a detrimental impact on the safe useful life expectancy of these trees.
- 5.3.2 Section 7.4.2.3 of BS 5837:2012 advises that new permanent hard surfacing should not exceed 20% of any existing unsurfaced ground within the RPA. The table below details the amount of new surface proposed within the RPA of each tree.
