PRINCIPAL CONSTRAINTS

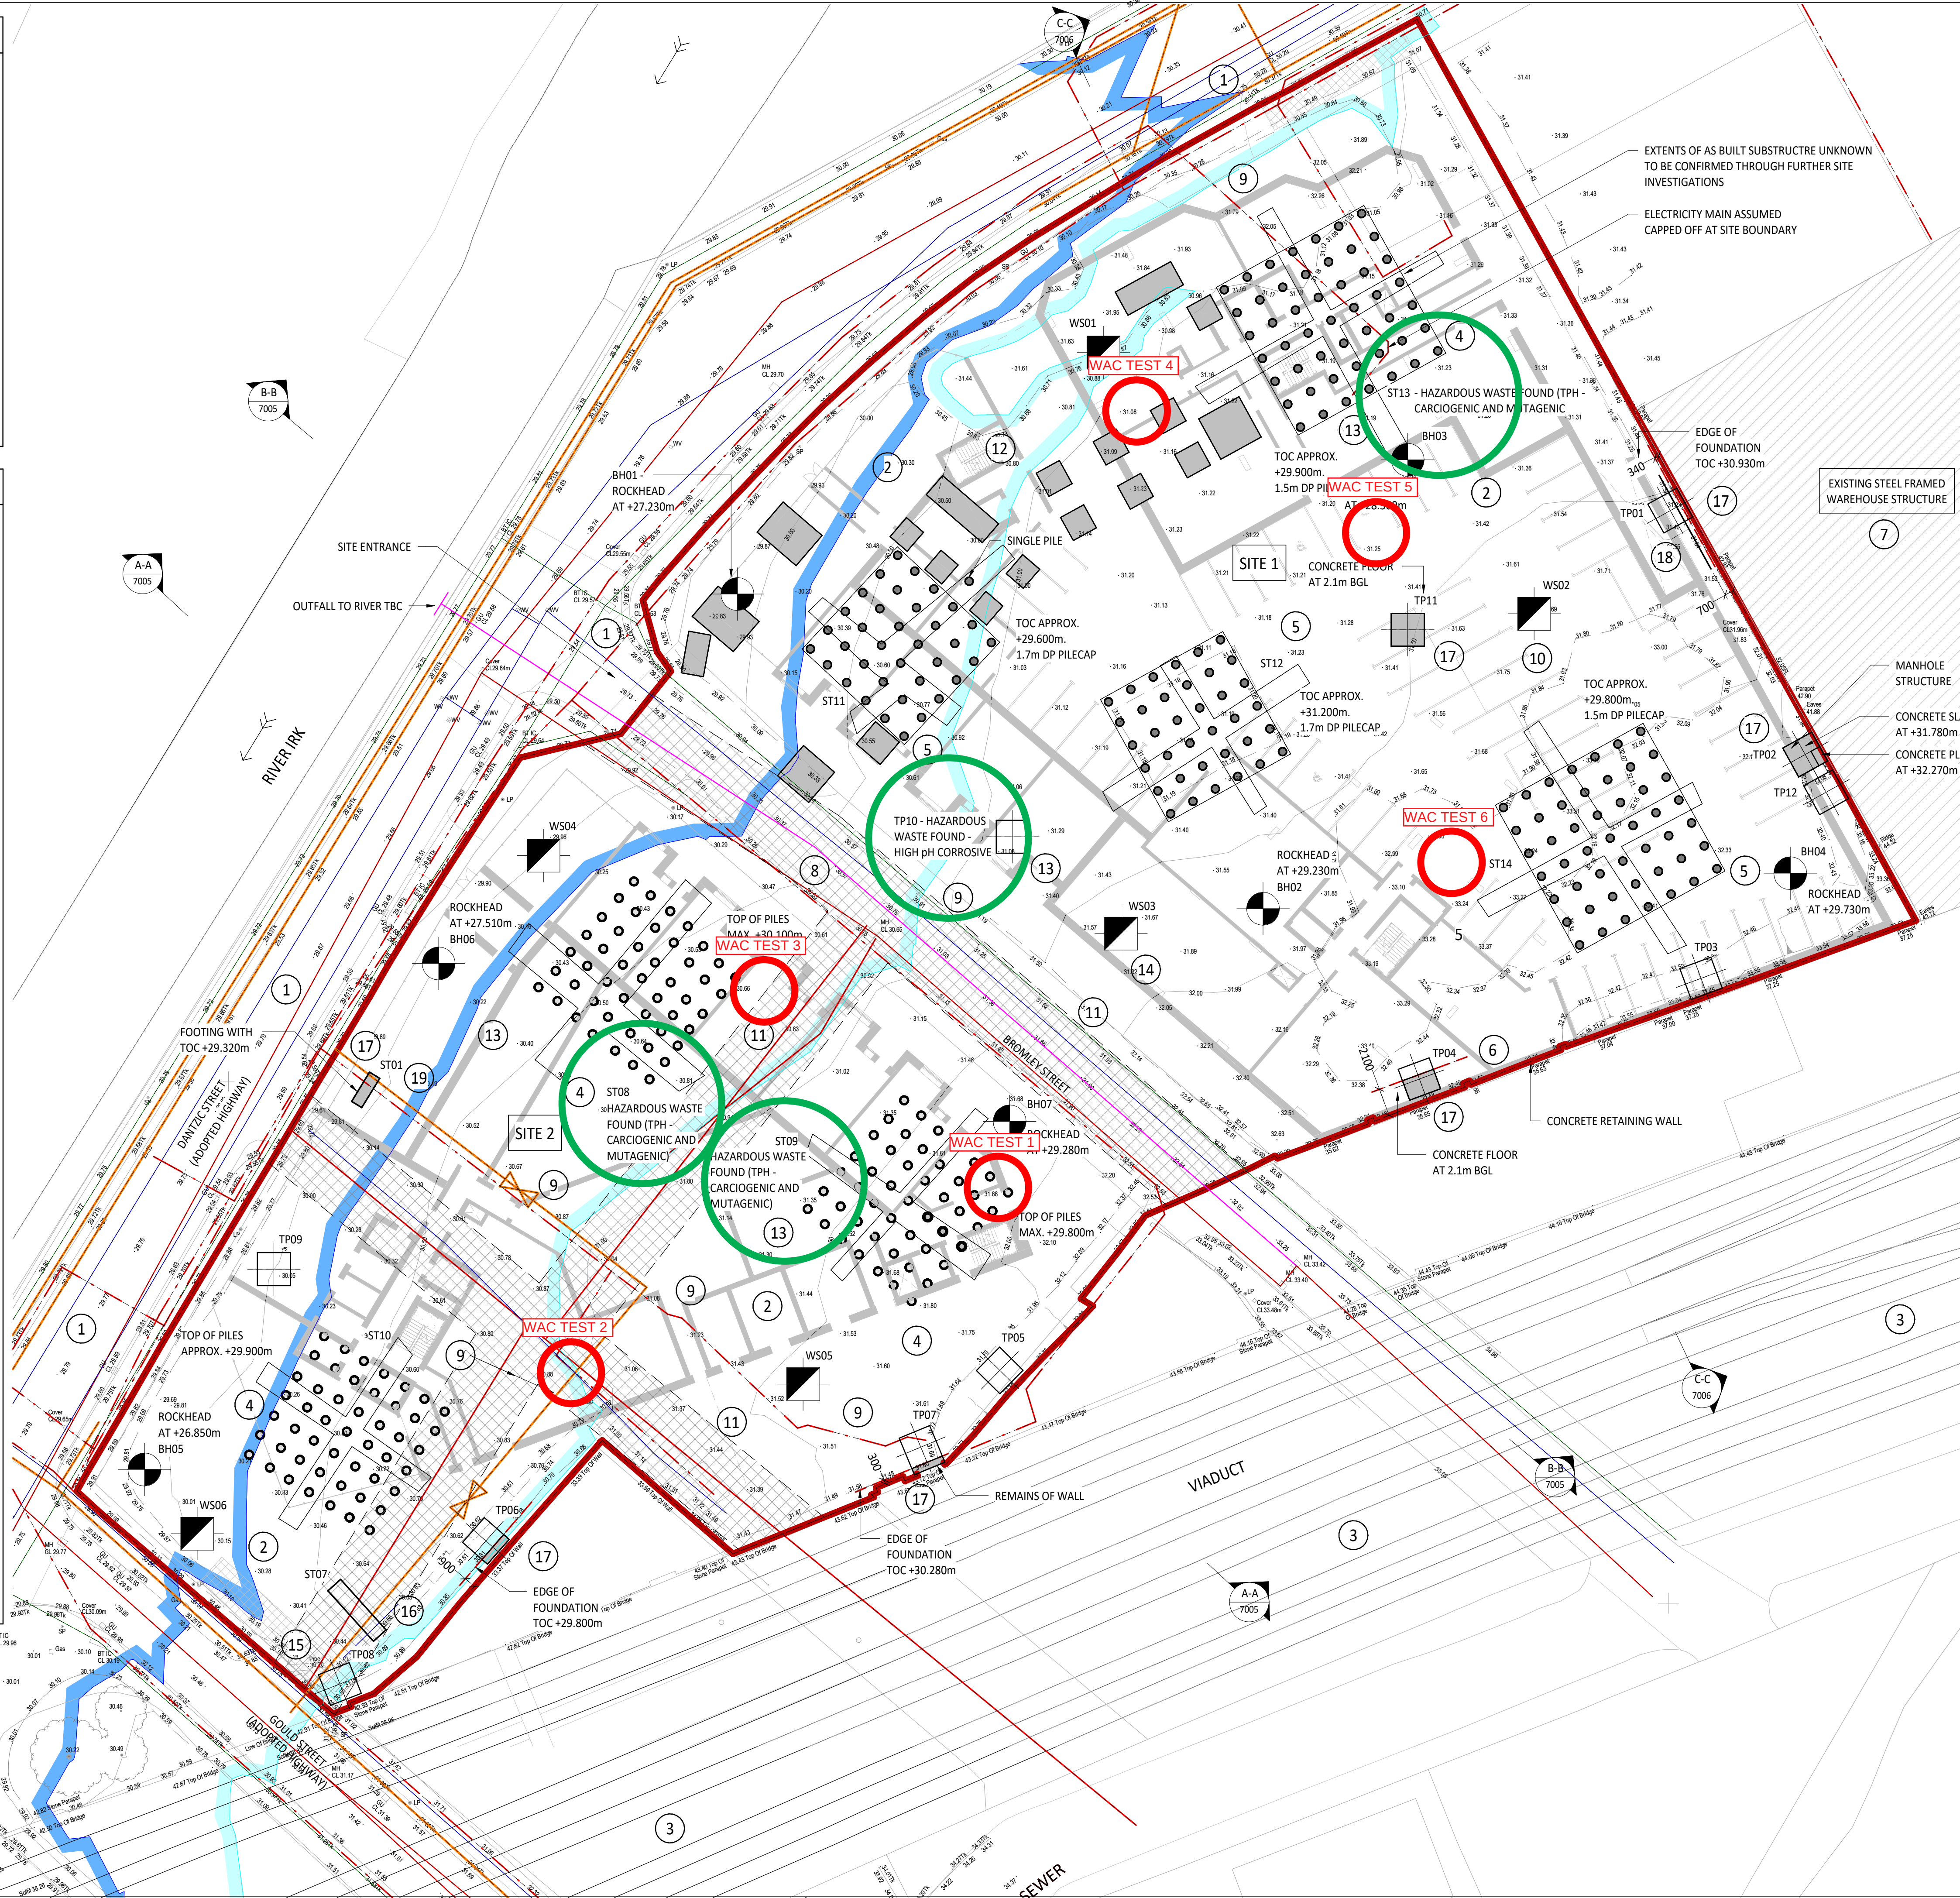
NUMEROUS BURIED SERVICES WITHIN DANTZIC STREET FOOTPATH

FLOOD ZONE 2 & 3 BASED UPON LEVELS PUBLISHED BY ENVIRONMENT AGENCY OCT 2017

OPERATIONAL NETWORK RAIL VIADUCT. NETWORK RAIL MAY IMPOSE CONSTRAINTS ON PROPOSED CONSTRUCTION SUCH AS VIBRATION AND MOVEMENT MONITORING AND ALLOWABLE PROXIMITY OF TOWER CRANES DURING CONSTRUCTION.

EXISTING 600mm DIA. PILE FOUNDATIONS BETWEEN 5-7m IN DEPTH CONFIRMED INSTALLED BY ALL FOUNDATIONS LTD. APPROXIMATE POSITIONS HAVE BEEN CONFIRMED THROUGH SITE INVESTIGATION AND ARE TO BE COORDINATED WITH PROPOSED STRUCTURES.

EXISTING 1.5 - 1.7m THK CONCRETE PILECAPS WITH EXISTING 600mm DIA. PILE FOUNDATIONS BETWEEN 5-7m IN DEPTH BELOW. CONFIRMED INSTALLED BY ALL FOUNDATIONS LTD. APPROXIMATE POSITION OF PILECAPS HAVE BEEN CONFIRMED THROUGH SITE INVESTIGATION. POSITION OF PILES TO BE CONFIRMED THROUGH SITE INVESTIGATION AND COORDINATED WITH PROPOSED STRUCTURES

REINFORCED CONCRETE RETAINING WALL ON PROPOSED DEVELOPMENT BOUNDARY. POTENTIAL RISK OF UNDERMINING TO BE MITIGATED THROUGH DESIGN OF ADJACENT PROPOSED STRUCTURES.

ADJACENT EXISTING INDUSTRIAL UNIT ASSUMED FOUNDED ON SHALLOW FOUNDATIONS AND TO BE A SINGLE STOREY STRUCTURE WITHOUT BASEMENT. POTENTIAL RISK OF UNDERMINING TO BE MITIGATED THROUGH DESIGN OF ADJACENT PROPOSED STRUCTURES

BROMLEY STREET ADOPTED HIGHWAYS BISECTING SITE PAVED WITH STONE COBBLES WHICH ARE POTENTIALLY OF INTEREST TO THE MCC CONSERVATION DEPARTMENT.

EXISTING BURIED SERVICES WITHIN DEVELOPMENT SITE NOTED ON SOURCE INFORMATION ASSUMED CAPPED OFF AT SITE BOUNDARY BY PREVIOUS SITE ENABLING WORKS. ASSUMPTION TO BE PROVEN BY GPR SURVEY. APPLIES TO DRAINAGE, GAS AND ELECTRICITY SERVICES SHOWN WITHIN SITE BOUNDARY

PRELIMINARY EASEMENT ZONE TO BE DISCUSSED WITH UNITED UTILITIES FOR SEWERS TO BE DIVERTED, EASEMENT IN EFFECT UNTIL THE DIVERSION IS COMPLETE

POTENTIAL EXISTING PAD FOUNDATIONS FROM PREVIOUS DEVELOPMENT - REBAR CAGES SHOWN AS INSTALLED IN ORDNANCE SURVEY AERIAL PHOTOGRAPH

HAZARDOUS WASTE ENCOUNTERED DURING SITE INVESTIGATION (DETAILS SHOWN IN EACH LOCATION)

AVERAGE GROUNDWATER LEVEL ENCOUNTERED IN INVESTIGATIONS +27.000m. ALLOW FOR DEWATERING IN EXCAVATIONS. POTENTIAL FOR RUNNING SANDS TO OCCUR WHERE GRANULAR DEPOSITS ARE SATURATED

APPROX. 300mm CAST IRON GAS MAIN STICKING OUT FROM GROUND (LIVE) IDENTIFIED DURING SITE INVESTIGATION

WATER PIPE RUNNING ACROSS SLOT TRENCH IDENTIFIED DURING SITE INVESTIGATION

EXISTING SLAB OR FOUNDATION IDENTIFIED DURING SITE INVESTIGATION

IRON GAS PIPE (30mm DIA.) AT +31.000m IDENTIFIED DURING SITE INVESTIGATION

30mm DIA. CAST IRON GAS PIPELINE (DEAD/REDUNDANT) IDENTIFIED DURING SITE INVESTIGATION
