# Water Safety Risk Review

| <b>Address of Premises</b> | On Bar Manchester<br>46 Canal Street, Manchester | | |
| <b>Date of Water Risk Review</b> | 1 <sup>st</sup> November 2021 | | |

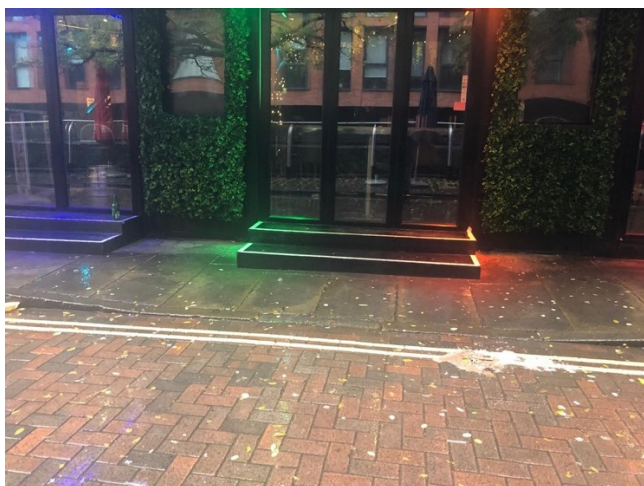
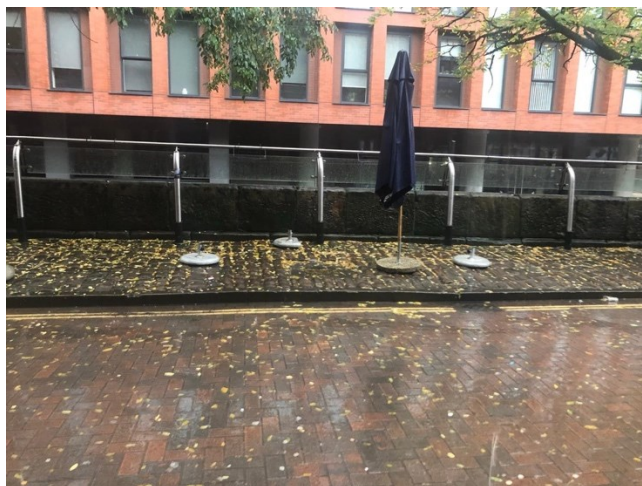
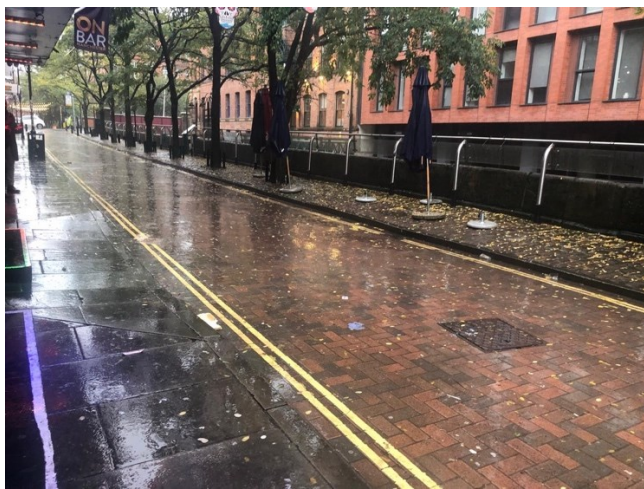
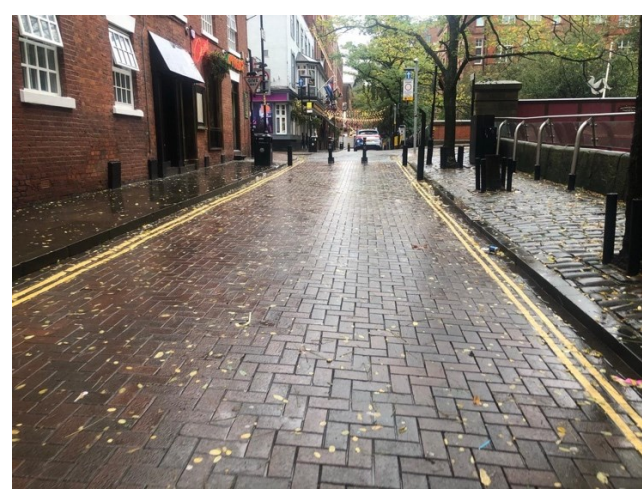
### Photos from Premises

| Construction/Maintenance Workers (Details of numbers – Premises occupants (Residents/employees)) | | |
|---|---|---|
| Drowning | Adequate 5 feet high barrier provided and maintained by Canal River Trust. (See photos) | Suitable warning sign recommended. |

| <b>General Comments:</b><br>The assessment noted that other than the suitable barrier in place, there are no established structure for rescuing someone who falls into the water course. However, the assessment notes that the 5ft high barrier provided and maintained by the Canal and River Trust provides adequate protection for occupants of the premises and customers sat outside the premises. In addition, it was also noted that there is no Lifebuoy within 100 meters of the proposed site as at the time of the assessment. | |

No Rescue visible Rescue Equipment in vicinity

| Construction/Maintenance Workers (Details of numbers – Premises occupants (Residents/employees)) | | |
|---|---|---|
| Rescue Equipment | Suitable rescue equipment such as Lifebuoy near water course and training for its use, recommended. Ensure safety equipment is secure but easy to access by authorised personnel. | |

| Suitable Warning Signs | Provide suitable warning sign on the danger of deep water.<br>Provide anti-climbing measures on nearby trees (especially during the construction phase). | |
