Project: 19 Atwood Road  
Didsbury

Drawing: Proposed Elevations

Project Ref: 20/018

Drawing No:  
**07**

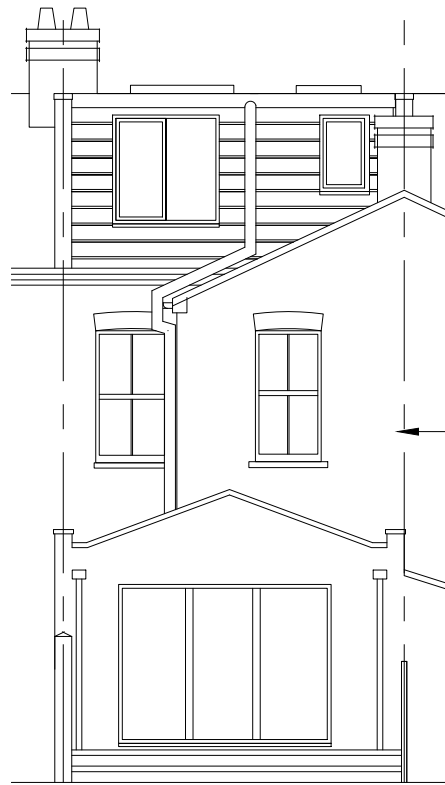
Rear Elevation

Existing party wall built to form the side of the new dormer with existing the wall boarded and insulated internally.
