| PRINCESS HOUSE<br>105-107 PRINCESS STREET<br>MANCHESTER | | | | | |
| EXISTING SECOND FLOOR<br>REFLECTED CEILING PLAN | | | | | |

| STATUS<br>PLANNING | | |

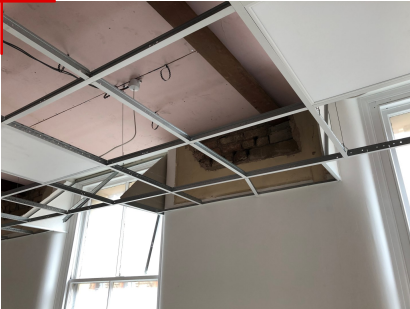
PHOTOGRAPH OF SUSPENDED CEILING WITH CUT-BACK TO ACCOMMODATE WINDOW HEADS AT GREATER HEIGHT

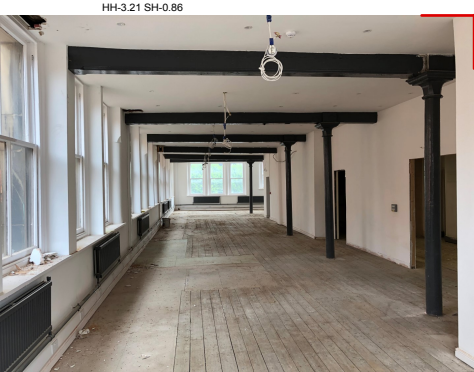
PHOTOGRAPH OF GENERAL AREA SHOWING HOW THE EXISTING FLOOR JOISTS ABOVE HAVE BEEN UNDERDRAWN WITH MODERN PLASTERBOARD AND SKIM FINISH, PAINTED WITH WHITE EMULSION AND THE SUBSEQUENT INSTALLATION OF MODERN SPOT DOWNLIGHTERS (WHICH ARE INAPPROPRIATE FOR OFFICE USE) MAIN SUPPORT BEAMS LEFT EXPOSED WITH PAINT FINISH.

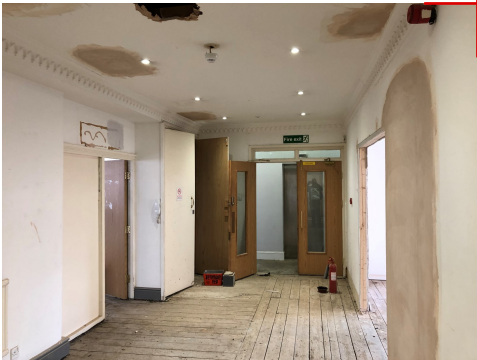
PHOTOGRAPH OF CIRCULATION LOBBIES AND PARTIALLY COMPLETED WC'S SHOWING HOW THE EXISTING FLOOR JOISTS ABOVE HAVE BEEN UNDERDRAWN WITH MODERN PLASTERBOARD AND SKIM FINISH, PAINTED WITH WHITE EMULSION AND THE SUBSEQUENT INSTALLATION OF MODERN SPOT DOWNLIGHTERS. CORNICE TO CIRCULATION LOBBY IS NON-ORIGINAL.

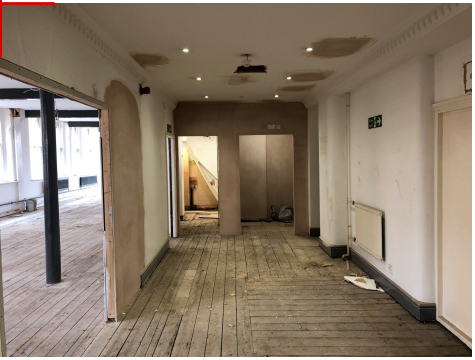
PHOTOGRAPH OF CIRCULATION LOBBIES AND PARTIALLY COMPLETED WC's SHOWING HOW THE EXISTING FLOOR JOISTS ABOVE HAVE BEEN UNDERDRAWN WITH MODERN PLASTERBOARD AND SKIM FINISH, PAINTED WITH WHITE EMULSION AND THE SUBSEQUENT INSTALLATION OF MODERN SPOT DOWNLIGHTERS. THE WALL ON THEIR RIGHT IS THE ORIGINAL SPINE WALL. THE WALL ON THE LEFT IS A MODERN PARTITION.
