# Moston Campus, Manchester

## Remediation Strategy

Ref: 074971-CUR-00-XX-RP-GE-003

Client Name: One Manchester Developments Limited

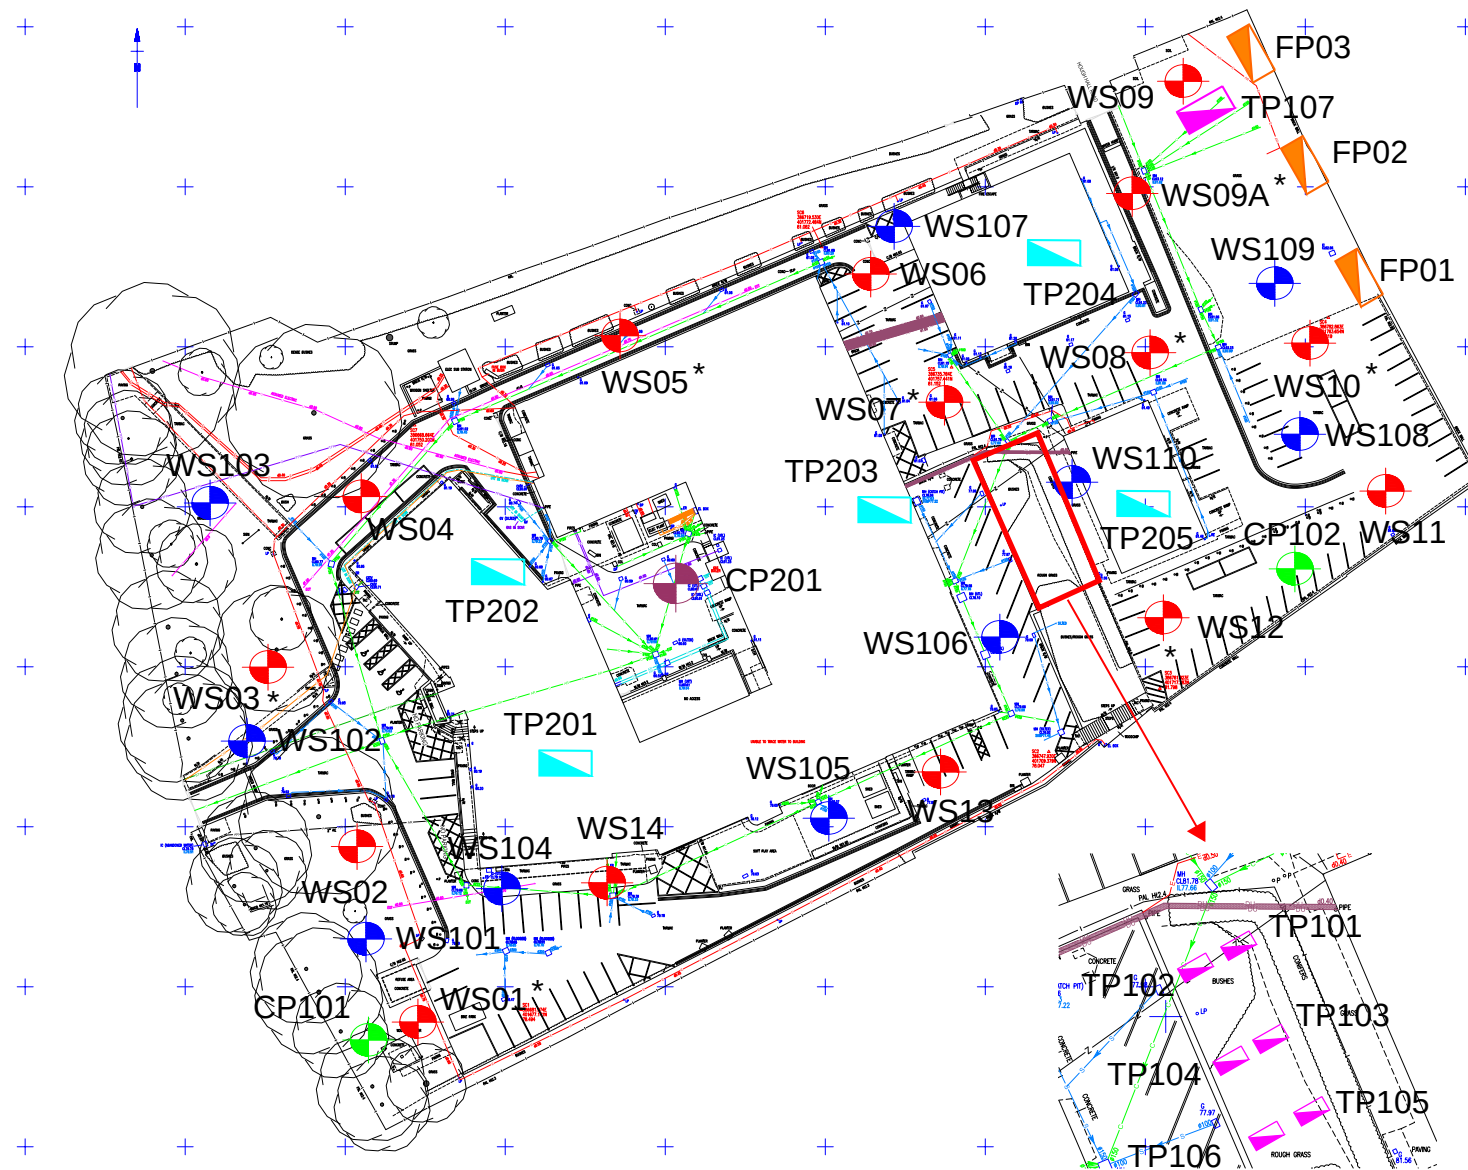
| Drg No: | Rev: |
|---|---|
| 074971-CUR-00-XX-DR-GE-002-V03 | / |

## January 2020 Investigation

Window Sample Borehole

Foundation Pit

Plans showing the locations of the exploratory holes undertaken by Curtins is contained with *Appendix A* for reference.

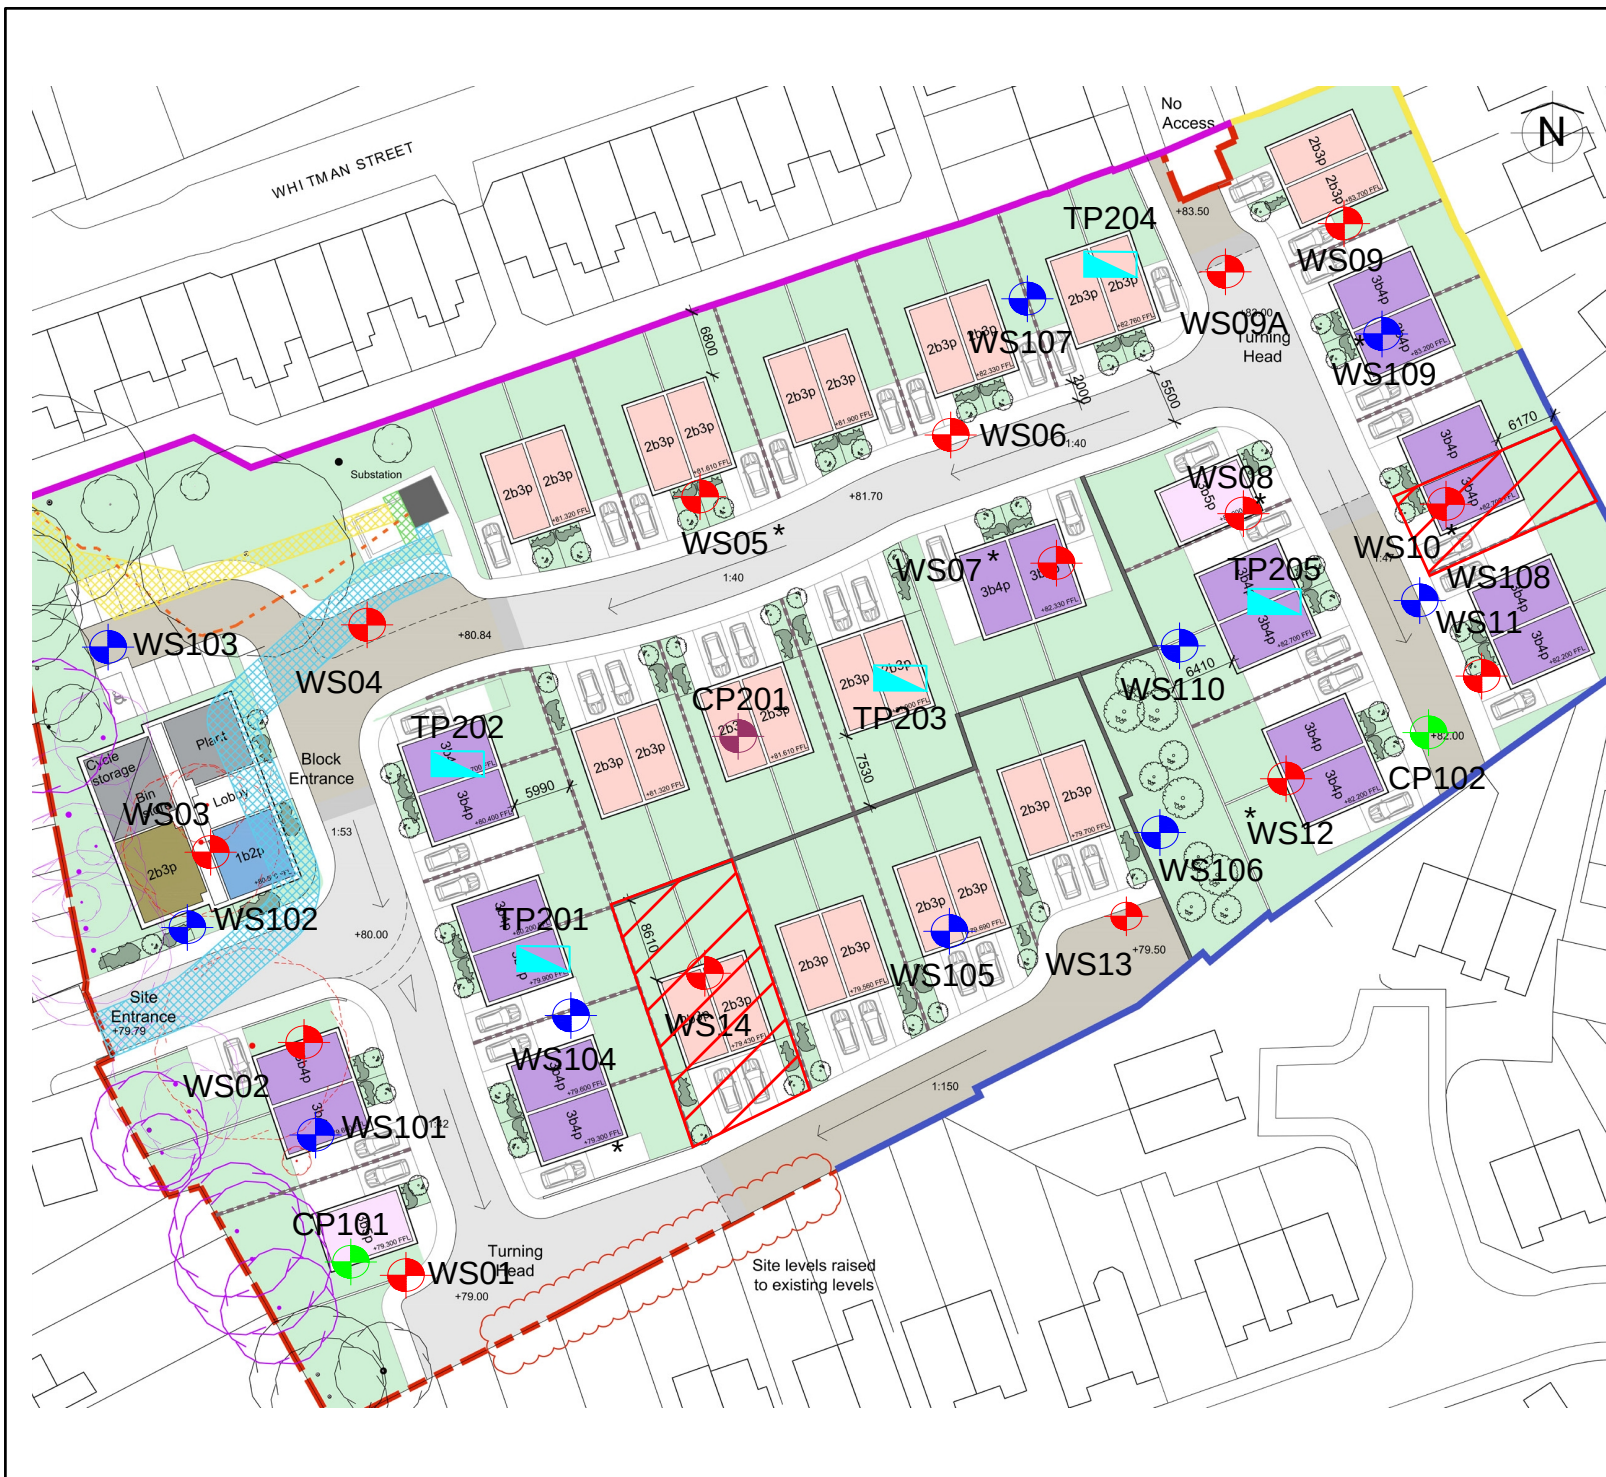
A GEOTEXTILE MEMBRANE IS REQUIRED UNDERLYING 450MM OF CLEAN CAPPING IN THESE GARDENS

ALL OTHER GARDENS AND SOFT LANDSCAPING REQUIRE 600MM OF CLEAN CAPPING (150MM OF TOPSOIL AND 450MM OF SUBSOIL).

It is recommended that within front and rear gardens of residential housing should have a minimum of 600mm clean capping as residents may plant and consume home grown produce but they are unlikely to excavate to deeper than 600mm in typical gardening activities.

The risk level is therefore lower for public open space where planting and consumption of homegrown produce is not anticipated and exposure to potentially contaminated soils is reduced, a minimum depth of 450mm capping is therefore recommended in these areas.

Notwithstanding, given Asbestos fibres and ACM was identified within soils across the site within three samples, it is recommended that capping is underlain by anti-dig separation layer (high visibility warning geotextile or a break layer) in these areas. For continuity and given the possibility of further fibres or ACMs existing in made ground soils in close proximity to where encountered, it is recommended that this anti-dig separation layer is therefore also extended to any soft landscaped areas beneath gardens WS10 and WS14. The area around WS09A is shown to be within the road, this hardstanding layer will break the source-receptor pathway therefore no capping is required within this area but hand picking should be undertaken around this area to remove visible fragments of asbestos before construct the road.
