MINSHULL HOUSE  
'CHORLTON SQUARE'

| project | kampus • listed buildings |
| drawing number | AW(00)237d |

**minshull proposed short elevation 01**  
do not scale from this drawing • all dimensions are to be set out and checked on site prior to starting construction • any discrepancy found between information given on this drawing and that given elsewhere or recorded on site shall be brought to the attention of the project architect immediately

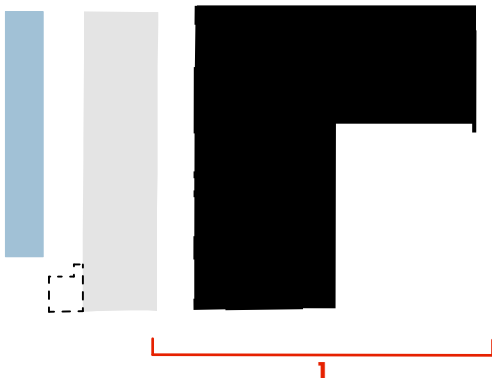
minshull house proposed elevation 01 • chorlton street

- 1 existing brickwork to be cleaned (method tbc)
- 2 new PPC aluminium windows
- 3 existing stone cills to be cleaned (method tbc)
- 4 slate roof re-laid with reclaimed tiles
- 5 existing stone copings to be repaired/replaced where necessary
- 6 existing timber doors repaired and re-instated
- 7 new PPC opening vents as part of window system
- 8 new PPC sleeve surround for new aluminium windows
- 9 new extension with black stained timber rainscreen cladding and glazed front
- 10 new timber gates to match cladding
- 11 mature trees
- 12 new timber door to existing escape stair
- 13 new cast iron rainwater downpipe + hopper
- 14 new circular vent for MVHR intake/extract

**note**  
all windows are drawn with common fenestration. this may change pending further investigation
