Pre-Construction  
Signal Reception Impact Survey

Barclay House Development, Manchester

7th May 2021

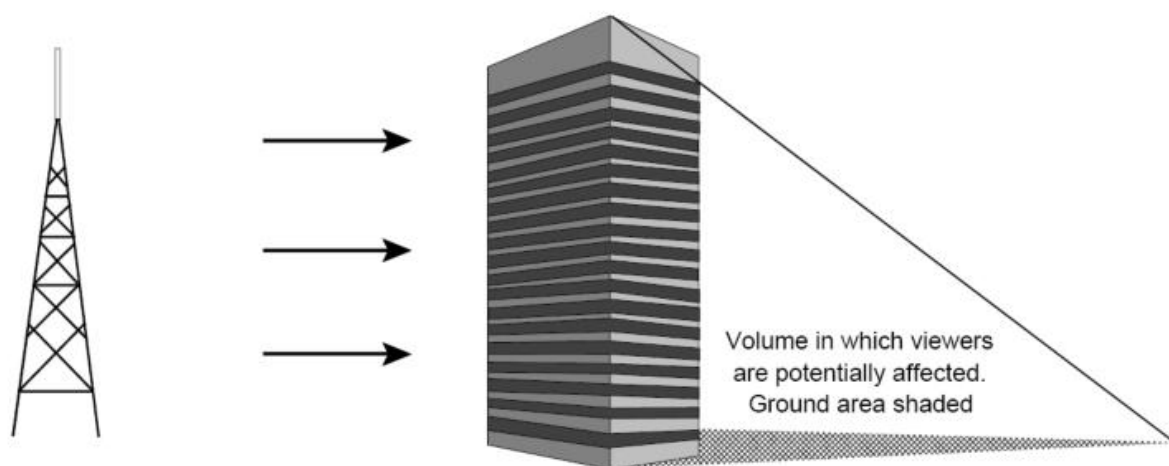
Figure 2 - Affected area in the 'shadow' zone behind the structure

Television signals do not create such a 'hard' shadow as visible light, and for the purposes of explanation, a 'shadow' zone must be considered which is divided into three sub-zones.

Within a few tens of metres from a solid structure, over the region where optical view of the transmitter is lost, the reduction in signal strength is critically dependent on the specific design and composition of the structure. For most brick and concrete buildings, the reduction is severe and in some cases almost total.

Further away from the structure (e.g. beyond 250 metres, but this varies depending on its size) the limit of the 'shadow' zone and signal reduction are determined by diffraction at the edges of the structure and reflection off surrounding structures. The simple condition of whether or not a location has an optical view of the transmitter is not enough to classify the potential interference zone adequately. In general, the effect is that the signal appears to bend around the sides of the structure; the shadow zone reduces in size and the signal strength is reduced by much less than simple ray optics would suggest.

Even further away from the structure (e.g. 5 km) complex multiple reflections and diffraction, caused by structures in the locality, may result in the 'shadow' zone becoming almost non-existent, against interfering signals that arrive on significantly different bearings. This can result in an increase in the ratio of wanted to unwanted signal as presented to the television receiver.

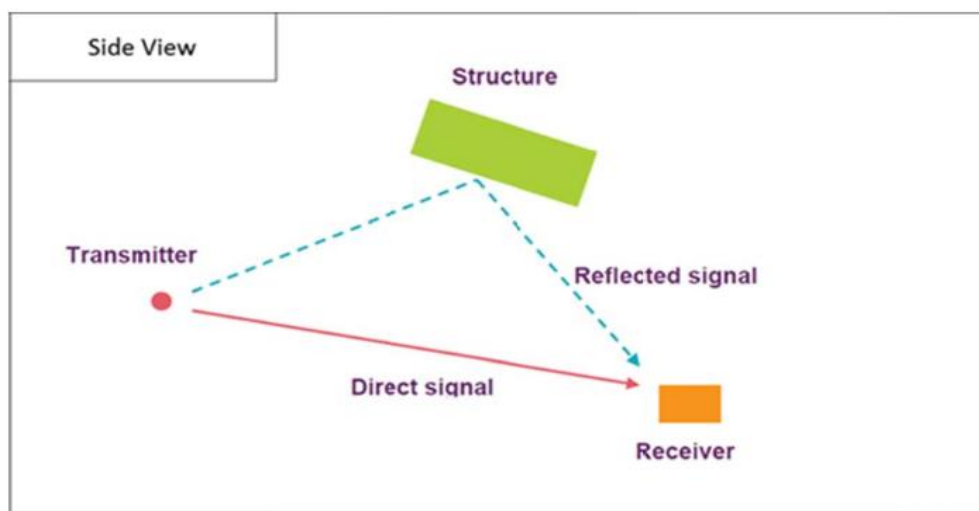
Larger developments with straight edges can reflect signals. This causes multipath interference which, with analogue signals, can manifest itself on the viewed images as 'ghosting'. The 'direct' signal arrives first (Shorter distance to travel) with the reflecting signals arriving, in a weaker state, causing the multiple image effect.

The images below (Taken from OFCOM) illustrate this:

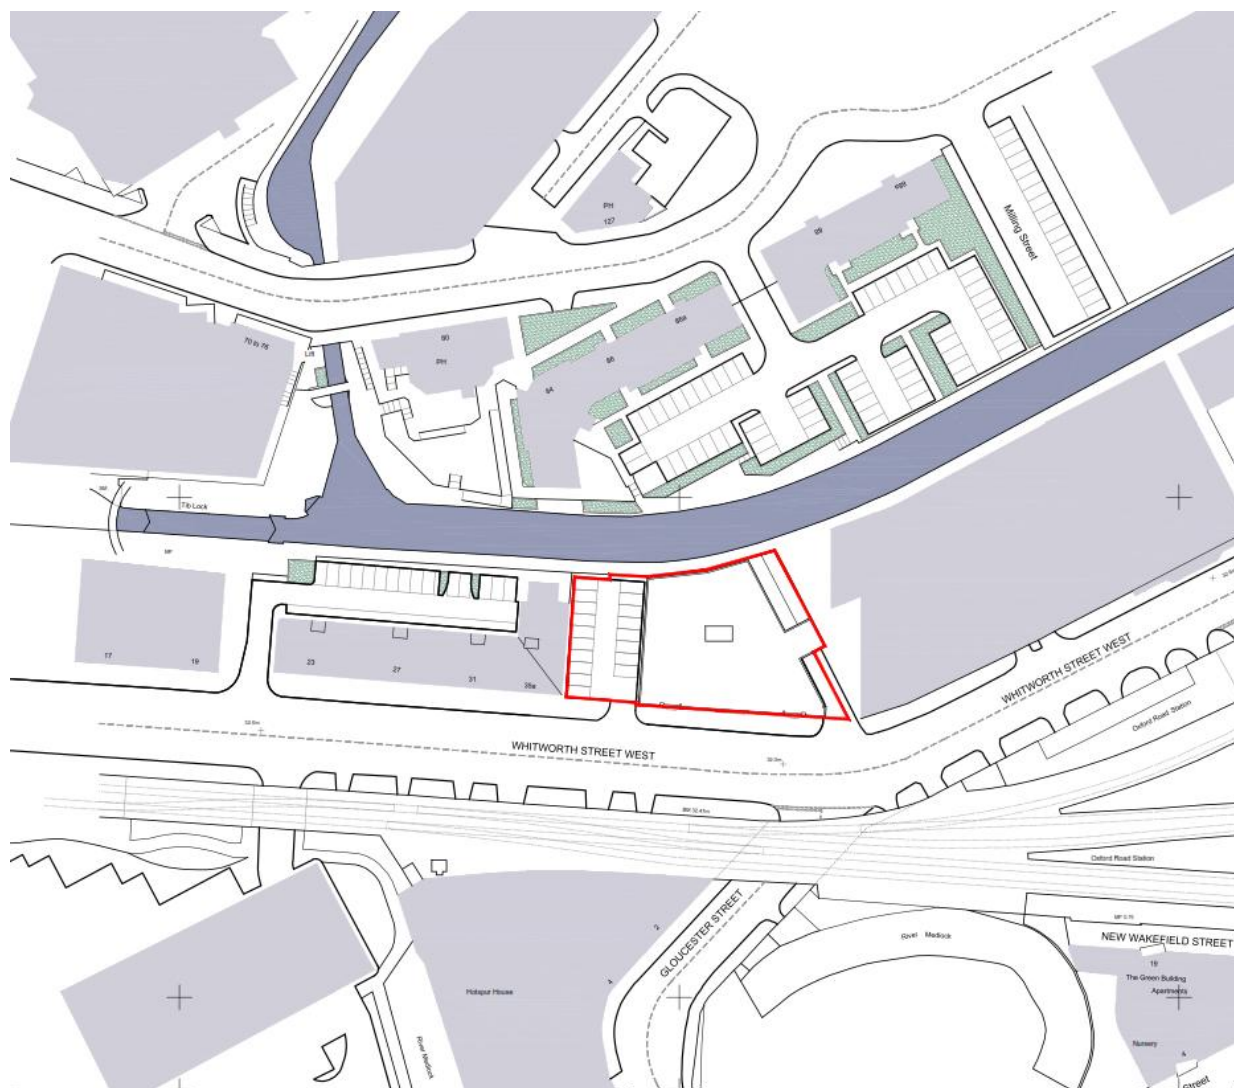
## DEVELOPMENT SITE PLAN

### **Barclay House, Whitworth Street West, Manchester**

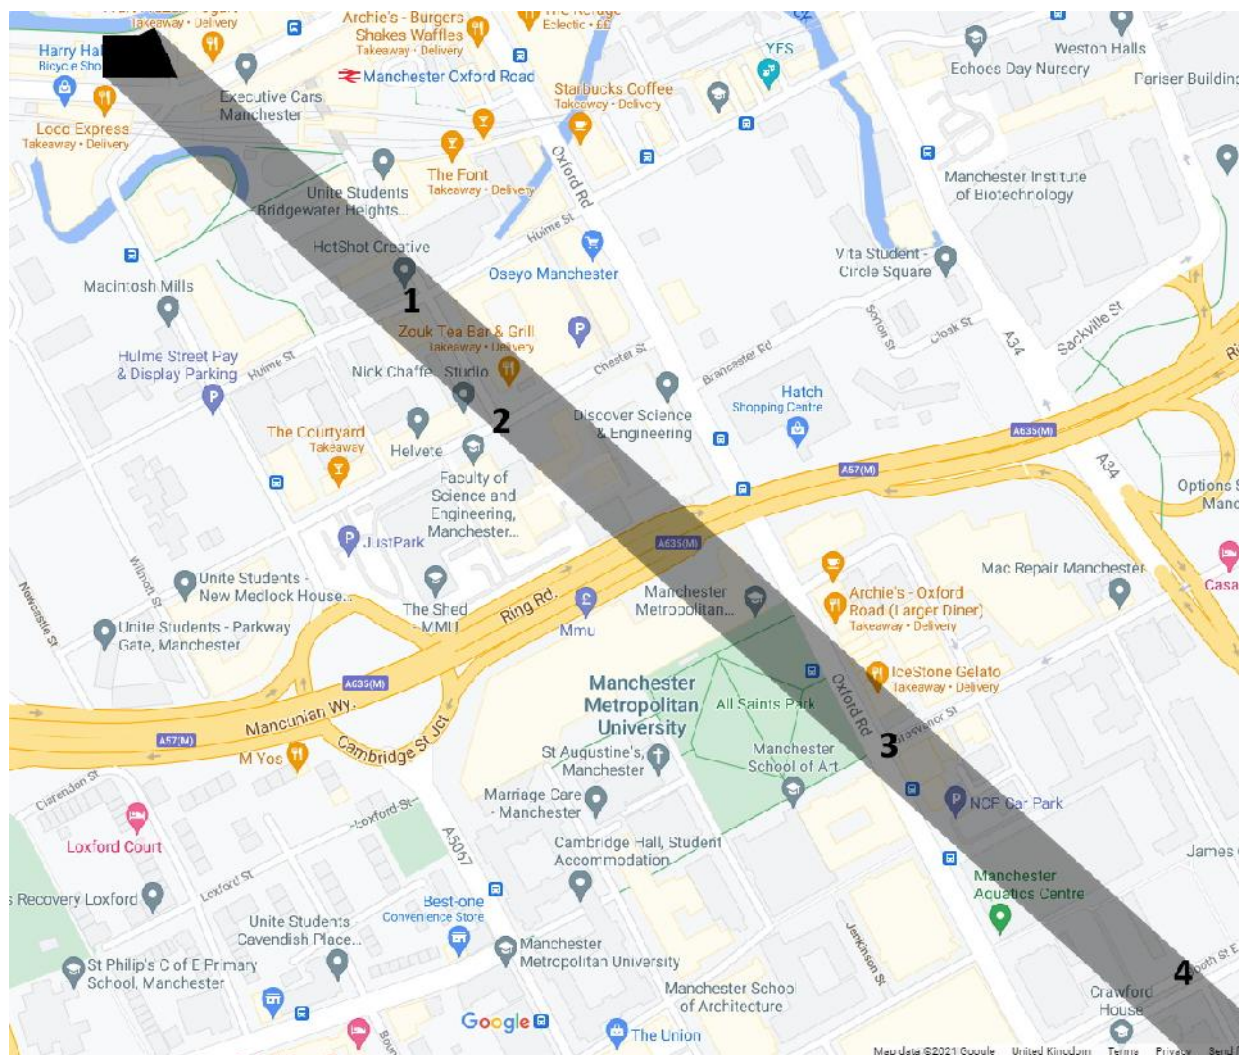
As this is a Pre Construction survey, the test locations are GPS logged to allow a comparative Post-Construction impact survey once the development has been completed.

Due to the nature of the surrounding area only 4 suitable test locations were able to be located and used.
