Phase I Geoenvironmental Site Assessment  
Manchester Life Phase 3

Reference:13-729-R1  
Date: February 2020

# PHASE I GEOENVIRONMENTAL SITE ASSESSMENT

Manchester Life Phase 3  
Land to the north and south of Jersey Street,  
Manchester,  
M4 6JW

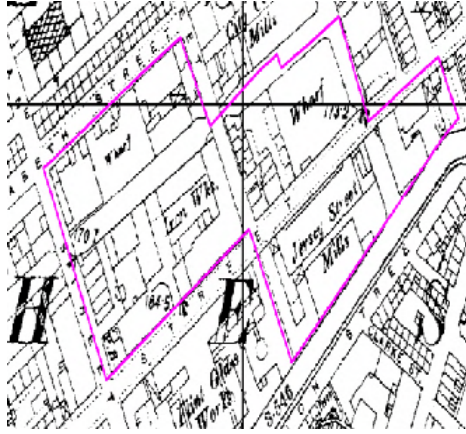
| MAP EDITION | HISTORICAL LAND USE | HISTORICAL MAP EXCERPT |
|---|---|---|
| 1893<br>1:2500 | <p><b>Parcel A</b><br/>Parcel A is entirely surfaced by buildings and intersected by a canal in the center. An Iron Works is present in the south east and a canal Wharf is located in the north off Bengal Arm.</p> <p><b>Parcel B</b><br/>The Parcel comprises a large Wharf in the eastern portion and numerous smaller buildings located to the east. The canal branch runs along the north and east.</p> <p><b>Parcel C</b><br/>The parcel comprises a number of large structures referred to as Jersey Street Mills.</p> | |

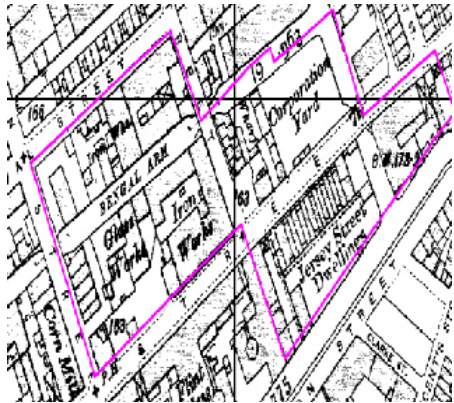
| MAP EDITION | HISTORICAL LAND USE | HISTORICAL MAP EXCERPT |
|---|---|---|
| 1908<br>1:2500 | <p><b>Parcel A</b><br/>The canal intersecting parcel A is referred to as Bengal Arm. The Wharf in the north of the site has been infilled and divided into a number of smaller buildings referred to as Iron Works. The buildings in the south west of the site are now referred to as a Glass Works.</p> <p><b>Parcel B</b><br/>The Wharf in this parcel has also been infilled and is now referred to as a Corporation Yard.</p> <p><b>Parcel C</b><br/>The Jersey Street Mill building to the west is now referred to as Jersey Street Dwellings and the north of the structure has been sub divided into a number of smaller structures.</p> | |

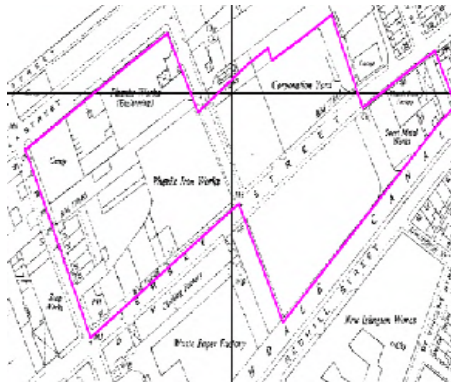
| <p><b>1952-1955</b><br/><b>1:2500</b></p> | <p><b>Parcel A</b></p> <p>The Iron Works located to the south east is now referred to as Phoenix Iron Works. The structures located in north east is also referred to as Phoenix Works (engineering). A garage is now present in the north west. The canal is no longer present.</p> <p><b>Parcel B</b></p> <p>The structures previously noted in the west are no longer present. The canal is no longer present.</p> <p><b>Parcel C</b></p> <p>All buildings in the west have been demolished. A chimney is present in the north east. A sheet metal works is present in the east in addition to a factory.</p> | |

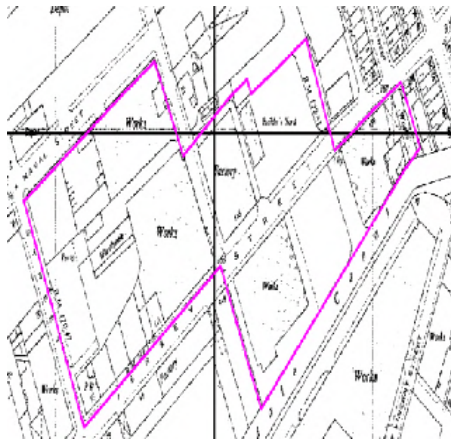
| <p><b>1958-1982</b><br/><b>1:1250</b></p> | <p><b>Parcel A</b></p> <p>The rectangular building present in the center is now referred to as a warehouse and the parcel no longer appears to be intersected by a canal.</p> <p><b>Parcel B</b></p> <p>The Corporation Yard present in the east is referred to as a builders yard. A structure has been developed to the west referred to as a factory. The canal is no longer present.</p> <p><b>Parcel C</b></p> <p>A works building has now been developed in the east of the site. The canal is no longer present.</p> | |

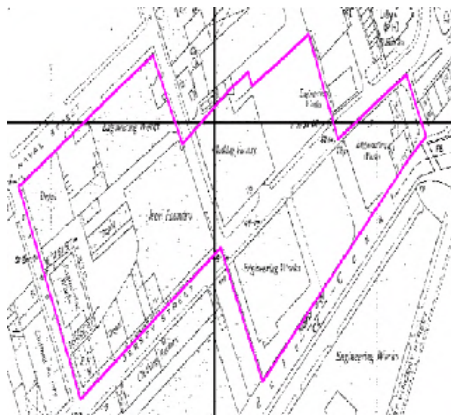
| <p><b>1958-1985</b><br/><b>1:1250</b></p> | <p><b>Parcel A</b></p> <p>The garage located to the north west and the warehouse located in the center are now referred to as depots. There is also an additional depot located to the south. An engineering works building is now present in the central western sector.</p> <p><b>Parcel B</b></p> <p>The factory located to the west is now specified as a clothing factory.</p> <p><b>Parcel C</b></p> <p>There have been no significant changes in parcel C.</p> | |

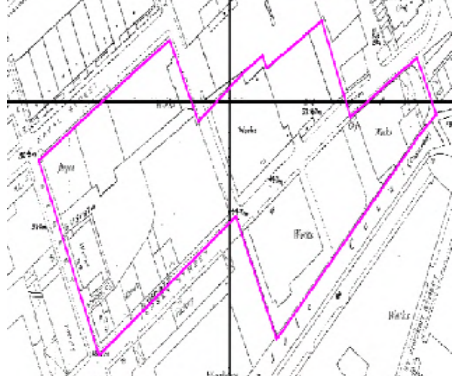
| <p><b>1979-1990</b><br/><b>1:1250</b></p> | <p><b>Parcel A</b><br/>The depot located in the center of the site has been demolished.</p> <p><b>Parcel B and C</b><br/>There have been no significant changes in parcel B and C.</p> | |

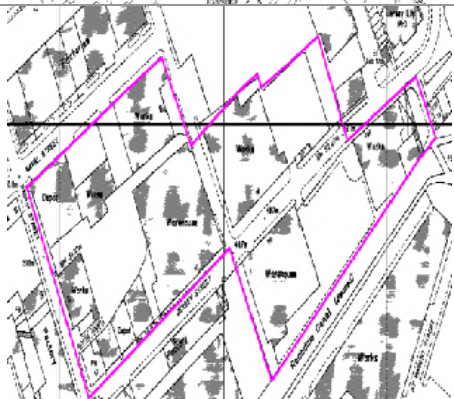
| <p><b>1988-1989</b><br/><b>1:1250</b></p> | <p><b>Parcel A</b><br/>The structure in the south east is now referred to as a warehouse.</p> <p><b>Parcel B</b><br/>There have been no significant changes in parcel B.</p> <p><b>Parcel C</b><br/>The structure in the west is now referred to as a warehouse.</p> | |

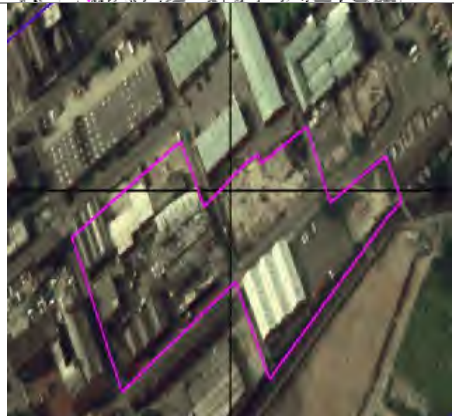
| <p><b>Envirocheck satellite image</b><br/><b>2000</b></p> | <p><b>Parcel A</b><br/>There have been no significant changes.</p> <p><b>Parcel B</b><br/>The works building to the east has been demolished. The parcel appears to be vacant and surfaced by hardstanding.</p> <p><b>Parcel C</b><br/>The works building located to the east has been demolished.</p> | |

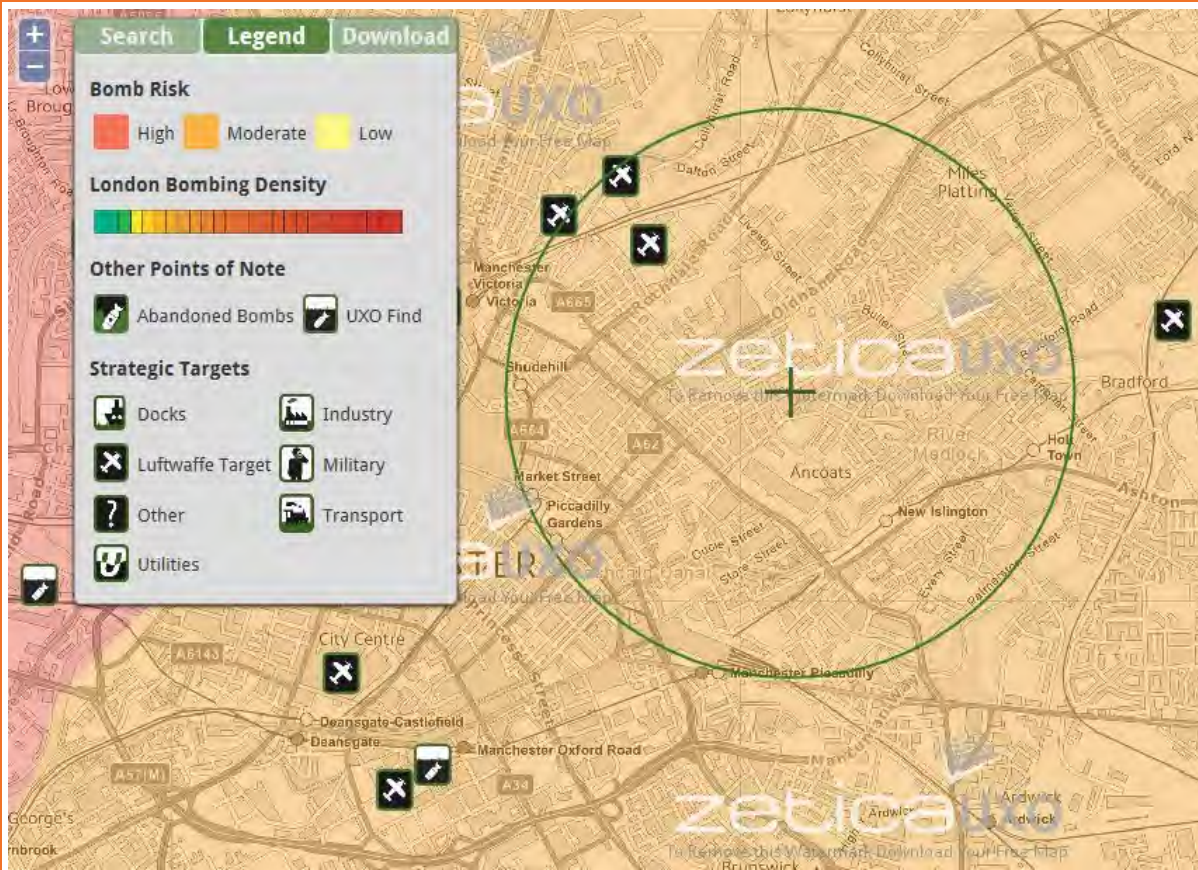
FIGURE 4.2 ZETICA UXO RISKS MAP

As the site is within the high-risk area, it is recommended that further detailed assessments are carried out to establish the level of risk and the potential need for mitigation.

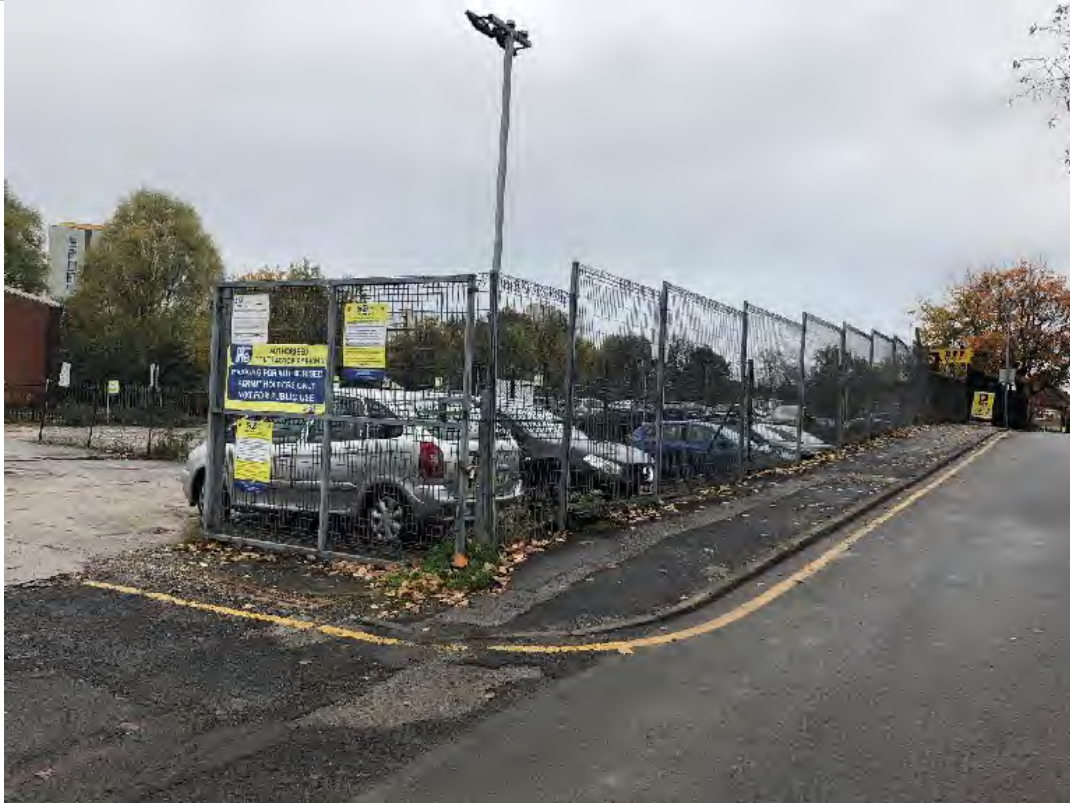
PLATE 3      PARCEL B LEVEL DIFFERENCE OVER CANAL BRIDGE

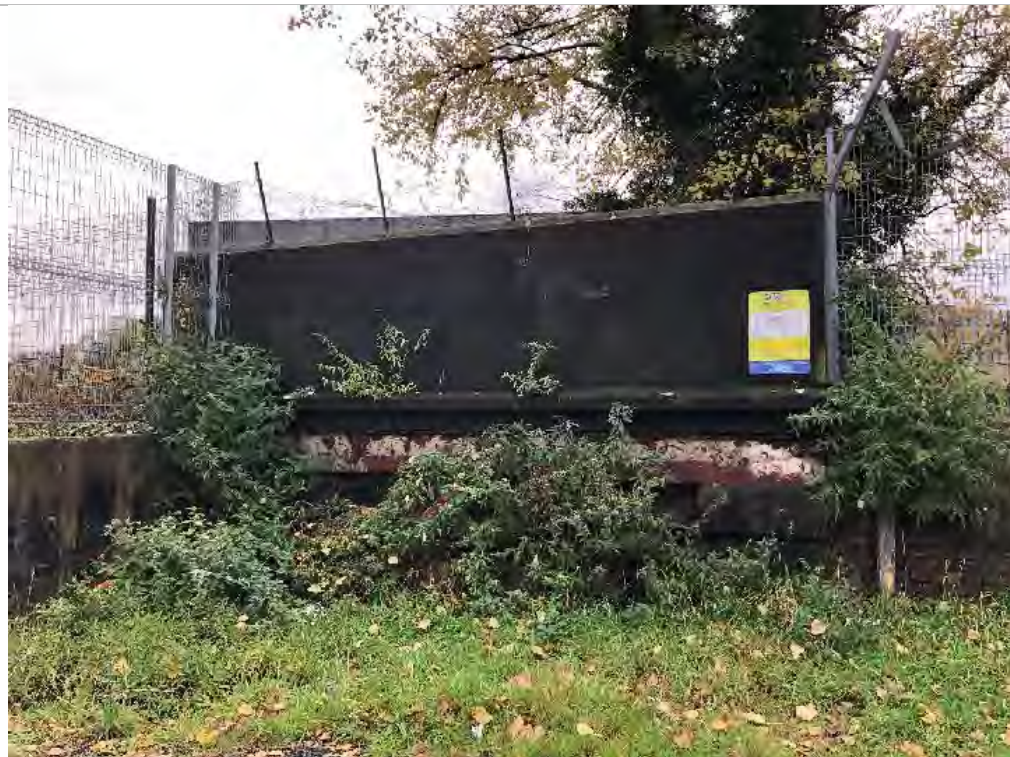
PLATE 6      EVIDENCE OF FORMER CANAL BRIDGE.
