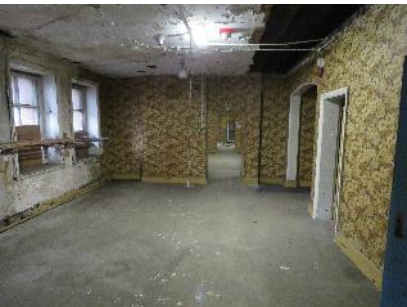
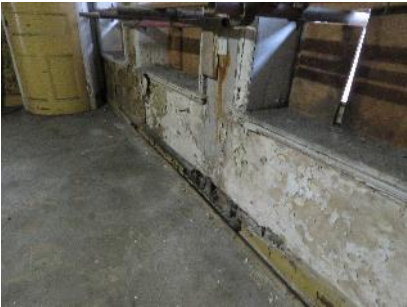
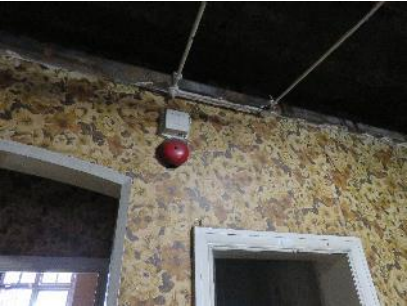
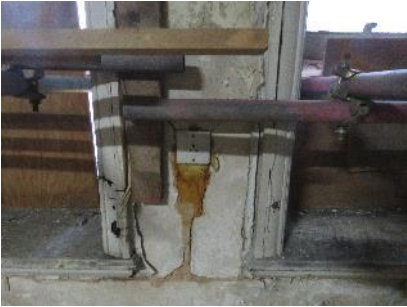
| Room Reference | Element | Description | Significance | Action | Photographs | | |
|---|---|---|---|---|---|---|--|
| 1.87 | Wall Finish(es) | Wallpaper | None | Remove | | | |
| | Ceiling Finish | Paint | Low | Remove flaking paint<br>Approx. 15m2 of plaster missing | | | |
| | Floor Finish | Adhesive and carpet over Wood block | None / None / High | Remove adhesive and carpet, retain Wood block | | | |
| | Fixtures & Fittings | Fireman's pole and cupboard<br>Radiator brackets<br>Ventilation grill | High<br>Low<br>Low | Retain<br><br>Remove<br>Retain | | | |
| | M&E Items | Heating pipes<br>Conduit<br>Switches<br>Misc. electrical items<br>Light<br>Plug sockets<br>Fire alarm | Low<br>None<br>None<br>None<br><br>None<br>None<br>Low | Remove all | | | |

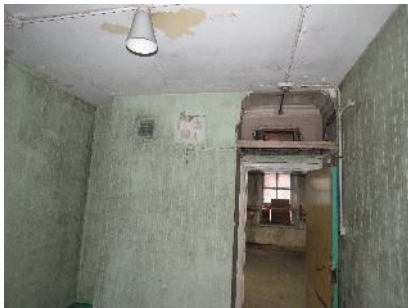
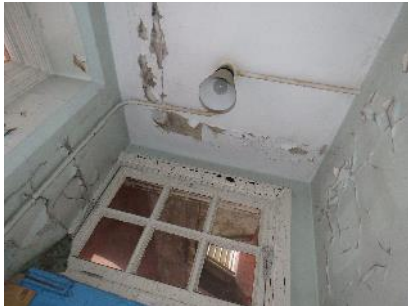
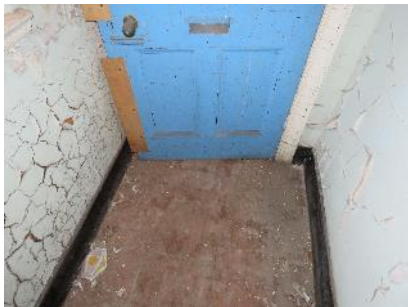
| Room Reference | Element | Description | Significance | Action | Photographs | | |
|---|---|---|---|---|---|---|--|
| 1.88 | Wall Finish(es) | Wallpaper | None | Remove | | | |
| | Ceiling Finish | Paint | Low | Remove flaking paint<br>Approx. 1m2 of missing plaster | | | |
| | Floor Finish | Red clay tile | Low | Retain | | | |
| | Fixtures & Fittings | Ventilation grill | Low | Retain | | | |
| | M&E Items | Light<br>Conduit<br>Switch<br>Heating pipes<br>Misc. cables | None<br>None<br>None<br>Low<br>None | Remove all | | | |

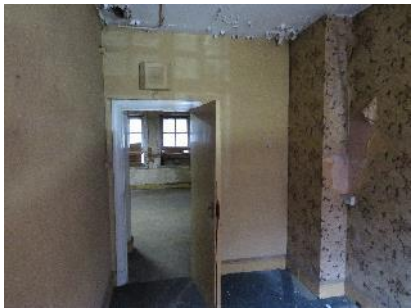
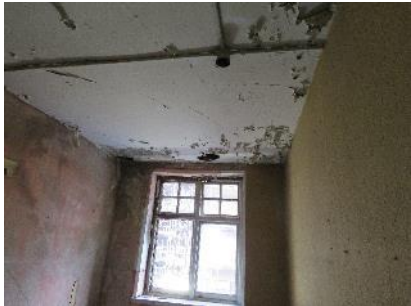
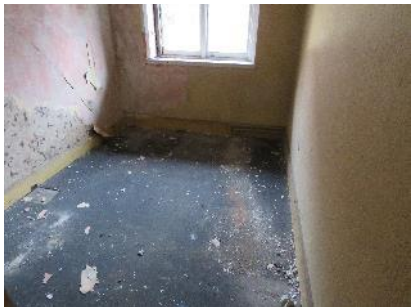
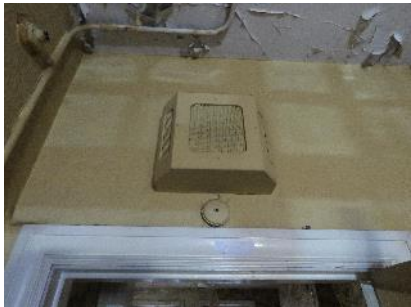
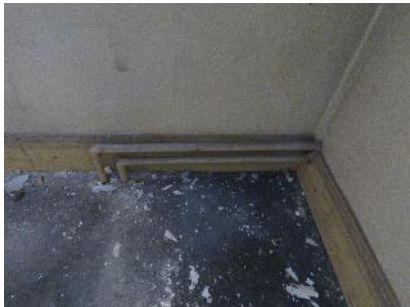
| Room Reference | Element | Description | Significance | Action | Photographs | | |
|---|---|---|---|---|---|--|--|
| 1.89 | Wall Finish(es) | Wallpaper | None | Remove | | | |
| | Ceiling Finish | Paint | Low | Remove flaking paint<br>Approx. 1m2 of missing plaster | | | |
| | Floor Finish | Carpet and adhesive over Wood block | None / none / high | Remove carpet and adhesive, retain Wood block | | | |
| | M&E Items | Heating pipes<br>Plug socket<br>Speaker<br>Light<br>Conduit<br>Switch | Low<br>None<br>Low<br>None<br>None<br>None | Remove<br>Remove<br>Retain / relocate<br>Remove<br>Remove<br>Remove | | | |

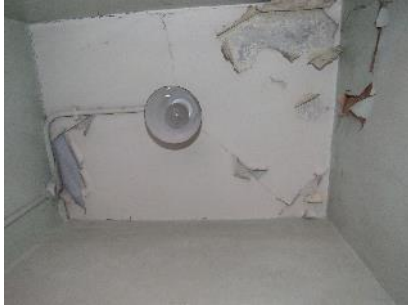
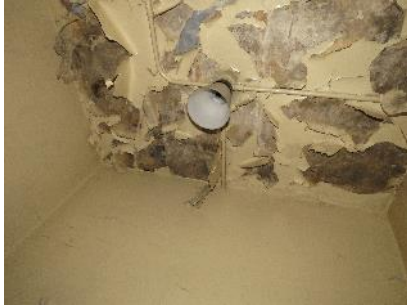
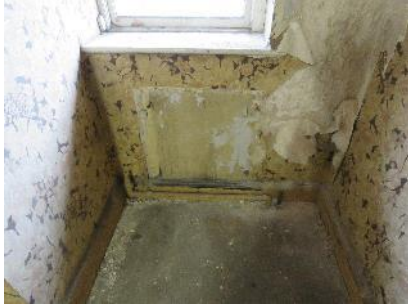
| Room Reference | Element | Description | Significance | Action | Photographs | | |
|---|---|---|---|---|---|---|---|
| 1.90 | Wall Finish(es) | Wallpaper<br>Paint | None<br>None | Remove<br>Remove flaking paint | | | |
| | Ceiling Finish | Paint | None | Remove flaking paint<br>Approx 2m2 of plaster missing | | | |
| | Floor Finish | Adhesive over<br>Wood block<br>Red clay tile | None / High<br>Low | Remove adhesive<br>and retain Wood<br>block<br>Retain | | | |
| | Fixtures & Fittings | Soap dispenser<br>Mirror<br>Speaker<br>Ventilation grill | None<br>None<br>Low<br>Low | Remove<br>Remove<br>Retain / relocate<br>Retain | | | |
| | M&E Items | Light<br>Conduit<br>Switches<br>Plug socket | None<br>None<br>None<br>None | Remove all | | | |

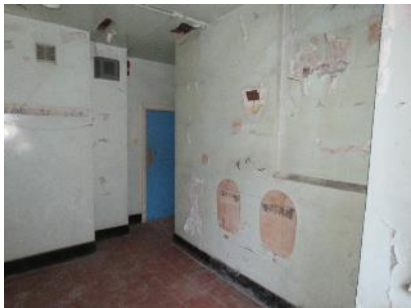
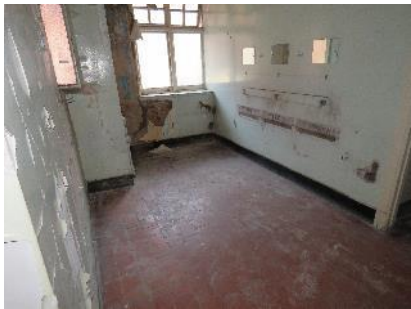
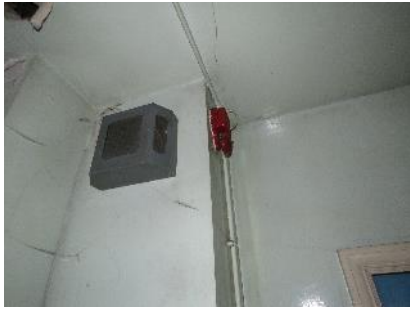
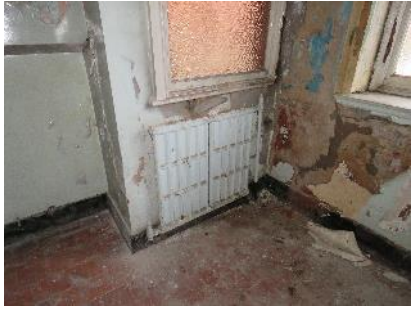
| Room Reference | Element | Description | Significance | Action | Photographs | | |
|---|---|---|---|---|---|---|--|
| 1.91 | Wall Finish(es) | Paint | None | Remove flaking paint | | | |
| | Ceiling Finish | Paint | None | Remove flaking paint<br>Approx. 3m2 of plaster missing | | | |
| | Floor Finish | Red clay tile | Low | Retain | | | |
| | Fixtures & Fittings | Mirrors<br>Battens<br>Fixings<br>Speaker<br>Ventilation grill<br>Cistern brackets<br>Timber board and hooks<br>Toilet roll holder | None<br>None<br>None<br>Low<br>Low<br>None<br>None<br>None | Remove<br>Remove<br>Remove<br>Retain / relocate<br>Retain<br>Remove<br>Remove<br>Remove | | | |
| | M&E Items | Misc. cables<br>Conduit<br>Lights<br>Radiator<br>Heating pipes | None<br>None<br>None<br>None<br>None | Remove all | | | |

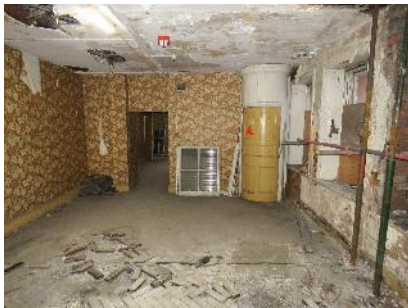
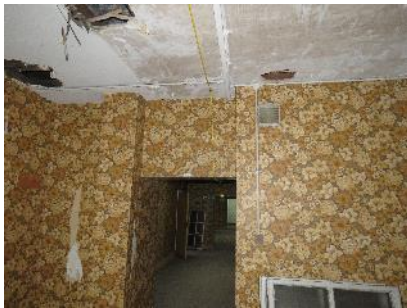
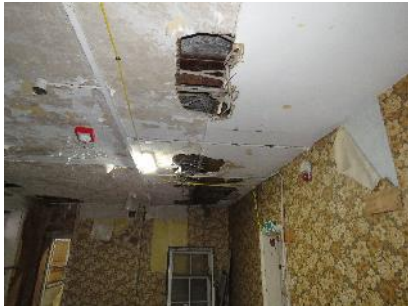
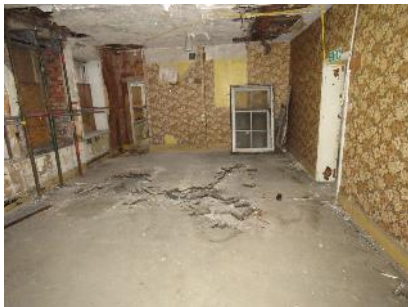
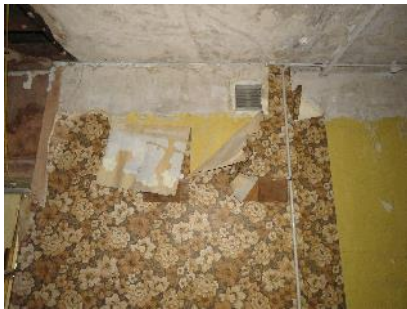
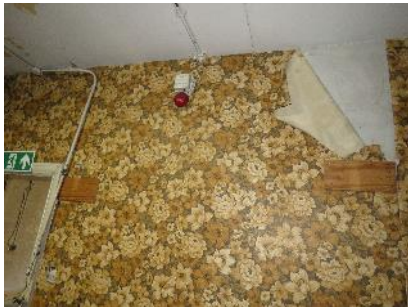
| Room Reference | Element | Description | Significance | Action | Photographs | | |
|---|---|---|---|---|---|---|--|
| 1.92 | Wall Finish(es) | Wallpaper | None | Remove | | | |
| | Ceiling Finish | Paint | Low | Remove flaking paint<br>Approx. 10m2 of plaster missing | | | |
| | Floor Finish | Adhesive and carpet over Wood block | None / None / High | Remove adhesive and carpet, retain Wood block | | | |
| | Fixtures & Fittings | Fireman's pole and cupboard<br>Radiator brackets<br>Ventilation grill | High<br>Low<br>Low | Retain<br><br>Remove<br>Retain | | | |
| | M&E Items | Heating pipes<br>Conduit<br>Switches<br>Misc. electrical items<br>Light<br>Plug sockets<br>Fire alarm | Low<br>None<br>None<br>None<br><br>None<br>None<br>Low | Remove all | | | |

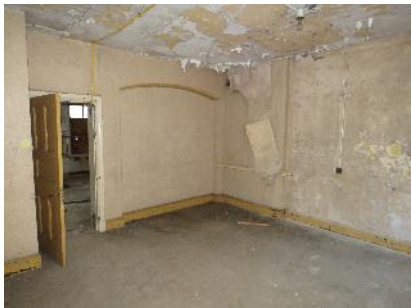
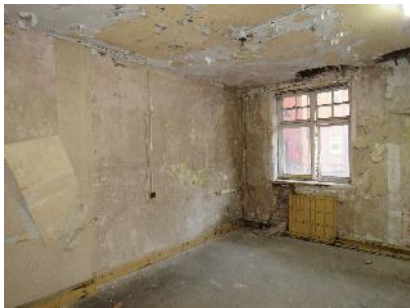
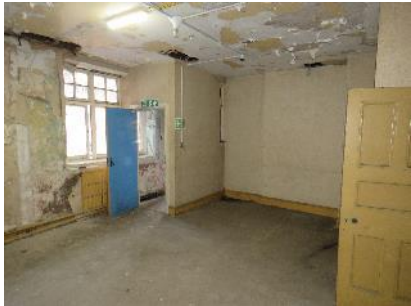
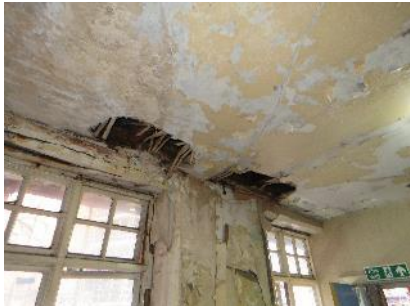
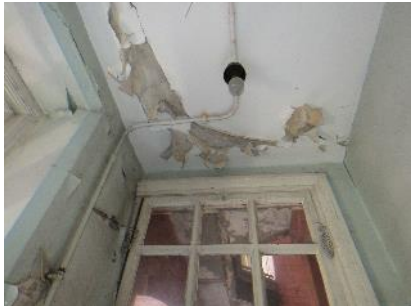
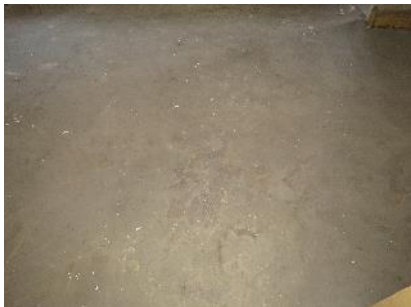
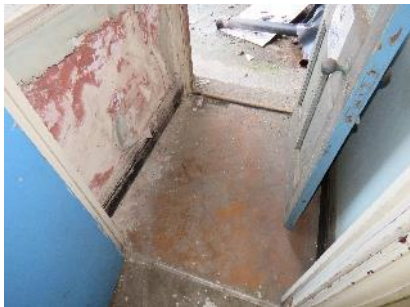
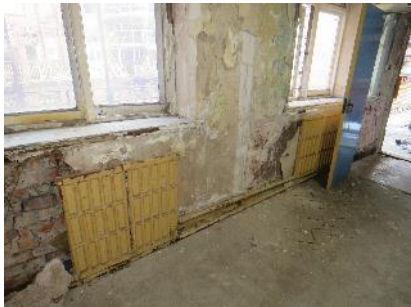
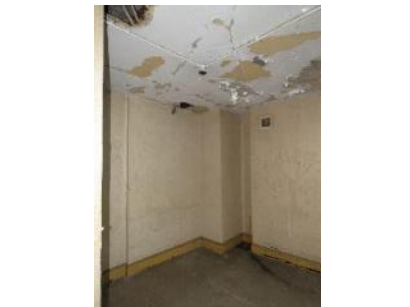
| Room Reference | Element | Description | Significance | Action | Photographs | | |
|---|---|---|---|---|---|---|---|
| 1.93 | Wall Finish(es) | Wallpaper | None | Remove | | | |
| | Ceiling Finish | Paint | Low | Remove flaking paint<br>Approx. 4m2 of plaster missing | | | |
| | Floor Finish | Adhesive over Wood block | None / high | Remove adhesive and retain Wood block | | | |
| | Fixtures & Fittings | Ventilation grills | Low | Retain | | | |
| | M&E Items | Radiators<br>Heating pipes<br>Light<br>Conduit<br>Switches<br>Plug sockets | None<br>None<br>None<br>None<br>None<br>None | Remove all | | | |

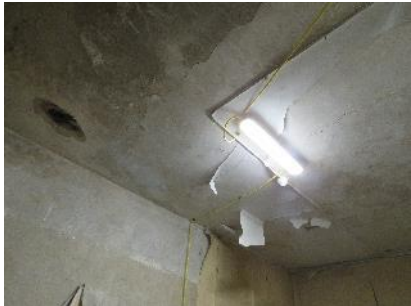
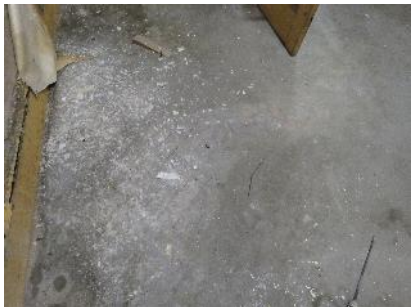
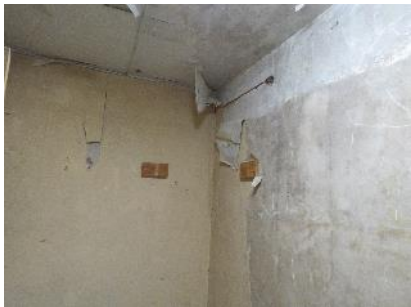
| Room Reference | Element | Description | Significance | Action | Photographs | | |
|---|---|---|---|---|---|--|--|
| 1.94 | Wall Finish(es) | Wallpaper | None | Remove | | | |
| | Ceiling Finish | Ceiling paper | None | Remove<br>Approx. 0.5m2 of plaster missing | | | |
| | Floor Finish | Adhesive over Wood block | None / high | Remove adhesive and retain Wood block | | | |
| | Fixtures & Fittings | Battens | None | Remove | | | |
| | M&E Items | Switch<br>Conduit | None<br>None | Remove | | | |

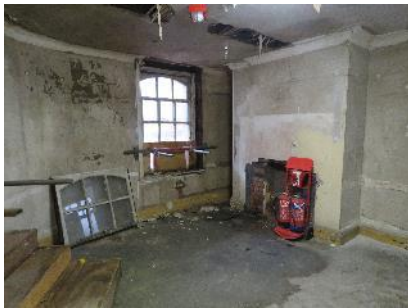
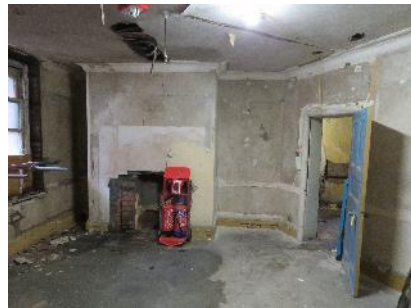
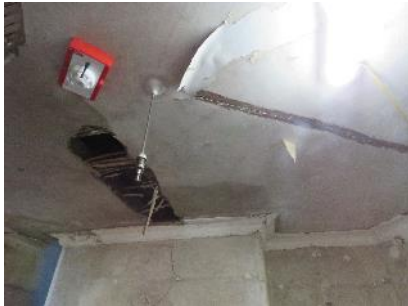
| Room Reference | Element | Description | Significance | Action | Photographs | | |
|---|---|---|---|---|---|---|--|
| 1.95 | Wall Finish(es) | Wallpaper | None | Remove | | | |
| | Ceiling Finish | Ceiling paper | None | Remove<br>Approx. 3m2 of plaster missing | | | |

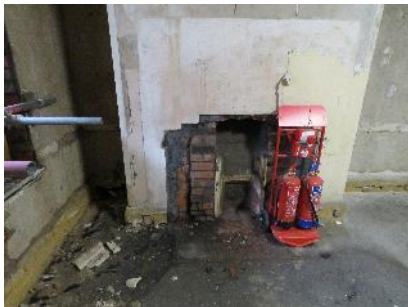
| Room Reference | Element | Description | Significance | Action | Photographs | | |
|---|---|---|---|---|---|---|--|
| | Floor Finish | Carpet and adhesive over Wood block | None / none / high | Remove carpet and adhesive, retain Wood block | | | |

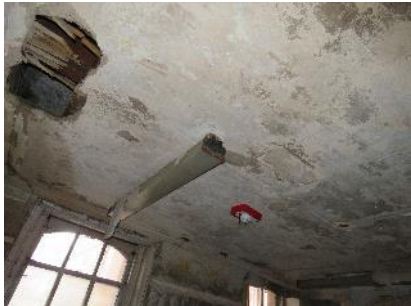
| Room Reference | Element | Description | Significance | Action | Photographs | | |
|---|---|---|---|---|---|---|--|
| | Ceiling Finish | Paint | Low | Remove flaking paint<br>Approx. 1m2 of plaster missing | | | |

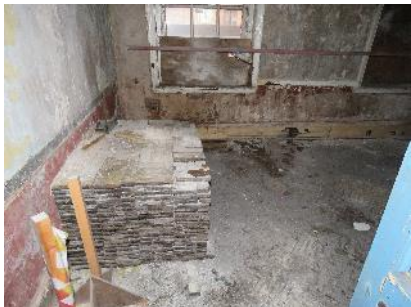
| Room Reference | Element | Description | Significance | Action | Photographs | | |
|---|---|---|---|---|---|---|--|
| | Floor Finish | Wood block (lifted) | High | Retain | | | |

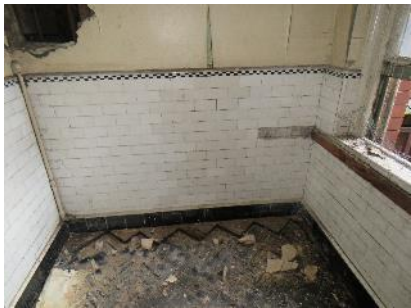
| Room Reference | Element | Description | Significance | Action | Photographs | | |
|---|---|---|---|---|---|---|--|
| 1.97 | Wall Finish(es) | White tile<br>Wallpaper<br>Paint | None<br>None<br>Low | Remove<br>Remove<br>Remove flaking paint | | | |

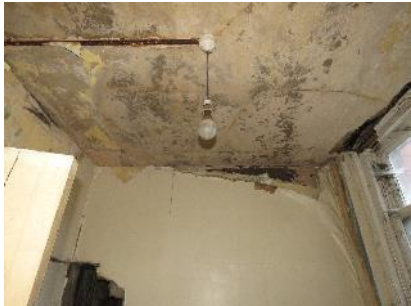
| Room Reference | Element | Description | Significance | Action | Photographs | | |
|---|---|---|---|---|---|---|--|
| | Ceiling Finish | Paint | Low | Remove flaking paint<br>Approx. 1m2 of plaster missing | | | |

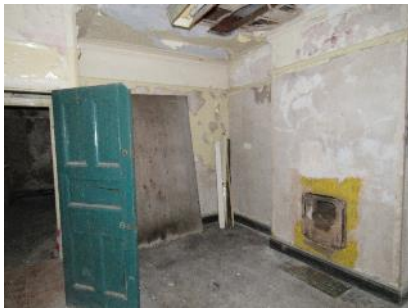
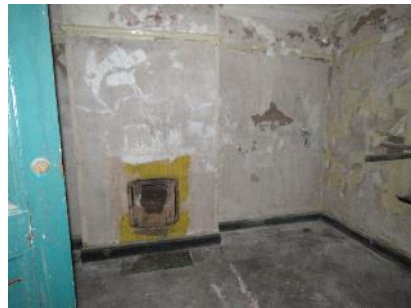
| Room Reference | Element | Description | Significance | Action | Photographs | | |
|---|---|---|---|---|---|---|--|
| 1.98 | Wall Finish(es) | Paint | Low | Remove flaking paint | | | |

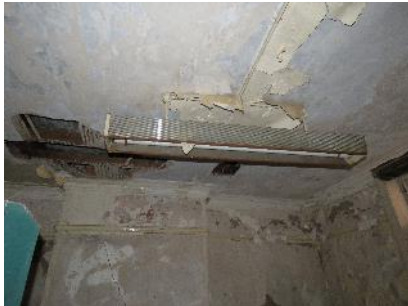
| Room Reference | Element | Description | Significance | Action | Photographs | | |
|---|---|---|---|---|---|---|--|
| | Ceiling Finish | Paint | Low | Remove flaking paint<br>Approx. 4m2 of plaster missing | | | |

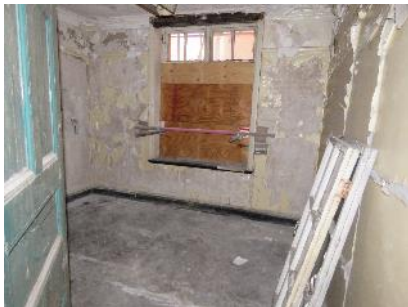
| Room Reference | Element | Description | Significance | Action | Photographs | | |
|---|---|---|---|---|---|---|--|
| | Floor Finish | Wood block<br>Glazed tile | High<br>Low | Retain<br>Retain | | | |

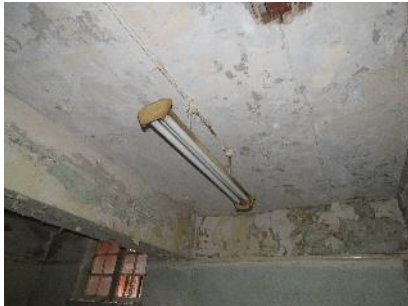
| Room Reference | Element | Description | Significance | Action | Photographs | | |
|---|---|---|---|---|---|--|--|
| | Ceiling Finish | Paint | Low | Remove flaking paint<br>Approx. 10m2 of plaster missing | | | |

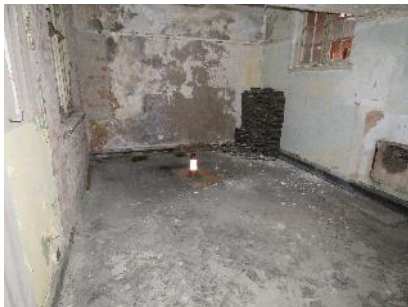
| Room Reference | Element | Description | Significance | Action | Photographs | | |
|---|---|---|---|---|---|--|--|
| | Floor Finish | Wood block (lifted)<br>Glazed tile | High<br>Low | Retain<br>Retain | | | |

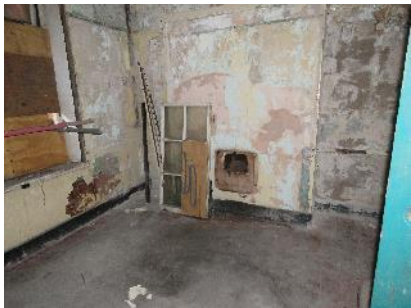
| Room Reference | Element | Description | Significance | Action | Photographs | | |
|---|---|---|---|---|---|--|--|
| 1.100 | Wall Finish(es) | Wallpaper | None | Remove | | | |

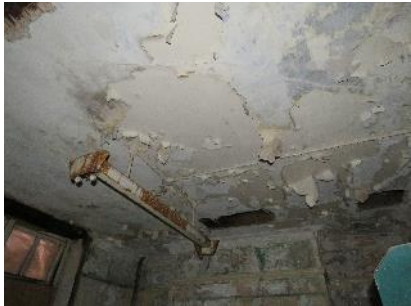
| Room Reference | Element | Description | Significance | Action | Photographs | | |
|---|---|---|---|---|---|--|--|
| | Ceiling Finish | Paint | Low | Remove flaking paint<br>Approx. 3m2 of plaster missing | | | |

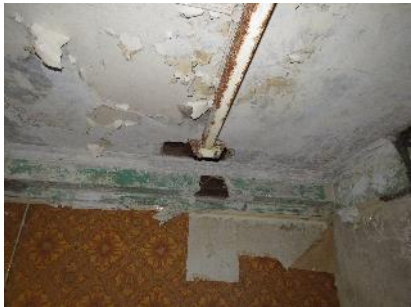
| Room Reference | Element | Description | Significance | Action | Photographs | | |
|---|---|---|---|---|---|--|--|
| | M&E Items | Modern light<br>Conduit<br>Plug socket<br>Misc. cables | None<br>None<br>None<br>None | Remove all | | | |

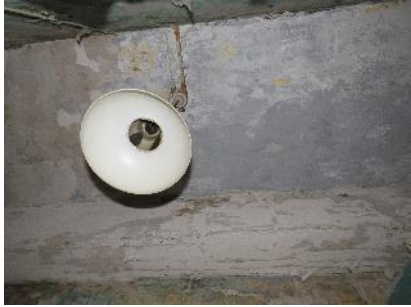
| Room Reference | Element | Description | Significance | Action | Photographs | | |
|---|---|---|---|---|---|--|--|
| | Ceiling Finish | Paint | Low | Remove flaking paint | | | |

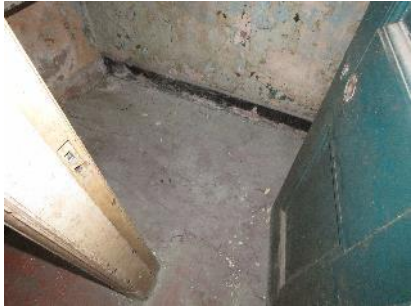
| Room Reference | Element | Description | Significance | Action | Photographs | | |
|---|---|---|---|---|---|--|--|
| | Floor Finish | Vinyl over red clay tile | None / low | Remove vinyl and retain red clay tile | | | |

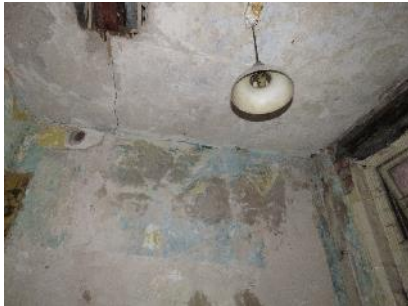
| Room Reference | Element | Description | Significance | Action | Photographs | | |
|---|---|---|---|---|---|--|--|
| | Ceiling Finish | Paint | Low | Remove flaking paint | | | |

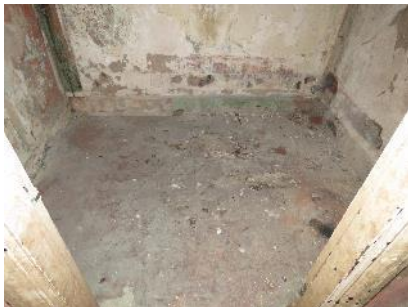
| Room Reference | Element | Description | Significance | Action | Photographs | | |
|---|---|---|---|---|---|--|--|
| | Floor Finish | Vinyl over red clay tile | None / low | Remove vinyl and retain red clay tile | | | |

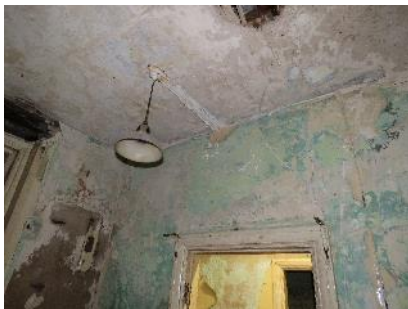
| Room Reference | Element | Description | Significance | Action | Photographs | | |
|---|---|---|---|---|---|--|--|
| | M&E Items | Early light switch<br>Conduit<br>Light | Low<br>None<br>None | Re-use if possible<br>Remove<br>Remove | | | |

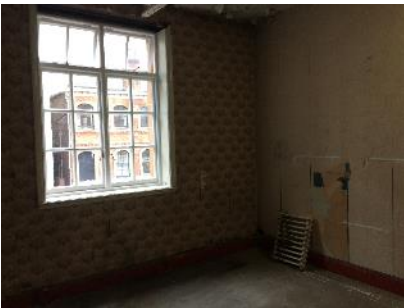
| Room Reference | Element | Description | Significance | Action | Photographs | | |
|---|---|---|---|---|---|--|--|
| 1.103 | Wall Finish(es) | Paint<br>Wallpaper | Low<br>None | Remove flaking paint<br>Remove | | | |

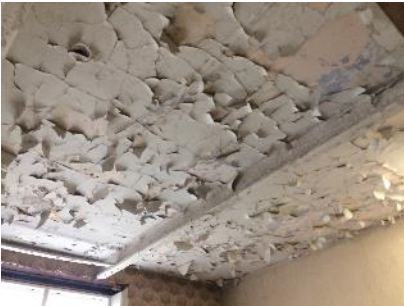
| Room Reference | Element | Description | Significance | Action | Photographs | | |
|---|---|---|---|---|---|--|--|
| | Ceiling Finish | Paint | Low | Remove flaking paint | | | |

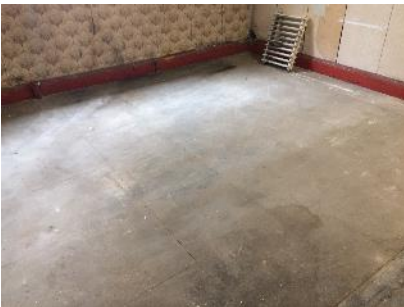
| Room Reference | Element | Description | Significance | Action | Photographs | | |
|---|---|---|---|---|---|--|--|
| | Floor Finish | Floor tile | None | Remove | | | |

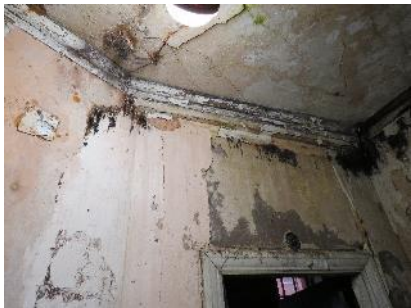
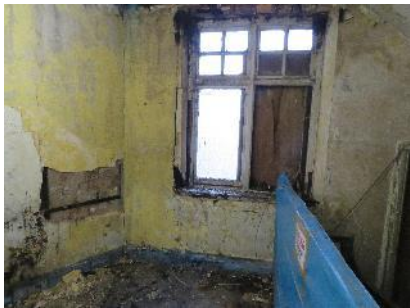
| Room Reference | Element | Description | Significance | Action | Photographs | | |
|---|---|---|---|---|---|---|--|
| 1.107 | Wall Finish(es) | Paint | None | Remove | | | |

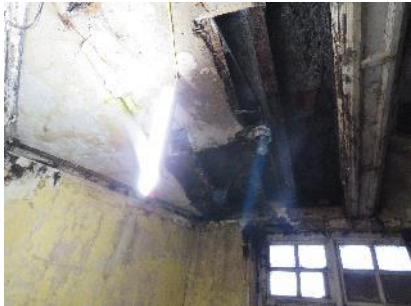
| Room Reference | Element | Description | Significance | Action | Photographs | | |
|---|---|---|---|---|---|---|--|
| | Ceiling Finish | Paint | None | Remove flaking paint<br>Approx. 4m2 of plaster missing | | | |

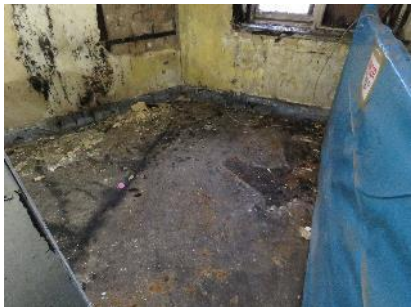
| Room Reference | Element | Description | Significance | Action | Photographs | | |
|---|---|---|---|---|---|---|--|
| | Floor Finish | Carpet over wood block | None / High | Remove carpet and adhesive, retain wood block | | | |

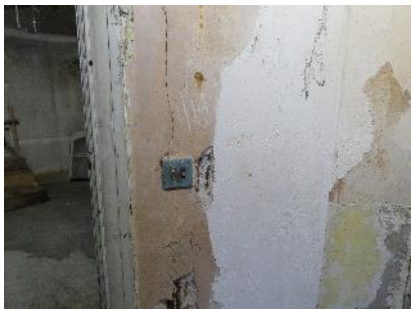
| Room Reference | Element | Description | Significance | Action | Photographs | | |
|---|---|---|---|---|---|---|--|
| | M&E Items | Misc. electrical items<br>Modern light<br>Conduit<br>Misc. cables | None<br>None<br>None<br>None | Remove all | | | |

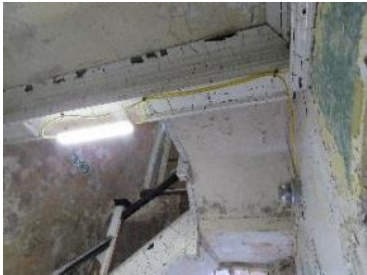
| Room Reference | Element | Description | Significance | Action | Photographs | | |
|---|---|---|---|---|---|---|--|
| | Ceiling Finish | Paint | Low | Remove flaking paint | | | |

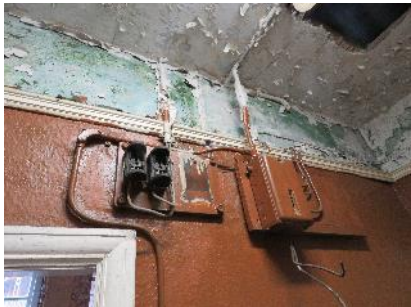
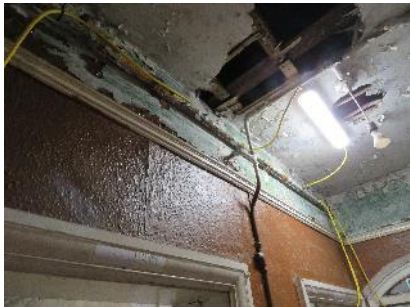
| Room Reference | Element | Description | Significance | Action | Photographs | | |
|---|---|---|---|---|---|---|--|
| | M&E Items | Misc. electrical items<br>Modern light<br>Conduit<br>Misc. cables<br>Misc. gas pipes | None<br>None<br>None<br>None<br>Low | Remove all | | | |

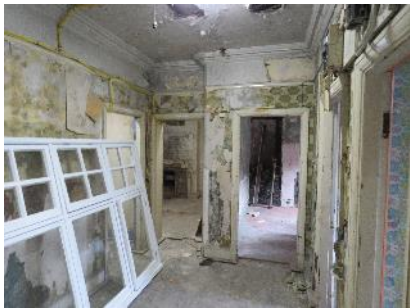
| Room Reference | Element | Description | Significance | Action | Photographs | | |
|---|---|---|---|---|---|---|---|
| 1.109 | Wall Finish(es) | Wallpaper | None | Remove | | | |

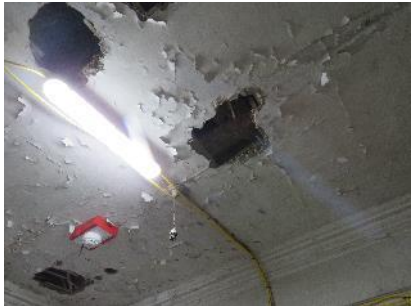
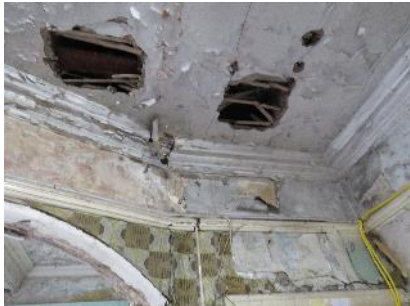
| Room Reference | Element | Description | Significance | Action | Photographs | | |
|---|---|---|---|---|---|---|---|
| | Ceiling Finish | Paint | Low | Remove flaking paint<br>Approx. 2m2 of plaster missing | | | |

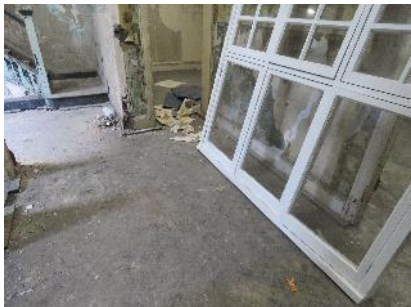
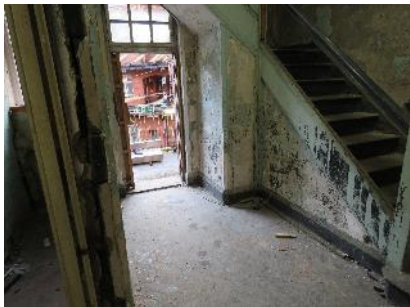
| Room Reference | Element | Description | Significance | Action | Photographs | | |
|---|---|---|---|---|---|---|---|
| | Floor Finish | Wood block (lifted) | High | Retain | | | |

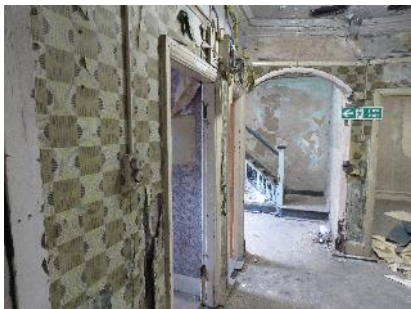
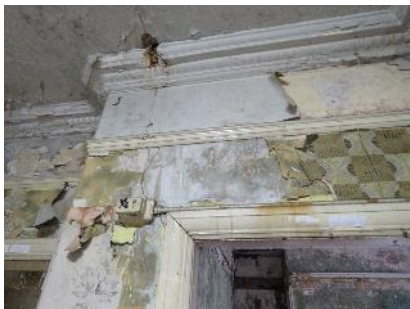
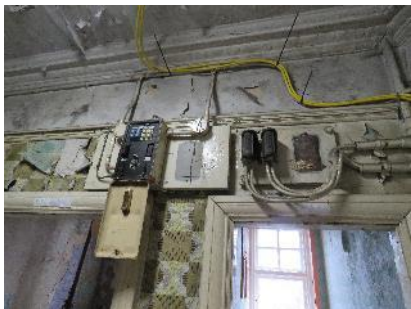
| Room Reference | Element | Description | Significance | Action | Photographs | | |
|---|---|---|---|---|---|---|---|
| | M&E Items | Misc. electrical items<br>Modern light<br>Light switches<br>Conduit<br>Misc. cables<br>Misc. gas pipes | None<br>None<br>Low<br>None<br>None<br>Low | Remove all | | | |

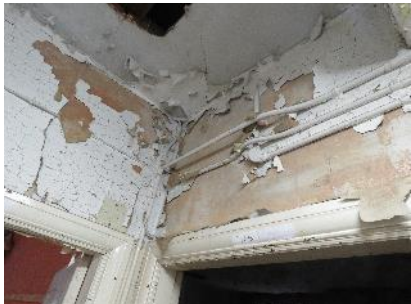
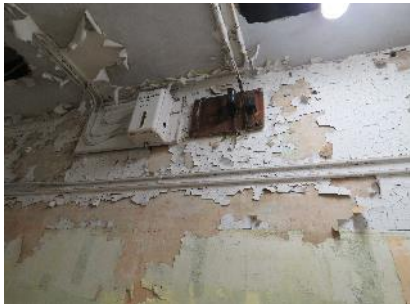
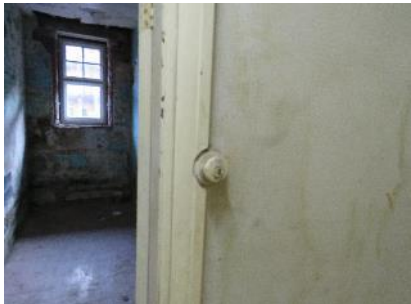
| Room Reference | Element | Description | Significance | Action | Photographs | | |
|---|---|---|---|---|---|---|---|
| | M&E Items | Gas pipe<br>Switch<br>Conduit<br>Light<br>Socket<br>Fuseboard<br>Misc. cables | Low<br>None<br>None<br>None<br>None<br>None<br>None | Remove all | | | |

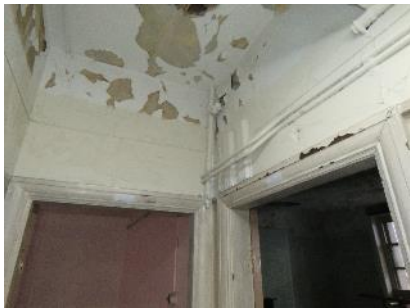
| Room Reference | Element | Description | Significance | Action | Photographs | | |
|---|---|---|---|---|---|---|---|
| 1.111 | Wall Finish(es) | Wallpaper | None | Remove | | | |

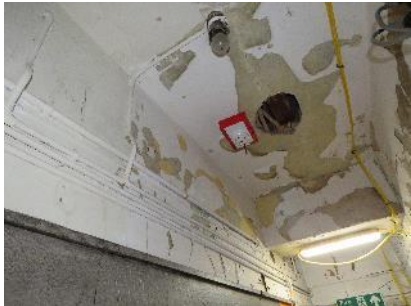
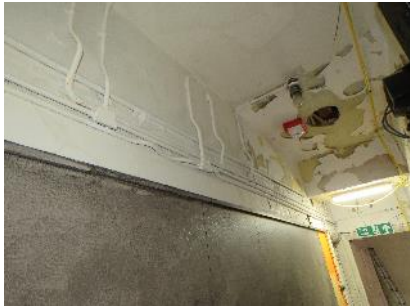
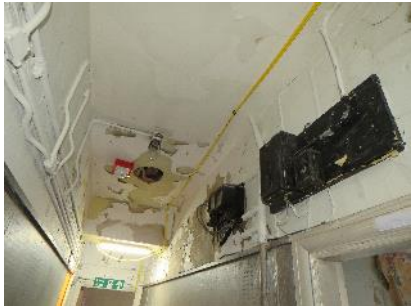
| Room Reference | Element | Description | Significance | Action | Photographs | | |
|---|---|---|---|---|---|---|---|
| | Ceiling Finish | Ceiling paper<br>Paint | None<br>None | Remove<br>Remove flaking paint<br>Approx. 1m2 of plaster missing | | | |

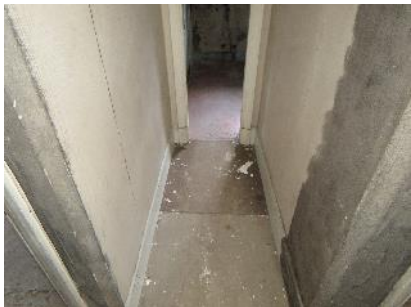
| Room Reference | Element | Description | Significance | Action | Photographs | | |
|---|---|---|---|---|---|---|---|
| | Floor Finish | Carpet tile and adhesive over red clay tile | None / Low | Remove carpet and adhesive, retain tile | | | |

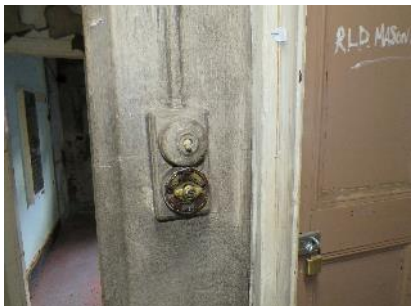
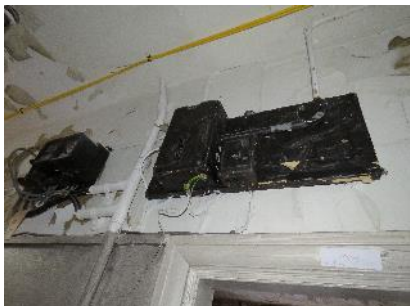
| Room Reference | Element | Description | Significance | Action | Photographs | | |
|---|---|---|---|---|---|---|---|
| | M&E Items | Misc. electrical items<br>Gas pipe | None<br>Low | Remove all | | | |

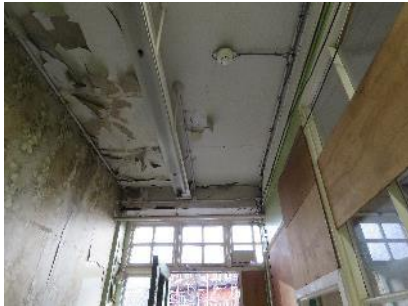
| Room Reference | Element | Description | Significance | Action | Photographs | | |
|---|---|---|---|---|---|--|--|
| | Ceiling Finish | Paint | Low | Remove flaking paint | | | |

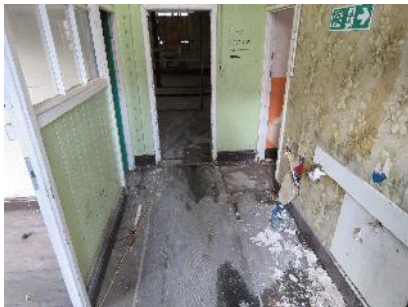
| Room Reference | Element | Description | Significance | Action | Photographs | | |
|---|---|---|---|---|---|--|--|
| | Floor Finish | Vinyl Carpet | None<br>None | Remove<br>Remove | | | |

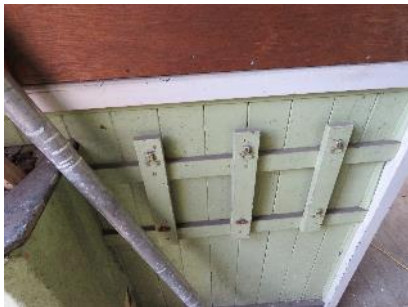
| Room Reference | Element | Description | Significance | Action | Photographs | | |
|---|---|---|---|---|---|--|--|
| | Fixtures & Fittings | Timber mounting brackets for fire extinguishers | None | Remove | | | |

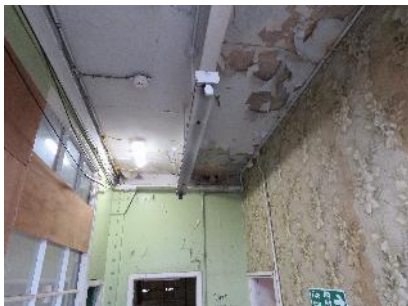
| Room Reference | Element | Description | Significance | Action | Photographs | | |
|---|---|---|---|---|---|--|--|
| | M&E Items | Heating pipes<br>Switch<br>Conduit<br>Light<br>Fire alarm<br>Smoke detector | Low<br>None<br>None<br>None<br>None<br>None | Remove all | | | |

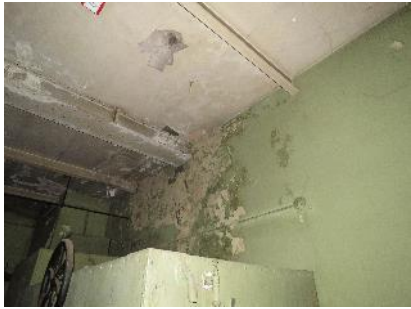
| Room Reference | Element | Description | Significance | Action | Photographs | | |
|---|---|---|---|---|---|---|--|
| | Ceiling Finish | Paint | None | Remove flaking paint | | | |

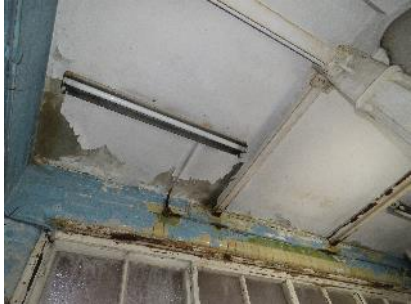
| Room Reference | Element | Description | Significance | Action | Photographs | | |
|---|---|---|---|---|---|---|--|
| | Ceiling Finish | Paint | Low | Remove flaking paint | | | |

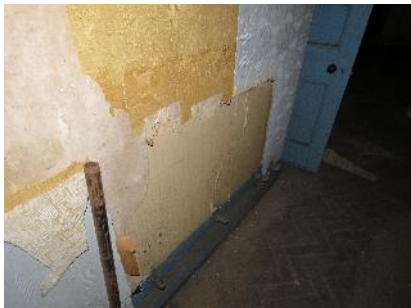
| Room Reference | Element | Description | Significance | Action | Photographs | | |
|---|---|---|---|---|---|---|--|
| 1.115 | Wall Finish(es) | Wallpaper<br>Paint | None<br>Low | Remove<br>Remove flaking paint | | | |

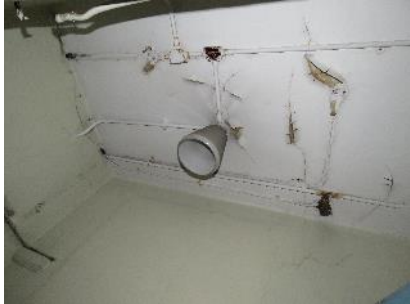
| Room Reference | Element | Description | Significance | Action | Photographs | | |
|---|---|---|---|---|---|---|--|
| | Ceiling Finish | Paint | Low | Remove flaking paint<br>Approx. 1m2 of plaster missing | | | |

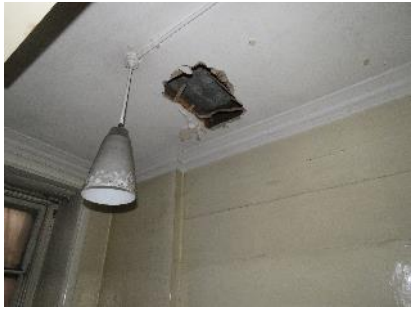
| Room Reference | Element | Description | Significance | Action | Photographs | | |
|---|---|---|---|---|---|--|--|
| | Ceiling Finish | Paint | Low | Remove flaking paint<br>Approx. 1m2 of plaster missing | | | |

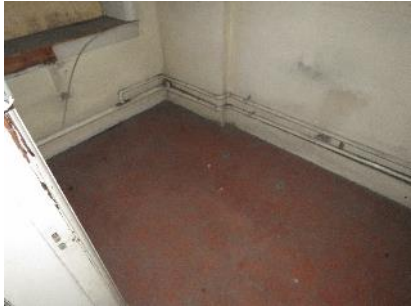
| Room Reference | Element | Description | Significance | Action | Photographs | | |
|---|---|---|---|---|---|--|--|
| | Floor Finish | Red clay tile | Low | Retain | | | |

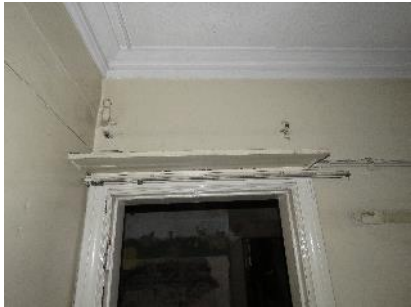
| Room Reference | Element | Description | Significance | Action | Photographs | | |
|---|---|---|---|---|---|--|--|
| | Fixtures & Fittings | Shelf<br>Brackets<br>Curtain rail<br>Misc. fixings | None<br>None<br>None<br>None | Remove<br>Remove<br>Remove<br>Remove all | | | |

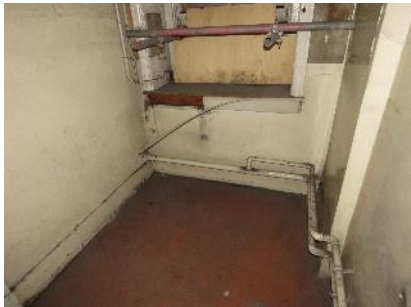
| Room Reference | Element | Description | Significance | Action | Photographs | | |
|---|---|---|---|---|---|--|--|
| | M&E Items | Heating pipes<br>Switches<br>Conduit<br>Gas pipe<br>Plug socket<br>Ceiling light | Low<br>None<br>None<br>Low<br>None<br>None | Remove all | | | |

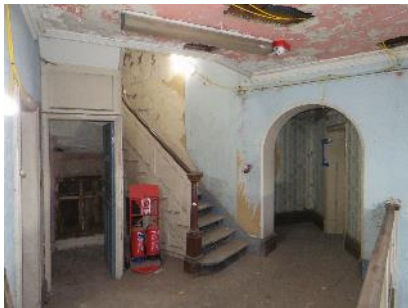
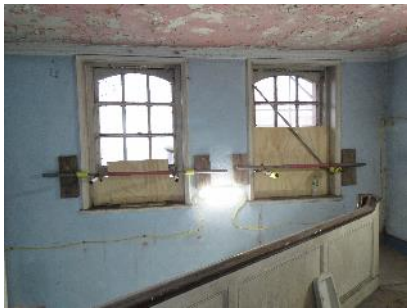
| Room Reference | Element | Description | Significance | Action | Photographs | | |
|---|---|---|---|---|---|---|--|
| 1.117 | Wall Finish(es) | Paint | Low | Remove flaking paint | | | |

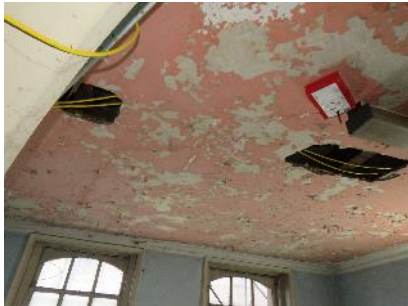
| Room Reference | Element | Description | Significance | Action | Photographs | | |
|---|---|---|---|---|---|---|--|
| | Ceiling Finish | Paint | Low | Remove flaking paint<br>Approx. 1m2 of plaster missing | | | |

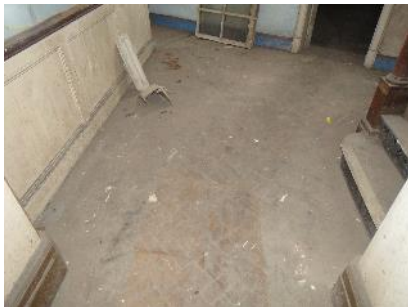
| Room Reference | Element | Description | Significance | Action | Photographs | | |
|---|---|---|---|---|---|---|--|
| | Floor Finish | Wood block | High | Retain | | | |

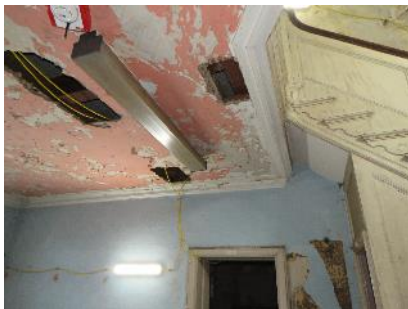
| Room Reference | Element | Description | Significance | Action | Photographs | | |
|---|---|---|---|---|---|---|--|
| | M&E Items | Heating pipe<br>Light switch<br>Light | Low<br>None<br>None | Remove all | | | |

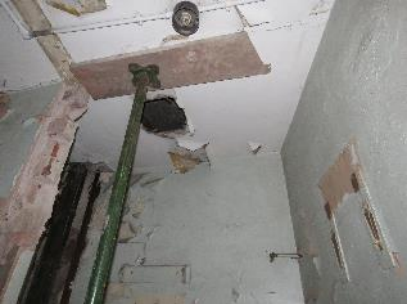
| Room Reference | Element | Description | Significance | Action | Photographs | | |
|---|---|---|---|---|---|---|--|
| | Ceiling Finish | Ceiling Paper | None | Remove | | | |

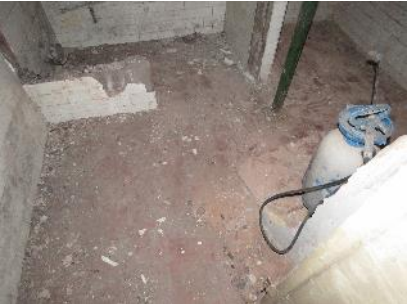
| Room Reference | Element | Description | Significance | Action | Photographs | | |
|---|---|---|---|---|---|---|--|
| | Floor Finish | Red clay tile | Low | Retain | | | |

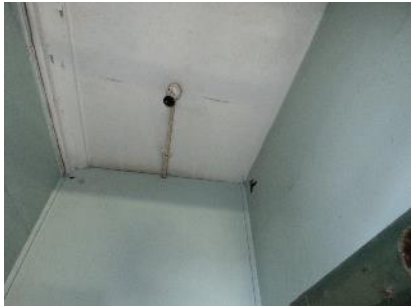
| Room Reference | Element | Description | Significance | Action | Photographs | | |
|---|---|---|---|---|---|--|--|
| | Ceiling Finish | Paint | Low | Remove flaking paint | | | |

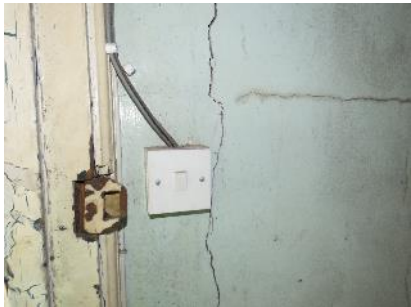
| Room Reference | Element | Description | Significance | Action | Photographs | | |
|---|---|---|---|---|---|--|--|
| | M&E Items | Switch<br>Cable<br>Light | None<br>None<br>None | Remove all | | | |

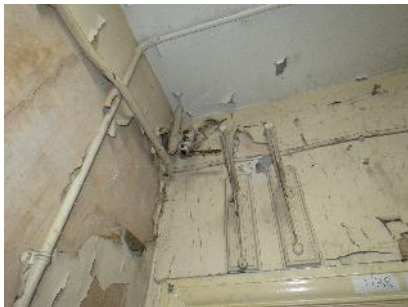
| Room Reference | Element | Description | Significance | Action | Photographs | | |
|---|---|---|---|---|---|--|--|
| | Fixtures & Fittings | Timber mounting boards<br>Brackets | None<br>None | Remove<br>Remove | | | |

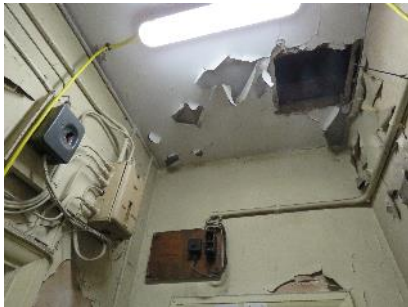
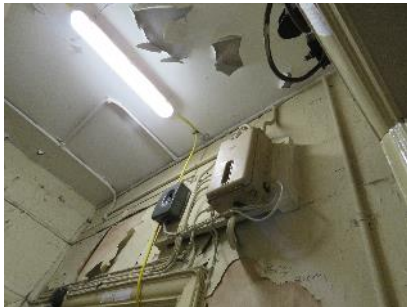
| Room Reference | Element | Description | Significance | Action | Photographs | | |
|---|---|---|---|---|---|--|--|
| | M&E Items | Gas pipes<br>Conduit<br>Misc. electrical items<br>Switch | Low<br>None<br>None<br>None | Remove all | | | |

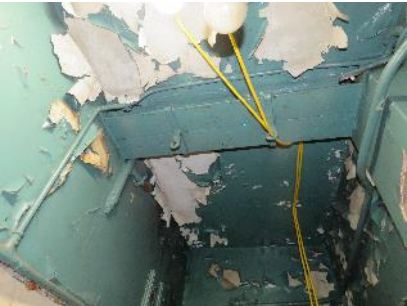
| Room Reference | Element | Description | Significance | Action | Photographs | | |
|---|---|---|---|---|---|---|--|
| | Ceiling Finish | Paint | Low | Remove flaking paint | | | |

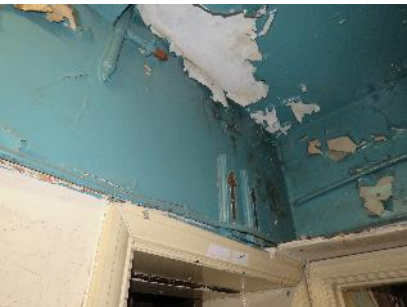
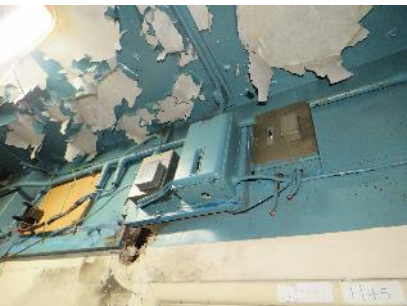
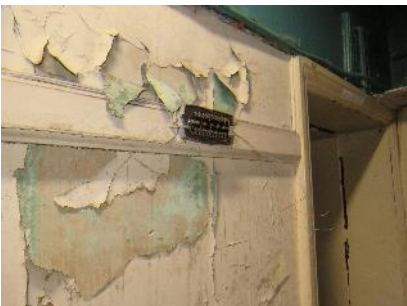
| Room Reference | Element | Description | Significance | Action | Photographs | | |
|---|---|---|---|---|---|---|--|
| | Fixtures & Fittings | Misc. timber boards<br>Hooks to beam | None<br>Low | Remove<br>Retain | | | |
| | M&E Items | Misc. electrical items<br>Telephone wires<br>Gas pipe | None<br><br>None<br>Low | Remove all | | | |

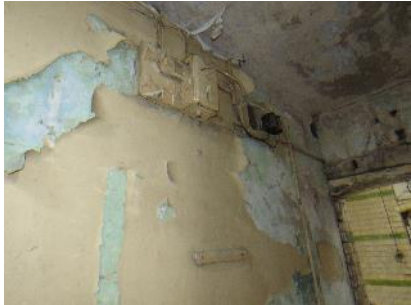
| Room Reference | Element | Description | Significance | Action | Photographs | | |
|---|---|---|---|---|---|---|--|
| 1.124 | Wall Finish(es) | Paint | Low | Remove flaking paint | | | |

| Room Reference | Element | Description | Significance | Action | Photographs | | |
|---|---|---|---|---|---|---|--|
| | Ceiling Finish | Paint | Low | Remove flaking paint<br>Approx. 1m2 of plaster missing | | | |
| | M&E Items | Conduit<br>Light<br>Misc. electrical items | None<br>None<br>None | Remove all | | | |

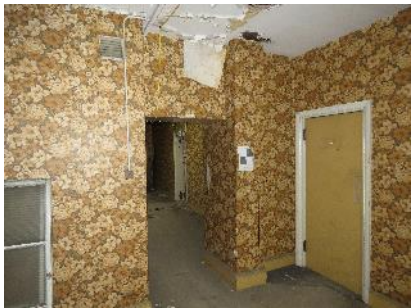
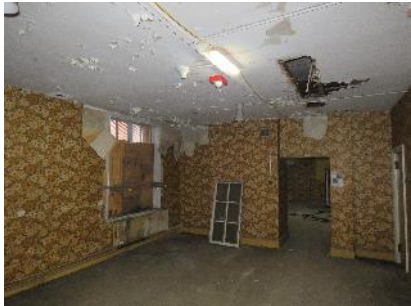
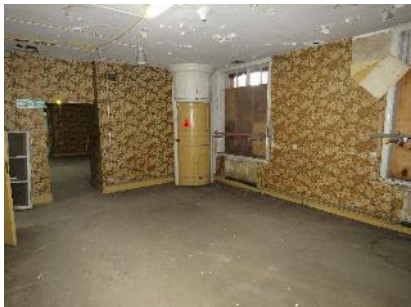
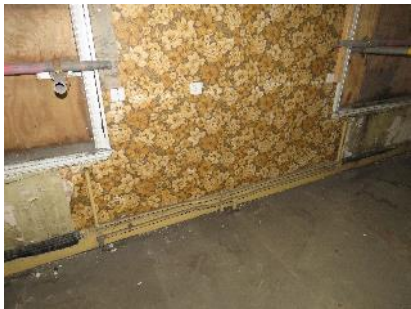
| Room Reference | Element | Description | Significance | Action | Photographs | | |
|---|---|---|---|---|---|--|--|
| | Ceiling Finish | Paint | Low | Remove flaking paint<br>Approx. 3m2 of plaster missing | | | |
| | Floor Finish | Adhesive and carpet over Wood block | None / None / High | Remove adhesive and carpet, retain Wood block | | | |
| | Fixtures & Fittings | Fireman's pole and cupboard<br>Radiator brackets<br>Ventilation grill | High<br>Low<br>Low | Retain<br><br>Remove<br>Retain | | | |

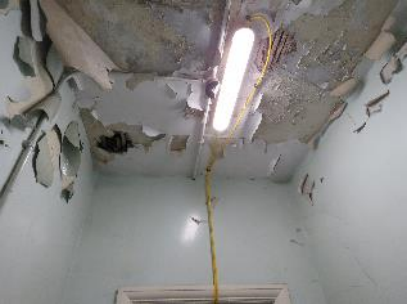
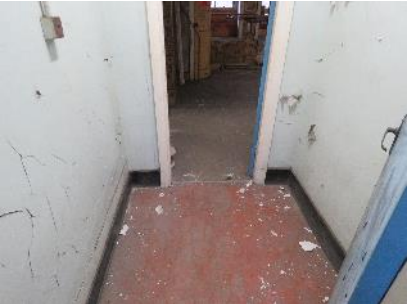
| Room Reference | Element | Description | Significance | Action | Photographs | | |
|---|---|---|---|---|---|--|--|
| 1.126 | Wall Finish(es) | Paint | Low | Remove flaking paint | | | |

| Room Reference | Element | Description | Significance | Action | Photographs | | |
|---|---|---|---|---|---|--|--|
| | Ceiling Finish | Paint | Low | Remove flaking paint<br>Approx. 1m2 of plaster missing | | | |
| | Floor Finish | Red clay tile | Low | Retain | | | |

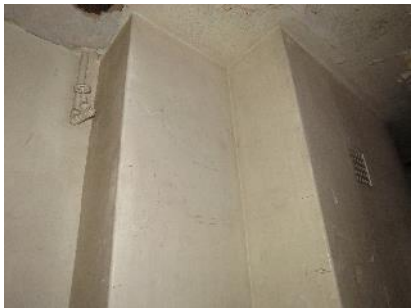
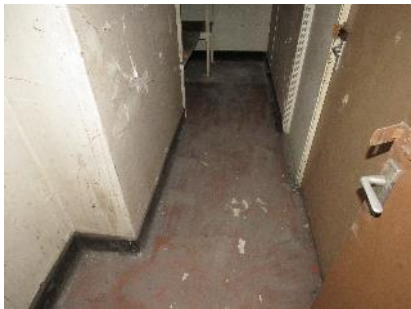
| Room Reference | Element | Description | Significance | Action | Photographs | | |
|---|---|---|---|---|---|--|--|
| 1.127 | Wall Finish(es) | Paint | Low | Remove flaking paint | | | |

| Room Reference | Element | Description | Significance | Action | Photographs | | |
|---|---|---|---|---|---|--|--|
| | Ceiling Finish | Paint | Low | Remove flaking paint<br>Approx. 2m2 of plaster missing | | | |
| | Floor Finish | Red clay tile | Low | Retain | | | |

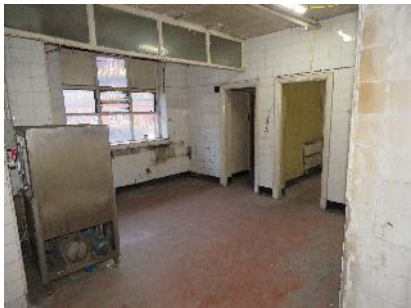
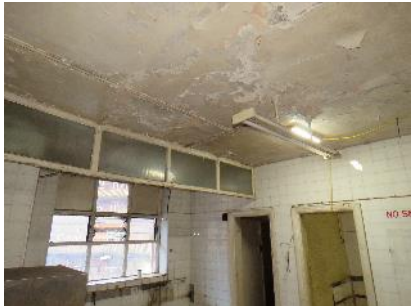
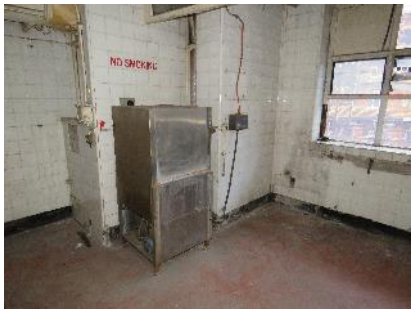
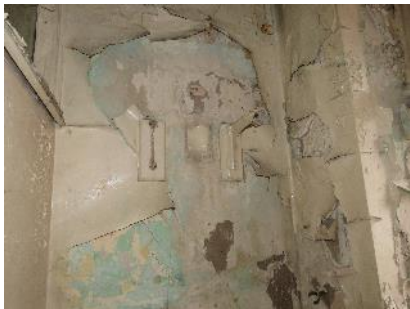
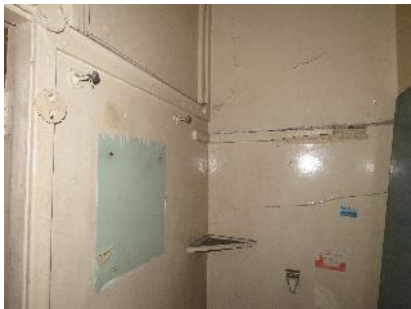
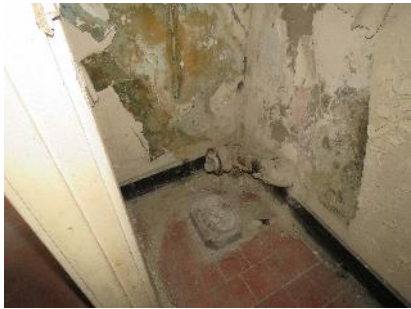
| Room Reference | Element | Description | Significance | Action | Photographs | | |
|---|---|---|---|---|---|---|---|
| | Ceiling Finish | Paint | Low | Remove flaking paint<br>Approx. 2m2 of plaster missing | | | |
| | Fixtures & Fittings | Glass screen<br>Dishwasher unit<br>No smoking sign<br>Battens<br>Towel rail<br>Cistern and sink brackets<br>Shelf | None<br>None<br>None<br>None<br>None<br>None<br>None | Remove all | | | |
| | M&E Items | Misc. electrical items<br>Modern lights<br>Ventilation ductwork and filter<br>Switches<br>Conduit<br>Waste pipe | None<br><br>None<br>None<br>None<br>None<br>None | Remove all | | | |
