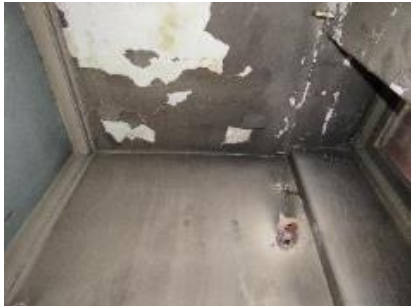
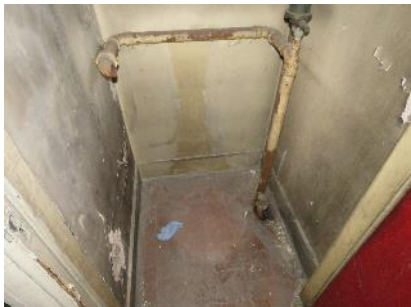
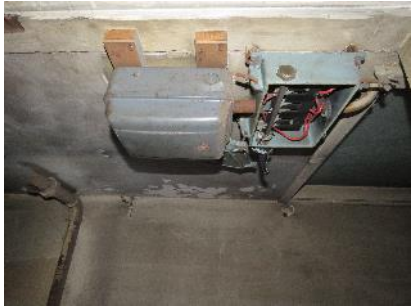
| Room Reference | Element | Description | Significance | Action | Photographs | | |
|---|---|---|---|---|---|--|--|
| 1.129 | Wall Finish(es) | Paint | Low | Remove flaking paint | | | |

| Room Reference | Element | Description | Significance | Action | Photographs | | |
|---|---|---|---|---|---|--|--|
| | Ceiling Finish | Paint | Low | Remove flaking paint | | | |
| | Floor Finish | Red clay tile | Low | Retain | | | |
| | M&E Items | Heating pipe<br>Fuse box | Low<br>None | Remove all | | | |

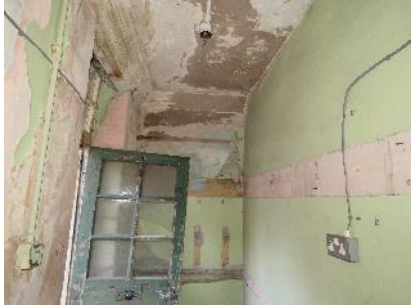
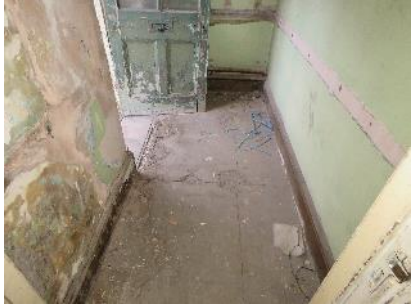
| Room Reference | Element | Description | Significance | Action | Photographs | | |
|---|---|---|---|---|---|--|--|
| 1.130 | Wall Finish(es) | Wallpaper | None | Remove | | | |

| Room Reference | Element | Description | Significance | Action | Photographs | | |
|---|---|---|---|---|---|--|--|
| | Ceiling Finish | Paint | Low | Remove flaking paint | | | |
| | Floor Finish | Vinyl over wood block | None/ high | Remove vinyl and retain wood block | | | |

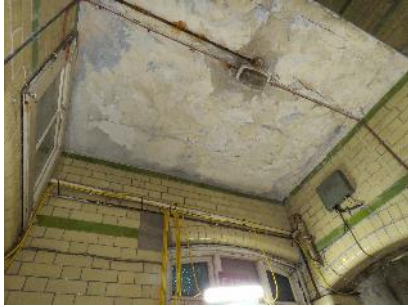
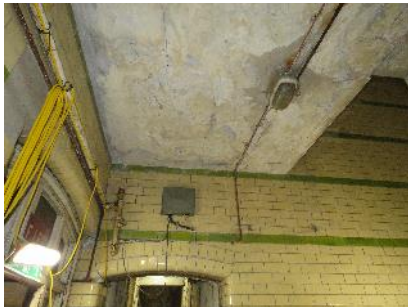
| Room Reference | Element | Description | Significance | Action | Photographs | | |
|---|---|---|---|---|---|--|--|
| 1.131 | Wall Finish(es) | Glazed brick | High | Retain | | | |

| Room Reference | Element | Description | Significance | Action | Photographs | | |
|---|---|---|---|---|---|--|--|
| | Ceiling Finish | Paint | Low | Remove flaking paint | | | |
| | M&E Items | Misc. pipes<br>Misc. electrical<br>items<br>Misc. wires /<br>cables<br>Light switch<br>Conduit<br>Light | Low<br>None<br>None<br>None<br>None<br>None | Remove all | | | |

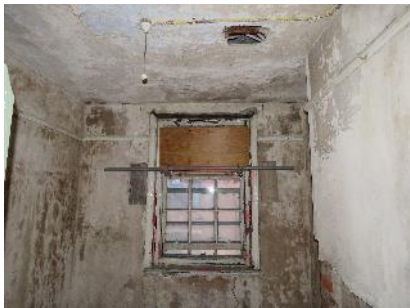
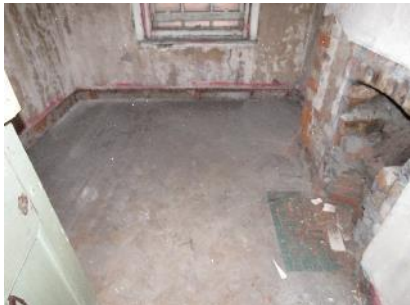
| Room Reference | Element | Description | Significance | Removed or Retained | Photographs | | |
|---|---|---|---|---|---|--|--|
| 2.01 | Wall Finish(es) | Paint | Low | Remove flaking paint | | | |

| Room Reference | Element | Description | Significance | Removed or Retained | Photographs | | |
|---|---|---|---|---|---|--|--|
| | Ceiling Finish | Paint | Low | Remove flaking paint<br>Approx. 1m2 of plaster missing | | | |
| | Floor Finish | Wood block<br>Glazed tile | High<br>Low | Retain<br>Retain | | | |

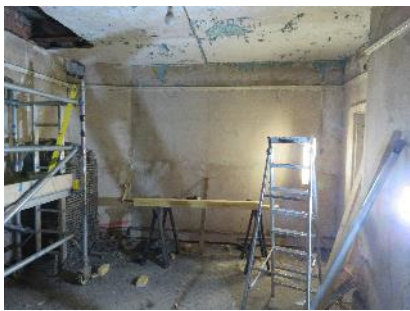
| Room Reference | Element | Description | Significance | Removed or Retained | Photographs | | |
|---|---|---|---|---|---|--|--|
| 2.02 | Wall Finish(es) | Paint | Low | Remove flaking paint | | | |

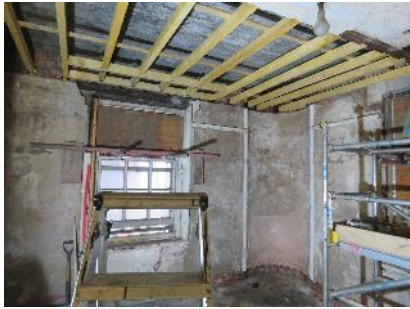
| Room Reference | Element | Description | Significance | Removed or Retained | Photographs | | |
|---|---|---|---|---|---|--|--|
| | Ceiling Finish | Paint | Low | Remove flaking paint<br>Approx. 15m2 of plaster missing | | | |

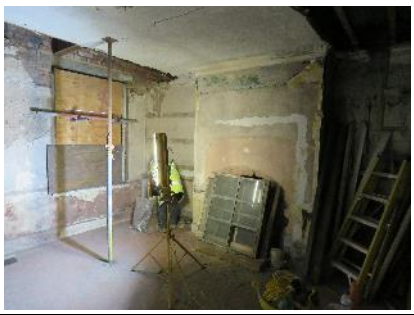
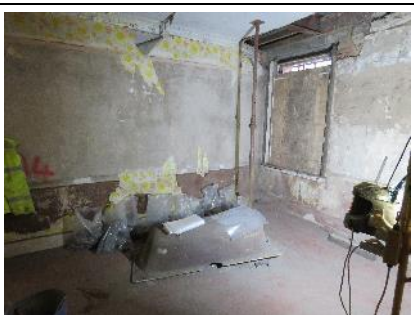
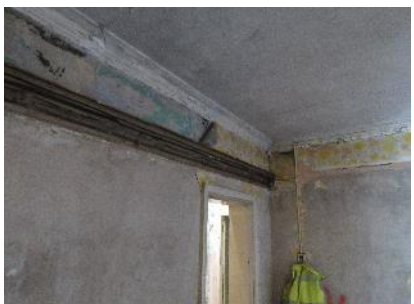
| Room Reference | Element | Description | Significance | Removed or Retained | Photographs | | |
|---|---|---|---|---|---|--|--|
| 2.04 | Wall Finish(es) | Wallpaper | None | Remove | | | |

| Room Reference | Element | Description | Significance | Removed or Retained | Photographs | | |
|---|---|---|---|---|---|--|--|
| | Ceiling Finish | Paint | Low | Remove flaking paint<br>Approx. 10m2 of plaster missing | | | |
| | Floor Finish | Red clay tile | Low | Retain | | | |
| | M&E Items | Conduit<br>Light | None<br>None | Remove all | | | |

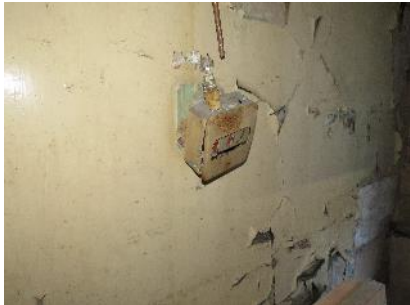
| Room Reference | Element | Description | Significance | Removed or Retained | Photographs | | |
|---|---|---|---|---|---|--|--|
| 2.05 | Wall Finish(es) | Paint<br>White Tile | Low<br>None | Remove flaking paint<br>Remove | | | |

| Room Reference | Element | Description | Significance | Removed or Retained | Photographs | | |
|---|---|---|---|---|---|--|--|
| | M&E Items | Gas pipe<br>Plug socket<br>Conduit<br>Light | Low<br>None<br>None<br>None | Remove all | | | |

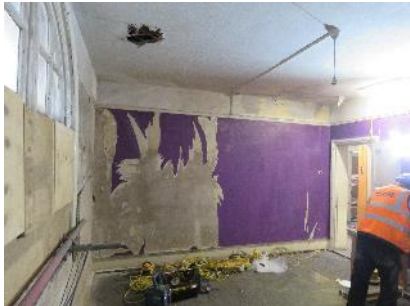
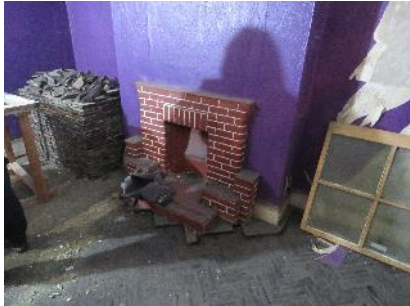
| Room Reference | Element | Description | Significance | Removed or Retained | Photographs | | |
|---|---|---|---|---|---|--|--|
| 2.06 | Wall Finish(es) | Wallpaper | None | Remove | | | |

| Room Reference | Element | Description | Significance | Removed or Retained | Photographs | | |
|---|---|---|---|---|---|--|--|
| | Ceiling Finish | Ceiling paper | None | Remove<br>Approx. 1m2 of plaster missing | | | |
| | Fixtures & Fittings | Modern fireplace | None | Remove | | | |

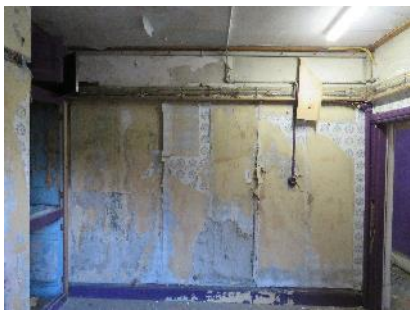
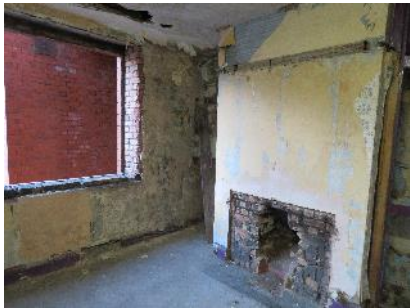
| Room Reference | Element | Description | Significance | Removed or Retained | Photographs | | |
|---|---|---|---|---|---|---|---|
| | Ceiling Finish | Ceiling paper | None | Remove<br>Approx. 2m2 of plaster missing | | | |
| | Fixtures & Fittings | Timber boards (boxing in)<br>Battens<br>Cupboards | None<br><br>None<br>Low | Remove<br><br>Remove<br>Remove | | | |

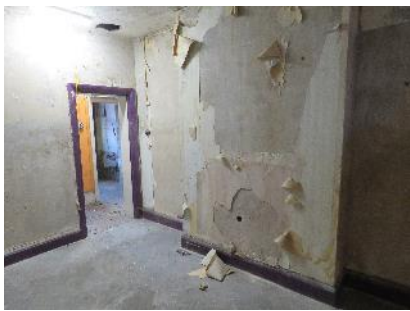
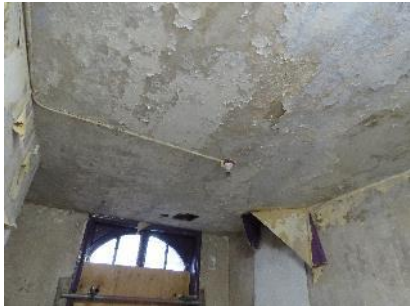
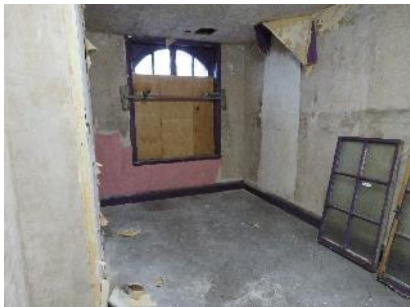
| Room Reference | Element | Description | Significance | Removed or Retained | Photographs | | |
|---|---|---|---|---|---|--|--|
| 2.09 | Wall Finish(es) | Wallpaper | None | Remove | | | |

| Room Reference | Element | Description | Significance | Removed or Retained | Photographs | | |
|---|---|---|---|---|---|--|--|
| | Ceiling Finish | Paint<br>Ceiling paper | Low<br>None | Remove flaking paint<br>Remove | | | |
| | Floor Finish | Wood block | High | Retain | | | |

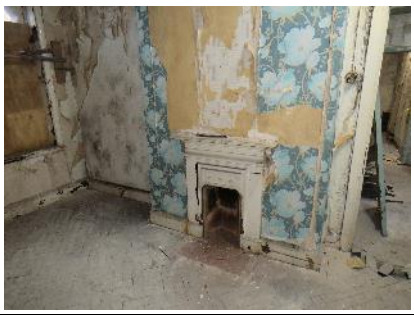
| Room Reference | Element | Description | Significance | Removed or Retained | Photographs | | |
|---|---|---|---|---|---|--|--|
| 2.10 | Wall Finish(es) | Wallpaper | None | Remove | | | |

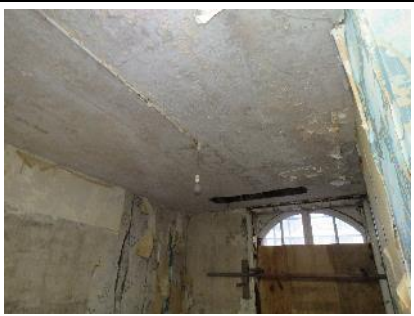
| Room Reference | Element | Description | Significance | Removed or Retained | Photographs | | |
|---|---|---|---|---|---|--|--|
| | Ceiling Finish | Paint | Low | Remove flaking paint<br>Approx. 2m2 of plaster missing | | | |

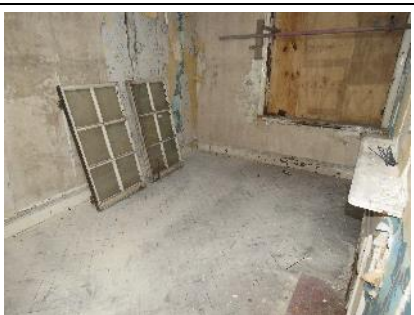
| Room Reference | Element | Description | Significance | Removed or Retained | Photographs | | |
|---|---|---|---|---|---|--|--|
| | Floor Finish | Wood block<br>Glazed tile | High<br>Low | Retain<br>Retain | | | |

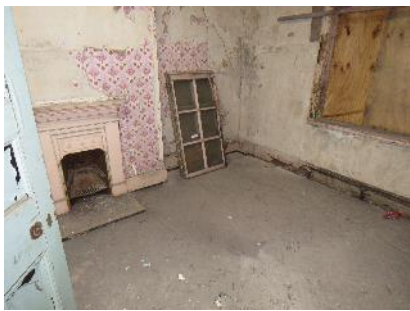
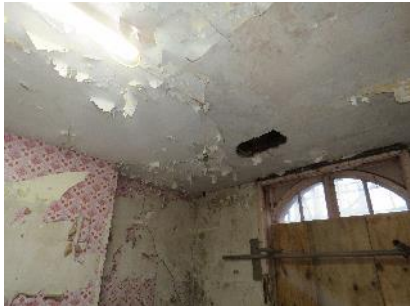
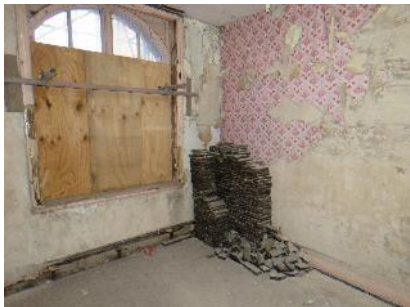
| Room Reference | Element | Description | Significance | Removed or Retained | Photographs | | |
|---|---|---|---|---|---|--|--|
| 2.11 | Wall Finish(es) | Wallpaper | None | Remove | | | |

| Room Reference | Element | Description | Significance | Removed or Retained | Photographs | | |
|---|---|---|---|---|---|--|--|
| | Ceiling Finish | Ceiling paper | None | Remove<br>Approx. 1m2 of plaster missing | | | |
| | Floor Finish | Wood block<br>Glazed tile | High<br>Low | Retain<br>Retain | | | |

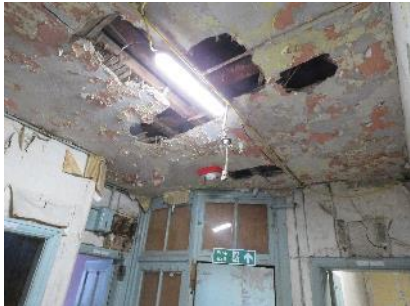
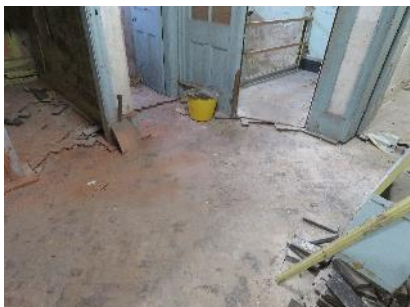
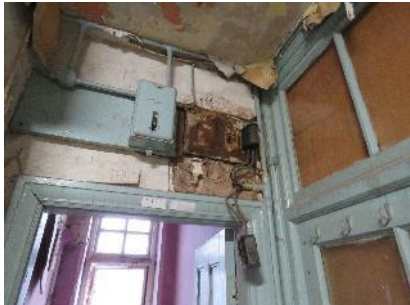
| Room Reference | Element | Description | Significance | Removed or Retained | Photographs | | |
|---|---|---|---|---|---|---|--|
| | Ceiling Finish | Paint | Low | Remove flaking paint | | | |
| | Floor Finish | Wood block (lifted) | High | Retain | | | |
| | M&E Items | Misc. electrical items<br>Early light switches<br>Conduit | None<br>Low<br>None | Remove all | | | |

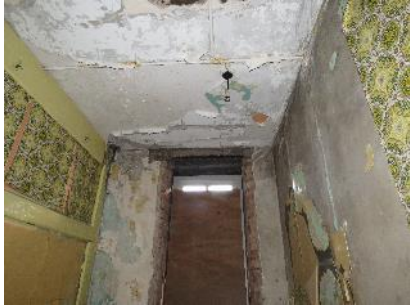
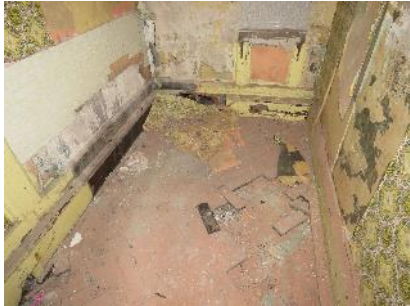
| Room Reference | Element | Description | Significance | Removed or Retained | Photographs | | |
|---|---|---|---|---|---|--|--|
| | Ceiling Finish | Ceiling paper | None | Remove | | | |
| | Floor Finish | Wood block | High | Retain | | | |

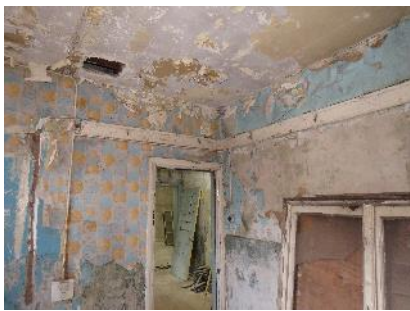
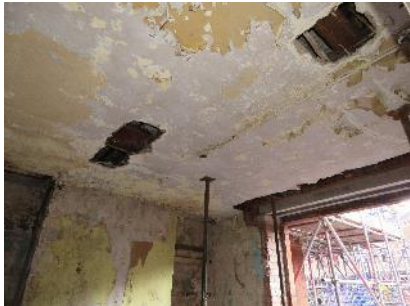
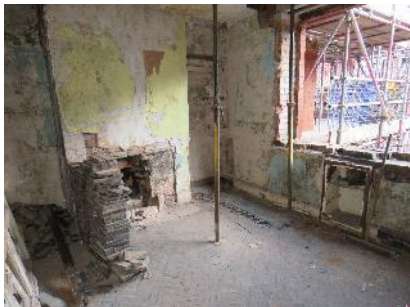
| Room Reference | Element | Description | Significance | Removed or Retained | Photographs | | |
|---|---|---|---|---|---|---|--|
| 2.15 | Wall Finish(es) | Wallpaper<br>White tile | None<br>None | Remove<br>Remove | | | |

| Room Reference | Element | Description | Significance | Removed or Retained | Photographs | | |
|---|---|---|---|---|---|---|--|
| | Ceiling Finish | Paint | Low | Remove flaking paint<br>Approx. 5m2 of plaster missing | | | |
| | Floor Finish | Wood block (lifted) | High | Retain | | | |

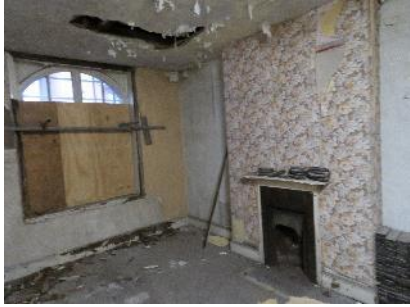
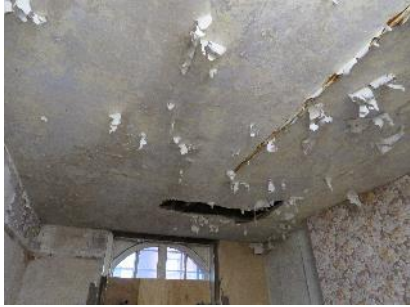
| Room Reference | Element | Description | Significance | Removed or Retained | Photographs | | |
|---|---|---|---|---|---|--|--|
| 2.16 | Wall Finish(es) | Wallpaper | None | Remove | | | |

| Room Reference | Element | Description | Significance | Removed or Retained | Photographs | | |
|---|---|---|---|---|---|--|--|
| | Ceiling Finish | Paint | Low | Remove flaking paint<br>Approx. 2m2 of plaster missing | | | |

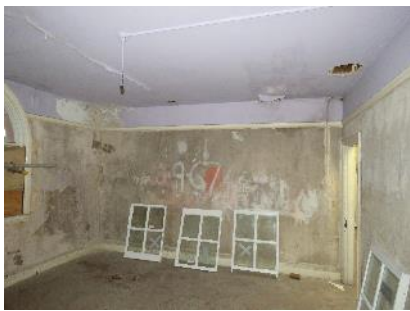
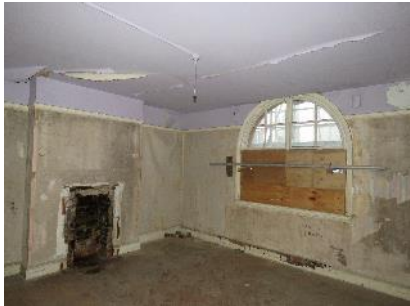
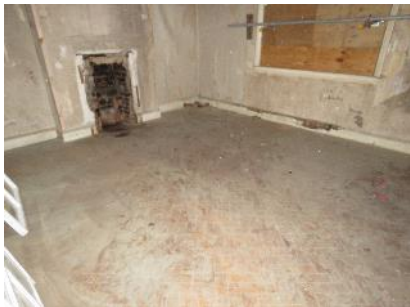
| Room Reference | Element | Description | Significance | Removed or Retained | Photographs | | |
|---|---|---|---|---|---|--|--|
| 2.17 | Wall Finish(es) | Wallpaper (largely removed)<br>White tile | None<br>None | Remove<br>Remove | | | |

| Room Reference | Element | Description | Significance | Removed or Retained | Photographs | | |
|---|---|---|---|---|---|--|--|
| | Ceiling Finish | Paint | Low | Remove flaking paint<br>Approx 1m2 of plaster missing | | | |
| | Floor Finish | Wood block<br>Glazed tile | High<br>Low | Retain<br>Retain | | | |

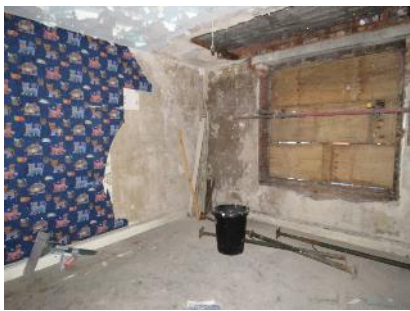
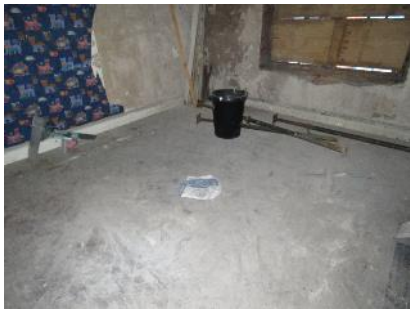
| Room Reference | Element | Description | Significance | Removed or Retained | Photographs | | |
|---|---|---|---|---|---|--|--|
| 2.18 | Wall Finish(es) | Wallpaper | None | Remove | | | |

| Room Reference | Element | Description | Significance | Removed or Retained | Photographs | | |
|---|---|---|---|---|---|--|--|
| | Ceiling Finish | Paint | Low | Remove flaking paint<br>Approx. 10m2 of plaster missing | | | |
| | Floor Finish | Wood block<br>Glazed tile | High<br>Low | Retain<br>Retain | | | |

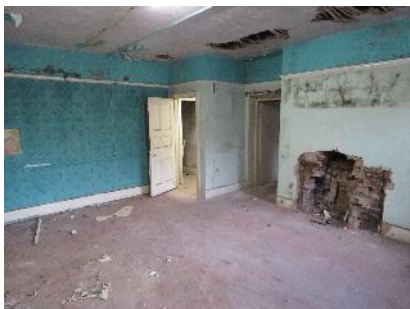
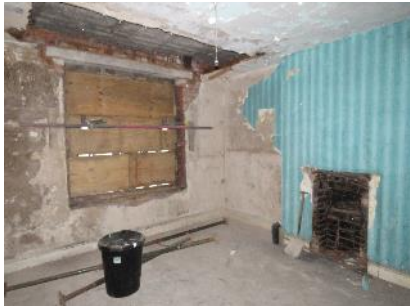
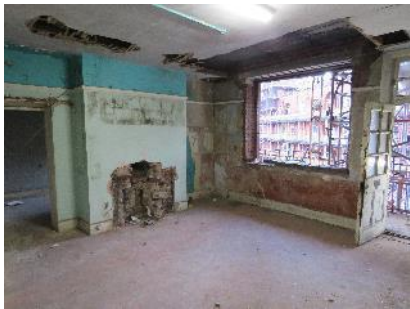
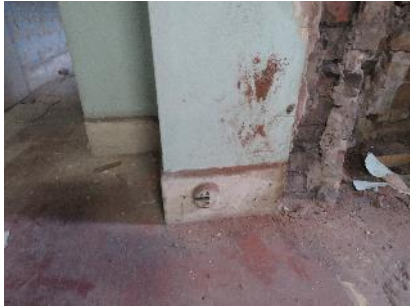
| Room Reference | Element | Description | Significance | Removed or Retained | Photographs | | |
|---|---|---|---|---|---|--|--|
| 2.19 | Wall Finish(es) | Wallpaper | None | Remove | | | |

| Room Reference | Element | Description | Significance | Removed or Retained | Photographs | | |
|---|---|---|---|---|---|--|--|
| | Ceiling Finish | Paint | Low | Remove flaking paint<br>Approx. 10m2 of plaster missing | | | |
| | Floor Finish | Red lay tile | Low | Retain | | | |
| | Fixtures & Fittings | Timber switch mount | Low | Remove | | | |

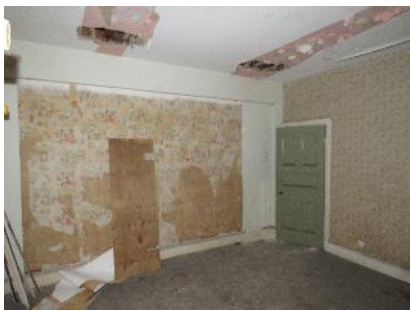
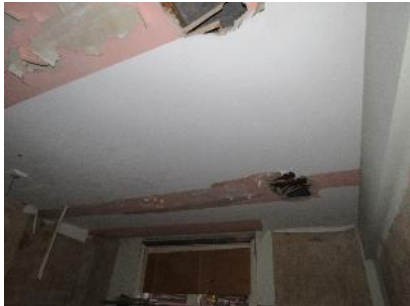
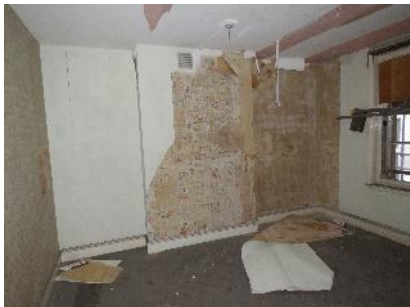
| Room Reference | Element | Description | Significance | Removed or Retained | Photographs | | |
|---|---|---|---|---|---|--|--|
| 2.23 | Wall Finish(es) | Wallpaper | None | Remove | | | |

| Room Reference | Element | Description | Significance | Removed or Retained | Photographs | | |
|---|---|---|---|---|---|--|--|
| | Ceiling Finish | Ceiling paper | None | Remove<br>Approx. 1m2 of plaster missing | | | |
| | Floor Finish | Wood block | High | Retain | | | |

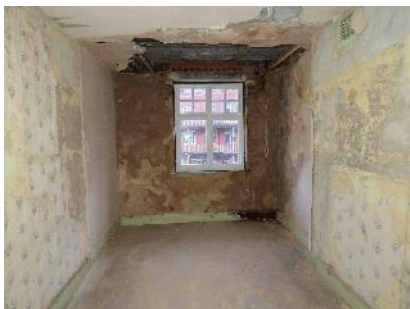
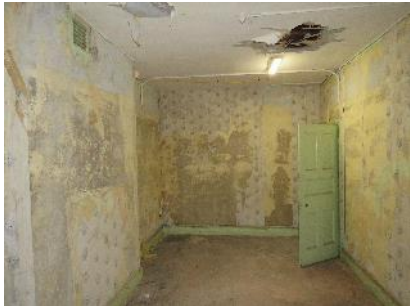
| Room Reference | Element | Description | Significance | Removed or Retained | Photographs | | |
|---|---|---|---|---|---|--|--|
| 2.24 | Wall Finish(es) | Wallpaper | None | Remove | | | |

| Room Reference | Element | Description | Significance | Removed or Retained | Photographs | | |
|---|---|---|---|---|---|--|--|
| | Ceiling Finish | Ceiling paper | None | Remove<br>Approx. 10m2 of plaster missing | | | |

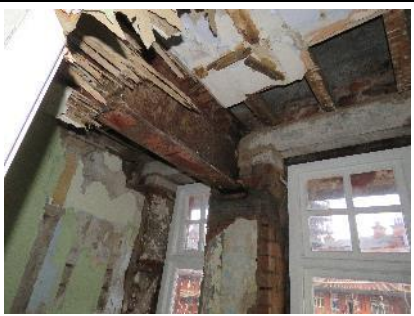
| Room Reference | Element | Description | Significance | Removed or Retained | Photographs | | |
|---|---|---|---|---|---|---|--|
| | Ceiling Finish | Paint | Low | Remove flaking paint<br>Approx. 8m2 of plaster missing | | | |

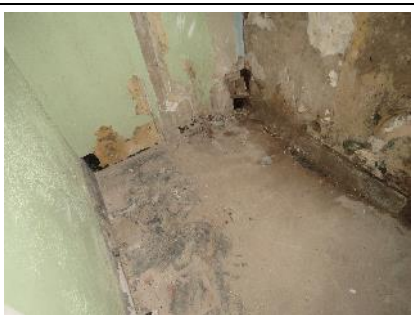
| Room Reference | Element | Description | Significance | Removed or Retained | Photographs | | |
|---|---|---|---|---|---|---|--|
| | Floor Finish | Raised Floor | None | Remove | | | |

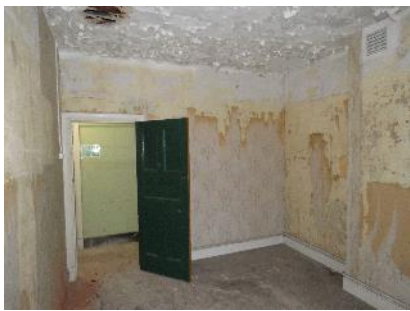
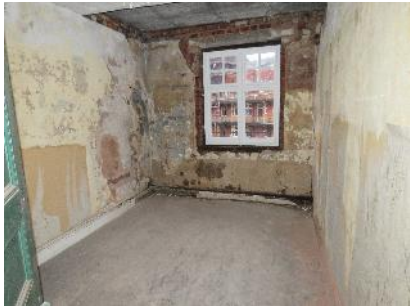
| Room Reference | Element | Description | Significance | Removed or Retained | Photographs | | |
|---|---|---|---|---|---|--|--|
| 2.26 | Wall Finish(es) | Wallpaper | None | Remove | | | |

| Room Reference | Element | Description | Significance | Removed or Retained | Photographs | | |
|---|---|---|---|---|---|--|--|
| | Ceiling Finish | Paint | Low | Remove flaking paint<br>Approx. 12m2 of plaster missing | | | |

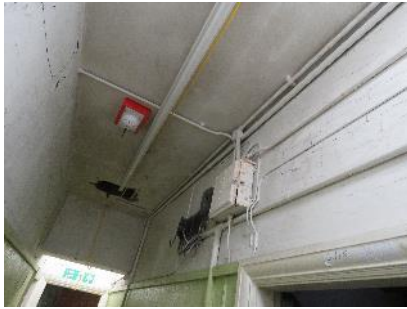
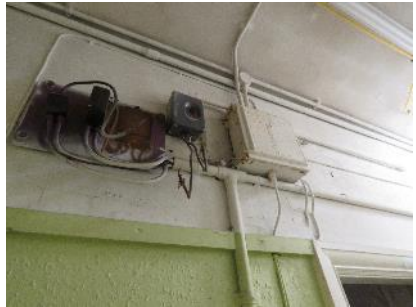
| Room Reference | Element | Description | Significance | Removed or Retained | Photographs | | |
|---|---|---|---|---|---|---|---|
| | Ceiling Finish | Paint | Low | Remove flaking paint<br>Approx. 2m2 of plaster missing | | | |
| | M&E Items | Modern light<br>Conduit<br>Misc. electrical equipment<br>Gas pipes<br>Sockets<br>Wires | None<br>None<br>None<br><br>Low<br>None<br>None | Remove all | | | |

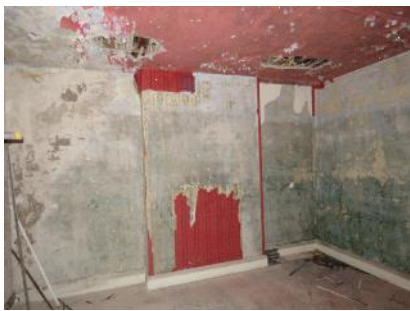
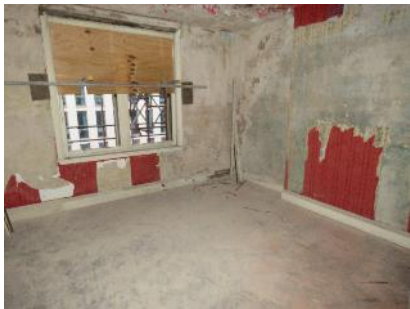
| Room Reference | Element | Description | Significance | Removed or Retained | Photographs | | |
|---|---|---|---|---|---|--|--|
| 2.28 | Wall Finish(es) | Wallpaper<br>Paint | None<br>Low | Remove<br>Remove flaking paint | | | |

| Room Reference | Element | Description | Significance | Removed or Retained | Photographs | | |
|---|---|---|---|---|---|--|--|
| | Floor Finish | Wood block | High | Retain | | | |

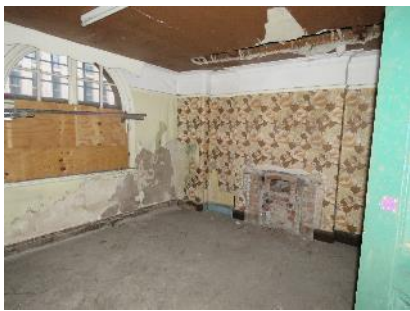
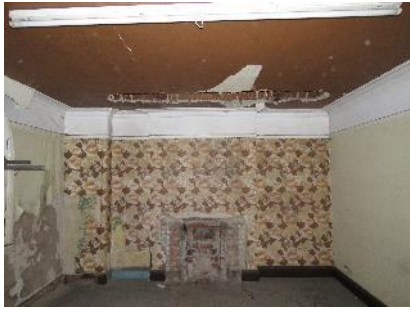
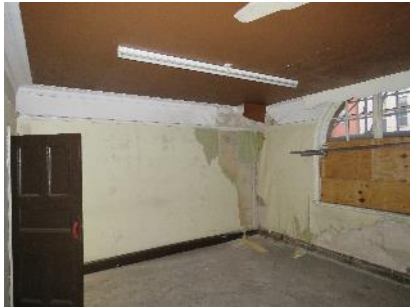
| Room Reference | Element | Description | Significance | Removed or Retained | Photographs | | |
|---|---|---|---|---|---|--|--|
| 2.29 | Wall Finish(es) | Wallpaper | None | Remove | | | |

| Room Reference | Element | Description | Significance | Removed or Retained | Photographs | | |
|---|---|---|---|---|---|--|--|
| | Ceiling Finish | Paint | Low | Remove flaking paint<br>Approx. 4m2 of plaster missing | | | |
| | M&E Items | Modern light<br>Plug socket<br>Cables | None<br>None<br>None | Remove all | | | |

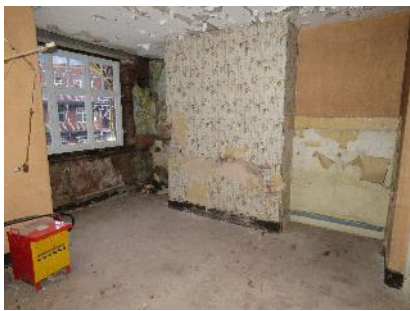
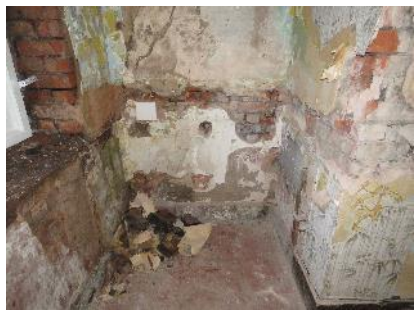
| Room Reference | Element | Description | Significance | Removed or Retained | Photographs | | |
|---|---|---|---|---|---|---|--|
| 2.30 | Wall Finish(es) | Wallpaper | None | Remove | | | |
| | Ceiling Finish | Paint | Low | Remove flaking paint<br>Approx. 6m2 of plaster missing | | | |

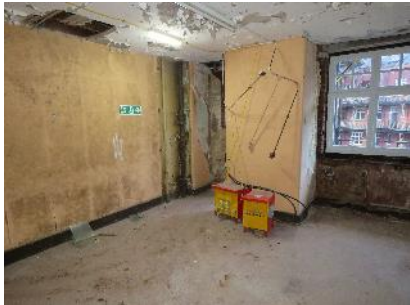
| Room Reference | Element | Description | Significance | Removed or Retained | Photographs | | |
|---|---|---|---|---|---|---|--|
| | M&E Items | 2no. Vertical pipes<br>Plug sockets<br>Conduit<br>Modern light<br>Switches | Low<br>None<br>None<br>None<br>None | Retain<br>Remove<br>Remove<br>Remove<br>Remove | | | |

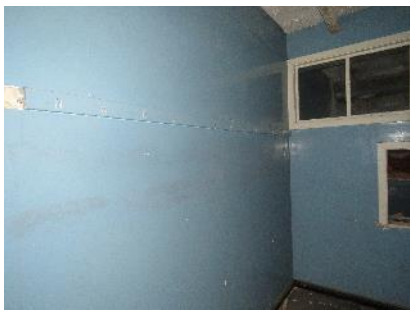
| Room Reference | Element | Description | Significance | Removed or Retained | Photographs | | |
|---|---|---|---|---|---|--|--|
| 2.31 | Wall Finish(es) | Paint | Low | Remove flaking paint | | | |

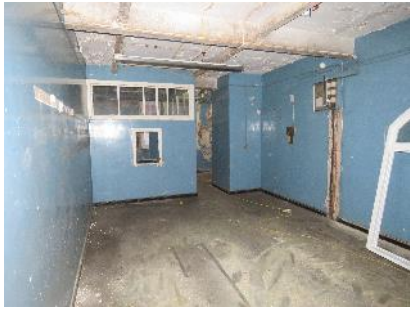
| Room Reference | Element | Description | Significance | Removed or Retained | Photographs | | |
|---|---|---|---|---|---|--|--|
| | Ceiling Finish | Paint | Low | Remove flaking paint | | | |

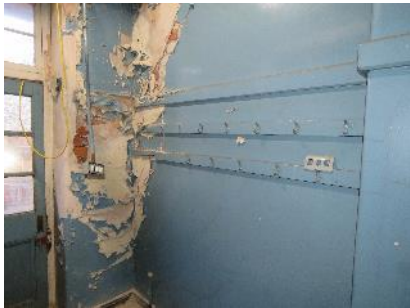
| Room Reference | Element | Description | Significance | Removed or Retained | Photographs | | |
|---|---|---|---|---|---|--|--|
| | Fixtures & Fittings | Battens<br>Modern hooks | None<br>None | Remove<br>Remove | | | |

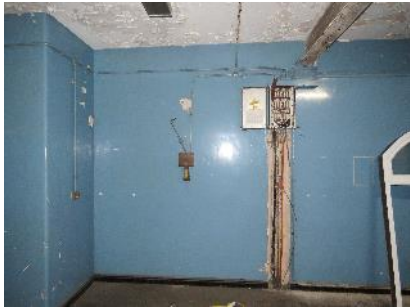
| Room Reference | Element | Description | Significance | Removed or Retained | Photographs | | |
|---|---|---|---|---|---|--|--|
| | M&E Items | Heating pipes<br>Misc. electrical items<br>Modern lighting<br>Modern switch<br>Conduit | Low<br>None<br>None<br>None<br>None | Remove all | <br> | | |

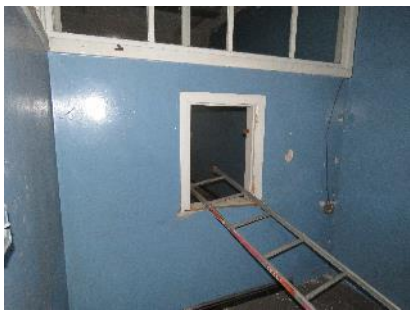
| Room Reference | Element | Description | Significance | Removed or Retained | Photographs | | |
|---|---|---|---|---|---|--|--|
| 2.32 | Wall Finish(es) | Paint | Low | Remove flaking paint | | | |

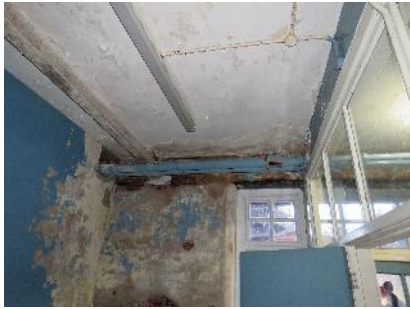
| Room Reference | Element | Description | Significance | Removed or Retained | Photographs | | |
|---|---|---|---|---|---|--|--|
| | Ceiling Finish | Paint | Low | Remove flaking paint | | | |

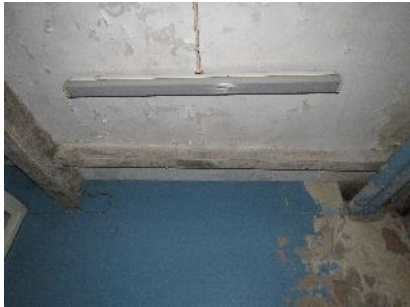
| Room Reference | Element | Description | Significance | Removed or Retained | Photographs | | |
|---|---|---|---|---|---|--|--|
| | M&E Items | Heating pipes<br>Misc. electrical items<br>Modern lighting<br>Modern switch<br>Conduit | Low<br>None<br>None<br>None<br>None | Remove all | | | |

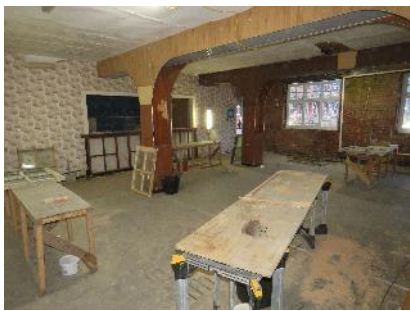
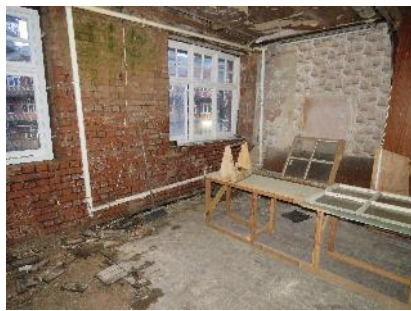
| Room Reference | Element | Description | Significance | Removed or Retained | Photographs | | |
|---|---|---|---|---|---|---|---|
| 2.33 | Wall Finish(es) | Wallpaper<br>Timber effect panels | None<br>None | Remove<br>Remove | | | |

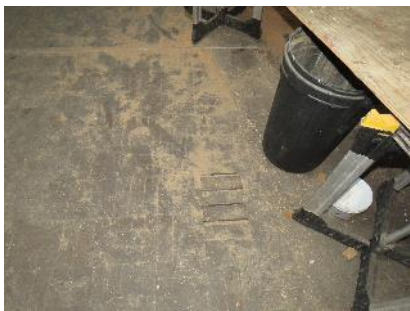
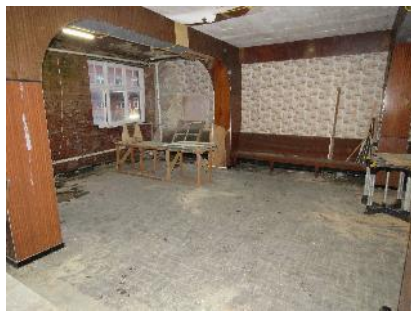
| Room Reference | Element | Description | Significance | Removed or Retained | Photographs | | |
|---|---|---|---|---|---|---|---|
| | Floor Finish | Wood block | High | Retain | | | |

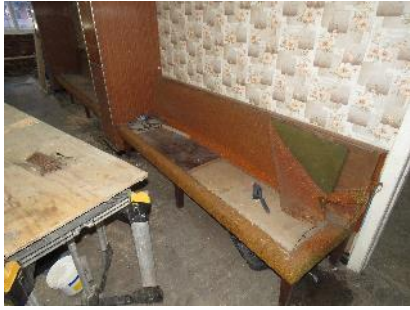
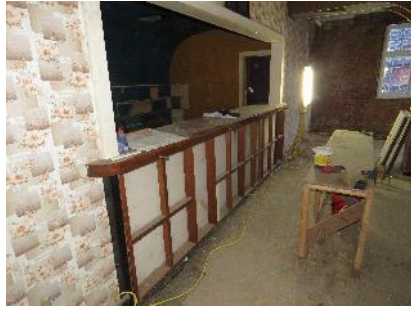
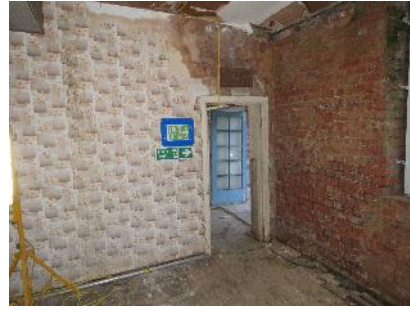
| Room Reference | Element | Description | Significance | Removed or Retained | Photographs | | |
|---|---|---|---|---|---|---|---|
| | Fixtures & Fittings | Fixed bench seating<br>Radiator brackets<br>Exit sign | None<br>None<br>None | Remove<br>Remove<br>Remove | | | |

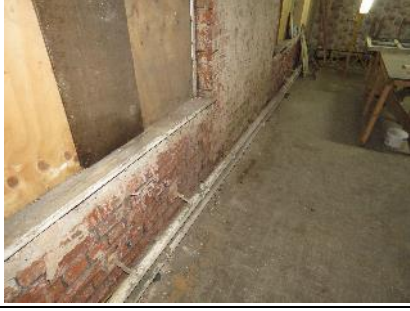
| Room Reference | Element | Description | Significance | Removed or Retained | Photographs | | |
|---|---|---|---|---|---|---|---|
| | M&E Items | Modern lights<br>Heating pipes<br>Misc. cables | None<br>Low<br>None | Remove all | | | |

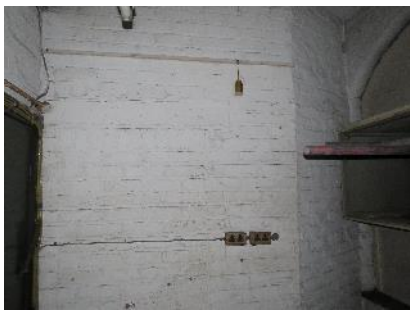
| Room Reference | Element | Description | Significance | Removed or Retained | Photographs | | |
|---|---|---|---|---|---|--|--|
| 2.34 | Wall Finish(es) | Painted brick | None | Remove flaking paint | | | |

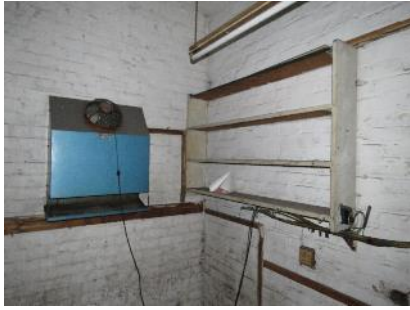
| Room Reference | Element | Description | Significance | Removed or Retained | Photographs | | |
|---|---|---|---|---|---|--|--|
| | Fixtures & Fittings | Timber shelves<br>Timber battens | None<br>None | Remove<br>Remove | | | |

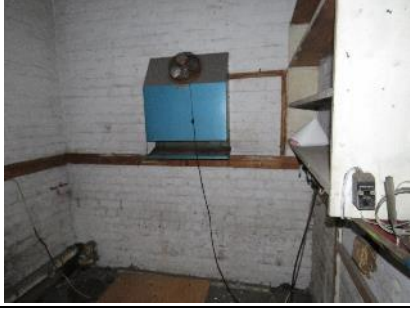
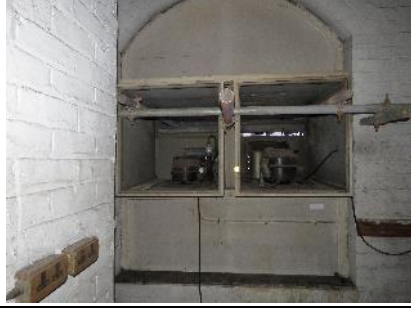
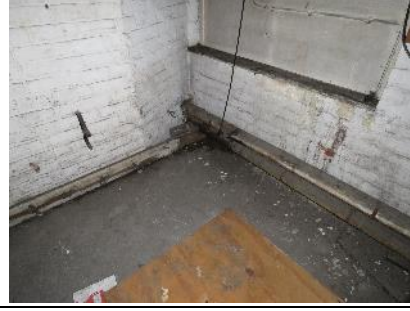
| Room Reference | Element | Description | Significance | Removed or Retained | Photographs | | |
|---|---|---|---|---|---|--|--|
| | M&E Items | Ventilation units<br>Plug sockets<br>Heating pipes<br>Modern lighting | Low<br>None<br>Low<br>None | Remove all | | | |

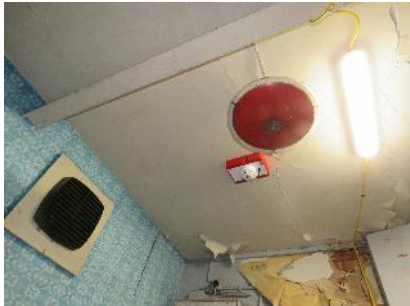
| Room Reference | Element | Description | Significance | Removed or Retained | Photographs | | |
|---|---|---|---|---|---|---|--|
| | Ceiling Finish | Paint | Low | Remove flaking paint | | | |

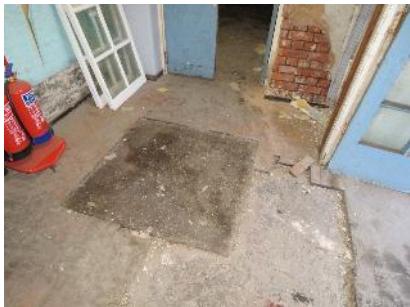
| Room Reference | Element | Description | Significance | Removed or Retained | Photographs | | |
|---|---|---|---|---|---|---|--|
| | Floor Finish | Wood block<br>Entrance mat | High<br>None | Retain<br>Replace | | | |

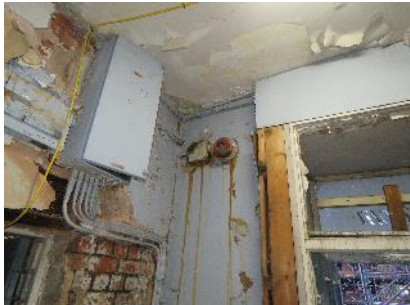
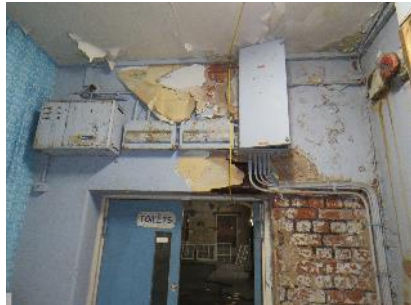
| Room Reference | Element | Description | Significance | Removed or Retained | Photographs | | |
|---|---|---|---|---|---|---|--|
| | M&E Items | Fire alarm<br>Ventilation unit<br>Misc. electrical items<br>Light<br>Light switches | Low<br>None<br>None<br>Medium<br>None | Retain<br>Remove<br>Remove<br>Retain<br>Remove | | | |

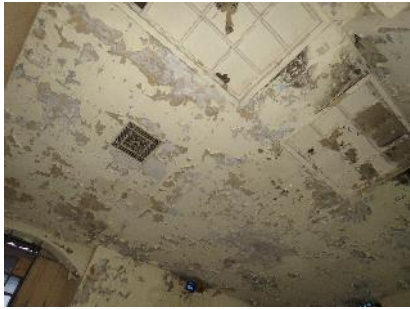
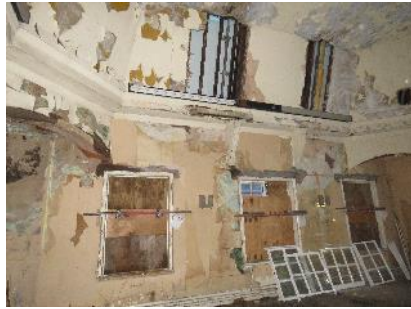
| Room Reference | Element | Description | Significance | Removed or Retained | Photographs | | |
|---|---|---|---|---|---|---|---|
| | Ceiling Finish | Paint | Low | Remove flaking paint<br>Approx. 10m2 of plaster missing | | | |

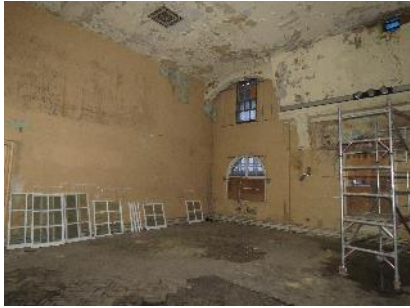
| Room Reference | Element | Description | Significance | Removed or Retained | Photographs | | |
|---|---|---|---|---|---|---|---|
| | Floor Finish | Wood block (partially lifted) | High | Retain | | | |

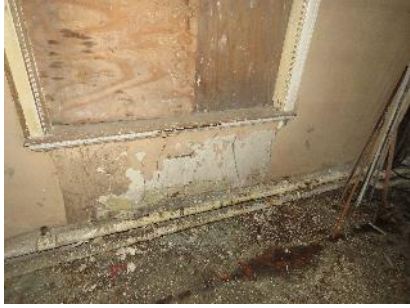
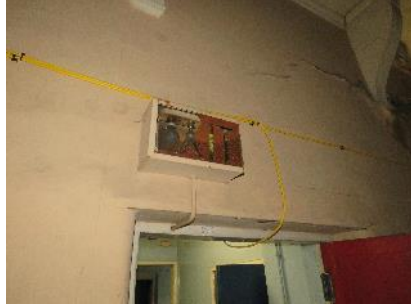
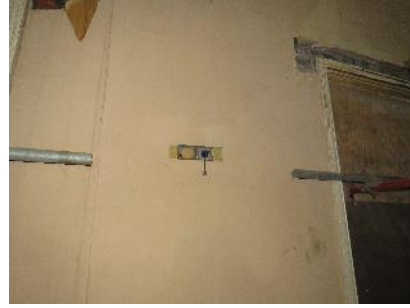
| Room Reference | Element | Description | Significance | Removed or Retained | Photographs | | |
|---|---|---|---|---|---|---|---|
| | Fixtures & Fittings | Ceiling vent<br>Radiator brackets<br>Exit sign | High<br>None<br>None | Retain<br>Remove<br>Remove | | | |

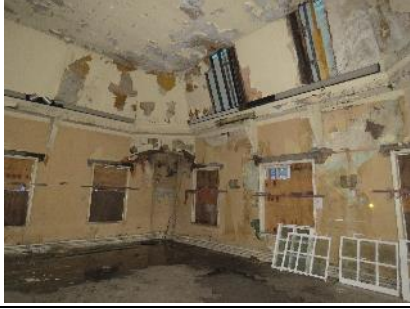
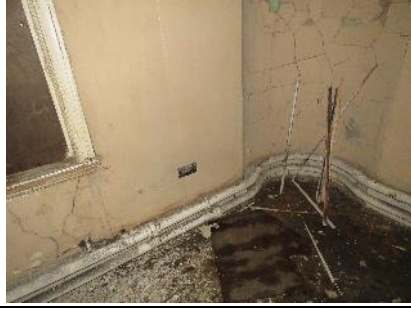
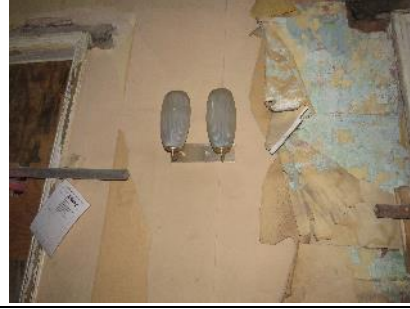
| Room Reference | Element | Description | Significance | Removed or Retained | Photographs | | |
|---|---|---|---|---|---|---|---|
| | M&E Items | Lighting<br>Heating pipes<br>Misc. cables<br>Plug sockets | None<br>Low<br>None<br>None | Remove all | | | |

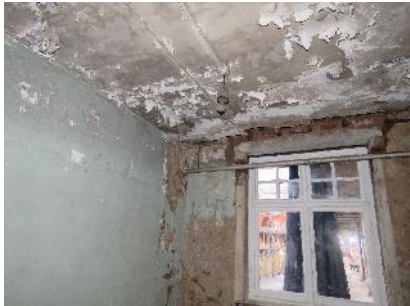
| Room Reference | Element | Description | Significance | Removed or Retained | Photographs | | |
|---|---|---|---|---|---|--|--|
| | Ceiling Finish | Paint | None | Remove flaking paint<br>Approx. 3m2 of plaster missing | | | |

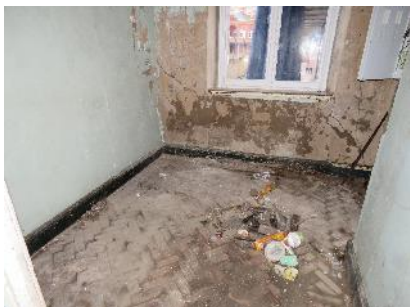
| Room Reference | Element | Description | Significance | Removed or Retained | Photographs | | |
|---|---|---|---|---|---|--|--|
| | Floor Finish | Wood block<br>Glazed tile | High<br>Low | Retain<br>Retain | | | |

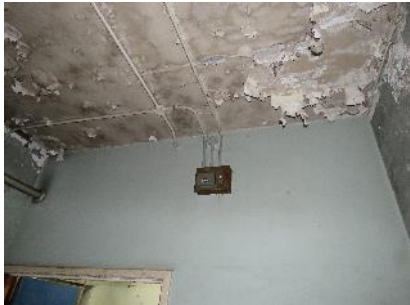
| Room Reference | Element | Description | Significance | Removed or Retained | Photographs | | |
|---|---|---|---|---|---|--|--|
| | M&E Items | Heating pipes<br>Fuse board<br>Fuse box<br>Lighting<br>Switch<br>Conduit | Low<br>None<br>None<br>None<br>None<br>None | Remove all | | | |

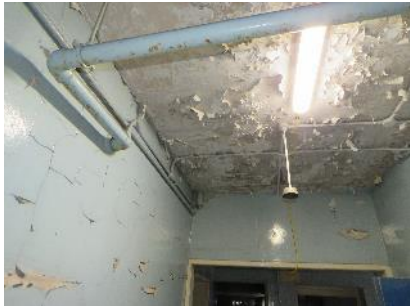
| Room Reference | Element | Description | Significance | Removed or Retained | Photographs | | |
|---|---|---|---|---|---|--|--|
| 2.38 | Wall Finish(es) | Paint | None | Remove flaking paint | | | |

| Room Reference | Element | Description | Significance | Removed or Retained | Photographs | | |
|---|---|---|---|---|---|--|--|
| | Ceiling Finish | Paint | None | Remove flaking paint<br>Approx. 5m2 of plaster missing | | | |

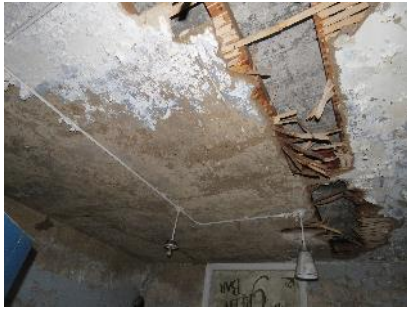
| Room Reference | Element | Description | Significance | Removed or Retained | Photographs | | |
|---|---|---|---|---|---|--|--|
| 2.39 | Wall Finish(es) | Paint<br>White Tile | Low<br>None | Remove flaking paint<br>Remove | | | |

| Room Reference | Element | Description | Significance | Removed or Retained | Photographs | | |
|---|---|---|---|---|---|--|--|
| | Ceiling Finish | Paint | None | Remove flaking paint<br>Approx. 6m2 of plaster missing | | | |

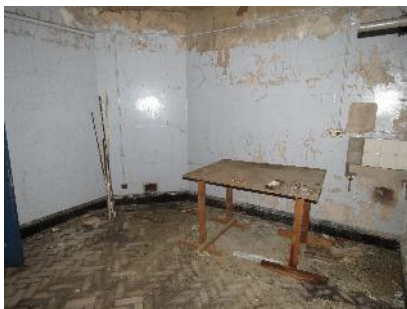
| Room Reference | Element | Description | Significance | Removed or Retained | Photographs | | |
|---|---|---|---|---|---|--|--|
| | Floor Finish | Wood block<br>Glazed tile | High<br>Low | Retain<br>Retain | | | |

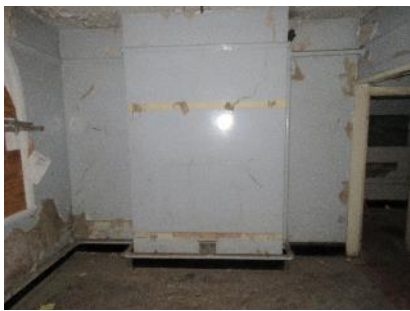
| Room Reference | Element | Description | Significance | Removed or Retained | Photographs | | |
|---|---|---|---|---|---|--|--|
| 2.41 | Wall Finish(es) | Paint | Low | Remove flaking paint | | | |

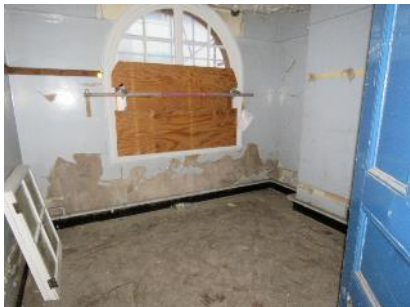
| Room Reference | Element | Description | Significance | Removed or Retained | Photographs | | |
|---|---|---|---|---|---|--|--|
| | Floor Finish | Wood block<br>Glazed tile | High<br>Low | Retain<br>Retain | | | |

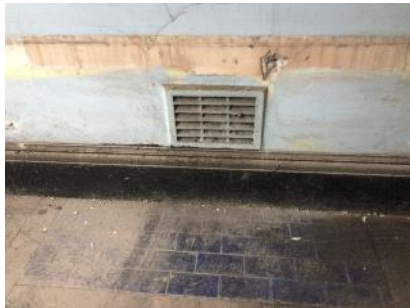
| Room Reference | Element | Description | Significance | Removed or Retained | Photographs | | |
|---|---|---|---|---|---|--|--|
| | Fixtures & Fittings | Ventilation grill<br>Timber batten | Low<br>None | Retain<br>Remove | | | |

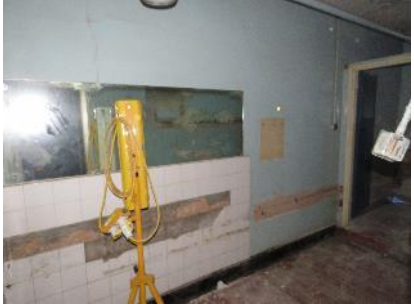
| Room Reference | Element | Description | Significance | Removed or Retained | Photographs | | |
|---|---|---|---|---|---|---|--|
| | Fixtures & Fittings | Urinal<br>Cistern brackets<br>Mirror<br>Timber batten | Low<br>None<br>None<br>None | Remove all | | | |

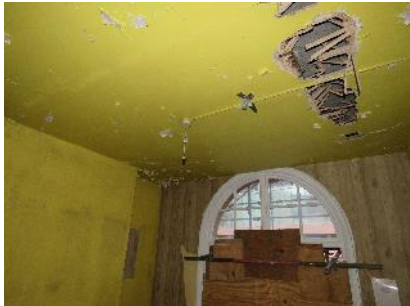
| Room Reference | Element | Description | Significance | Removed or Retained | Photographs | | |
|---|---|---|---|---|---|--|--|
| 2.43 | Wall Finish(es) | Wallpaper | None | Remove | | | |

| Room Reference | Element | Description | Significance | Removed or Retained | Photographs | | |
|---|---|---|---|---|---|--|--|
| | Ceiling Finish | Paint | None | Remove flaking apint<br>Approx. 3m2 of plaster missing | | | |

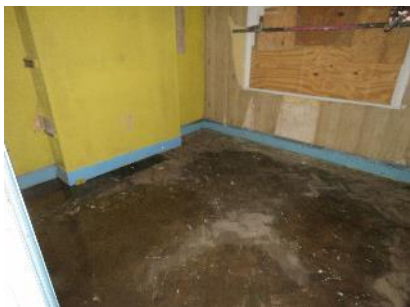
| Room Reference | Element | Description | Significance | Removed or Retained | Photographs | | |
|---|---|---|---|---|---|--|--|
| | Floor Finish | Wood block<br>Glazed tile | High<br>Low | Retain<br>Retain | | | |

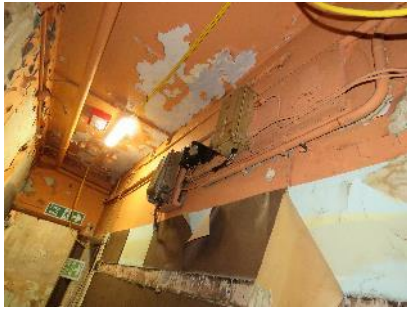
| Room Reference | Element | Description | Significance | Removed or Retained | Photographs | | |
|---|---|---|---|---|---|--|--|
| 2.45 | Wall Finish(es) | Wallpaper<br>Paint | None<br>Low | Remove<br>Remove flaking paint | | | |

| Room Reference | Element | Description | Significance | Removed or Retained | Photographs | | |
|---|---|---|---|---|---|--|--|
| | Ceiling Finish | Paint | Low | Remove flaking paint | | | |

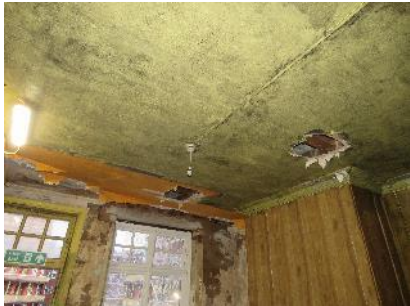
| Room Reference | Element | Description | Significance | Removed or Retained | Photographs | | |
|---|---|---|---|---|---|--|--|
| 2.46 | Wall Finish(es) | Wallpaper | None | Remove | | | |

| Room Reference | Element | Description | Significance | Removed or Retained | Photographs | | |
|---|---|---|---|---|---|--|--|
| | Ceiling Finish | Ceiling paper | None | Remove<br>Approx. 4m2 of plaster missing | | | |

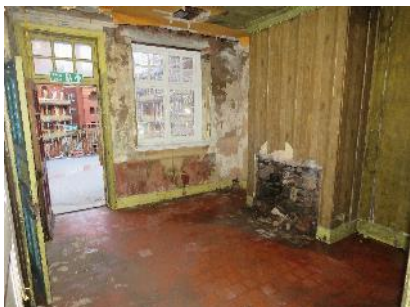
| Room Reference | Element | Description | Significance | Removed or Retained | Photographs | | |
|---|---|---|---|---|---|--|--|
| | Floor Finish | Red clay tile<br>White tile | Low<br>Low | Retain<br>Retain | | | |

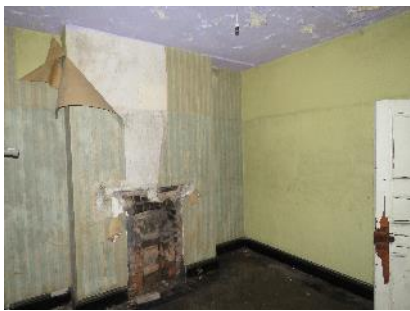
| Room Reference | Element | Description | Significance | Removed or Retained | Photographs | | |
|---|---|---|---|---|---|--|--|
| 2.47 | Wall Finish(es) | Wallpaper | None | Remove | | | |

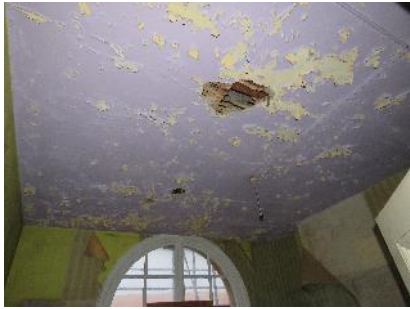
| Room Reference | Element | Description | Significance | Removed or Retained | Photographs | | |
|---|---|---|---|---|---|--|--|
| | Ceiling Finish | Paint | Low | Remove flaking paint | | | |

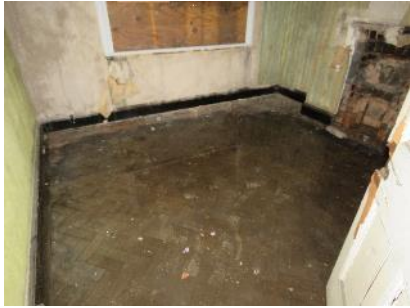
| Room Reference | Element | Description | Significance | Removed or Retained | Photographs | | |
|---|---|---|---|---|---|--|--|
| | Floor Finish | Wood block<br>Glazed tile | High<br>Low | Retain<br>Retain | | | |

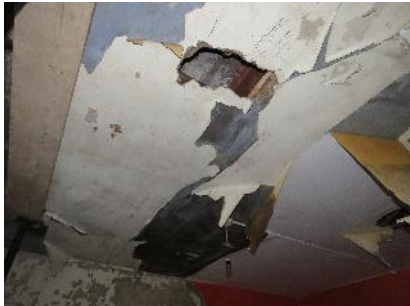
| Room Reference | Element | Description | Significance | Removed or Retained | Photographs | | |
|---|---|---|---|---|---|--|--|
| 2.48 | Wall Finish(es) | Wallpaper | None | Remove | | | |

| Room Reference | Element | Description | Significance | Removed or Retained | Photographs | | |
|---|---|---|---|---|---|--|--|
| | Ceiling Finish | Ceiling paper | None | Remove<br>Approx. 5m2 of plaster missing | | | |

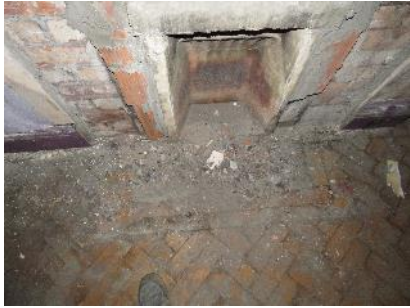
| Room Reference | Element | Description | Significance | Removed or Retained | Photographs | | |
|---|---|---|---|---|---|--|--|
| 2.49 | Wall Finish(es) | Wallpaper | None | Remove | | | |

| Room Reference | Element | Description | Significance | Removed or Retained | Photographs | | |
|---|---|---|---|---|---|--|--|
| | Floor Finish | Wood block | High | Retain | | | |

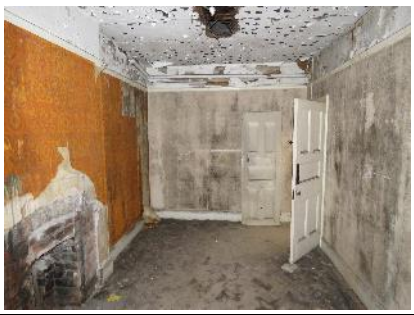
| Room Reference | Element | Description | Significance | Removed or Retained | Photographs | | |
|---|---|---|---|---|---|--|--|
| 2.50 | Wall Finish(es) | Wall paper | None | Remove | | | |

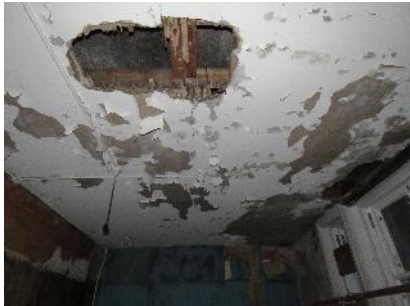
| Room Reference | Element | Description | Significance | Removed or Retained | Photographs | | |
|---|---|---|---|---|---|--|--|
| 2.51 | Wall Finish(es) | Wallpaper | None | Remove | | | |

| Room Reference | Element | Description | Significance | Removed or Retained | Photographs | | |
|---|---|---|---|---|---|--|--|
| | Ceiling Finish | Paint | Low | Remove flaking paint<br>Approx. 3m2 of plaster missing | | | |

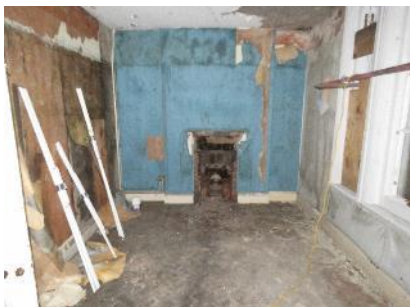
| Room Reference | Element | Description | Significance | Removed or Retained | Photographs | | |
|---|---|---|---|---|---|--|--|
| | Floor Finish | Wood block<br>Glazed tile | High<br>Low | Retain<br>Retain | | | |

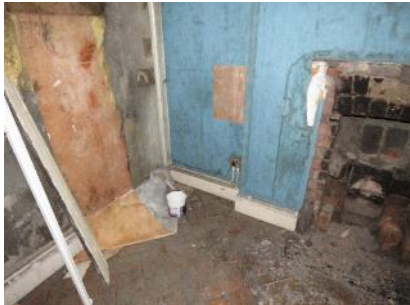
| Room Reference | Element | Description | Significance | Removed or Retained | Photographs | | |
|---|---|---|---|---|---|--|--|
| | M&E Items | Early switch<br>Conduit<br>Light<br>Plug socket | Low<br>None<br>None<br>None | Remove all | | | |
