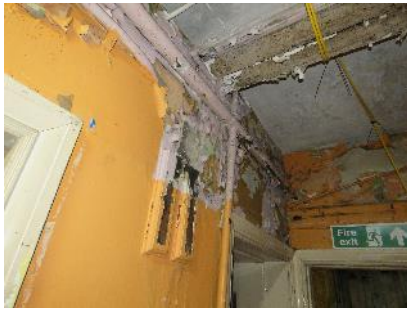
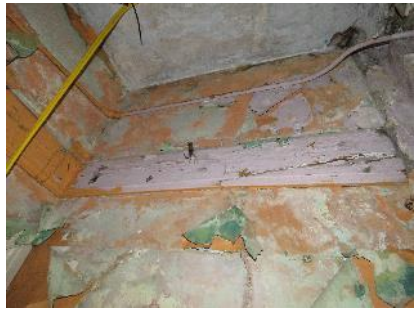
| Room Reference | Element | Description | Significance | Removed or Retained | Photographs | | |
|---|---|---|---|---|---|---|--|
| | Fixtures & Fittings | Timber boards | None | Remove | | | |

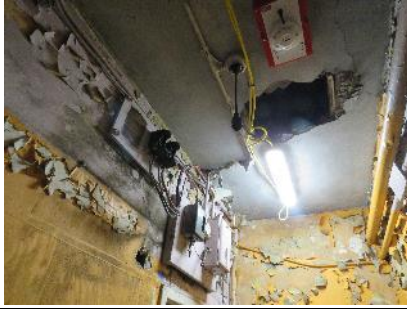
| Room Reference | Element | Description | Significance | Removed or Retained | Photographs | | |
|---|---|---|---|---|---|---|--|
| | M&E Items | Early light switch<br>misc. electrical items<br>Light<br>Conduit<br>Gas pipe | Low<br>None<br>None<br>None<br>Low | Remove all | | | |

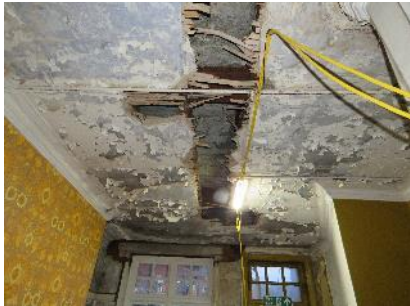
| Room Reference | Element | Description | Significance | Removed or Retained | Photographs | | |
|---|---|---|---|---|---|--|--|
| 2.54 | Wall Finish(es) | Wallpaper<br>White tile | None<br>None | Remove<br>Remove | | | |

| Room Reference | Element | Description | Significance | Removed or Retained | Photographs | | |
|---|---|---|---|---|---|--|--|
| | Ceiling Finish | Paint<br>Ceiling tile | Low<br>None | Remove flaking paint<br>Remove<br>Approx. 10m2 of plaster missing | | | |

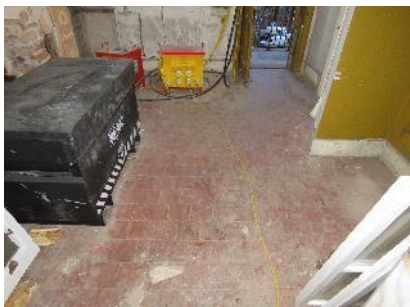
| Room Reference | Element | Description | Significance | Removed or Retained | Photographs | | |
|---|---|---|---|---|---|--|--|
| | Floor Finish | Red clay tile | Low | Retain | | | |

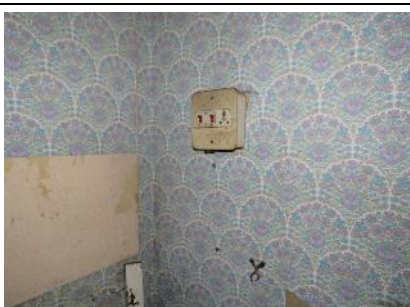
| Room Reference | Element | Description | Significance | Removed or Retained | Photographs | | |
|---|---|---|---|---|---|--|--|
| | M&E Items | Timber conduit<br>Conduit<br>Gas pipe<br>Switches<br>Plug socket<br>Light | None<br>None<br>Low<br>None<br>None<br>None | Remove all | | | |

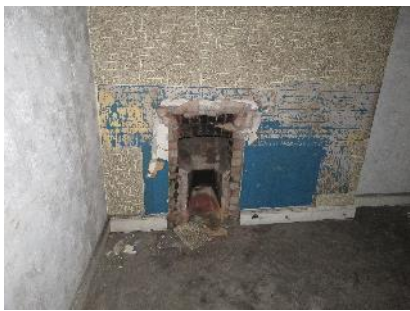
| Room Reference | Element | Description | Significance | Removed or Retained | Photographs | | |
|---|---|---|---|---|---|---|--|
| 2.55 | Wall Finish(es) | Wallpaper | None | Remove | | | |

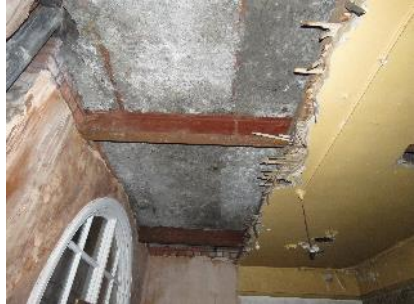
| Room Reference | Element | Description | Significance | Removed or Retained | Photographs | | |
|---|---|---|---|---|---|---|--|
| | Ceiling Finish | Paint | Low | Remove flaking paint<br>Approx. 20m2 of plaster missing | | | |

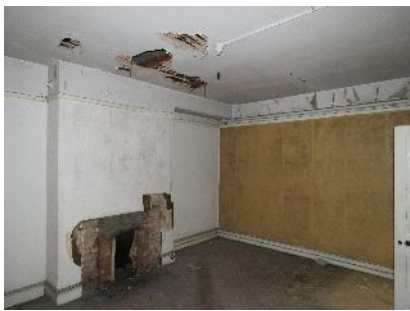
| Room Reference | Element | Description | Significance | Removed or Retained | Photographs | | |
|---|---|---|---|---|---|--|--|
| 2.56 | Wall Finish(es) | Wallpaper | None | Remove | | | |

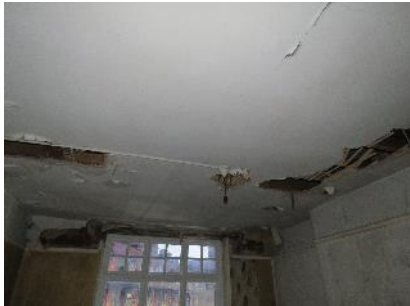
| Room Reference | Element | Description | Significance | Removed or Retained | Photographs | | |
|---|---|---|---|---|---|--|--|
| | Ceiling Finish | Paint | Low | Remove flaking paint<br>Approx. 5m2 of plaster missing | | | |

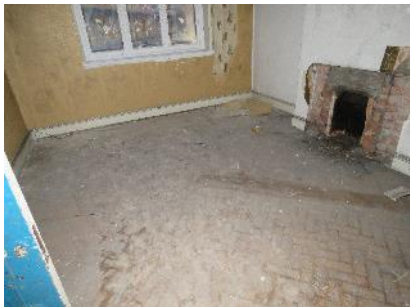
| Room Reference | Element | Description | Significance | Removed or Retained | Photographs | | |
|---|---|---|---|---|---|--|--|
| | Floor Finish | Wood block | High | Retain | | | |

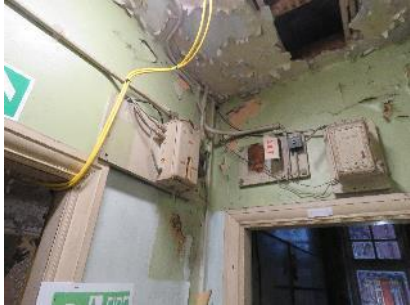
| Room Reference | Element | Description | Significance | Removed or Retained | Photographs | | |
|---|---|---|---|---|---|--|--|
| | M&E Items | Misc. electrical items<br>Switch<br>Conduit<br>Gas pipe<br>Early switch | None<br>None<br>None<br>Low<br>Low | Remove all | | | |

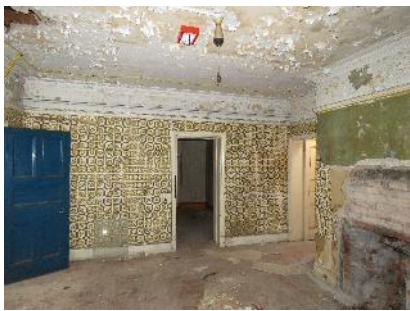
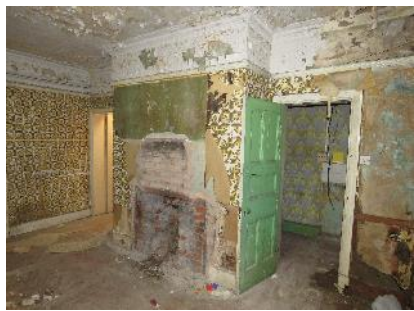
| Room Reference | Element | Description | Significance | Removed or Retained | Photographs | | |
|---|---|---|---|---|---|---|--|
| 2.60 | Wall Finish(es) | Wallpaper<br>Paint | None<br>Low | Remove<br>Remove flaking paint | | | |

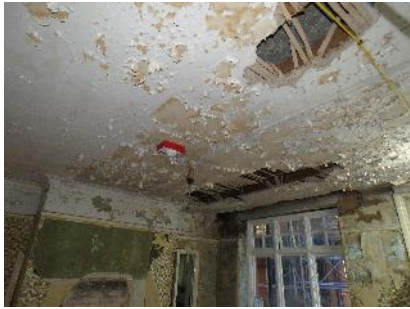
| Room Reference | Element | Description | Significance | Removed or Retained | Photographs | | |
|---|---|---|---|---|---|---|--|
| | Ceiling Finish | Paint | Low | Remove flaking paint<br>Approx. 10m2 of plaster missing | | | |

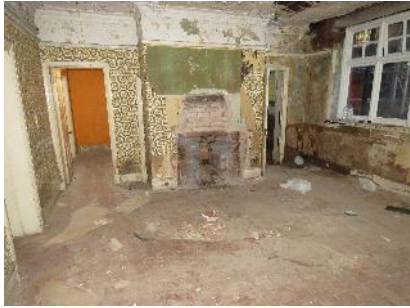
| Room Reference | Element | Description | Significance | Removed or Retained | Photographs | | |
|---|---|---|---|---|---|---|--|
| | Floor Finish | Red clay tile | Low | Retain | | | |

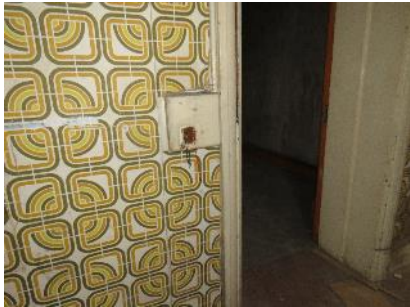
| Room Reference | Element | Description | Significance | Removed or Retained | Photographs | | |
|---|---|---|---|---|---|---|--|
| | M&E Items | Early switch<br>Conduit<br>Light<br>Plug socket<br>Gas pipe<br>Misc. electrical items | Low<br>None<br>None<br>None<br>Low<br>None | Remove all | | | |

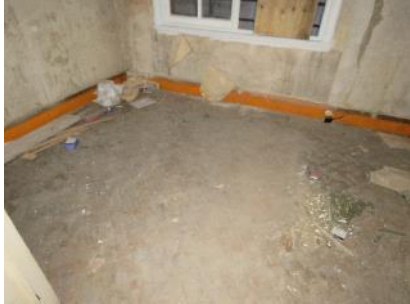
| Room Reference | Element | Description | Significance | Removed or Retained | Photographs | | |
|---|---|---|---|---|---|--|--|
| 2.61 | Wall Finish(es) | Wallpaper | None | Remove | | | |

| Room Reference | Element | Description | Significance | Removed or Retained | Photographs | | |
|---|---|---|---|---|---|--|--|
| | Floor Finish | Wood block | High | Retain | | | |

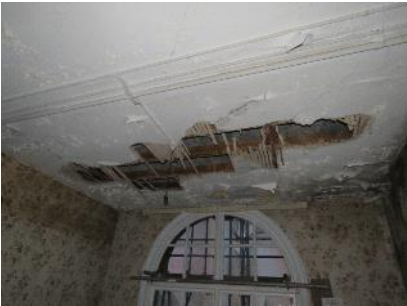
| Room Reference | Element | Description | Significance | Removed or Retained | Photographs | | |
|---|---|---|---|---|---|--|--|
| 2.62 | Wall Finish(es) | Wallpaper | None | Remove | | | |

| Room Reference | Element | Description | Significance | Removed or Retained | Photographs | | |
|---|---|---|---|---|---|--|--|
| | Ceiling Finish | Paint | Low | Remove flaking paint<br>Approx. 6m2 of plaster missing | | | |

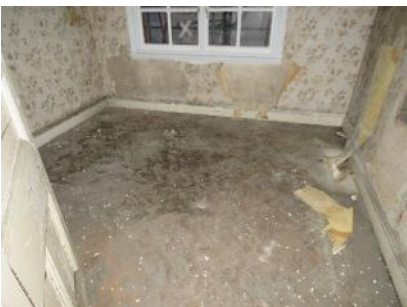
| Room Reference | Element | Description | Significance | Removed or Retained | Photographs | | |
|---|---|---|---|---|---|--|--|
| | Floor Finish | Wood block | High | Retain | | | |

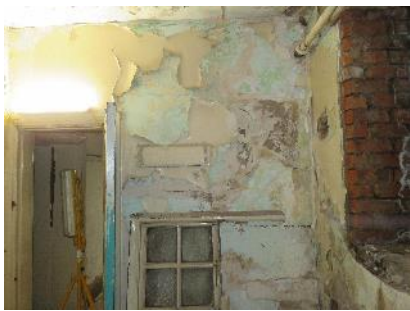
| Room Reference | Element | Description | Significance | Removed or Retained | Photographs | | |
|---|---|---|---|---|---|--|--|
| 2.66 | Wall Finish(es) | Paint | Low | remove flaking paint | | | |

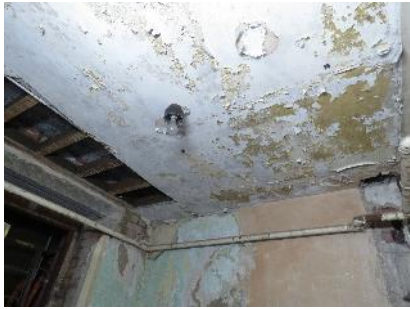
| Room Reference | Element | Description | Significance | Removed or Retained | Photographs | | |
|---|---|---|---|---|---|--|--|
| | Ceiling Finish | Paint | Low | Remove flaking paint<br>Approx. 3m2 of plaster missing | | | |

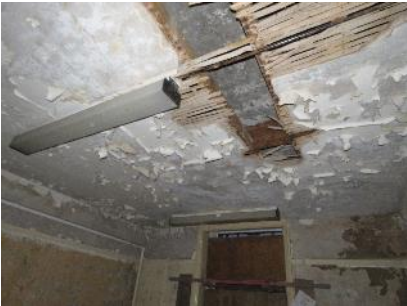
| Room Reference | Element | Description | Significance | Removed or Retained | Photographs | | |
|---|---|---|---|---|---|--|--|
| 2.67 | Wall Finish(es) | Wallpaper | None | Remove | | | |

| Room Reference | Element | Description | Significance | Removed or Retained | Photographs | | |
|---|---|---|---|---|---|--|--|
| | Ceiling Finish | Paint | Low | Remove flaking paint<br>Approx. 5m2 of plaster missing | | | |

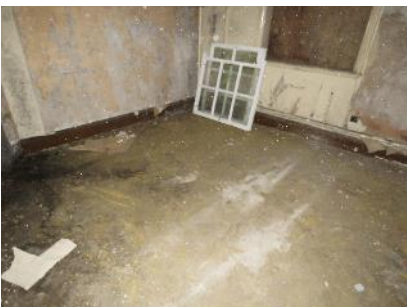
| Room Reference | Element | Description | Significance | Removed or Retained | Photographs | | |
|---|---|---|---|---|---|--|--|
| | Floor Finish | Wood block | High | Retain | | | |

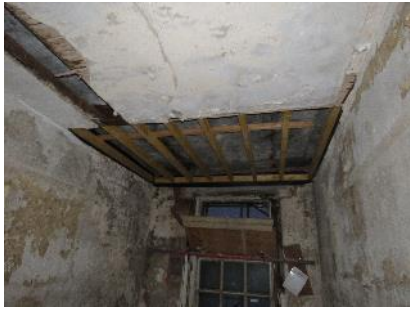
| Room Reference | Element | Description | Significance | Removed or Retained | Photographs | | |
|---|---|---|---|---|---|--|--|
| | Ceiling Finish | Paint | Low | Remove flaking paint<br>Approx. 20m2 of plaster missing | | | |

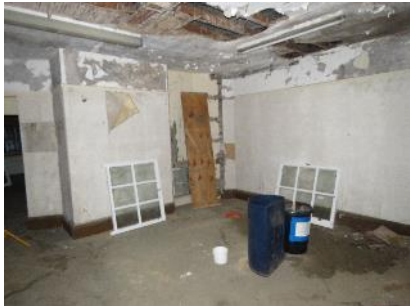
| Room Reference | Element | Description | Significance | Removed or Retained | Photographs | | |
|---|---|---|---|---|---|---|--|
| | Ceiling Finish | Paint | Low | Remove flaking paint<br>Approx. 15m2 of plaster missing | | | |

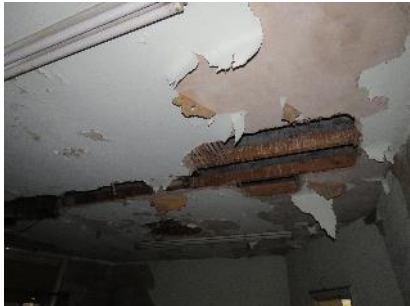
| Room Reference | Element | Description | Significance | Removed or Retained | Photographs | | |
|---|---|---|---|---|---|--|--|
| | Ceiling Finish | Ceiling paper | None | Remove<br>Approx. 10m2 of plaster missing | | | |

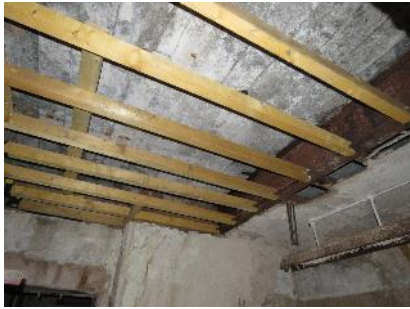
| Room Reference | Element | Description | Significance | Removed or Retained | Photographs | | |
|---|---|---|---|---|---|---|--|
| | Ceiling Finish | Ceiling paper | None | Remove<br>Approx. 15m2 of plaster missing | | | |

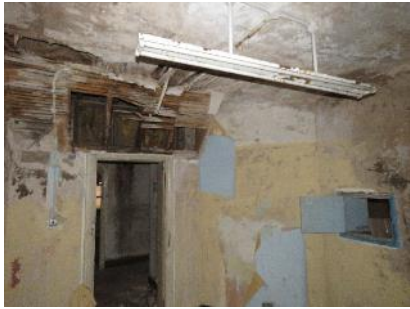
| Room Reference | Element | Description | Significance | Removed or Retained | Photographs | | |
|---|---|---|---|---|---|--|--|
| | Ceiling Finish | Paint | Low | Remove flaking paint<br>Approx. 8m2 of plaster missing | | | |

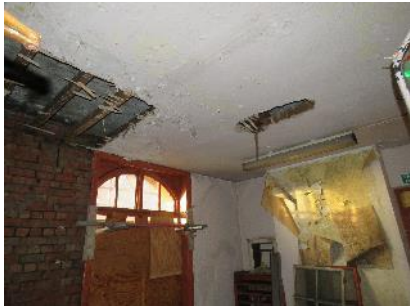
| Room Reference | Element | Description | Significance | Removed or Retained | Photographs | | |
|---|---|---|---|---|---|--|--|
| 2.82 | Wall Finish(es) | Wallpaper | None | Remove | | | |

| Room Reference | Element | Description | Significance | Removed or Retained | Photographs | | |
|---|---|---|---|---|---|--|--|
| | Ceiling Finish | Paint | Low | Remove flaking paint<br>Approx. 5m2 of plaster missing | | | |

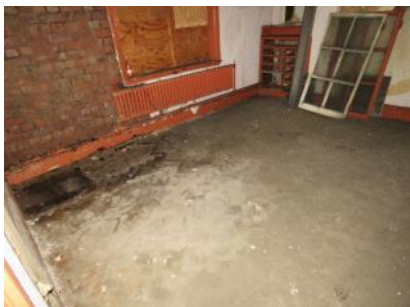
| Room Reference | Element | Description | Significance | Removed or Retained | Photographs | | |
|---|---|---|---|---|---|--|--|
| | Floor Finish | Adhesive over wood block | None / High | Remove adhesive and retain wood block | | | |

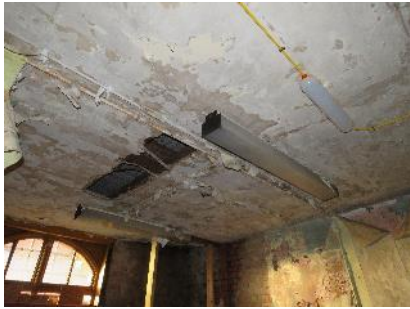
| Room Reference | Element | Description | Significance | Removed or Retained | Photographs | | |
|---|---|---|---|---|---|--|--|
| | Ceiling Finish | Paint | Low | Remove flaking paint<br>Approx. 2m2 of plaster missing | | | |

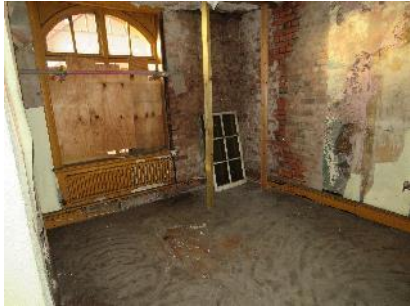
| Room Reference | Element | Description | Significance | Removed or Retained | Photographs | | |
|---|---|---|---|---|---|--|--|
| | Floor Finish | Adhesive over wood block | None / High | Remove adhesive and retain wood block | | | |

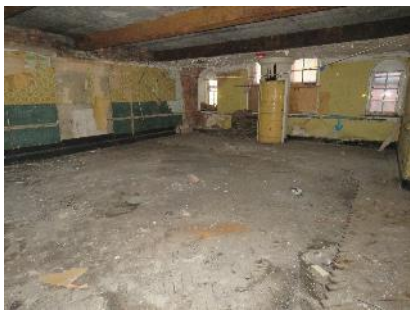
| Room Reference | Element | Description | Significance | Removed or Retained | Photographs | | |
|---|---|---|---|---|---|---|--|
| 2.84 | Wall Finish(es) | Wallpaper | None | Remove | | | |

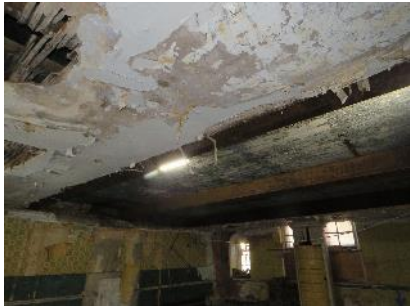
| Room Reference | Element | Description | Significance | Removed or Retained | Photographs | | |
|---|---|---|---|---|---|---|--|
| | Ceiling Finish | Paint | Low | Remove flaking paint<br>Approx. 100m2 of plaster missing | | | |

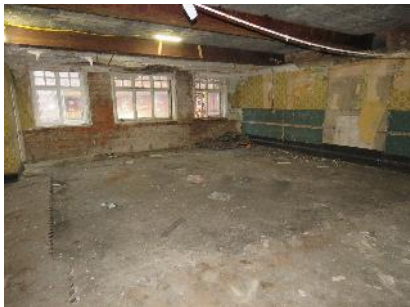
| Room Reference | Element | Description | Significance | Removed or Retained | Photographs | | |
|---|---|---|---|---|---|---|--|
| | Floor Finish | Wood block (50% lifted) | High | Retain | | | |

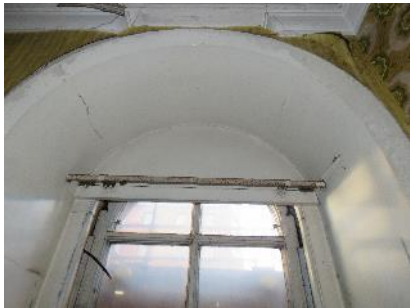
| Room Reference | Element | Description | Significance | Removed or Retained | Photographs | | |
|---|---|---|---|---|---|---|--|
| | Fixtures & Fittings | Fireman's cupboard<br>Curtain rails | High<br>None | Retain<br>Remove | | | |

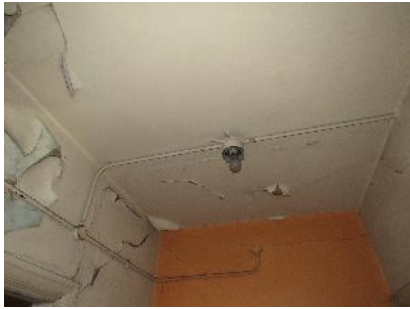
| Room Reference | Element | Description | Significance | Removed or Retained | Photographs | | |
|---|---|---|---|---|---|--|--|
| | Ceiling Finish | Paint | Low | Remove flaking paint | | | |

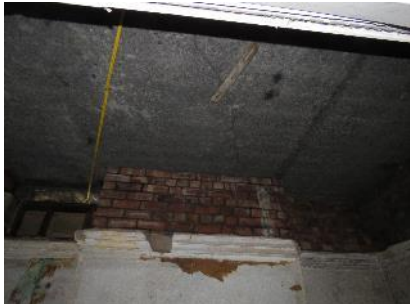
| Room Reference | Element | Description | Significance | Removed or Retained | Photographs | | |
|---|---|---|---|---|---|--|--|
| | Ceiling Finish | N/A | N/A | 12m2 of missing ceiling | | | |

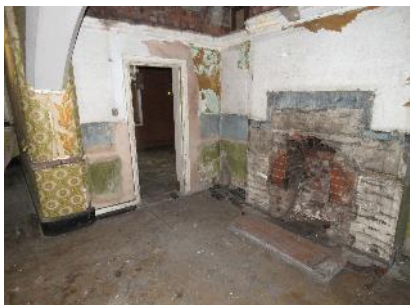
| Room Reference | Element | Description | Significance | Removed or Retained | Photographs | | |
|---|---|---|---|---|---|--|--|
| | Floor Finish | Wood block | High | Retain | | | |

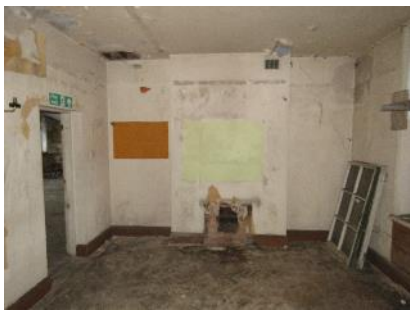
| Room Reference | Element | Description | Significance | Removed or Retained | Photographs | | |
|---|---|---|---|---|---|---|--|
| 2.87 | Wall Finish(es) | Wallpaper | None | Remove | | | |

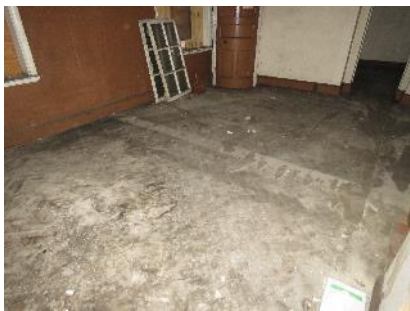
| Room Reference | Element | Description | Significance | Removed or Retained | Photographs | | |
|---|---|---|---|---|---|---|--|
| | Floor Finish | Carpet and adhesive over wood block<br><br>Red clay tile | None / None / High<br><br>Low | Remove carpet and adhesive and retain wood block<br>Retain | | | |

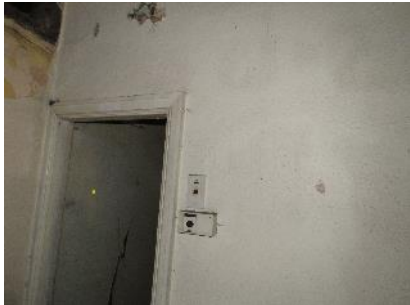
| Room Reference | Element | Description | Significance | Removed or Retained | Photographs | | |
|---|---|---|---|---|---|---|--|
| | M&E Items | Fuse box<br>Switches<br>Wall lights<br>Plug sockets | None<br>None<br>None<br>None | Remove all | | | |

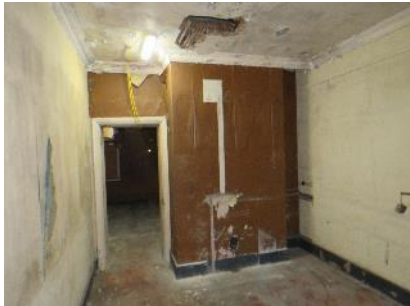
| Room Reference | Element | Description | Significance | Removed or Retained | Photographs | | |
|---|---|---|---|---|---|---|--|
| | Ceiling Finish | Paint | Low | Remove flaking paint<br>Approx. 3m2 of plaster missing | | | |

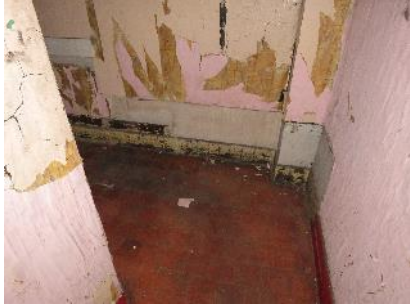
| Room Reference | Element | Description | Significance | Removed or Retained | Photographs | | |
|---|---|---|---|---|---|--|--|
| | Floor Finish | Red clay tile | Low | Retain | | | |

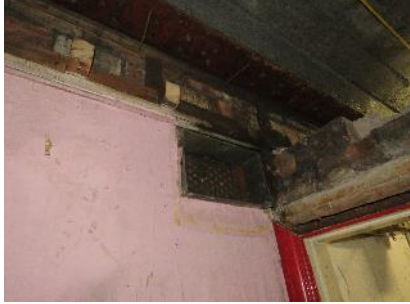
| Room Reference | Element | Description | Significance | Removed or Retained | Photographs | | |
|---|---|---|---|---|---|--|--|
| | Fixtures & Fittings | Timber boards<br>Misc. timber item | None<br>None | Remove<br>Remove | | | |

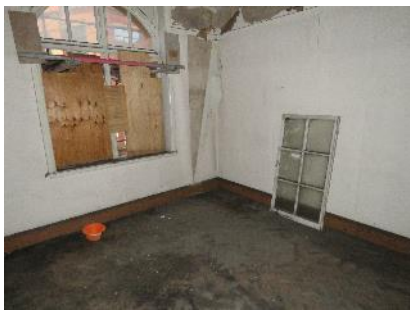
| Room Reference | Element | Description | Significance | Removed or Retained | Photographs | | |
|---|---|---|---|---|---|--|--|
| 2.90 | Wall Finish(es) | Wallpaper | None | Remove | | | |

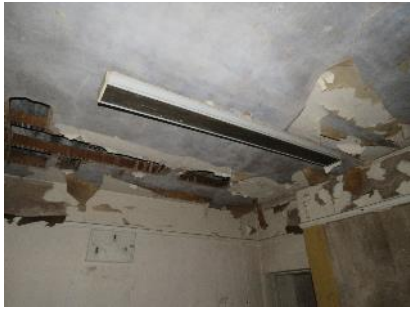
| Room Reference | Element | Description | Significance | Removed or Retained | Photographs | | |
|---|---|---|---|---|---|--|--|
| | Ceiling Finish | Ceiling paper | None | Remove<br>Approx. 4m2 of plaster missing | | | |

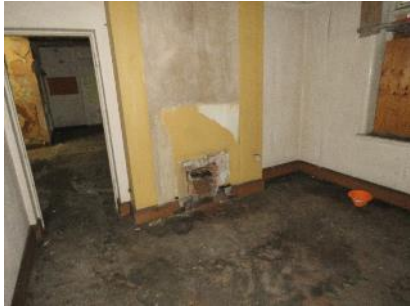
| Room Reference | Element | Description | Significance | Removed or Retained | Photographs | | |
|---|---|---|---|---|---|--|--|
| | Floor Finish | Adhesive over wood block | None / High | Remove adhesive and retain wood block | | | |

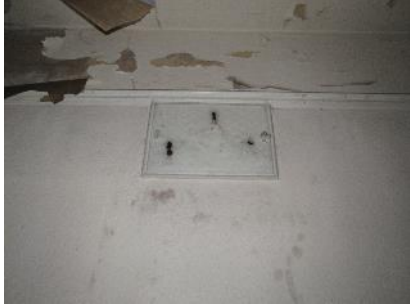
| Room Reference | Element | Description | Significance | Removed or Retained | Photographs | | |
|---|---|---|---|---|---|--|--|
| | Fixtures & Fittings | Wall hatch<br>Ventilation grill | Low<br>Low | Retain<br>Retain | | | |

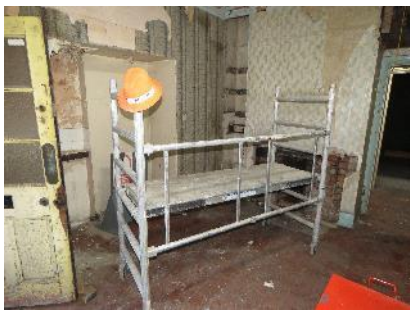
| Room Reference | Element | Description | Significance | Removed or Retained | Photographs | | |
|---|---|---|---|---|---|---|--|
| 2.91 | Wall Finish(es) | Wallpaper<br>White tile | None<br>None | Remove<br>Remove | | | |

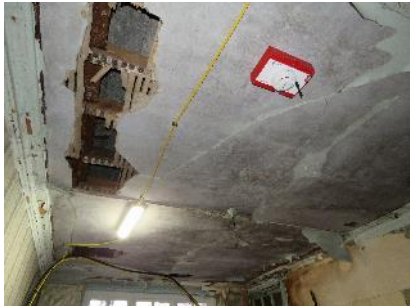
| Room Reference | Element | Description | Significance | Removed or Retained | Photographs | | |
|---|---|---|---|---|---|---|--|
| | Ceiling Finish | Ceiling paper<br>Paint | None<br>Low | Remove<br>Remove flaking paint<br>Approx. 5m2 of plaster missing | | | |

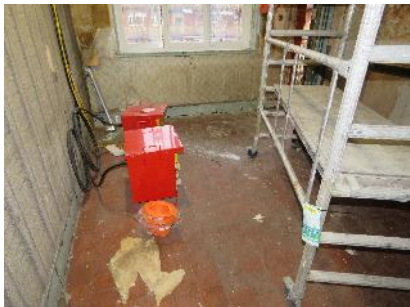
| Room Reference | Element | Description | Significance | Removed or Retained | Photographs | | |
|---|---|---|---|---|---|---|--|
| | Floor Finish | Red clay tile<br>White tile | Low<br>Low | Retain<br>Retain | | | |

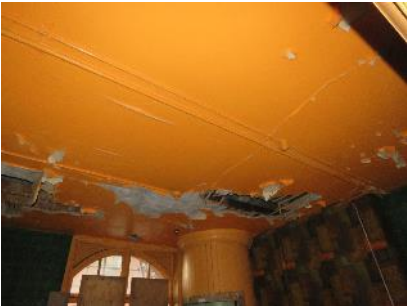
| Room Reference | Element | Description | Significance | Removed or Retained | Photographs | | |
|---|---|---|---|---|---|--|--|
| | Ceiling Finish | Paint | Low | Remove flaking paint<br>Approx. 8m2 of plaster missing | | | |

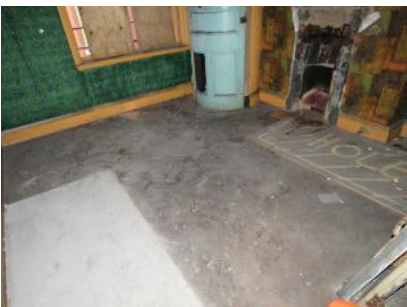
| Room Reference | Element | Description | Significance | Removed or Retained | Photographs | | |
|---|---|---|---|---|---|--|--|
| | Floor Finish | Wood block<br>Glazed tile | High<br>Low | Retain<br>Retain | | | |

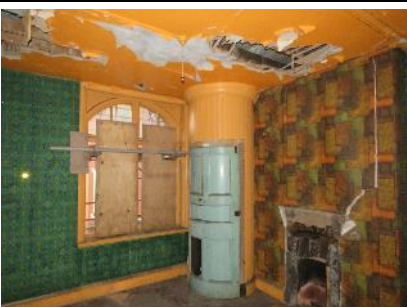
| Room Reference | Element | Description | Significance | Removed or Retained | Photographs | | |
|---|---|---|---|---|---|--|--|
| | Fixtures & Fittings | Fireman's cupboard<br>Ventilation grill | High<br>Low | Retain<br>Retain | | | |

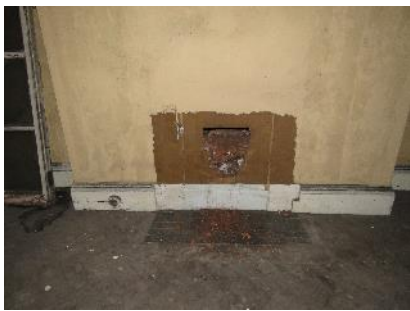
| Room Reference | Element | Description | Significance | Removed or Retained | Photographs | | |
|---|---|---|---|---|---|--|--|
| 2.97 | Wall Finish(es) | Wallpaper | None | Remove | | | |

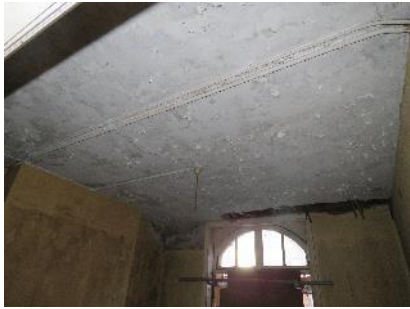
| Room Reference | Element | Description | Significance | Removed or Retained | Photographs | | |
|---|---|---|---|---|---|--|--|
| | Ceiling Finish | Paint | Low | Remove flaking paint<br>Approx. 2m2 of plaster missing | | | |

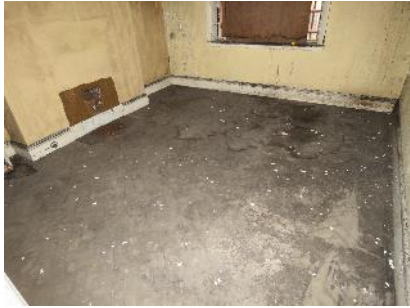
| Room Reference | Element | Description | Significance | Removed or Retained | Photographs | | |
|---|---|---|---|---|---|--|--|
| | Floor Finish | Wood block<br>Glazed tile | High<br>Low | Retain<br>Retain | | | |

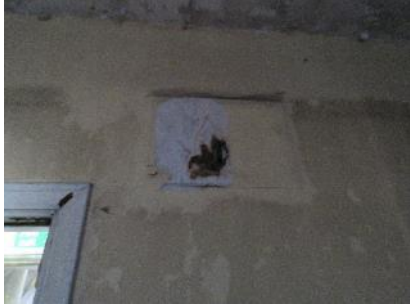
| Room Reference | Element | Description | Significance | Removed or Retained | Photographs | | |
|---|---|---|---|---|---|--|--|
| | Fixtures & Fittings | Timber plug socket mount<br>Ventilation grill | None<br>Low | Remove<br>Retain | | | |

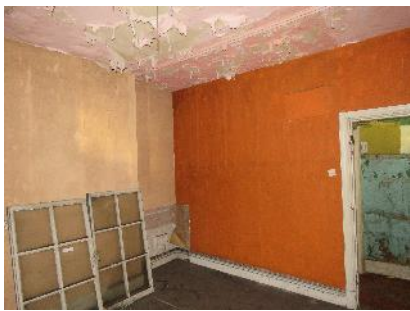
| Room Reference | Element | Description | Significance | Removed or Retained | Photographs | | |
|---|---|---|---|---|---|--|--|
| 2.98 | Wall Finish(es) | Wallpaper | None | Remove | | | |

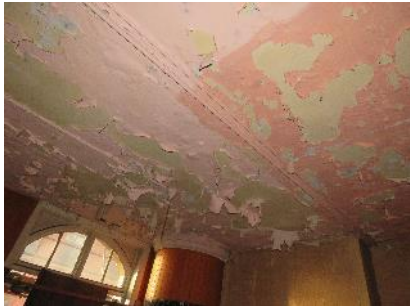
| Room Reference | Element | Description | Significance | Removed or Retained | Photographs | | |
|---|---|---|---|---|---|--|--|
| | Ceiling Finish | Paint | Low | Remove flaking paint<br>Approx. 0.5m2 of plaster missing | | | |

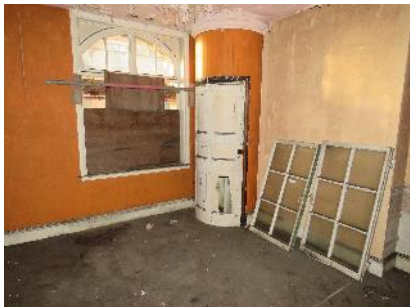
| Room Reference | Element | Description | Significance | Removed or Retained | Photographs | | |
|---|---|---|---|---|---|--|--|
| | Floor Finish | Wood block | High | Retain | | | |

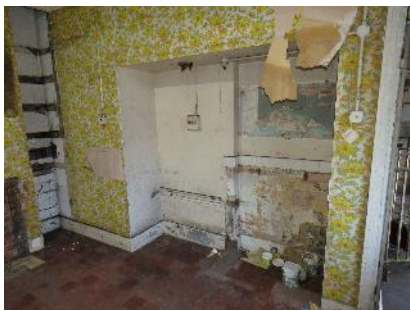
| Room Reference | Element | Description | Significance | Removed or Retained | Photographs | | |
|---|---|---|---|---|---|--|--|
| 2.99 | Wall Finish(es) | Wallpaper<br>White tile | None<br>None | Remove<br>Remove | | | |

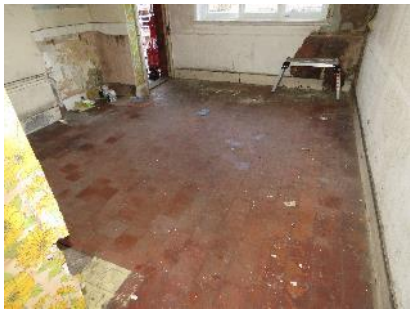
| Room Reference | Element | Description | Significance | Removed or Retained | Photographs | | |
|---|---|---|---|---|---|--|--|
| | Floor Finish | Red clay tile<br>White tile | Low<br>Low | Retain<br>Retain | | | |

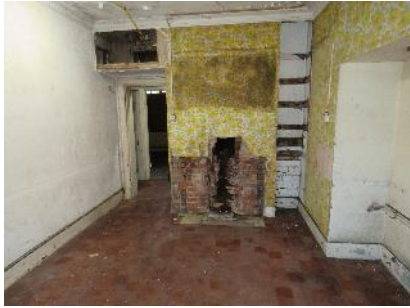
| Room Reference | Element | Description | Significance | Removed or Retained | Photographs | | |
|---|---|---|---|---|---|--|--|
| | Fixtures & Fittings | Timber board | None | Remove | | | |

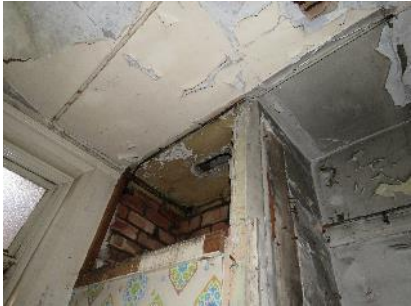
| Room Reference | Element | Description | Significance | Removed or Retained | Photographs | | |
|---|---|---|---|---|---|---|--|
| | Fixtures & Fittings | Timber batten<br>Timber board | None<br>None | Remove<br>Remove | | | |

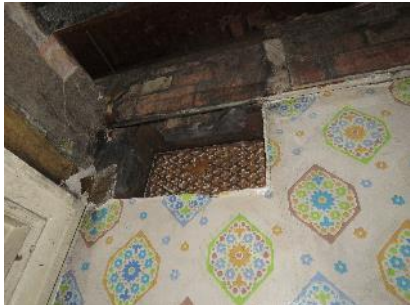
| Room Reference | Element | Description | Significance | Removed or Retained | Photographs | | |
|---|---|---|---|---|---|---|--|
| | M&E Items | Conduit<br>Misc. cable<br>Ventilation ductwork | None<br>None<br>Low | Remove all | | | |
