CLIENT AMBASSADOR THEATRE GROUP

PROJECT MANCHESTER OPERA HOUSE

TITLE WINDOW REPAIR - W11-LG

DRAWING NUMBER 19-143- WR11

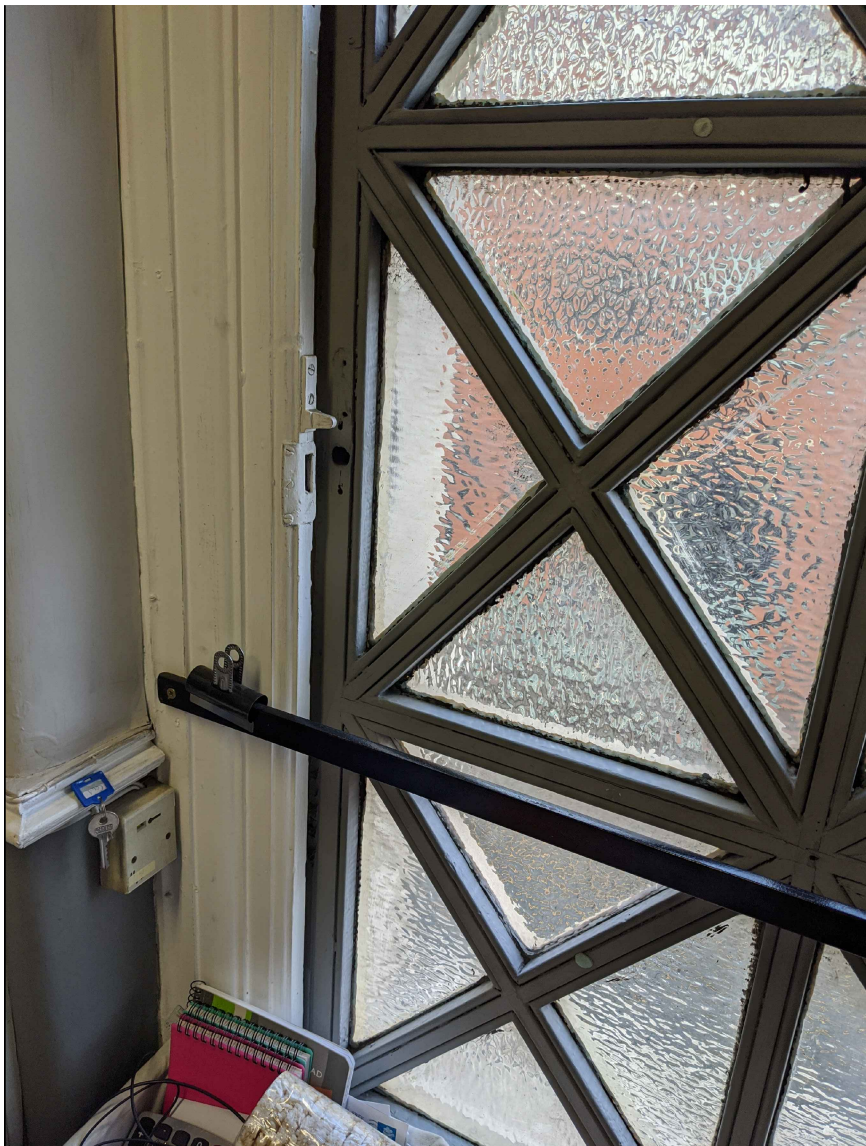
Window W11-LG Store

Once all repairs have been carried out.

Clean down and remove any loose paint. Prepare surface to receive new painted finish, preferably using specialized scrapers or heat guns where appropriate. Avoid using an alkaline based paint stripper as the surface needs to be ph.neutral.

Repaint with linseed oil based paint to give long lasting preservation of the timber and breathability. Apply in 2-3no thin coats with 24hr drying time between coats as manufacturers recommendations.

Carefully clean glass and check for damage. If any glass needs to be removed during the course of the repair it must be labeled and re-used in its original location and orientation. Ensure rebates are clean, dusted given a thin coat of paint before linseed-oil bedding putty is applied. Once bead is re-fixed use more putty to seal between glass and frame joint.

Check all ironmongery is in sound working order. Ease any moving parts with lubricant if required. Ensure all hinges are sound, if not replace with like for like hinges using stainless steel fastenings. If replacement ironmongery is required source to closely match original black iron window fasteners and stays as indicated below.

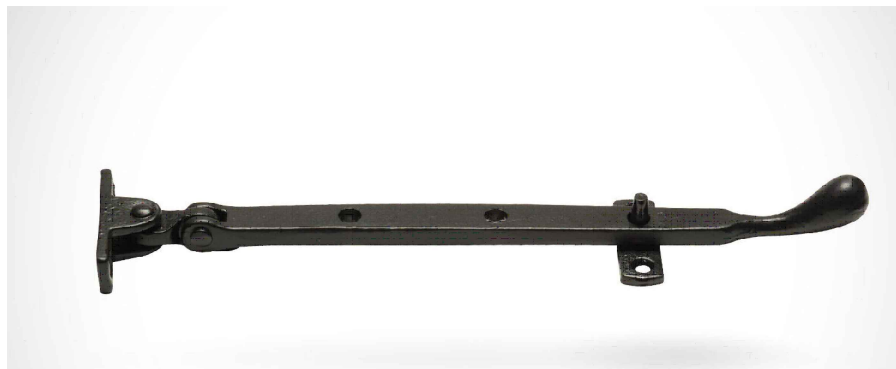
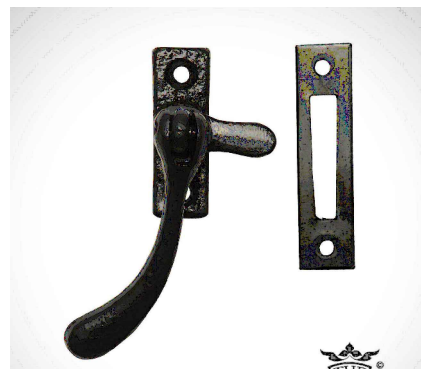
For reference these are available from 'The Victorian Emporium' - N.B ensure size is suitable to coordinate with existing ironmongery that is being retained.

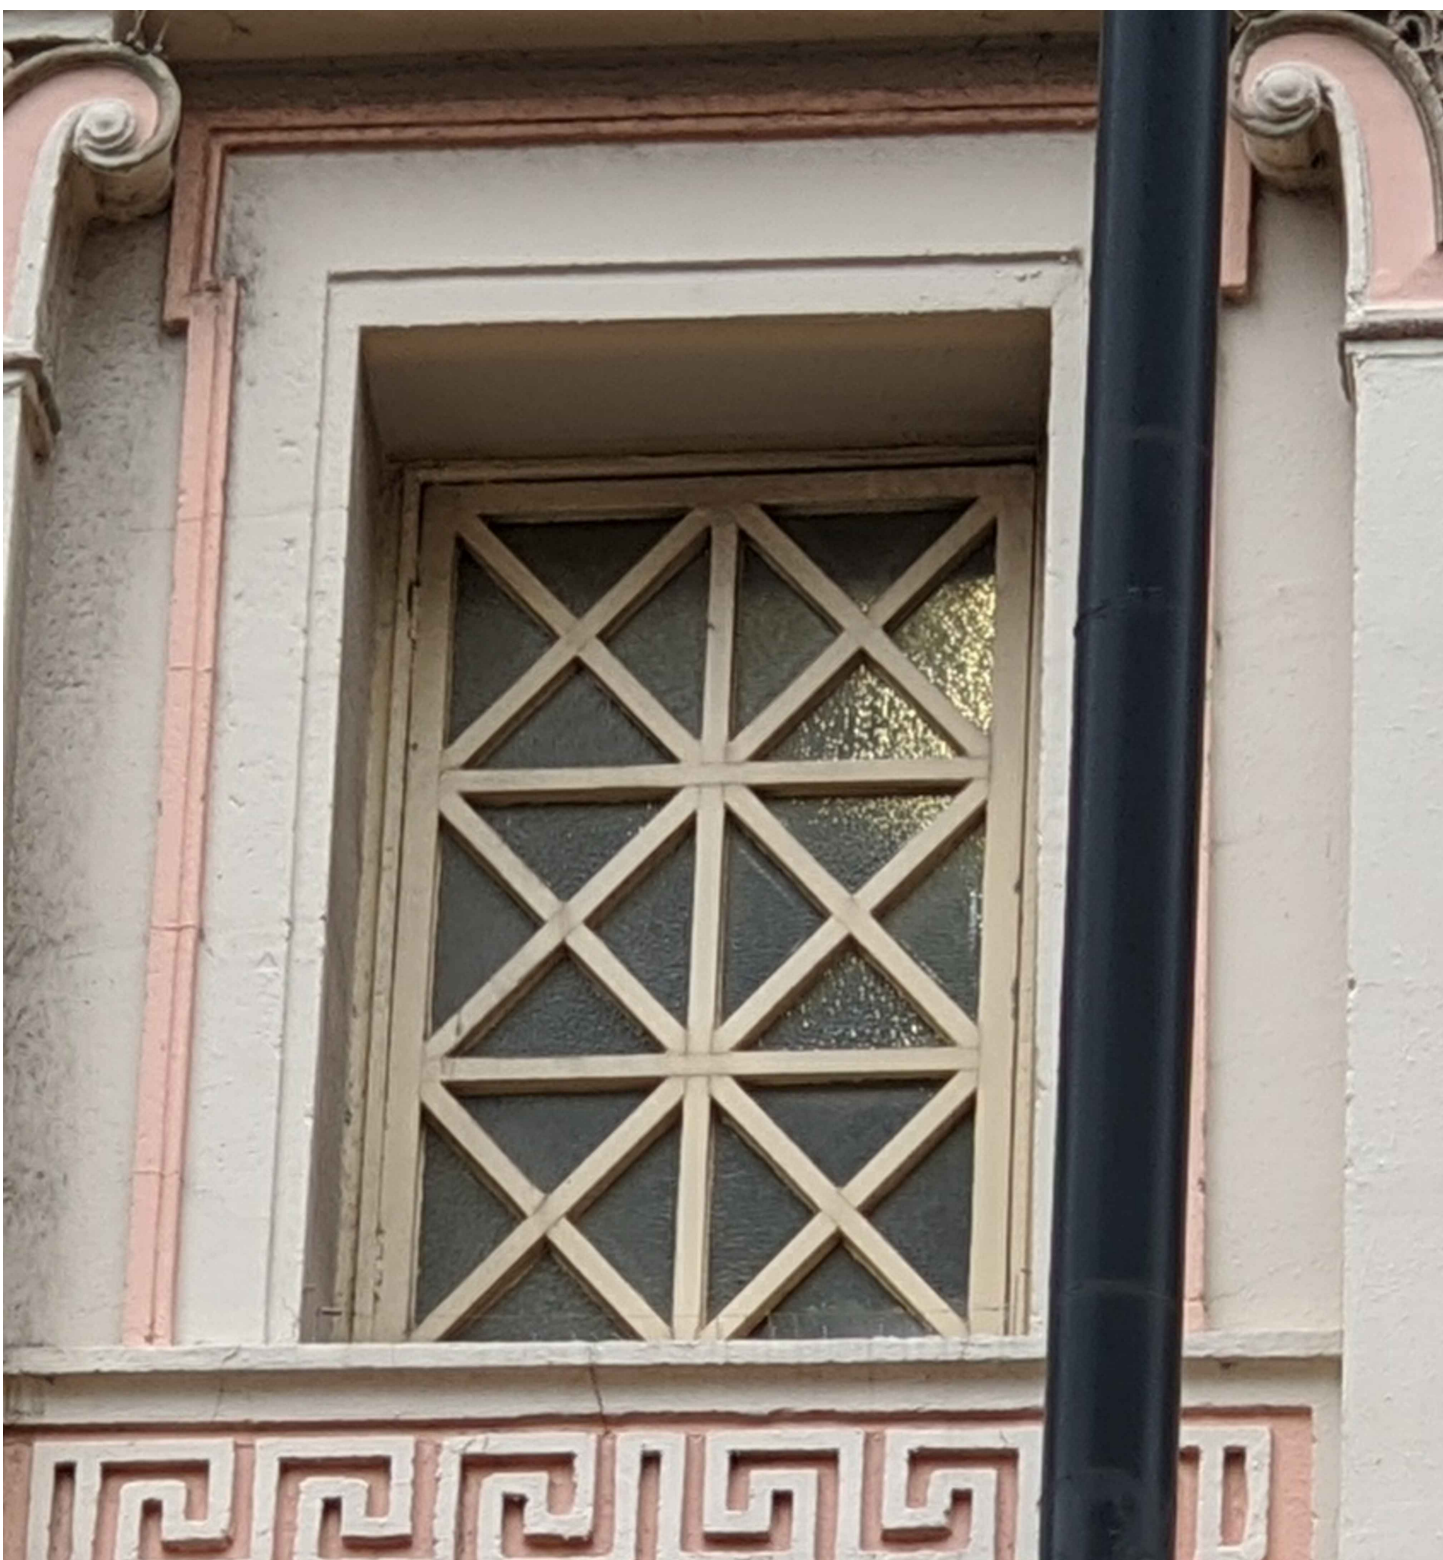
Window W11-LG Store

Once casement has been removed and the existing frame has been left in-situ, check frame and cill for and damage or rot. Record areas and report to CA.

Where external cills are to be replaced - replicate the profile of the existing cill in a durable hardwood such as oak incorporating a drip detail to the underside. Any new cill parts should be butt jointed below the casement frame. Finish using linseed oil based paint as described above in the colour to match the existing colour.
