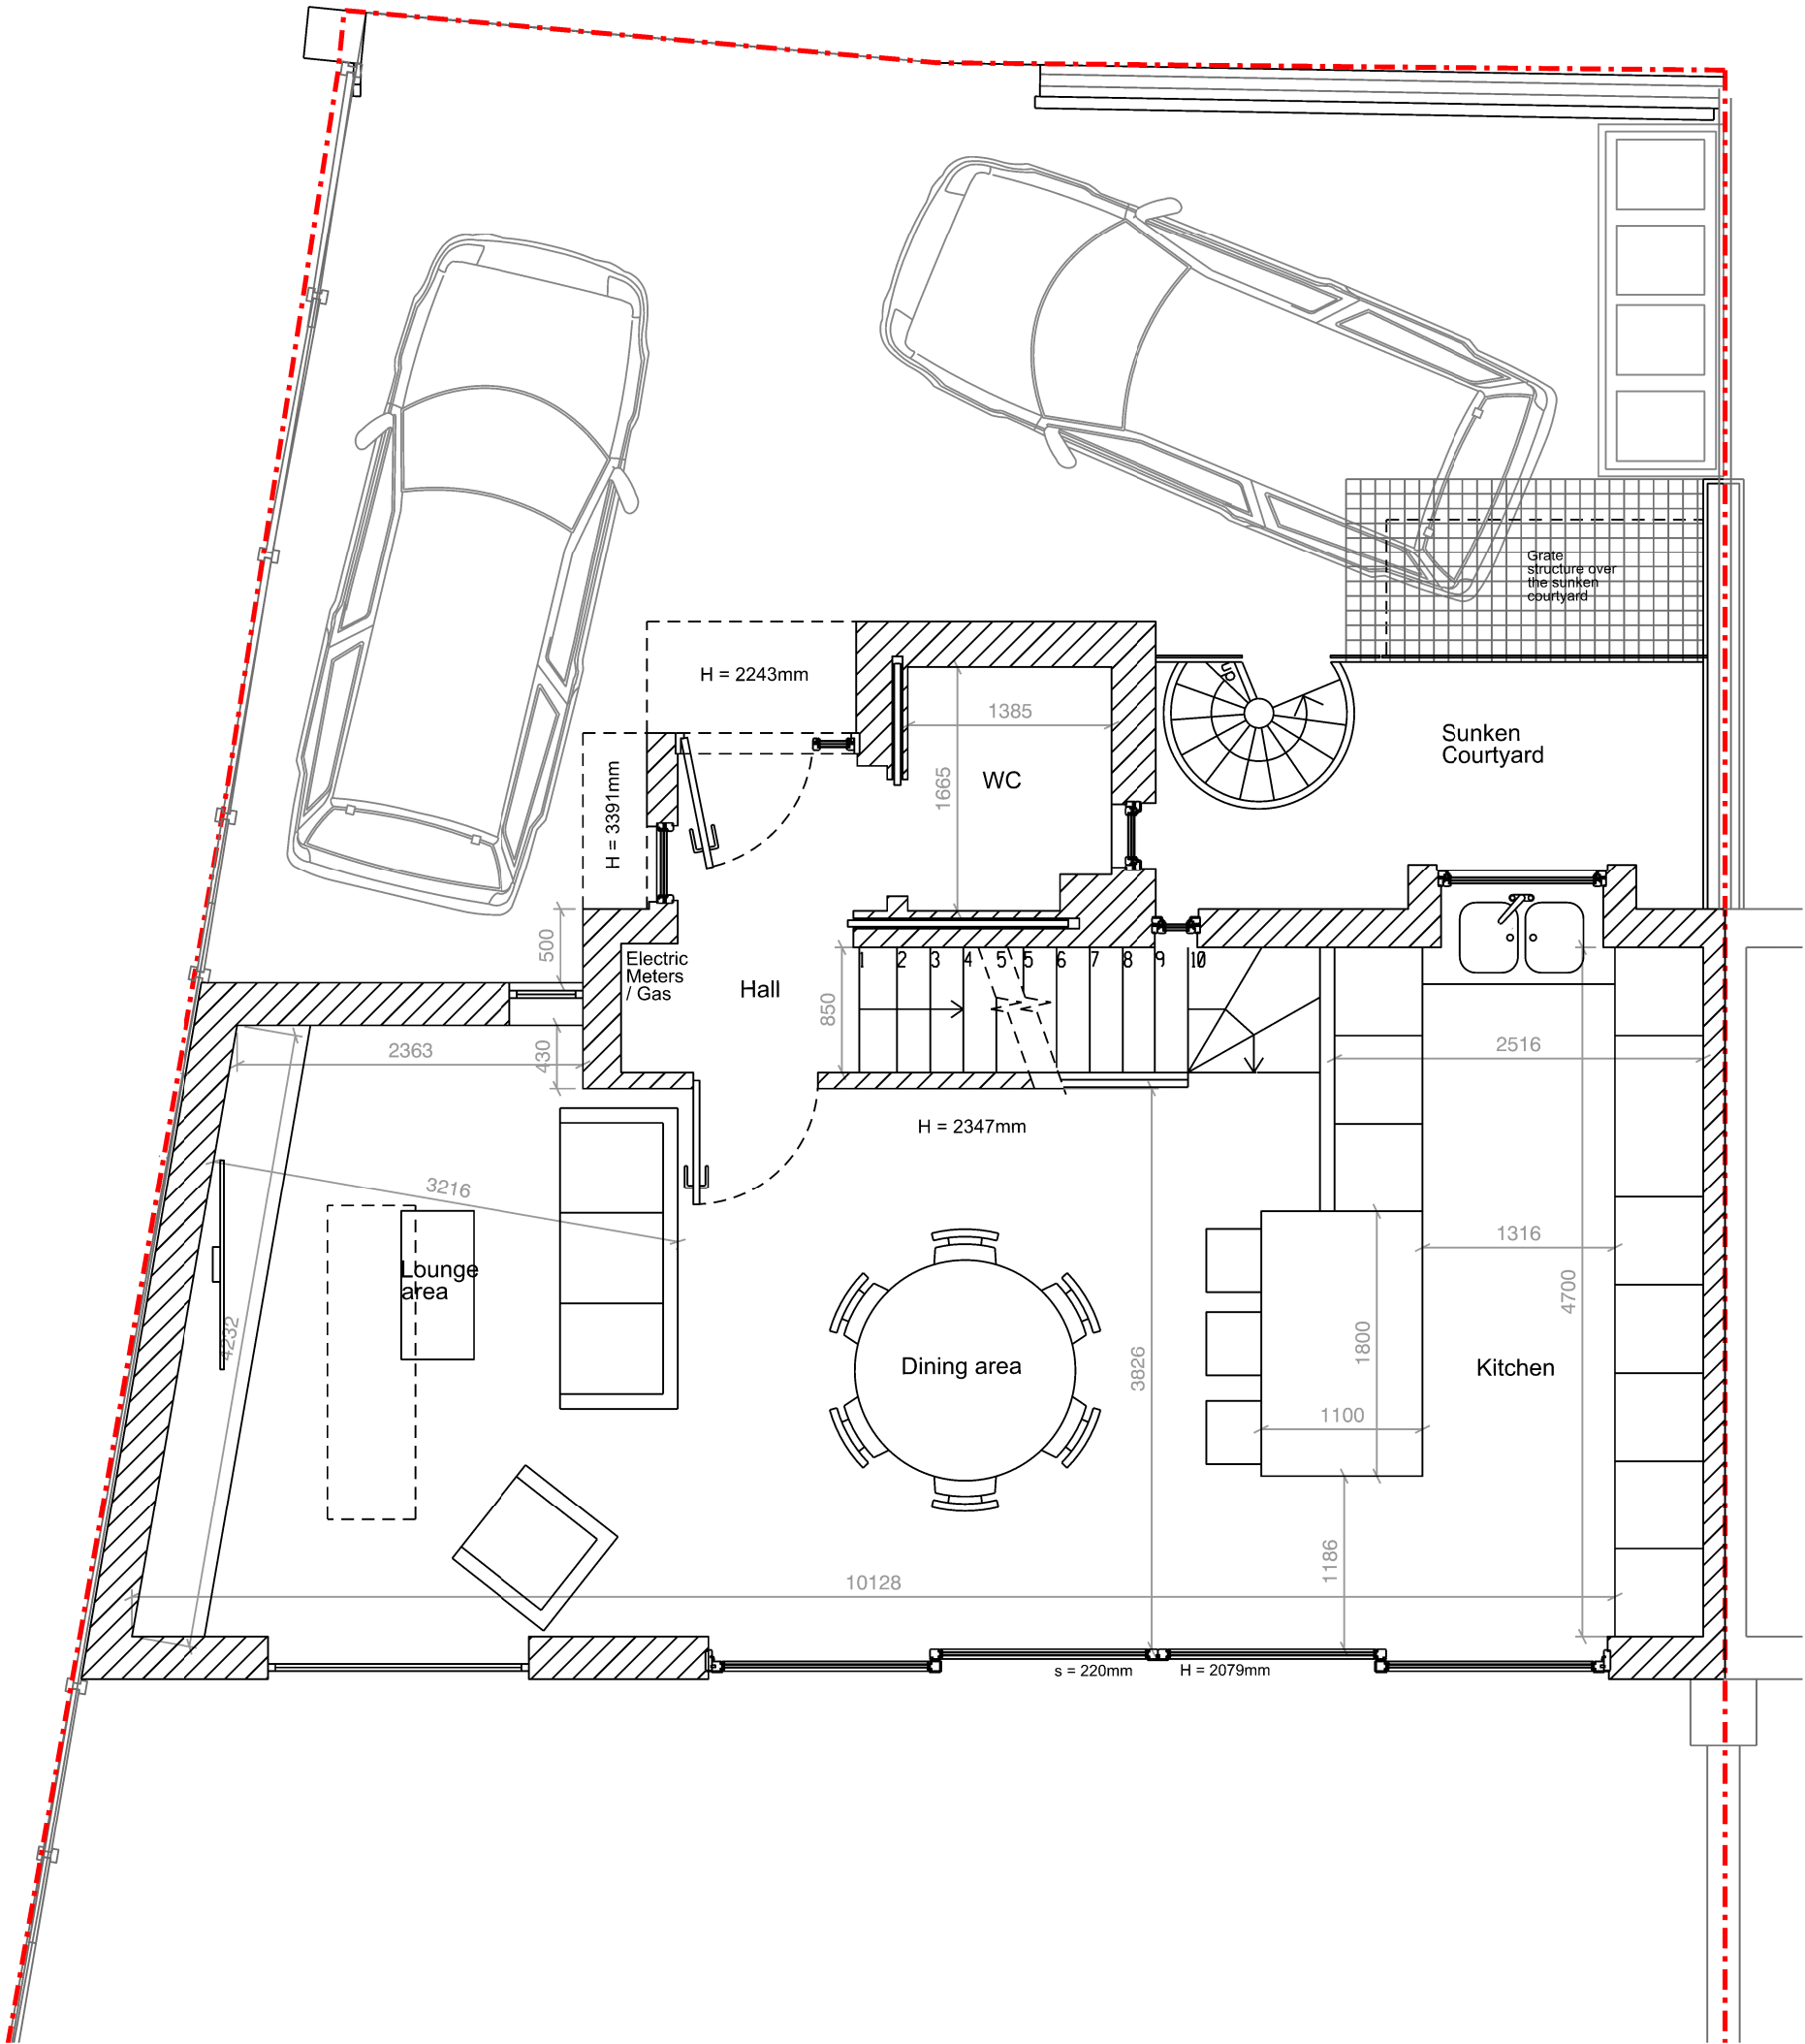
Proposed Ground Floor Plan

Existing brick  
boundary wall  
with timber fence  
over to be  
maintained

New wider  
vehicular and  
pedestrian  
entrance with  
timber sliding  
gate

Existing porous  
block paving to  
be maintained

Existing  
timber  
boundary  
fence to be  
maintained

New flat  
membrane roof  
to extension

Existing first  
floor extrusion  
to be maintained

New aluminium  
framed rooflight

Existing zinc  
roof to be  
maintained

Existing stone  
tiled patio to be  
maintained

Existing  
lawned area  
to be  
maintained

Existing timber  
boundary  
fences to  
be  
maintained

New porous  
block paving to  
match existing

Bin store area  
to be  
maintained

Existing timber  
boundary fence  
to be maintained

New structural  
galvanised steel  
grate over  
sunken courtyard  
to make car  
parking space  
larger

Existing  
rooflights to be  
maintained

Existing brick and  
render boundary  
wall to be  
maintained
