project 43-47 piccadilly, manchester  
job no. 7422  
title existing retained facade elevation  
scale 1:50 @ A3  
drawing no. 7546-al(02)0061

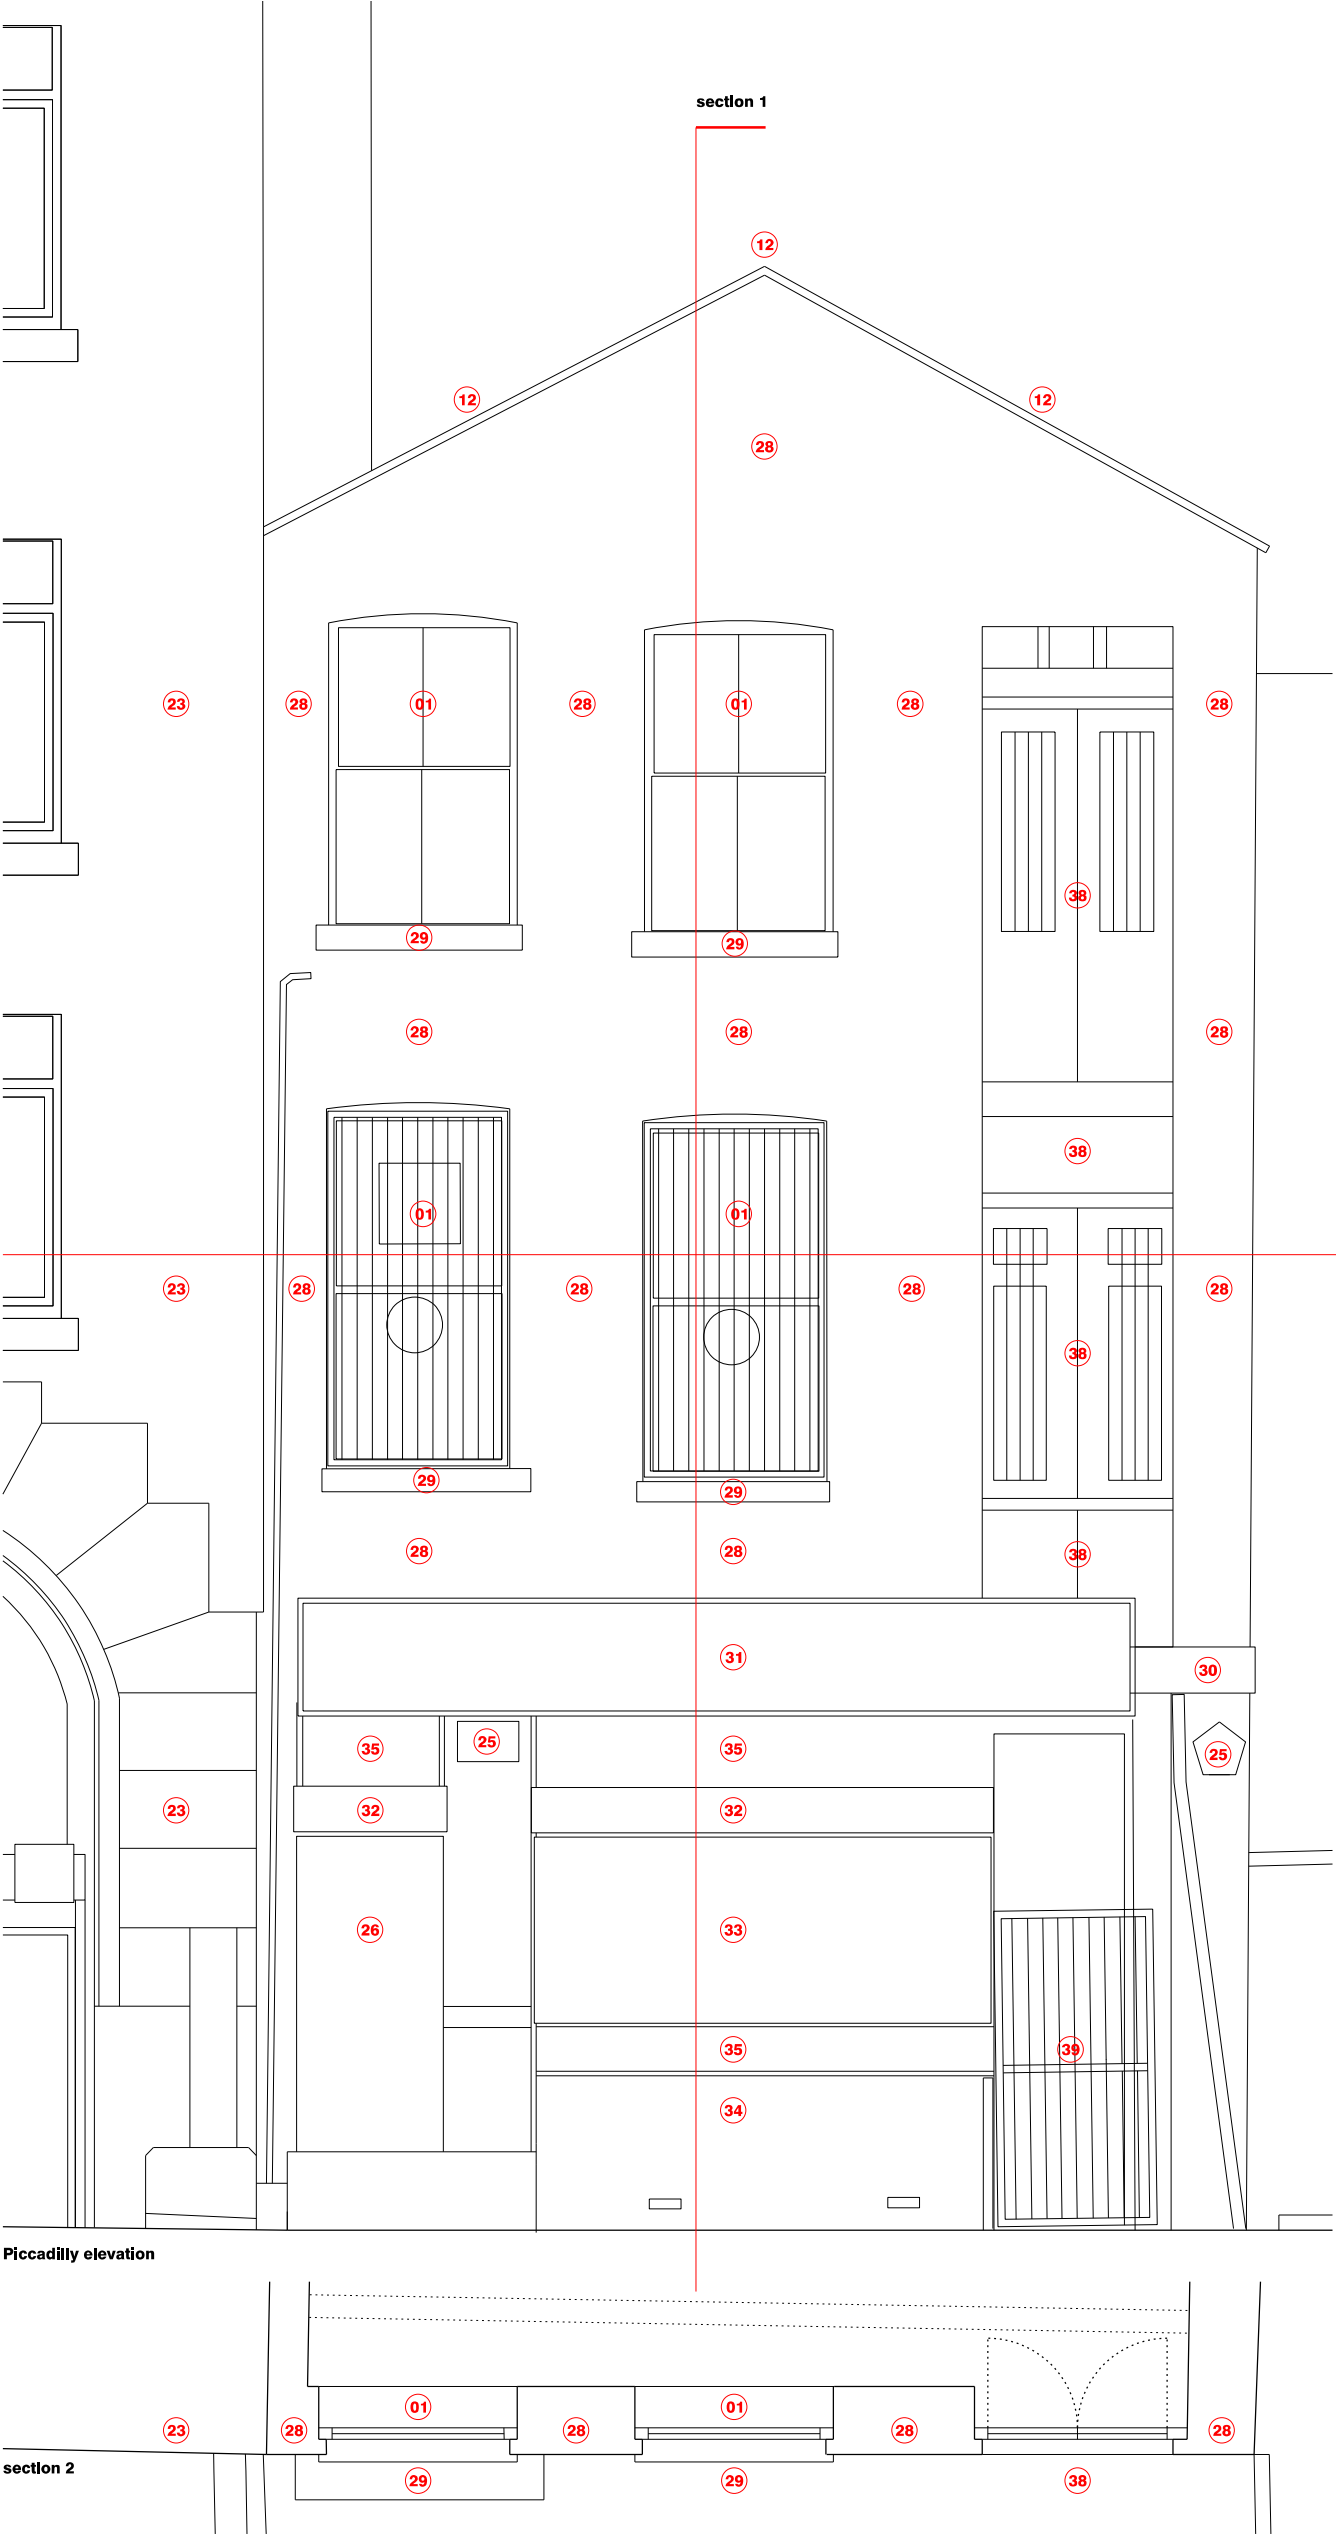
- 01 existing timber window, internal architraves, and cill  
02 existing dado rail  
03 existing skirting  
04 existing painted plaster wall  
05 existing painted plaster ceiling  
06 existing plasterboard ceiling concealing existing ceiling with possible cornice above  
07 existing chipboard raised floor  
08 existing cornices (others may be revealed following soft-strip)  
09 existing stone slab floor  
10 existing timber ceiling and beams  
11 existing floor tiles and skirtings  
12 existing slate roof  
13 existing timber door  
14 existing painted facade  
15 existing cornice  
16 existing lay-in ceiling tiles concealing existing ceiling with possible cornice above  
17 existing timber floor  
18 existing shop signage and roller shutter  
19 existing shop front door and glazed screens  
20 existing timber plasters

- 21 existing shop fit-out  
22 existing painted brickwork  
23 gable and chimney of 49 Piccadilly  
24 remnant of former TSB facade  
25 lights, alarms and other non-original items fixed to facade  
26 roller shutters concealing timber door  
27 hoarding  
28 existing brickwork  
29 existing stone cill  
30 steel beam supporting brickwork above  
31 sign  
32 roller shutter  
33 shop front  
34 painted brickwork  
35 plywood  
36 non-original plasterboard  
37 timber beam and floor  
38 timber loading bay doors  
39 metal gate
