# RACHEL HACKING ECOLOGY

## **RE: 125555/FO/2019 DISCHARGE OF CONDITION 11 (BAT & BIRD BOXES) AND 12 (BAT TREE INSPECTION METHOD STATEMENT) AT 29 BERRY BROW, CLAYTON BRIDGE**

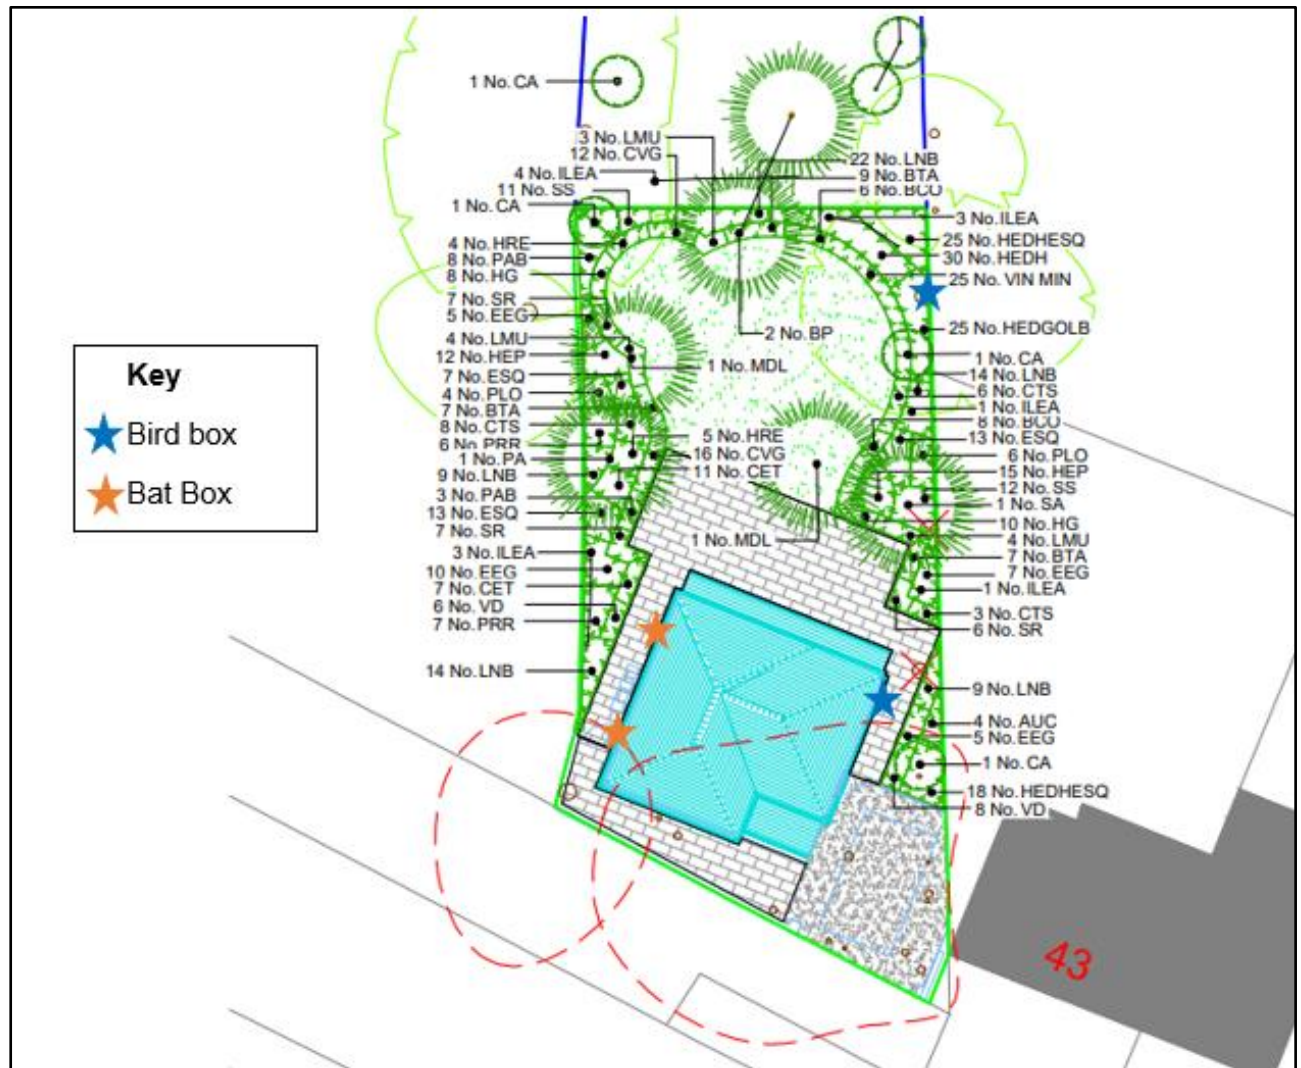
**FIGURE 1 – INDICATIVE LOCATIONS OF BIRD BOXES AND BAT BRICKS SHOWN ON LANDSCAPE PROPOSAL PLAN (DRAWING NUMBER 6297.01)**

**One** [House Sparrow](#) box is to be erected onto new building on site. The box should be erected on north, west or east-facing elevation and should be positioned approximately 4 metres off the ground. **One** general purpose bird nesting box ([Schwegler 1B](#) or similar) is to be positioned on a retained tree on site. This should be erected approximately 4m off the ground, face east or west and be clear of possible predation risks. Figure 1 shows the indicative positions of the boxes on site.

**Two** bat bricks will be incorporated into the fabric of the new building, with a variety of box types used to provide roosting opportunities for a range of bat species. The bat bricks/integrated wall boxes will be [Habibat 001 bat boxes](#) (or similar). These should be positioned on the southern or western elevations of the building, at least 3m from the ground. The bat boxes should be located adjacent to suitable bat commuting/foraging habitat. The bat boxes must not be placed close to new light sources. Figure 1 shows the indicative positions of the boxes on site.
