| Project: | LONDON ROAD FIRE STATION |

| Drg Title: | GROUND FLOOR OBSERVATIONS<br>SHEET 2 OF 3 |

| 060270 / 10-00-02 | V01 |

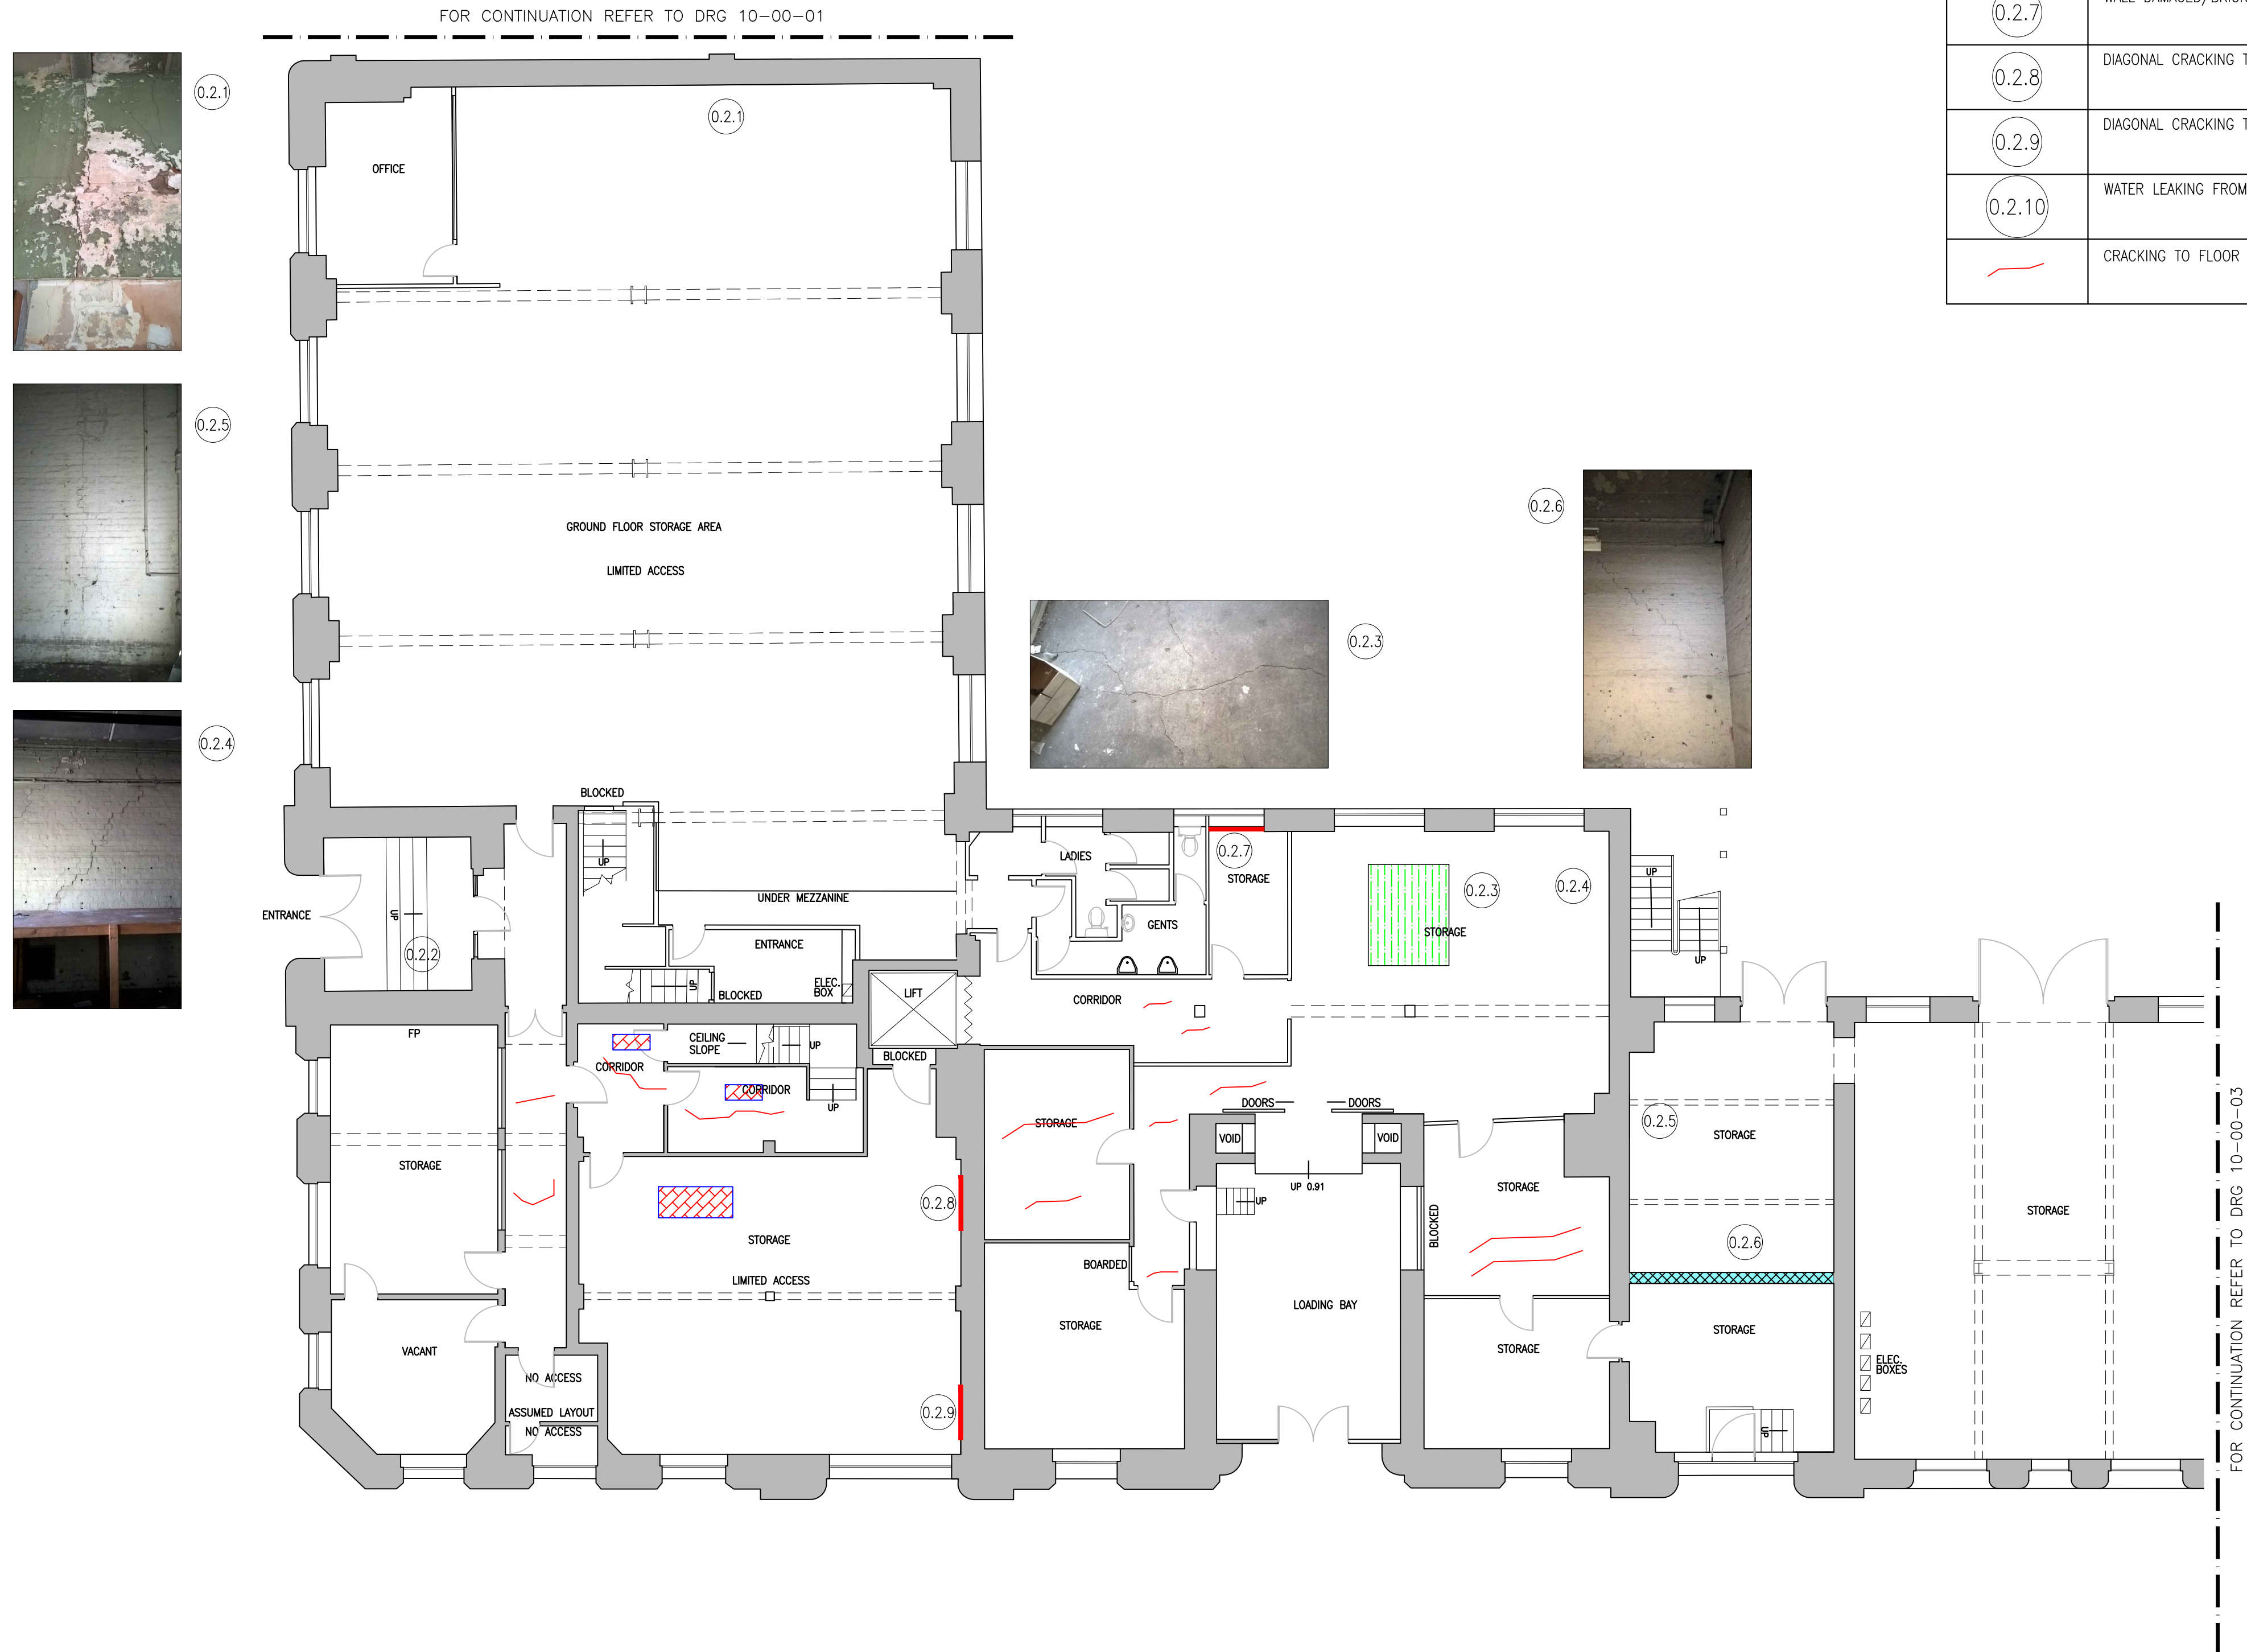
PLAN ON EXISTING GROUND FLOOR  
SCALE 1:100

| REF | OBSERVATION |
|---|---|
| 0.2.1 | FULL HEIGHT CRACK IN WALL IN LINE WITH TRANSFER BEAM ABOVE. |
| 0.2.2 | CRACKING TO FINISHES. |
| 0.2.3 | CRACKING TO FLOOR SCREED. |
| 0.2.4 | DIAGONAL CRACKING TO WALL EVIDENT TO ONE SIDE ONLY. |
| 0.2.5 | STRAIGHT FULL HEIGHT CRACK IN MASONRY. |
| 0.2.6 | DIAGONAL CRACK THROUGH MASONRY PARTITION WALL EVIDNET FROM BOTH SIDES. |
| 0.2.7 | WALL DAMAGED/BRICKWORK BROKEN OFF |
| 0.2.8 | DIAGONAL CRACKING TO THE WALL FINISHES. |
| 0.2.9 | DIAGONAL CRACKING TO WALL ALONG THE MORTAR JOINT. |
| 0.2.10 | WATER LEAKING FROM THE CEILING. |
| | CRACKING TO FLOOR FINISHES/SCREED |
