# Tree Survey & Arboricultural Impact Assessment

Site: Land to the rear of 5 Demesne Road, Whalley Range, Manchester, M16 8HG

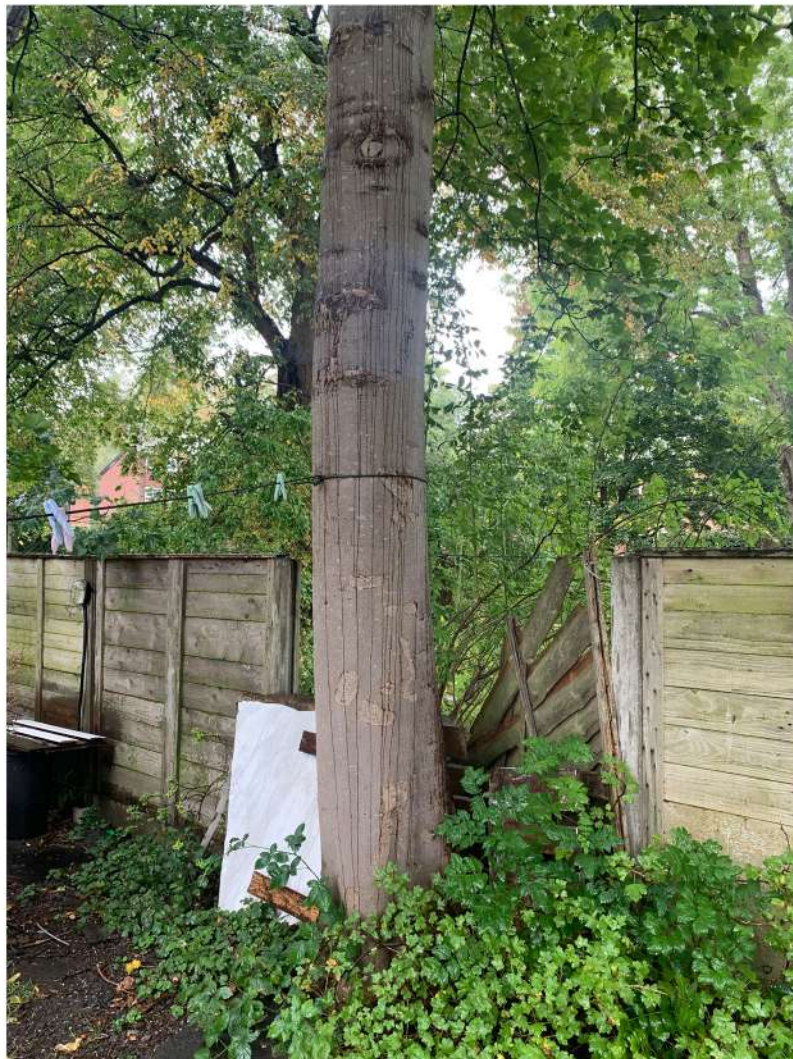
| Tree Ref | Species | Height (m) | Condition | Category | Notes |
|---|---|---|---|---|---|
| T1 | Sycamore Maple ( <i>Acer pseudoplatanus</i> ) | 11.0 | Fair | B2 | moderate landscape value |

- Retain T1 as a higher-value boundary tree providing screening.
- Protect all retained trees with fencing to the full Root Protection Area (RPA).
- Undertake crown lifting/pruning only if necessary for clearance.
- Any works should avoid bird nesting season (March–August).
- Replacement planting is recommended for long-term amenity value.

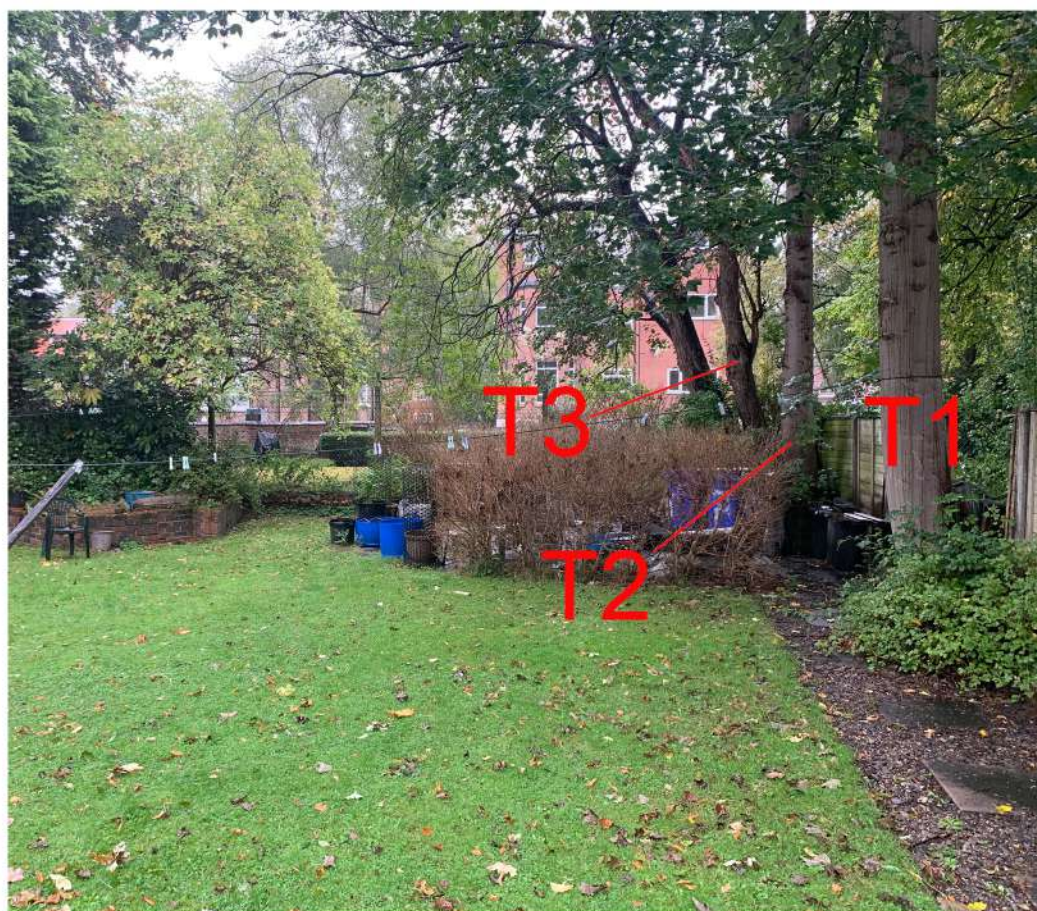
**Boundary Easement Note:** All surveyed trees (T1–T3) are located immediately adjacent to the boundary fence. Their Root Protection Areas (RPAs) therefore extend partly beneath the fence line. Any construction or service works within this margin should be carefully planned to avoid root damage. Protective fencing will be positioned along the inside of the boundary line, creating an easement to safeguard both the trees and neighbouring property interests.

The proposed bungalow is located centrally within the plot. Trees T1–T3 are positioned along the site boundaries; there is no requirement for tree removal. The development will not adversely impact the trees. Protective fencing in line with BS5837 should be installed prior to construction, and any works within Root Protection Areas should be carried out using no-dig or hand-dig methods to minimise disturbance.
