# John Wood Architect

project 1661 project title 33 Thomas Street  
drawing 3115 - issue 03 External Opening OE.02.01  
issue date 18/06/2025 scales shown @ A3

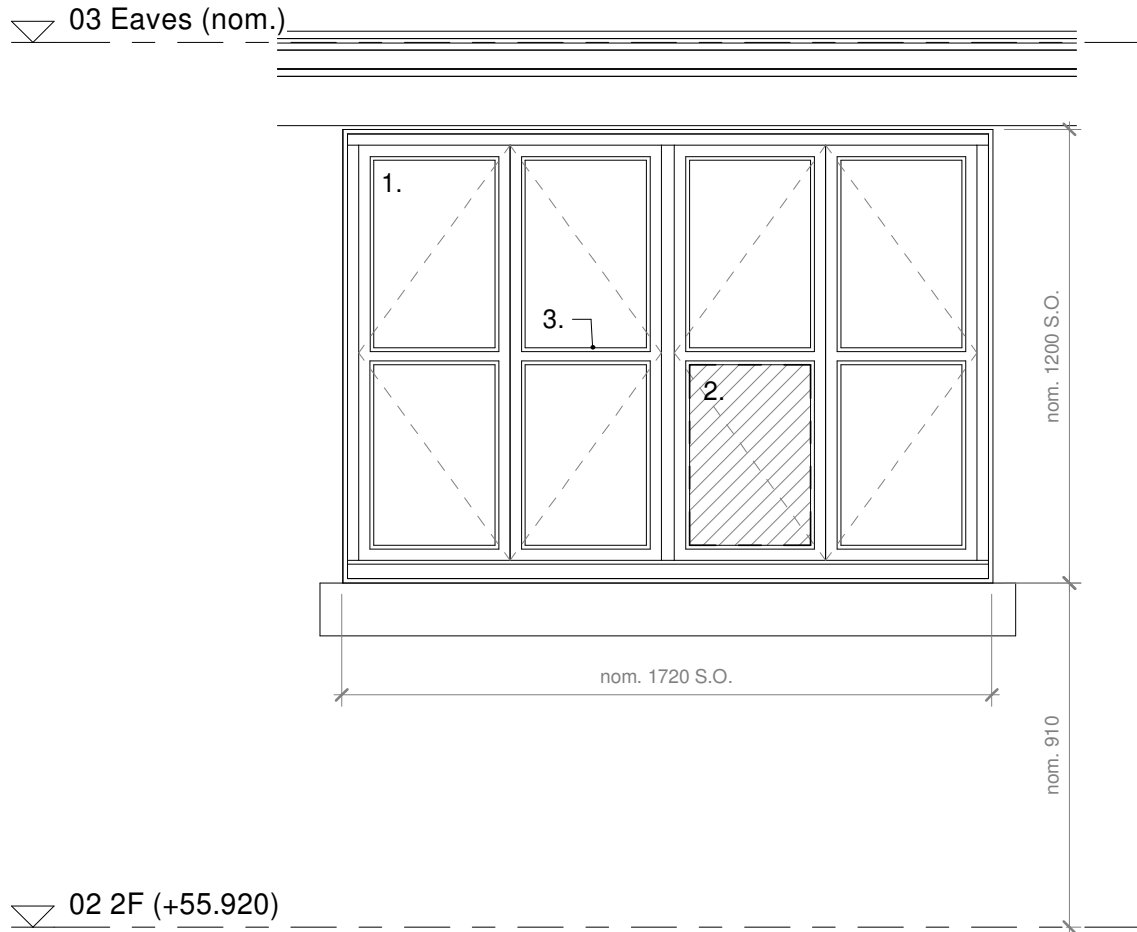
OE.02.01-Elevation  
scale 1 : 20

1. Existing window, loose paint carefully removed and repainted using linseed oil paint, Colour: 'blackout' by Brouns.
2. Broken glass panes removed and replaced with laminated replica single glazing, L10/124.
3. New glass secured in place with putty / existing loose putty removed and replaced as necessary.
4. Secondary glazing to be installed inside existing windows, L10/131.
5. Wall and roof build-up shown indicatively - tbc on site and refer to typical details.
6. Window lintels repaired or replaced in accordance with structural engineer's specification.
