St Margaret's (App. 2),  
Manchester  
For Charlotte Street Estates

Newton Street  
Elevation - Repairs

and Conditions 2/2

DRWG NO. P(217)

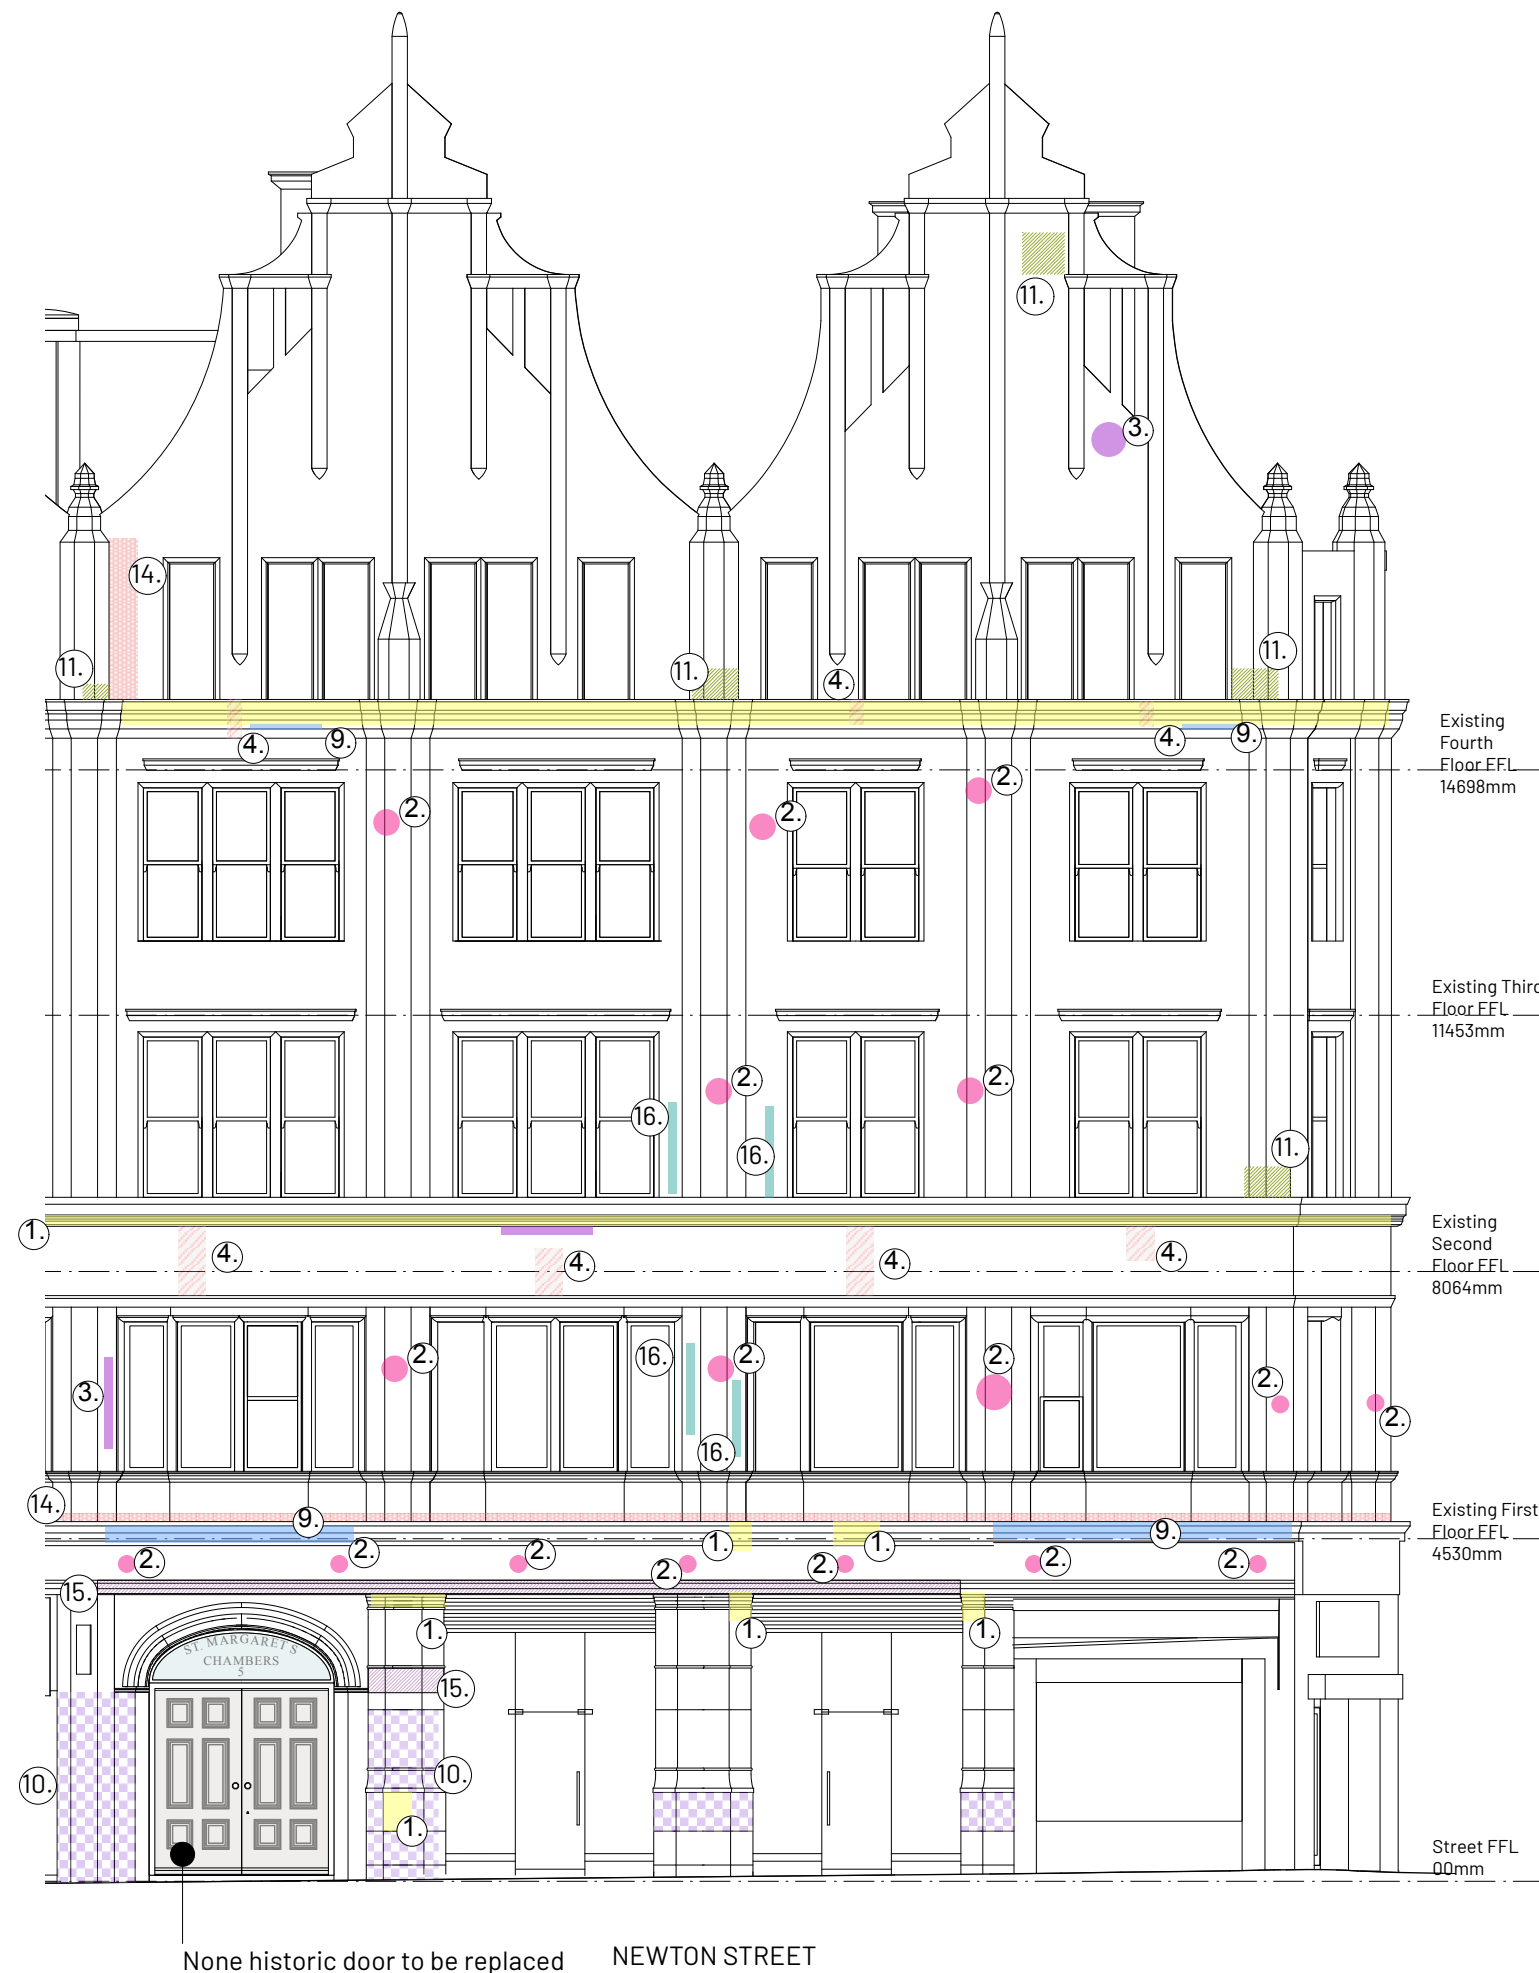
- 1 Sandstone erosion - close inspection required.
- 2 Holes left by redundant fixings - mortar fill in accordance with specification.
- 3 Gaps in brickwork. Close inspection required to inform replacement with matching material.

- 4 Missing pointing between frieze panels. Reinstate in accordance with specification.
- 5 Redundant plant equipment carefully remove and make good fabric in accordance with specification.

- 6 Eroded sandstone coping. Close inspection required. Replacement matching stone inserts may be required to prevent further deterioration.
- 7 Rusting lintels. Clean off and repaint in accordance with specification.

- 8 Biological growth to be removed from roof level.
- 9 Coping water staining. May require repointing. Close inspection required.
- 10 Previous repairs to sandstone. Poorly matched aesthetic and presumed composition, but no evidence repairs are causing damage to surrounding historic fabric. Add to building maintenance plan for regular monitoring.

- 11 Biological growth to stone to be cleaned in accordance with specification.
- 12 Water staining may be caused by missing pointing. Close inspection required to inform repair strategy.

- 13 Signs of cracking. Further inspection required on site.
- 14 Redundant cables/lights/alarm box. Carefully remove
- 15 Residue from former sign to be cleaned off sandstone. Method pending site trials.

- 16 Existing timber to be carefully removed from brickwork

General atmospheric dirt to masonry faces. No sign of causing damage to underlying fabric. Propose no action.

Flashings to be renewed as required

All notes based on pavement level inspection only. Close inspection required following receipt of Listed Building Consent to inform final scope of repair works package.
