St Margarets (App. 2),  
Manchester  
For Charlotte Street Estates

## Back Piccadilly Elevation - Repairs and Conditions

PROJECT REF. 2093  
DRWG NO. P(226)  
REVISION  
SCALE 1:100 @ A3  
DATE 1st Aug 25  
DRAWN GS

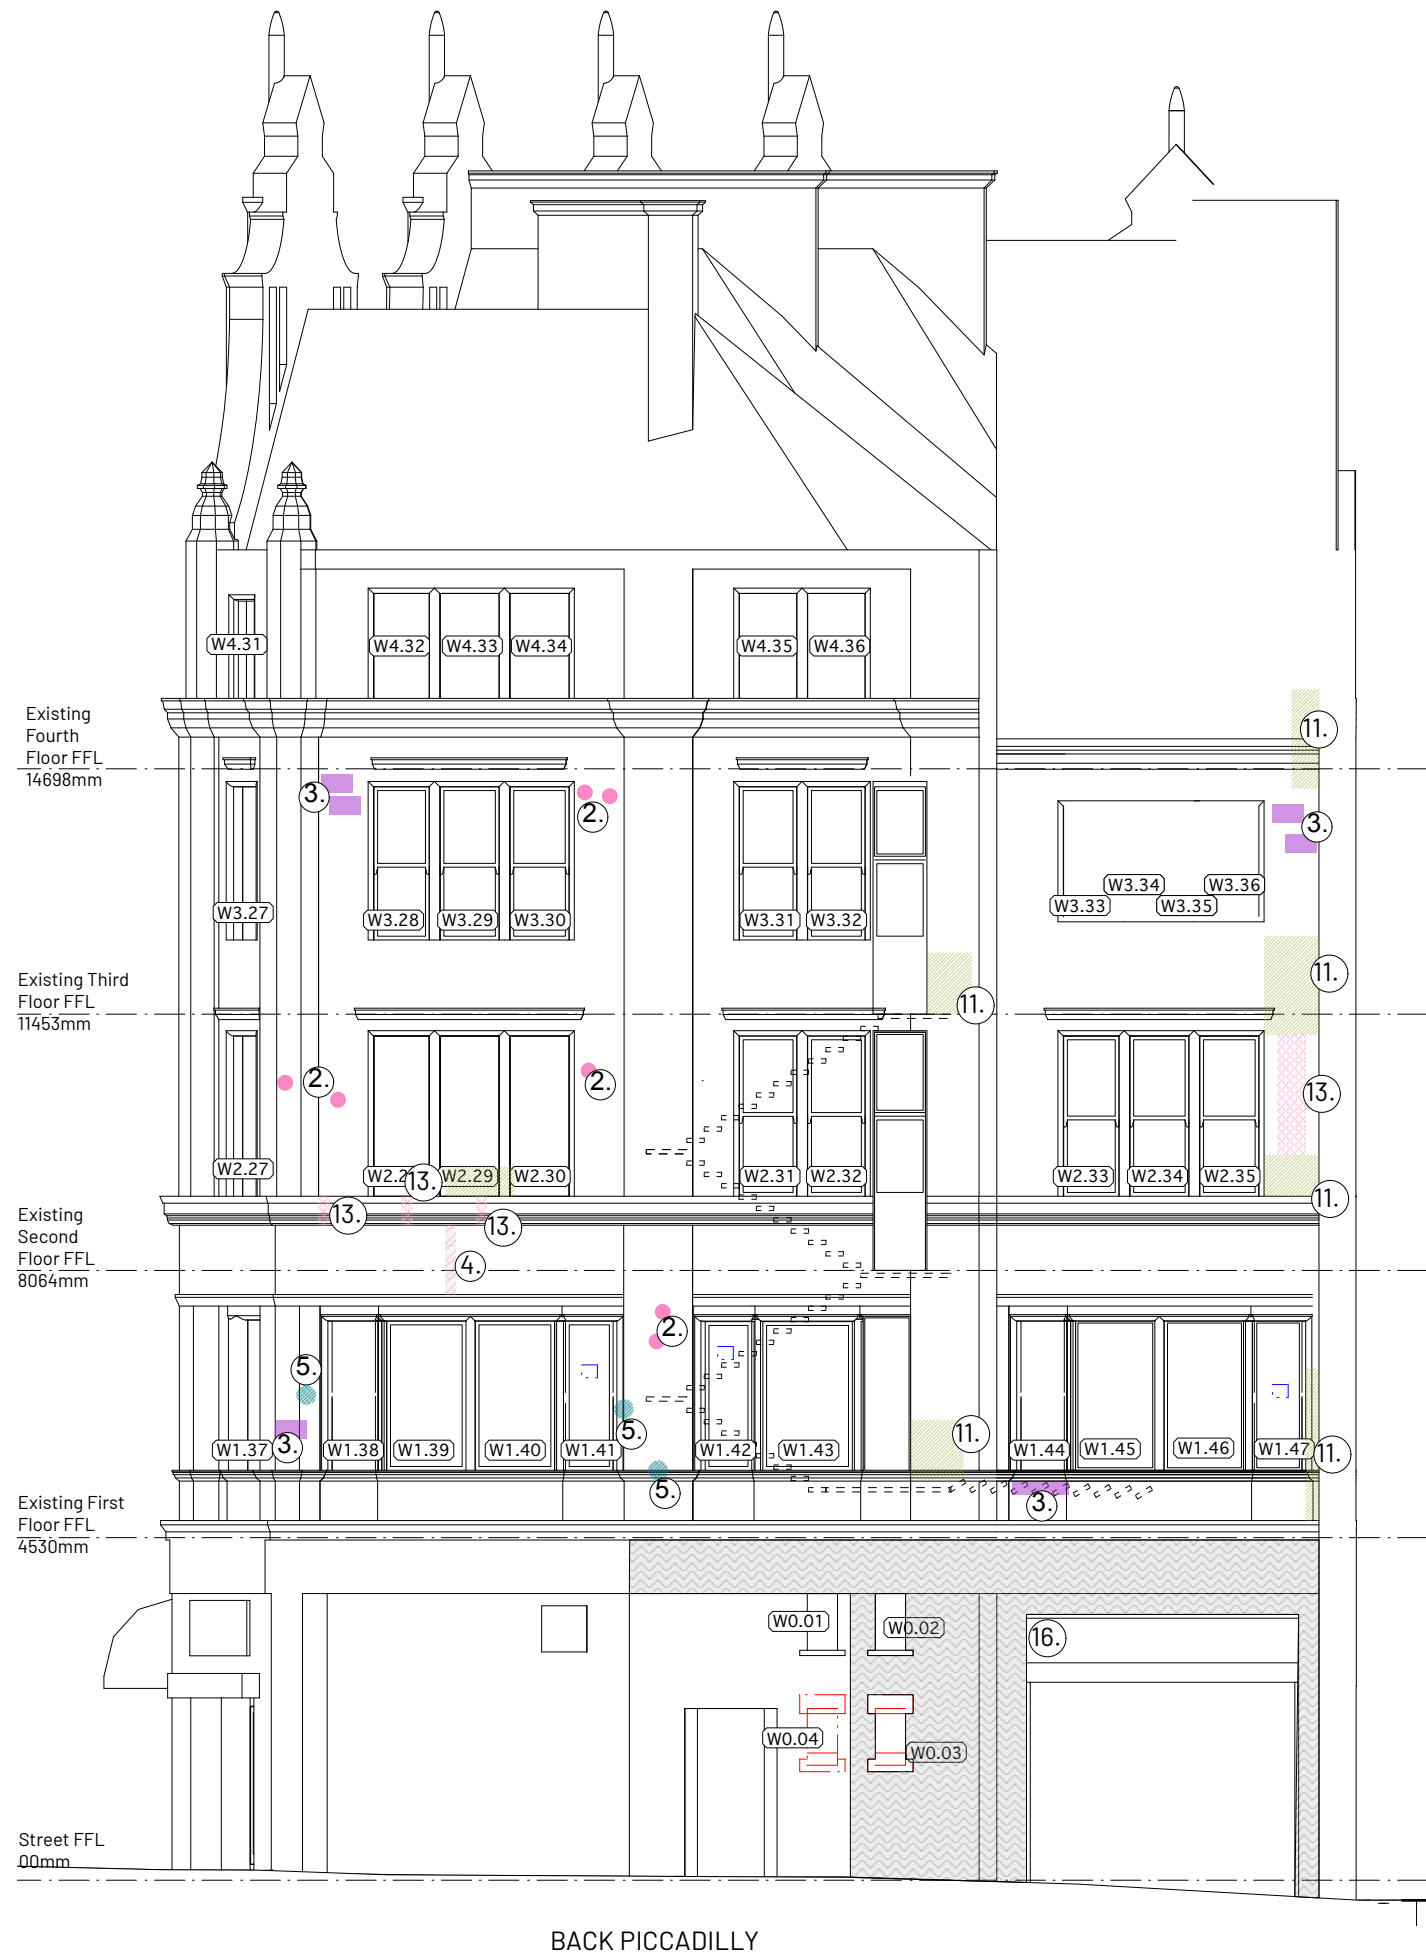
- 1 Sandstone erosion - close inspection required.
- 2 Holes left by redundant fixings - mortar fill in accordance with specification.
- 3 Gaps in brickwork. Close inspection required to inform replacement with matching material.

- 4 Missing pointing between frieze panels. Reinstate in accordance with specification.
- 5 Redundant plant equipment carefully remove and make good fabric in accordance with specification.

- 6 Eroded sandstone coping. Close inspection required. Replacement matching stone inserts may be required to prevent further deterioration.
- 7 Rusting lintels Clean off and repaint in accordance with specification.

- 8 Biological growth to be removed from roof level.
- 9 Coping water staining. May require repointing. Close inspection required.
- 10 Previous repairs to sandstone. Poorly matched aesthetic and presumed composition, but no evidence repairs are causing damage to surrounding historic fabric. Add to building maintenance plan for regular monitoring.

- 11 Biological growth to stone to be cleaned in accordance with specification.
- 12 Water staining may be caused by missing pointing. Close inspection required to inform repair strategy.

- 13 Signs of cracking. Further inspection required on site.
- 14 Redundant cables/lights/alarm box. Carefully remove
- 15 Residue from former sign to be cleaned off sandstone. Method pending site trials.

- 16 Non-original paintwork to be carefully removed.

General atmospheric dirt to masonry faces. No sign of causing damage to underlying fabric. Propose no action.
