# ARBORICULTURAL IMPLICATIONS ASSESSMENT

PROPOSED DEVELOPMENT

LANCASTER HOUSE  
7 LANCASTER ROAD  
DIDSBURY

Author: C. Salisbury  
Date: 30 November 2022  
Ref: TRE/LH7LRD

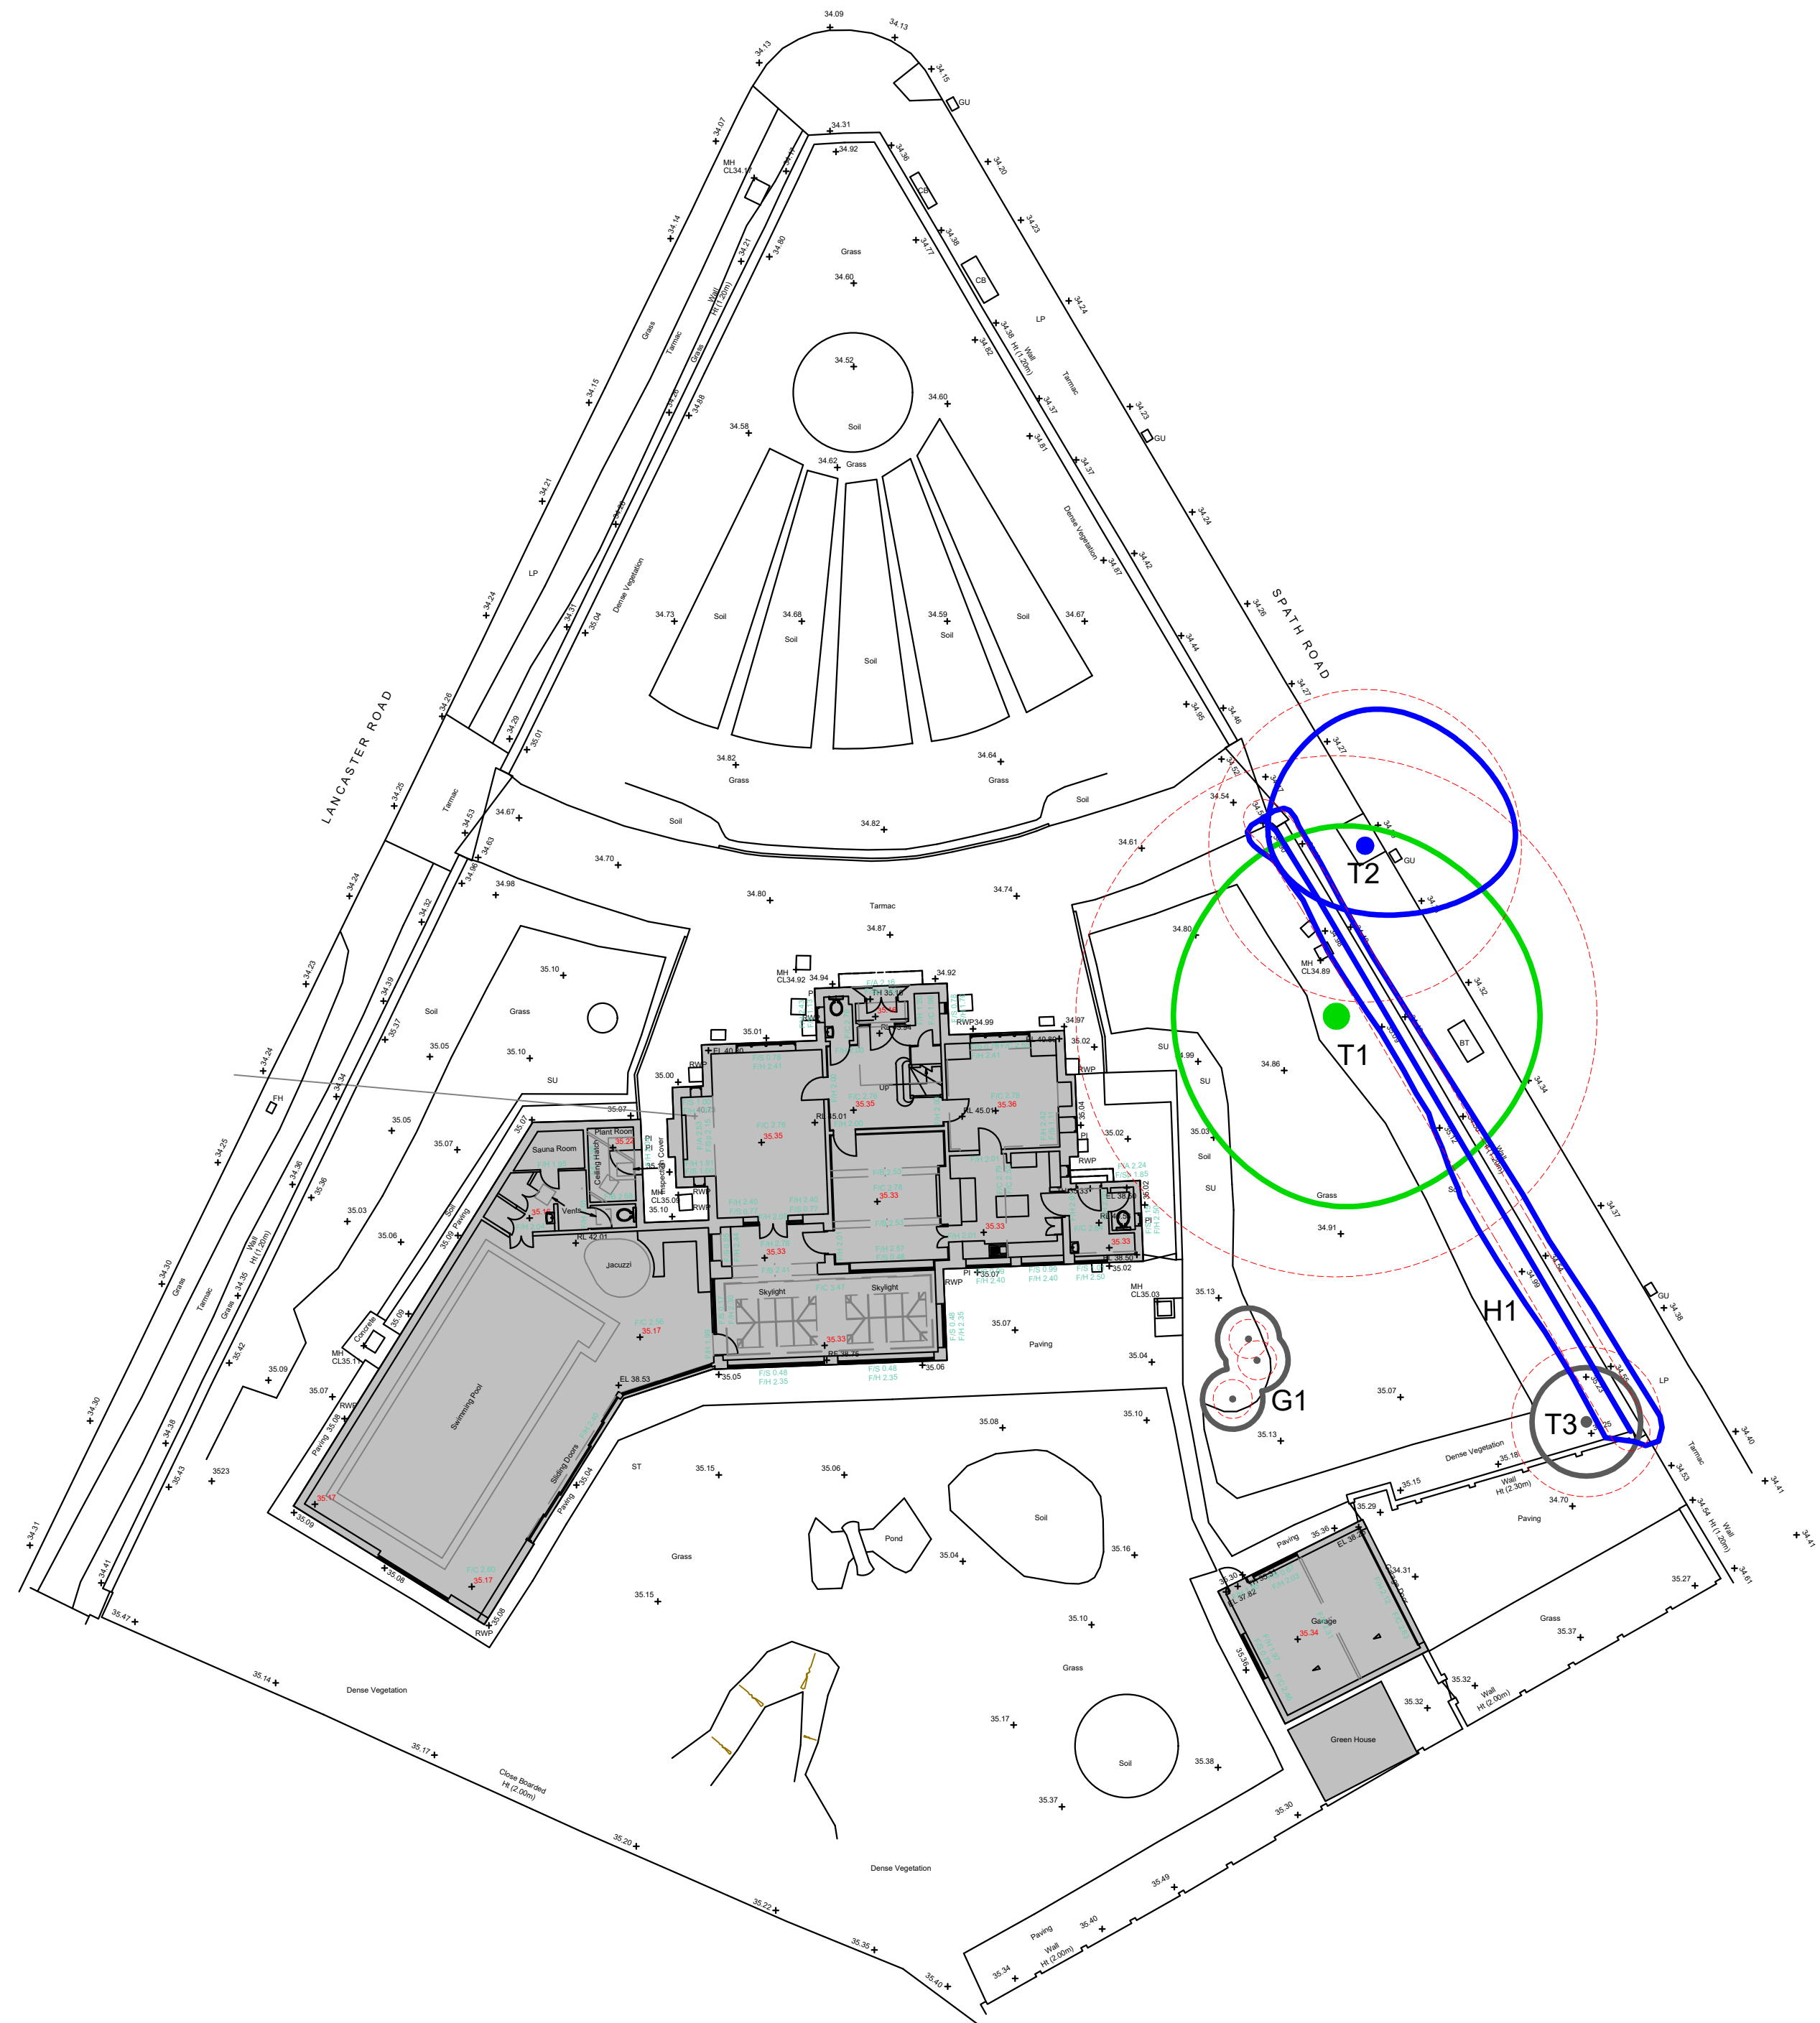
Drawing Title:  
BS5837 Plan

- 2.1 The trees were surveyed (prefixed T, or G for group) and recorded in the tree schedule in appendix one. Where groups are recorded, average height and diameter at breast height (DBH) of the trees in the group are reported. Where access to the base of any trees was limited, stem size was estimated.
- 2.2 All the trees were assessed using: a grading A to C (retention) and U (removal); condition and age class as defined in appendix two.
- 2.3 Where appropriate, canopy spread for each tree was recorded at four cardinal points in order to reproduce an accurate representation of the crown shape of the tree on the tree plan in appendix three.
- 2.4 The survey included all trees within the proposal area and trees near to the proposal.

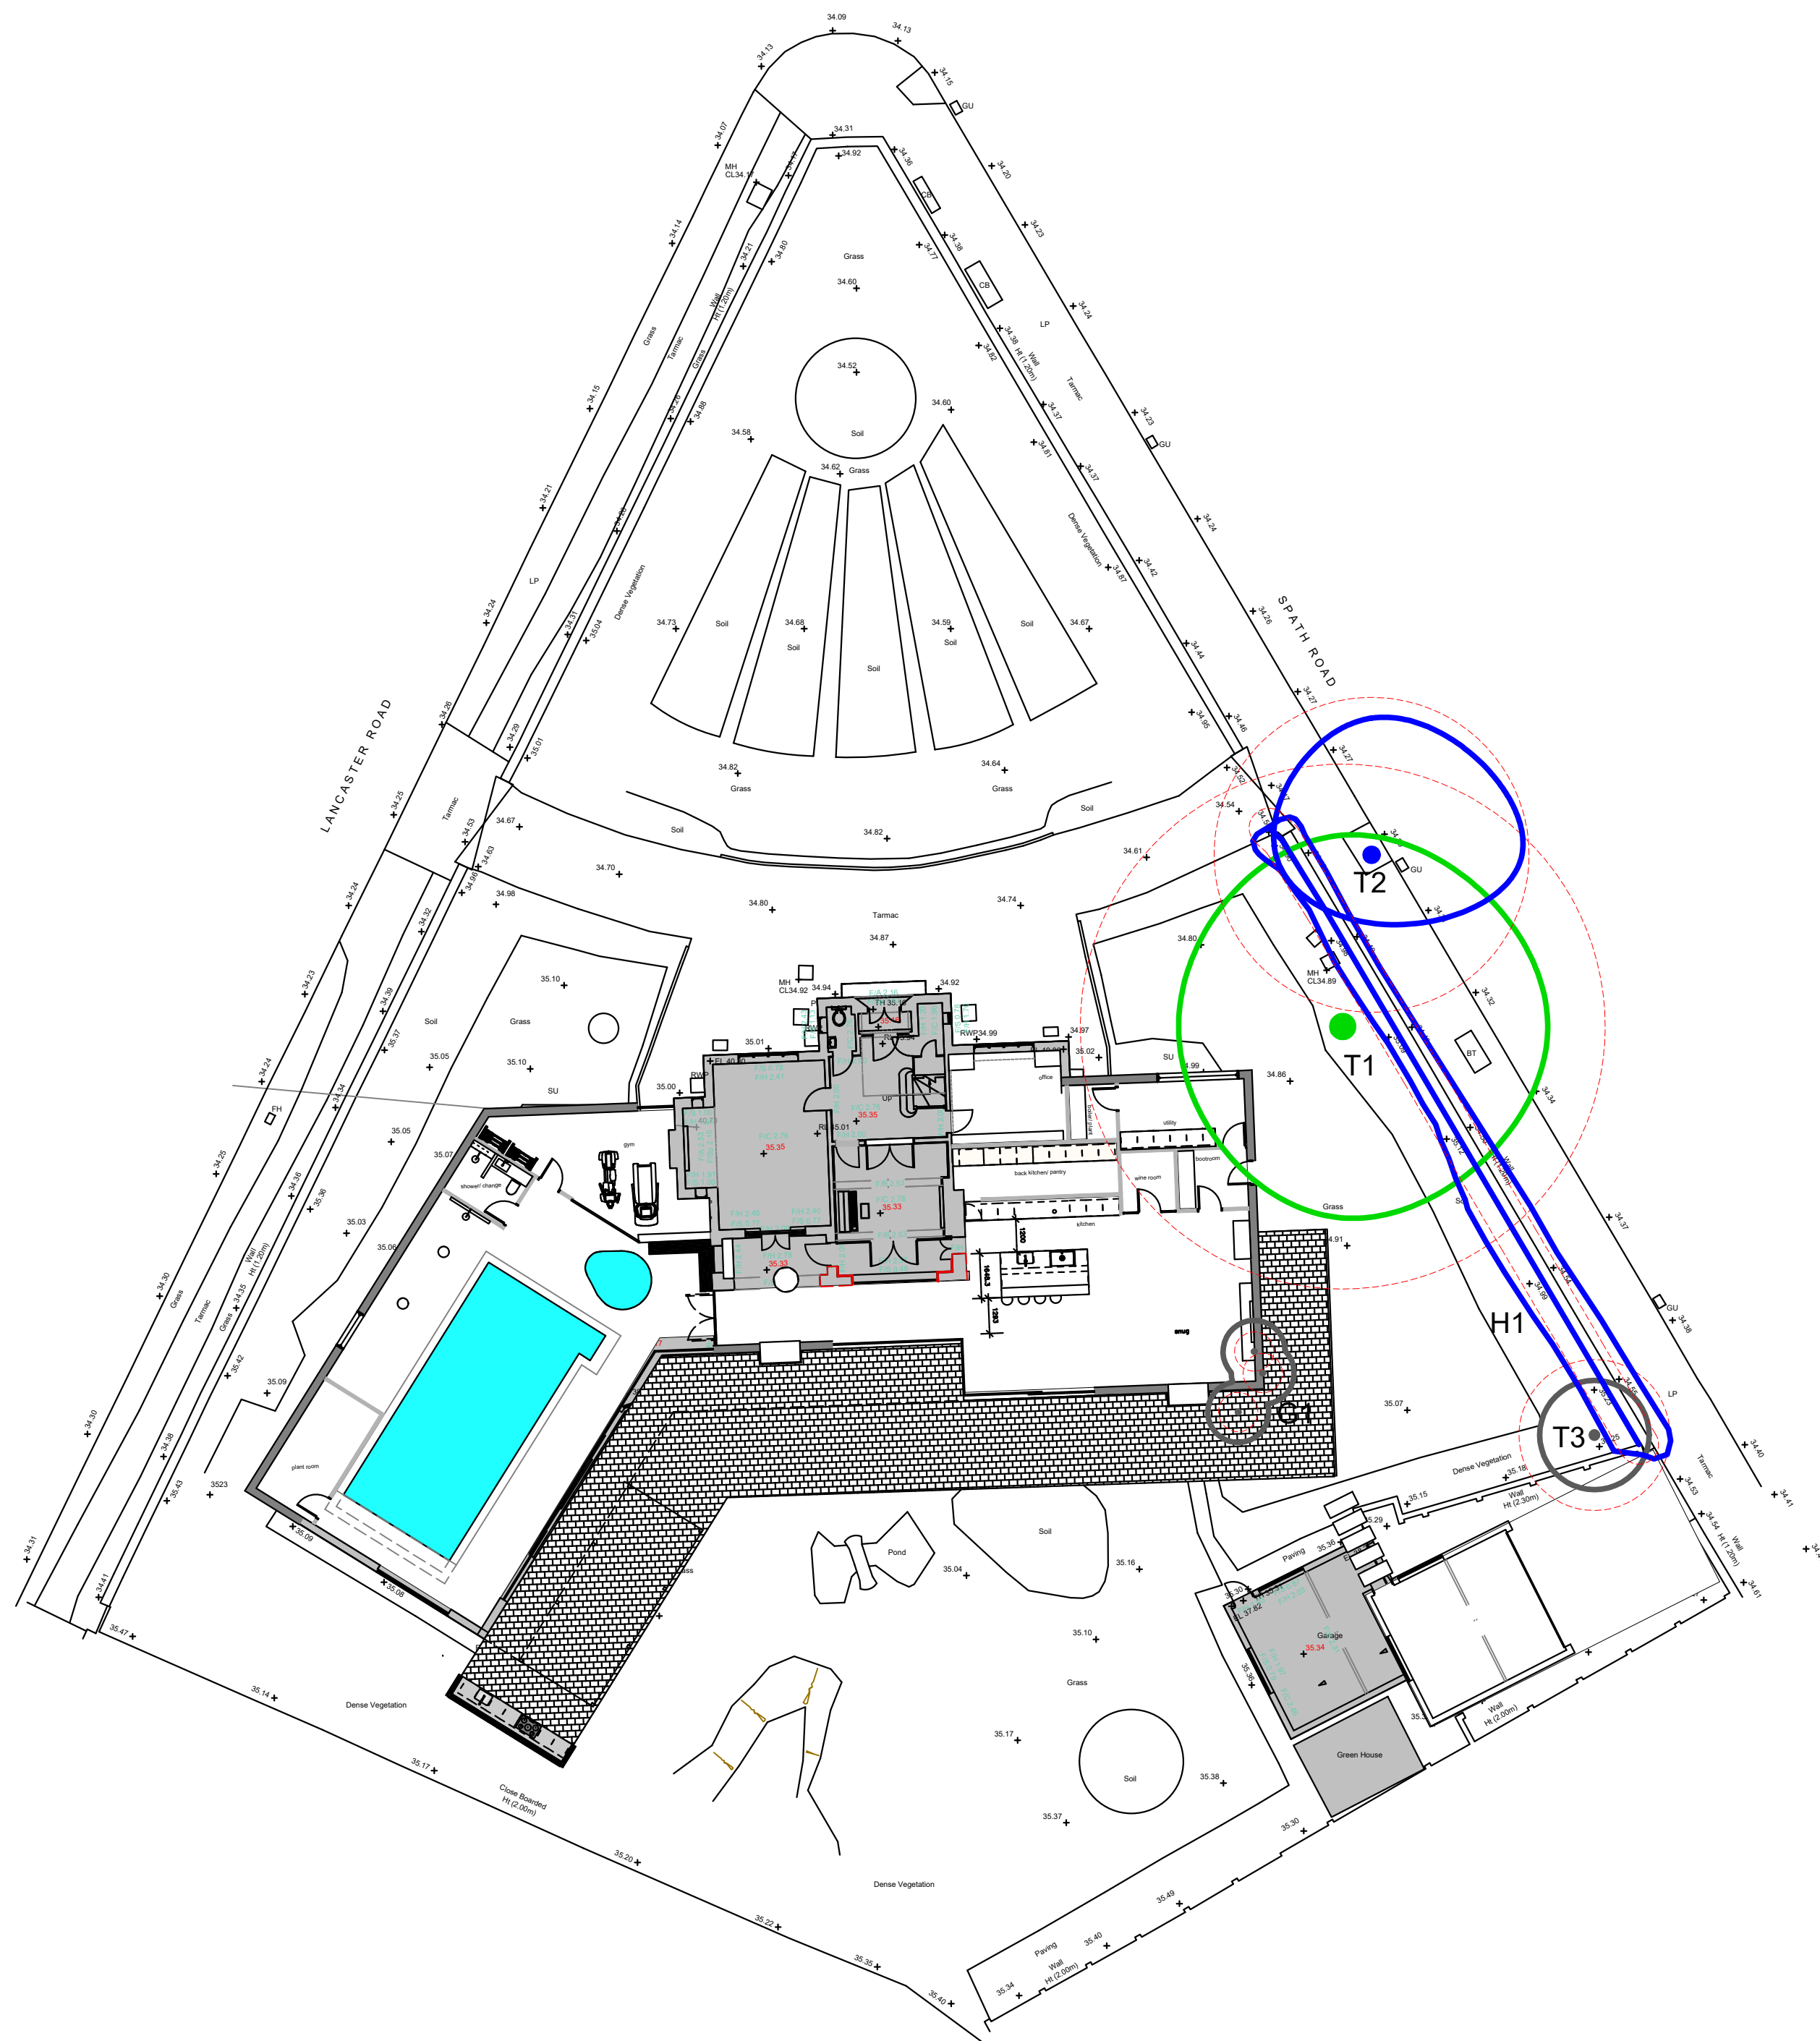
Drawing Title:  
AIS Plan

- 3.1 Due to the proposed development and its associated infrastructure there are a number of locations where the proposals are in close proximity to the trees surveyed. The Site Layout Plan within appendix three identifies the trees in relation to the proposed development.
- 3.2 In order to fully assess the impact of the proposals an Impact Table has been created detailing each tree, which shows the proximity of the associated works to the tree.
- 3.3 This can then be assessed in accordance with BS 5837:2012 to determine whether the development will have a detrimental impact on the health of each tree. Once this has been determined remedial measures can be detailed to reduce the impact the proposals will have on the treescape.

- 5.1.1 The impact table below shows the proposed development having a minor encroachment into the root protection area of T1 & G5. It is felt that due to the species, condition and limited extent of encroachment the proposal will not have a detrimental impact on the safe useful life expectancy of these trees.
- 5.1.2 Section 7.5.3 of BS 5837:2012 advises that where a slab or minor structure is to be formed within the RPA it should not exceed 20% of any existing unsurfaced ground. The table below details the amount of encroachment within the RPA.

- 5.2.1 The impact table below shows the proposed patio having a minor encroachment into the root protection area of T1 & T6. It is felt that due to the species, condition and limited extent of encroachment the proposal will not have a detrimental impact on the safe useful life expectancy of these trees.
- 5.2.2 Section 7.4.2.3 of BS 5837:2012 advises that new permanent hard surfacing should not exceed 20% of any existing unsurfaced ground within the RPA. The table below details the amount of new surface proposed within the RPA of each tree.
