# KELBROOK ROAD OPENSHAW

## PHASE 2 GEO-ENVIRONMENTAL INVESTIGATION, RISK ASSESSMENT AND REMEDIATION STRATEGY

**Job Number:** LKC 21 1095

**Date:** September 2021

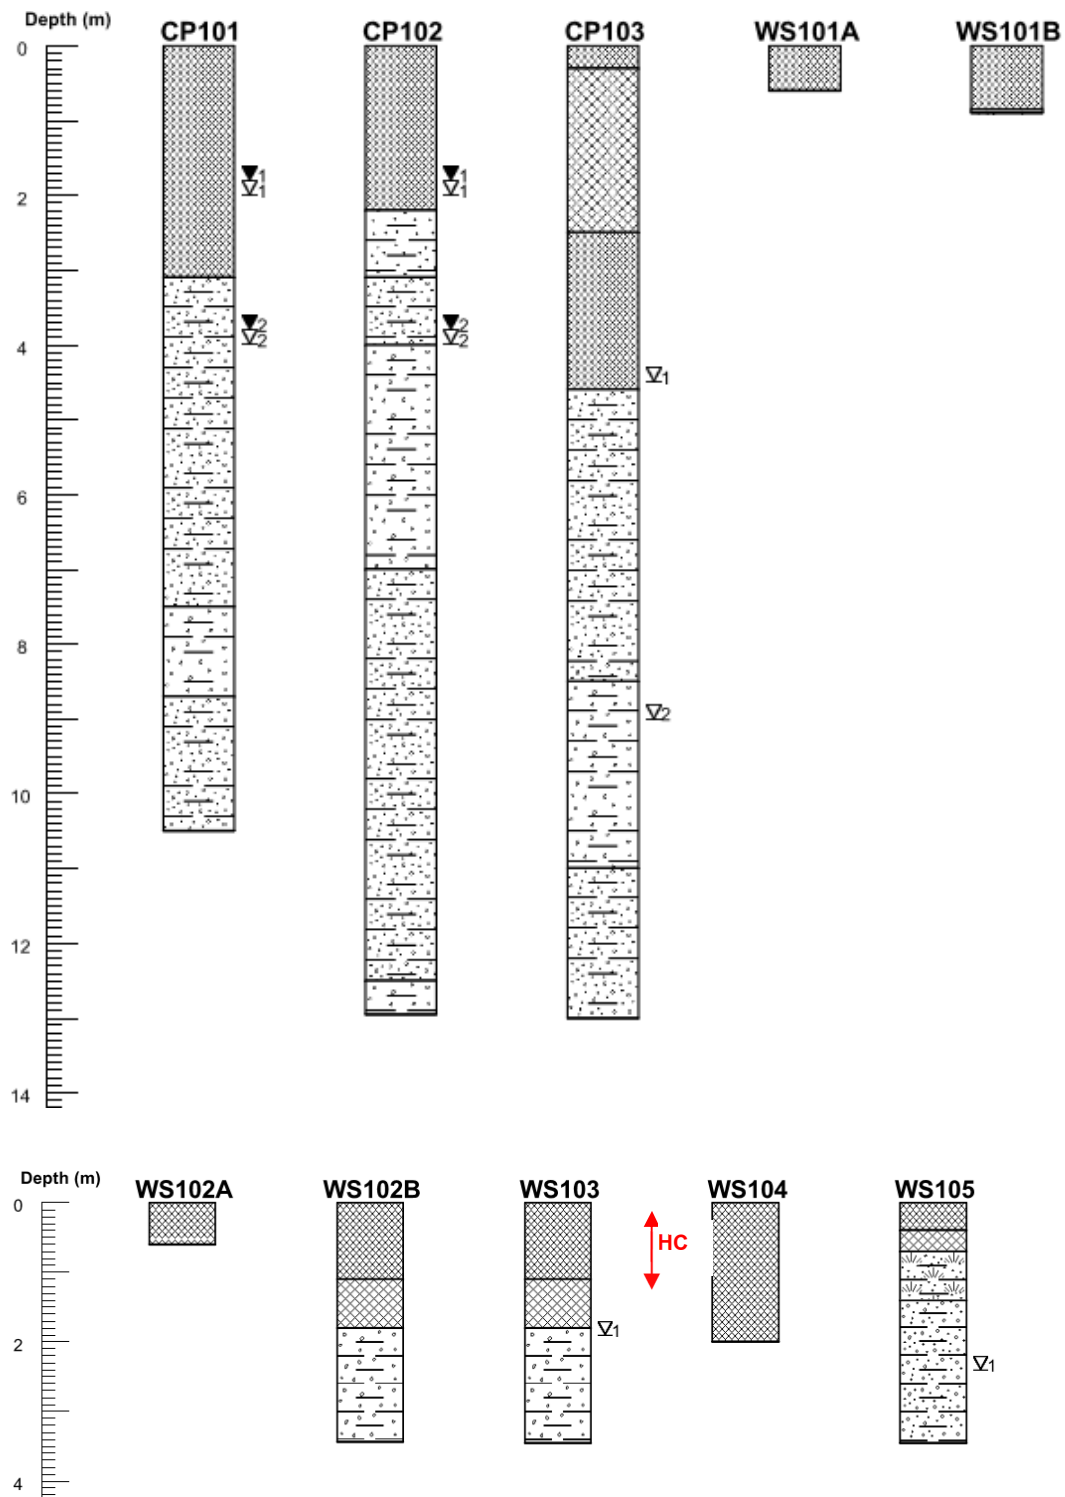
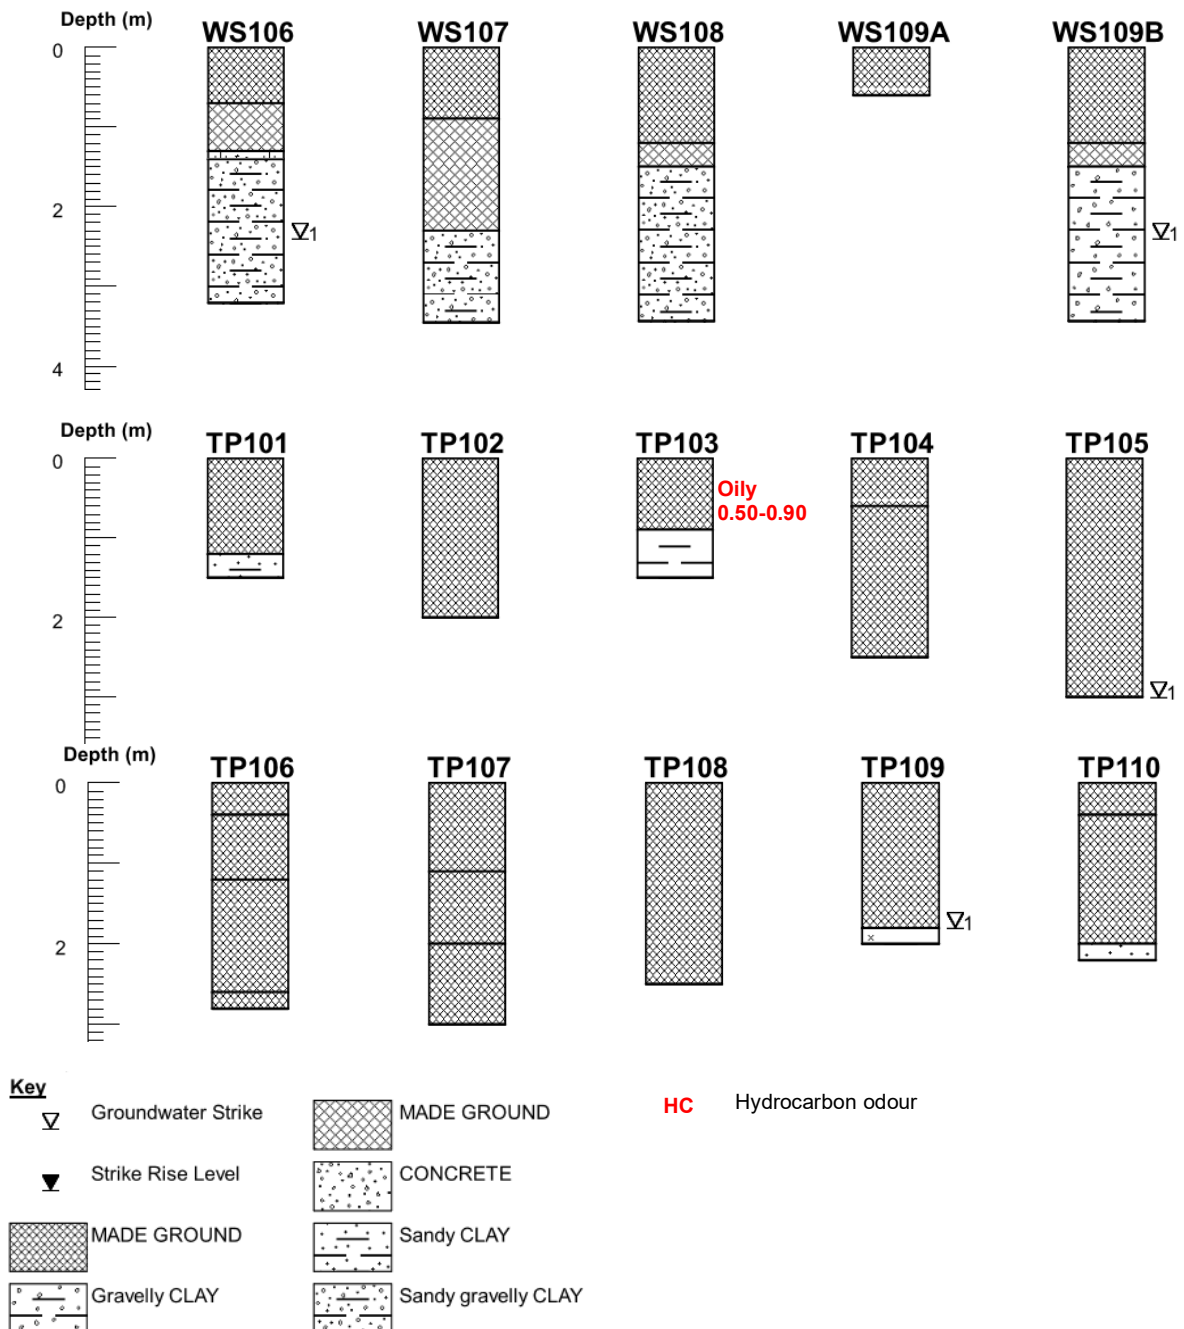
Plate 4-1: Summary of ground conditions.

The ground conditions beneath the site comprised Made Ground underlain by natural variably sandy gravelly CLAY (Diamicton). A summary section of the logs is provided in Plate 4-1, with additional comments below.

Plate 4-1 (cont.): Summary of ground conditions.

TP104 was located above the route of the suspected culvert and advanced to 2.50mbgl before encountering a refusal on Made Ground boulders. No evidence of a culvert was observed during the advancing of this location.

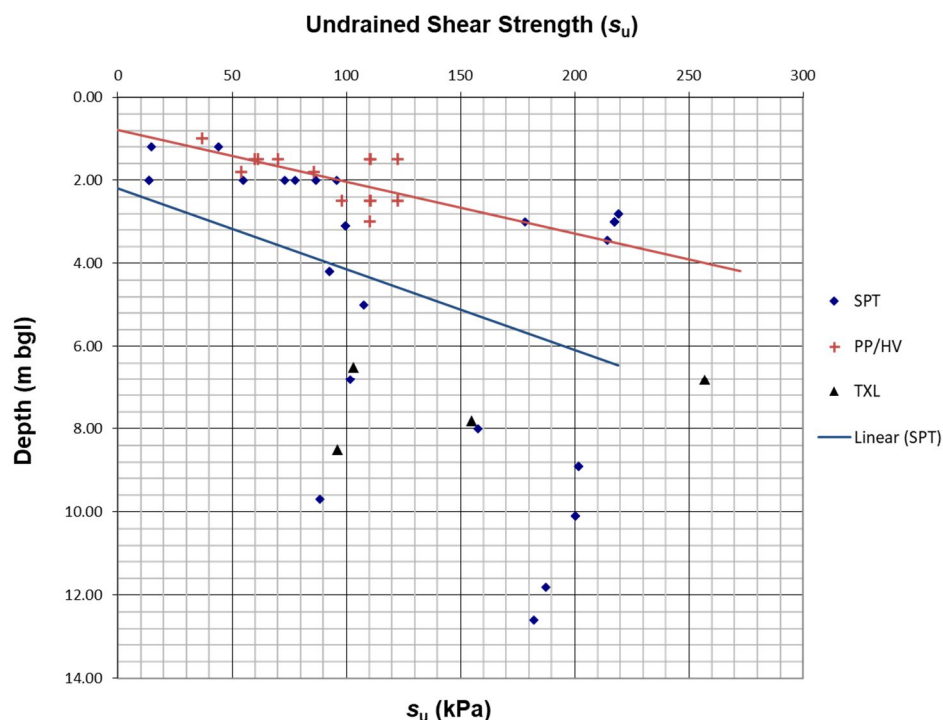
Graph 5-1: Summary of  $s_u$  vs depth from in-situ SPT, PP and HV and laboratory TXL testing.

Strength of the natural cohesive material has been assessed using in-situ testing by SPT, Pocket Penetrometer (PP) and Hand Shear Vane (HV). The results of the testing have been plotted against depth as is shown in Graph 5-1 below:

From Graph 5-1 it can be seen that the strength of the cohesive deposits typically increase with depth.

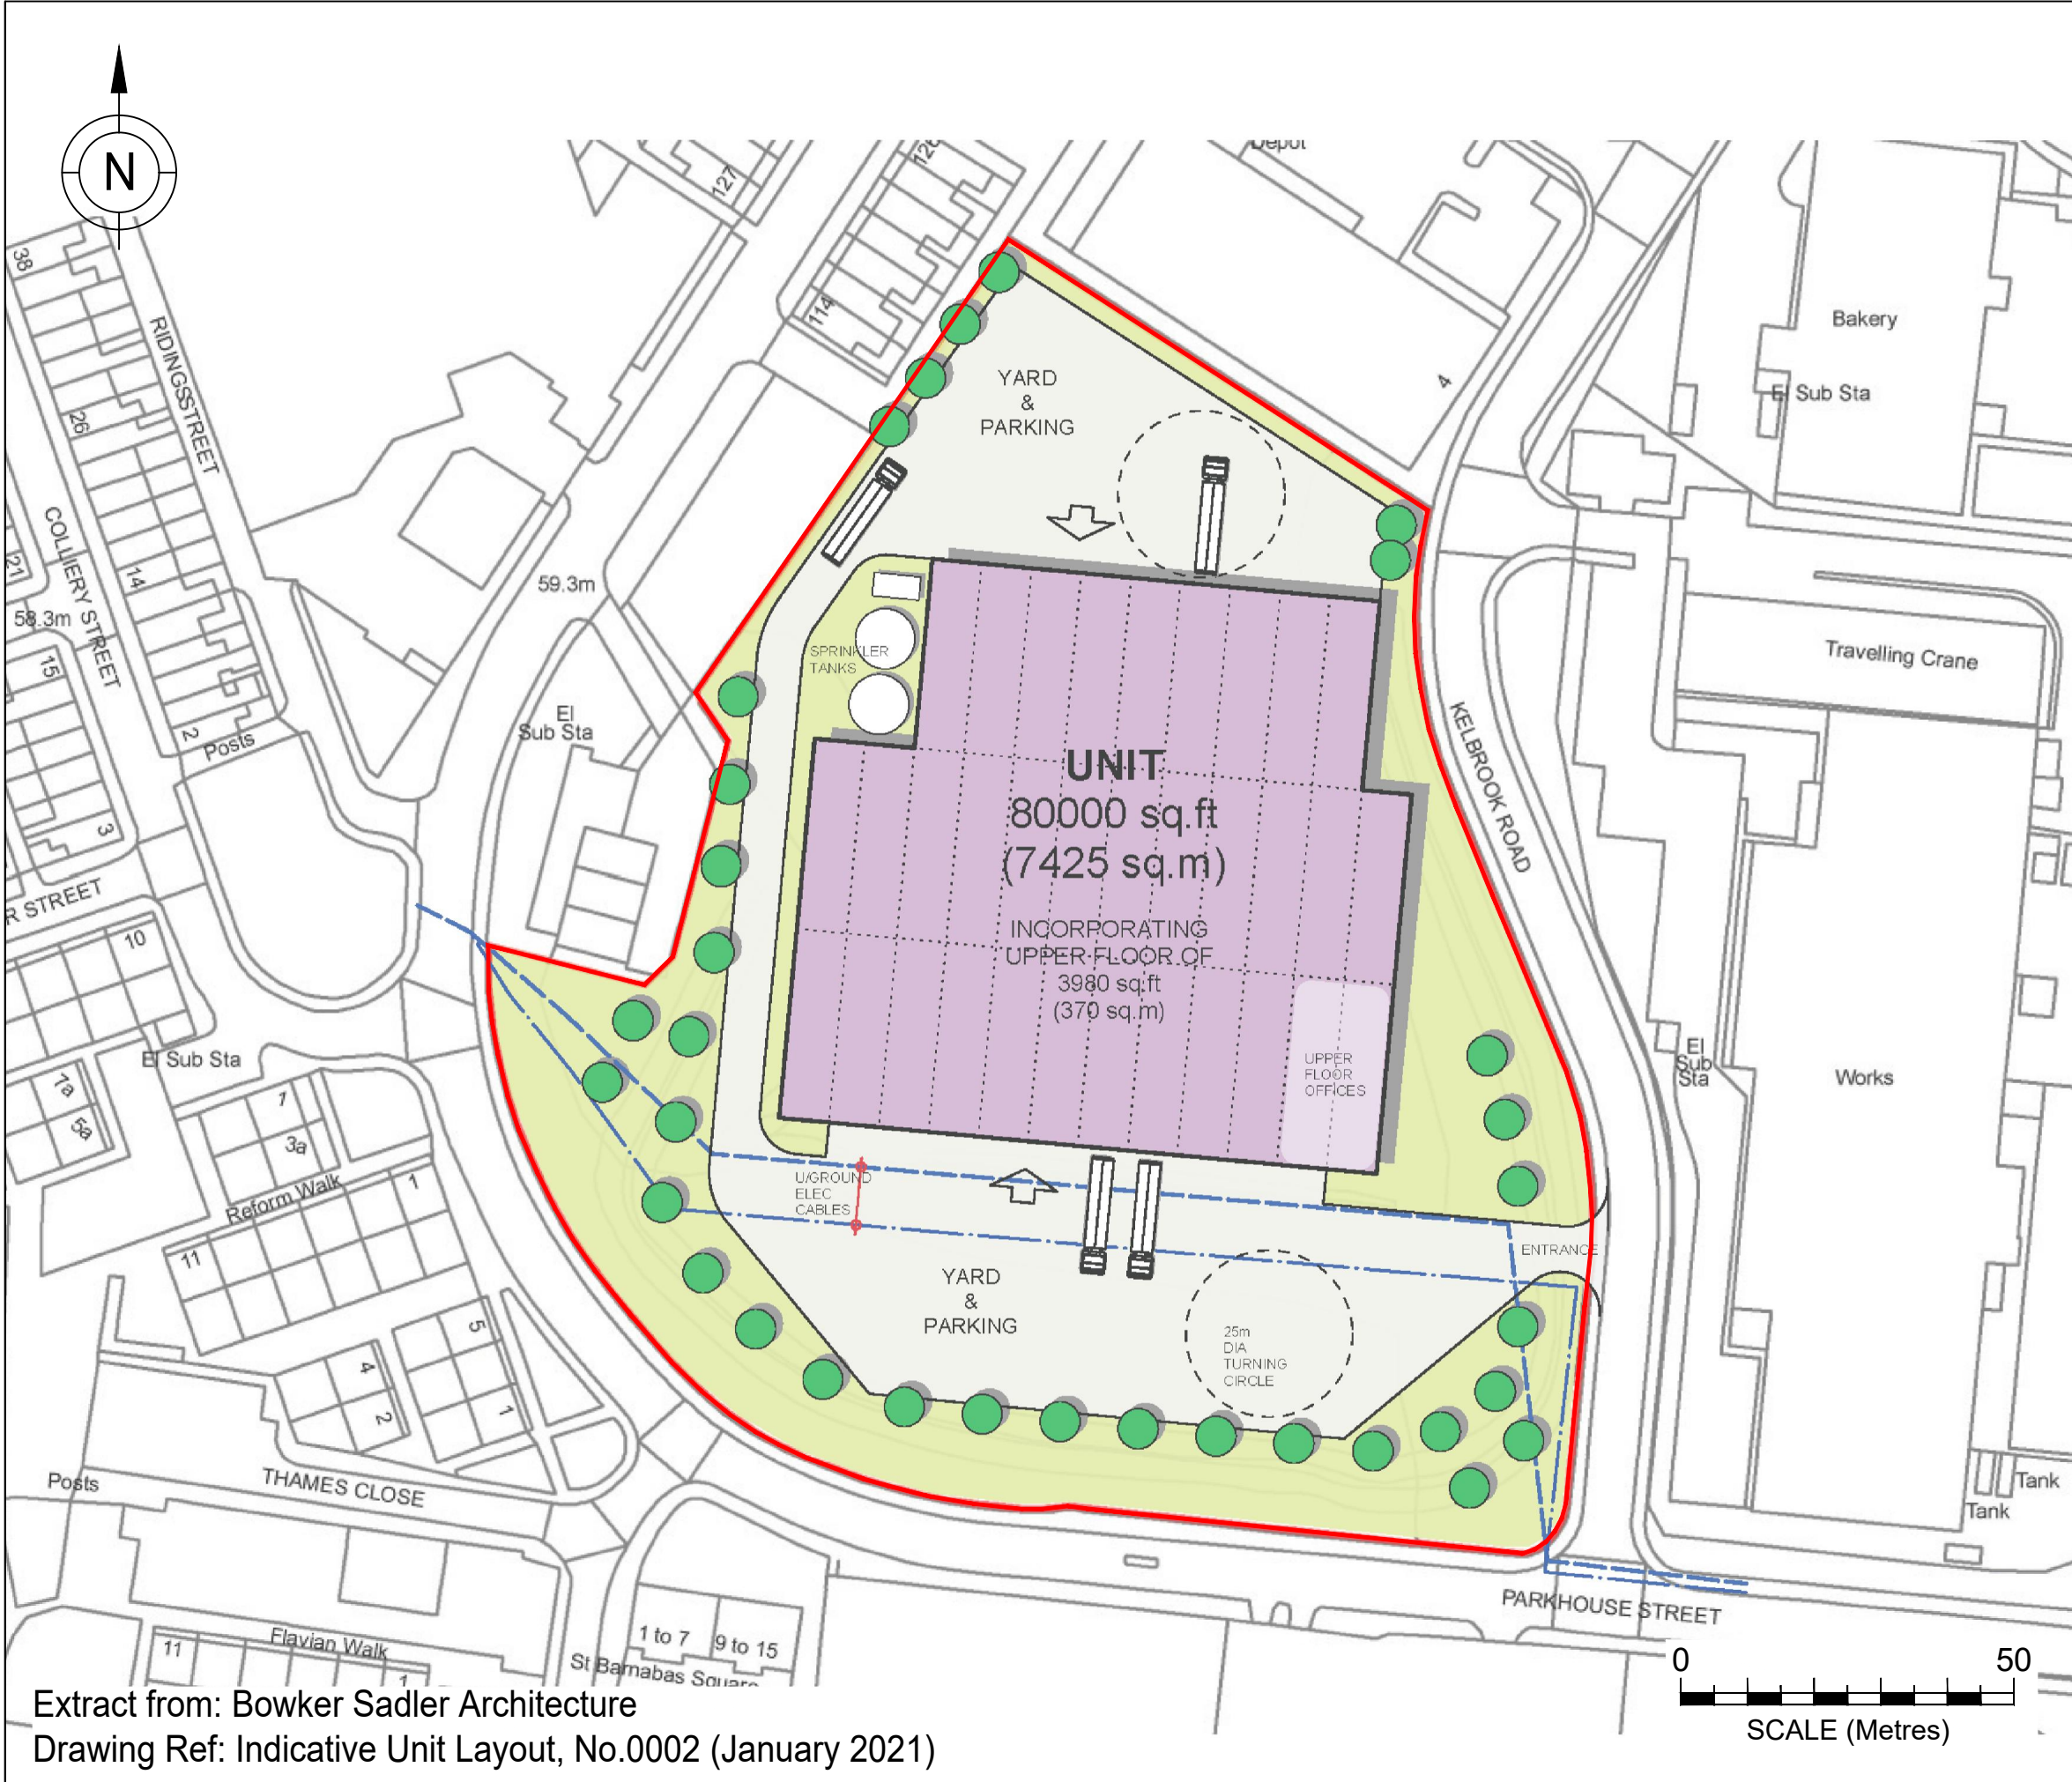
| Job No.:<br>LKC 21 1095 | Drawn By:<br>BR | Checked By:<br>CH | Drawn:<br>March 2021 | Scale (see scale bar):<br>1:10,000 &<br>1:2,000 @ A4 | | Figure:<br>1 | |

Site Boundary

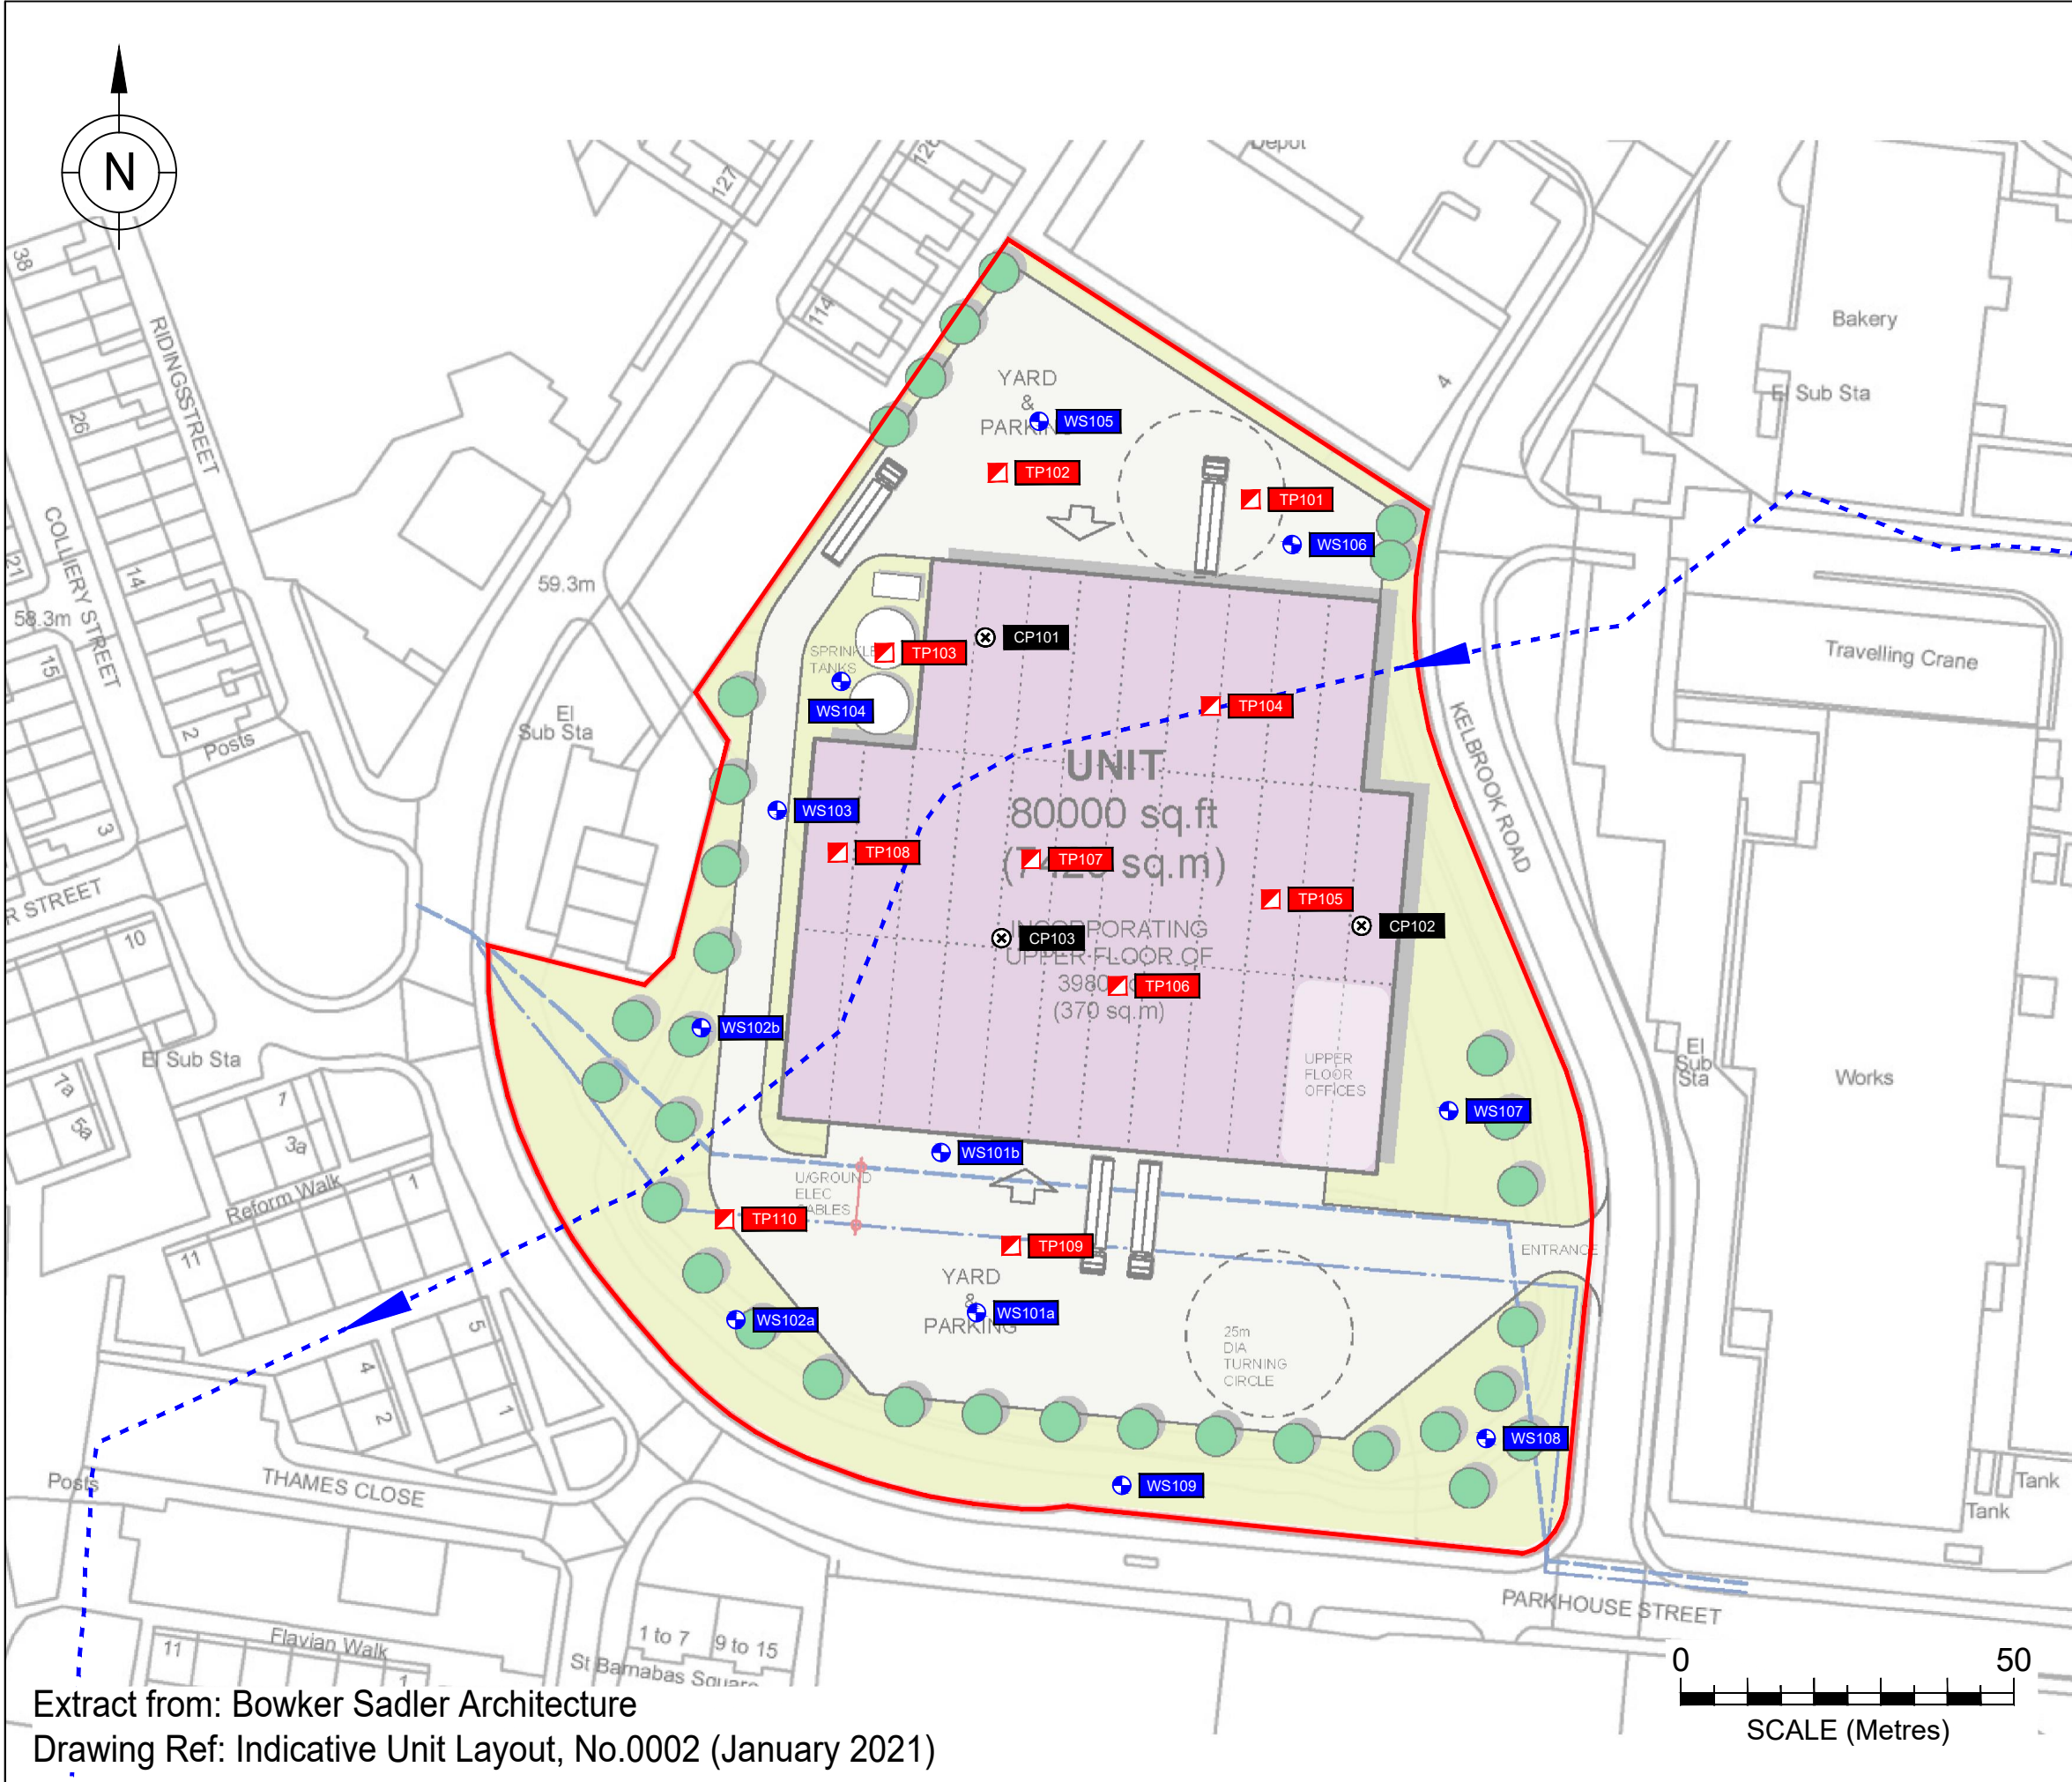
### KEY

- Site Boundary
- Window Sample Borehole (WS)
- Trial Pit (TP)
- Cable Percussive Borehole (CP)
- Culvert (1200BR) (United Utilities, Sewer Records 15/03/2021)

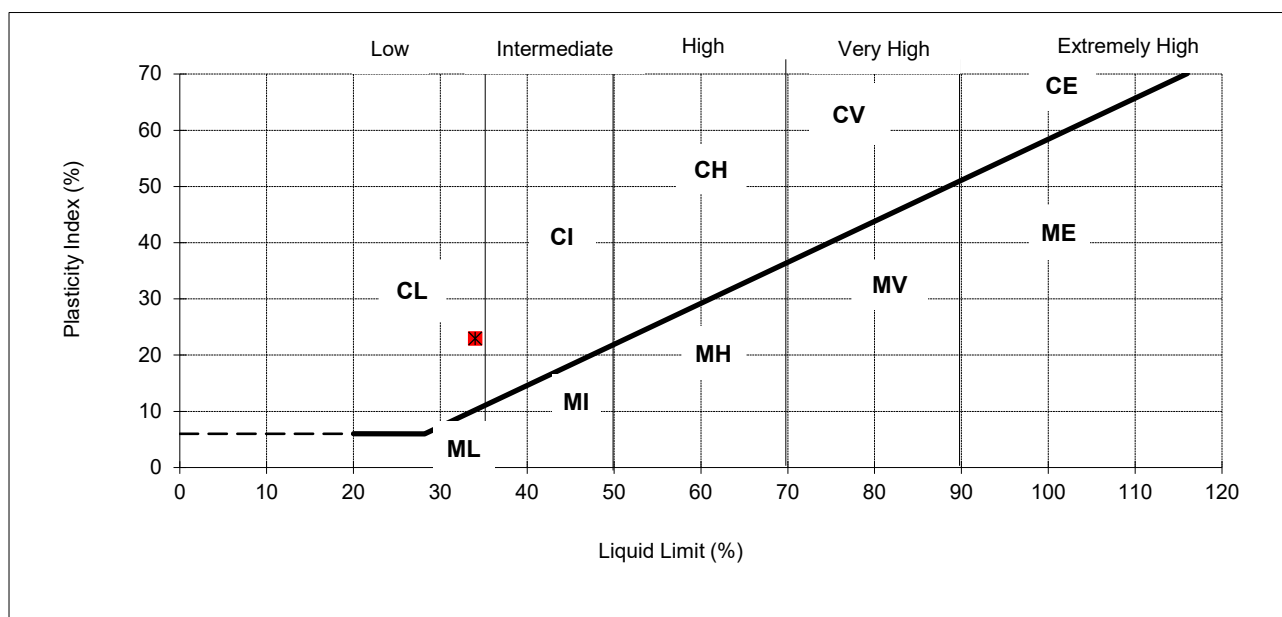
| Moisture Content<br>(Natural)<br>(%) | Liquid Limit<br>(%) | Plastic Limit<br>(%) | Plasticity Index<br>(%) | Passing<br>425 micron<br>(%) |
| 17 | 34 | 11 | 23 | 98 |

Sample tested in natural condition

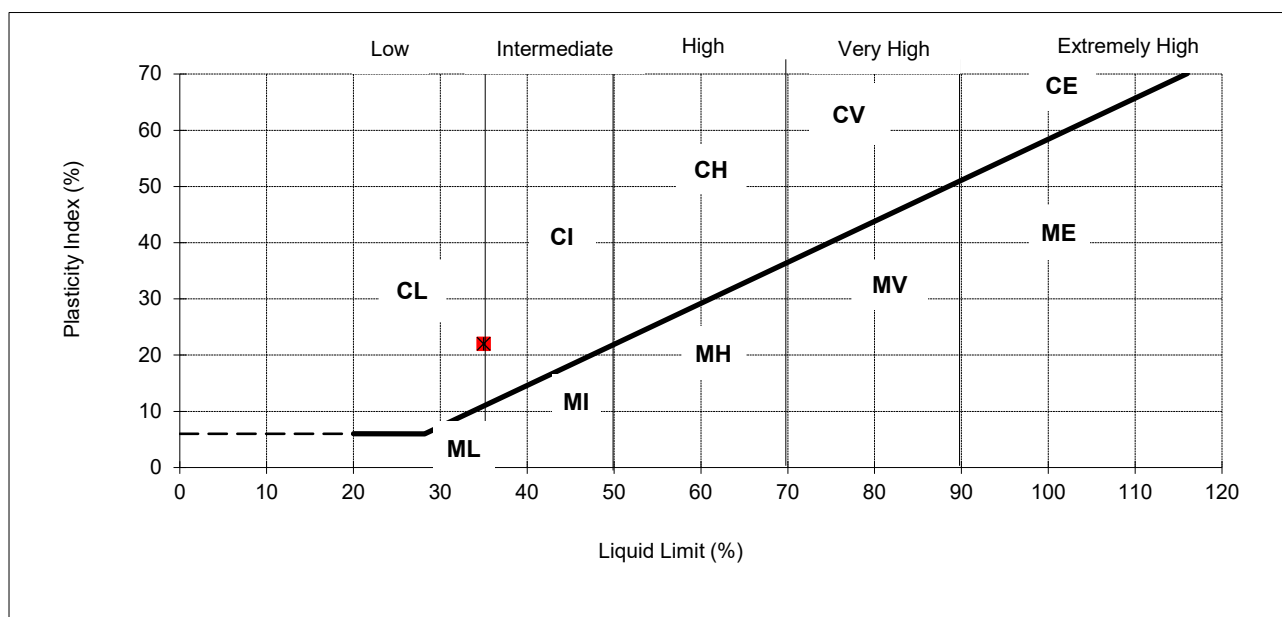
| Moisture Content<br>(Natural)<br>(%) | Liquid Limit<br>(%) | Plastic Limit<br>(%) | Plasticity Index<br>(%) | Passing<br>425 micron<br>(%) |
| 36 | 35 | 13 | 22 | 100 |

Sample tested in natural condition

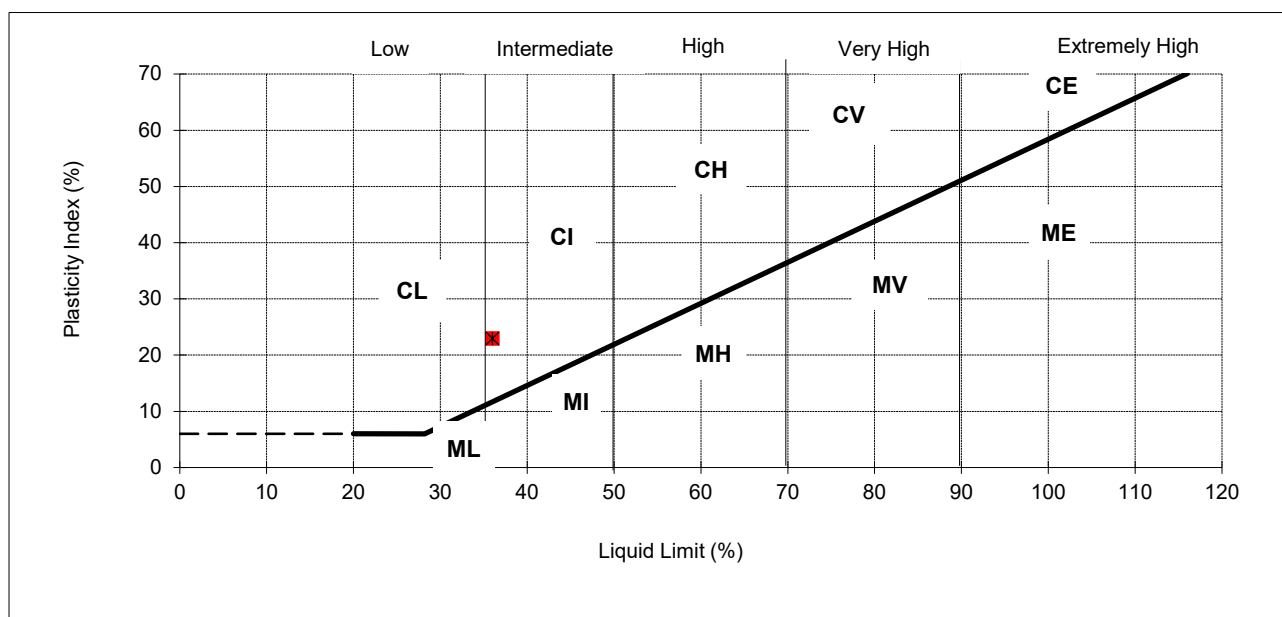
| Moisture Content<br>(Natural)<br>(%) | Liquid Limit<br>(%) | Plastic Limit<br>(%) | Plasticity Index<br>(%) | Passing<br>425 micron<br>(%) |
| 18 | 36 | 13 | 23 | 98 |

Sample tested in natural condition

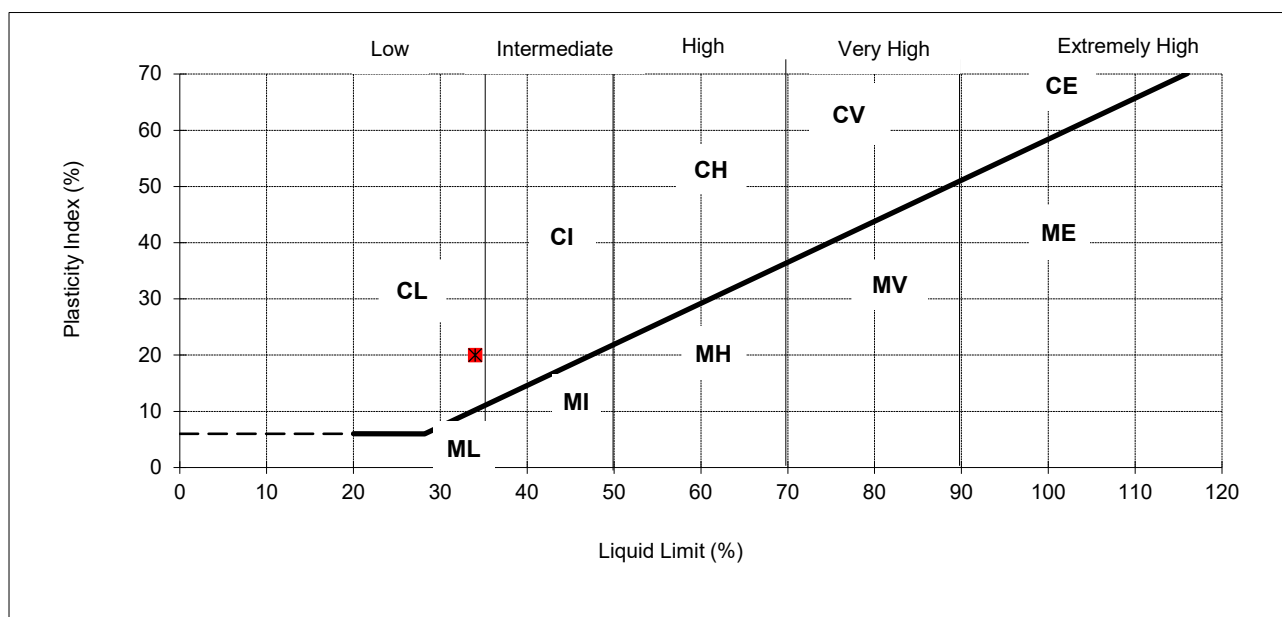
| Moisture Content<br>(Natural)<br>(%) | Liquid Limit<br>(%) | Plastic Limit<br>(%) | Plasticity Index<br>(%) | Passing<br>425 micron<br>(%) |
| 19 | 34 | 14 | 20 | 100 |

Sample tested in natural condition

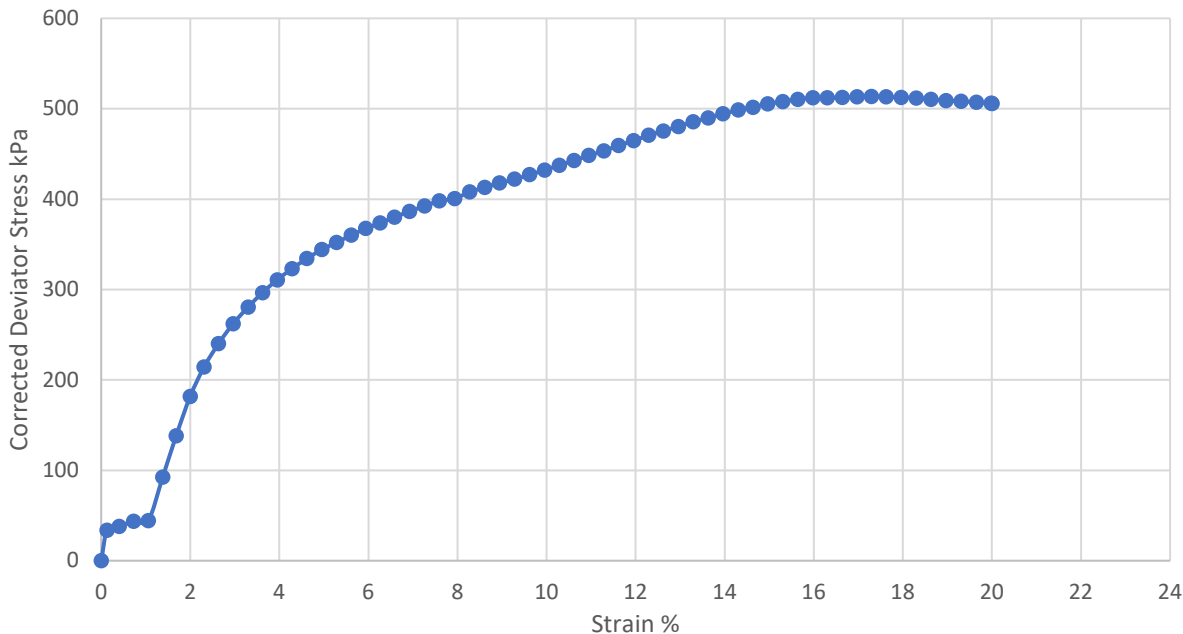
**CORRECTED DEVIATOR STRESS vs AXIAL STRAIN**

**TEST TYPE**  
SINGLE STAGE

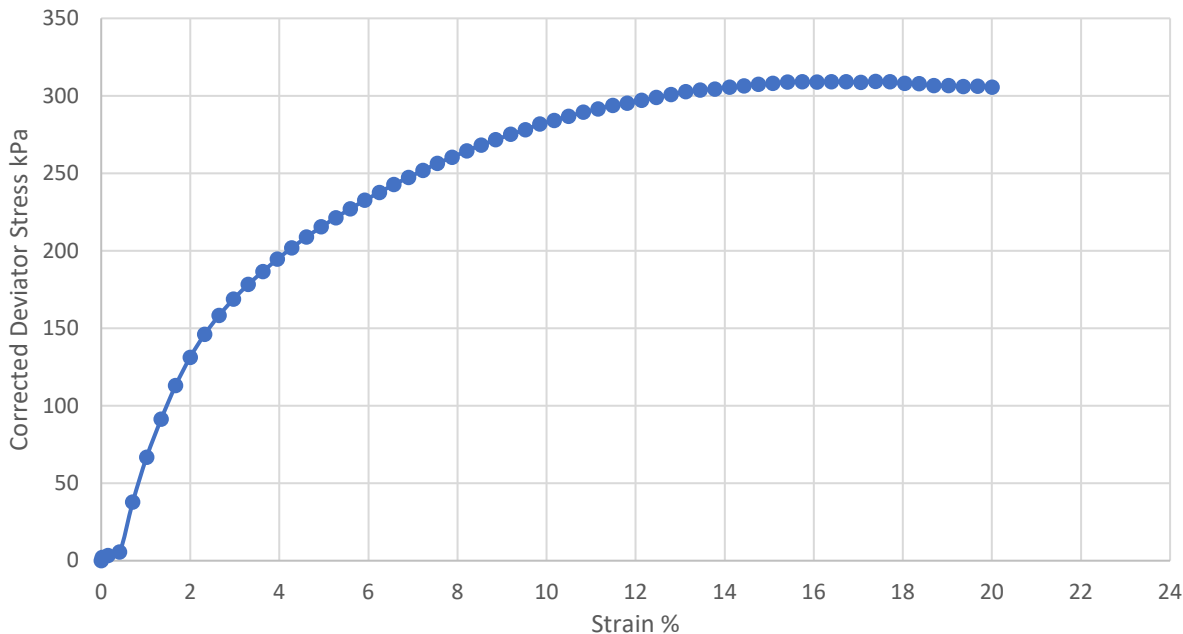
**CORRECTED DEVIATOR STRESS vs AXIAL STRAIN**

**TEST TYPE**  
SINGLE STAGE

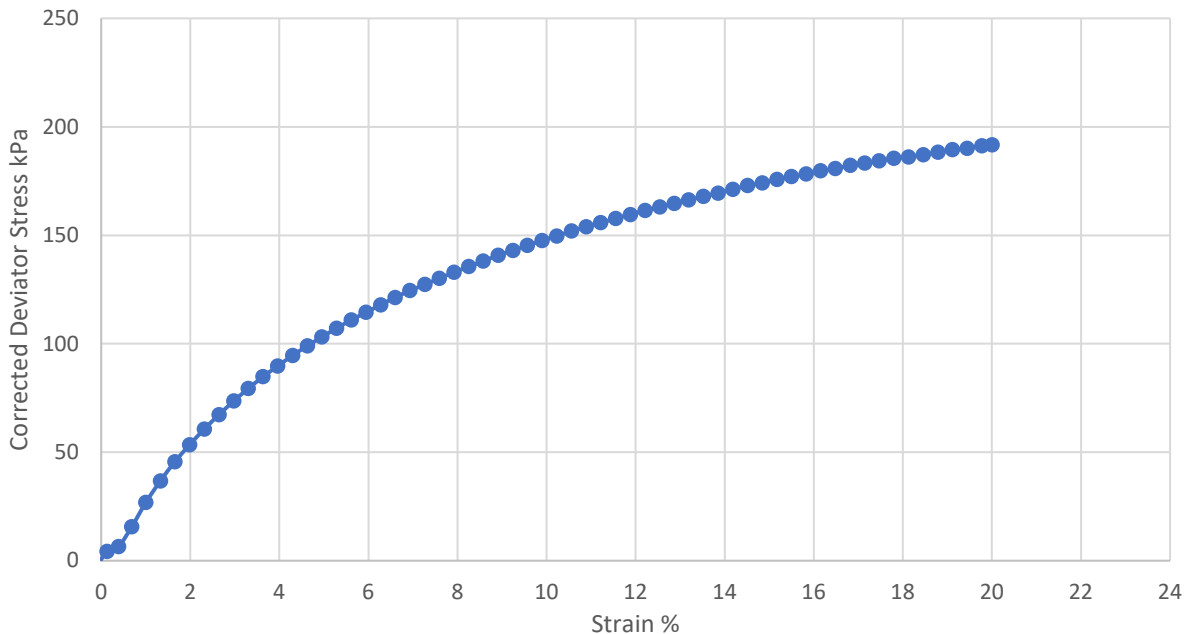
**CORRECTED DEVIATOR STRESS vs AXIAL STRAIN**

**TEST TYPE**  
SINGLE STAGE

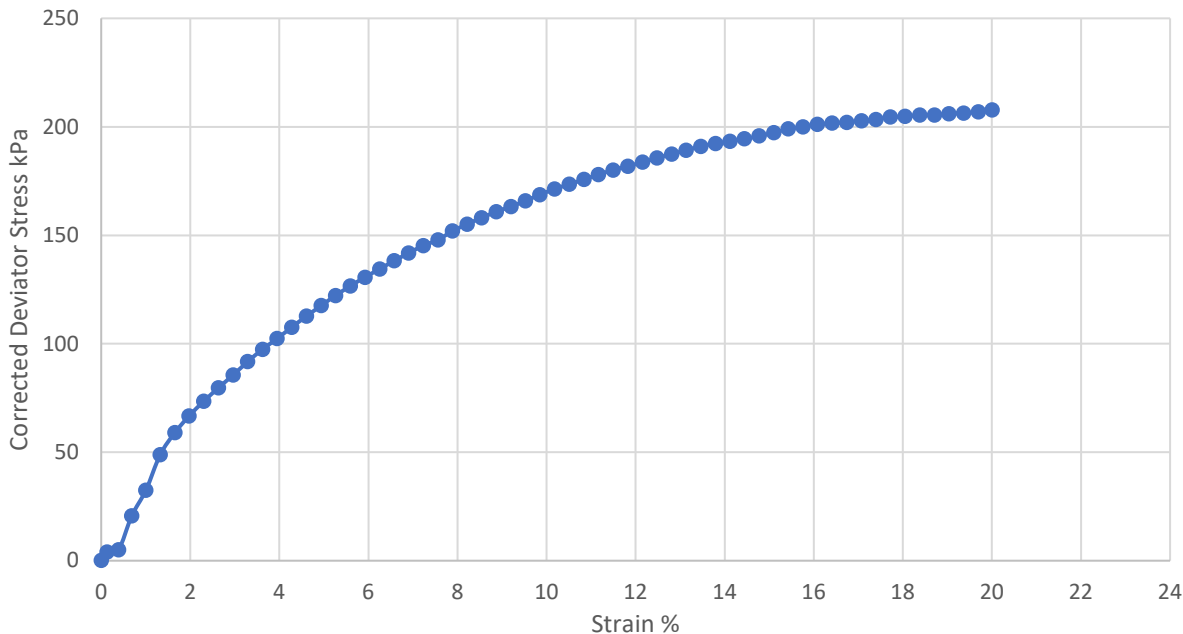
**CORRECTED DEVIATOR STRESS vs AXIAL STRAIN**

TEST TYPE  
SINGLE STAGE

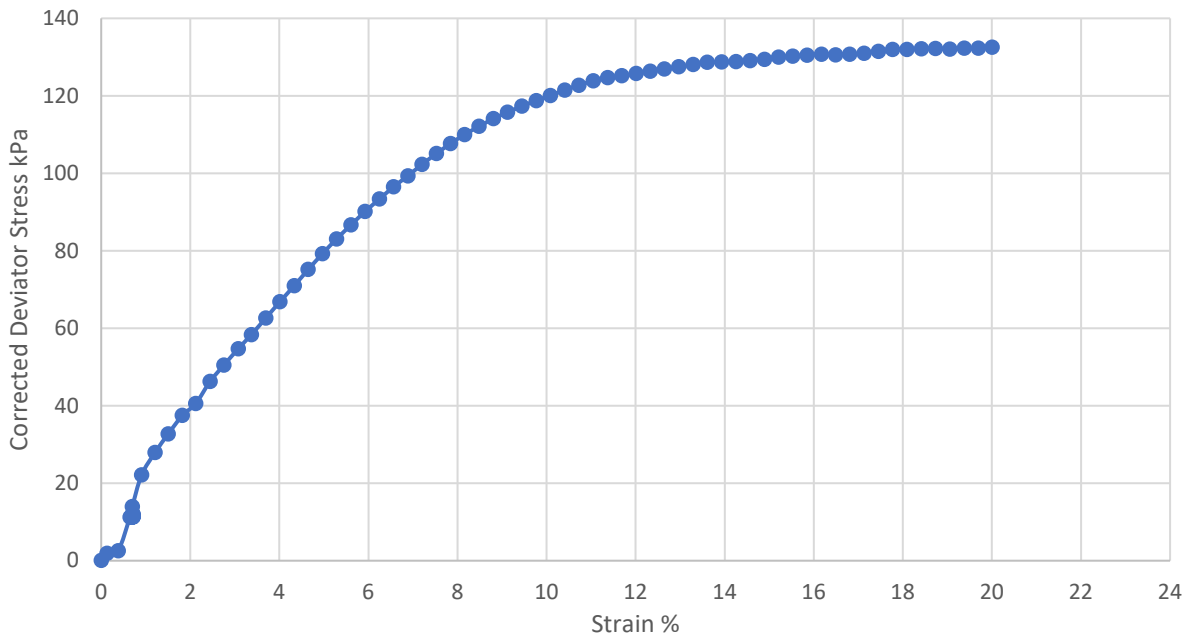
**CORRECTED DEVIATOR STRESS vs AXIAL STRAIN**

**TEST TYPE**  
SINGLE STAGE
