Project: MSP GREENHEYS

TYPICAL LEVEL 6  
RAINSCREEN PANEL PERFORATION PATTERNS

Drawing Ref: GRE-LON-ZZ-06-DR-X-05504 Suitability Revision

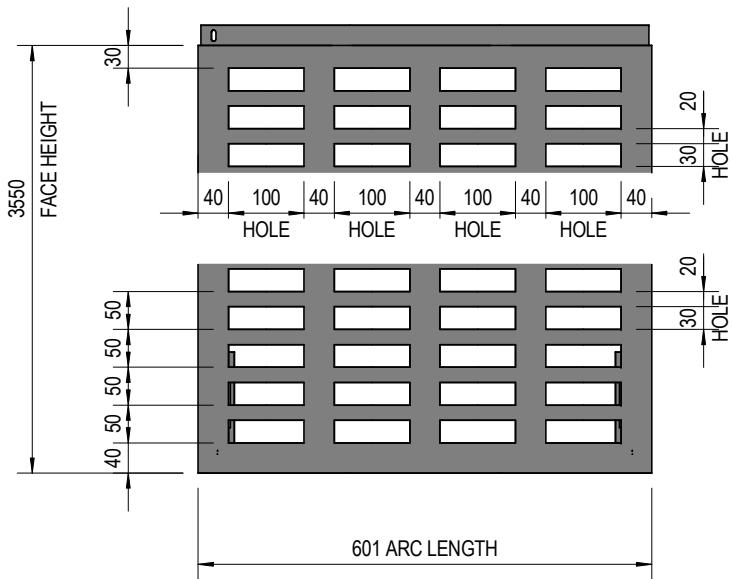
1 CURVED CORNER PANEL HOLE PATTERN  
SCALE 1 : 10

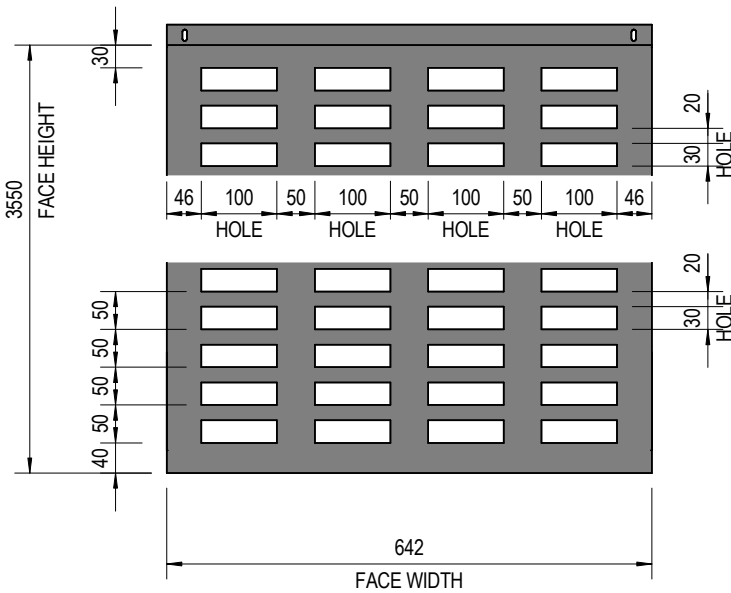
2 662 MODULE PANEL HOLE PATTERN  
SCALE 1 : 10

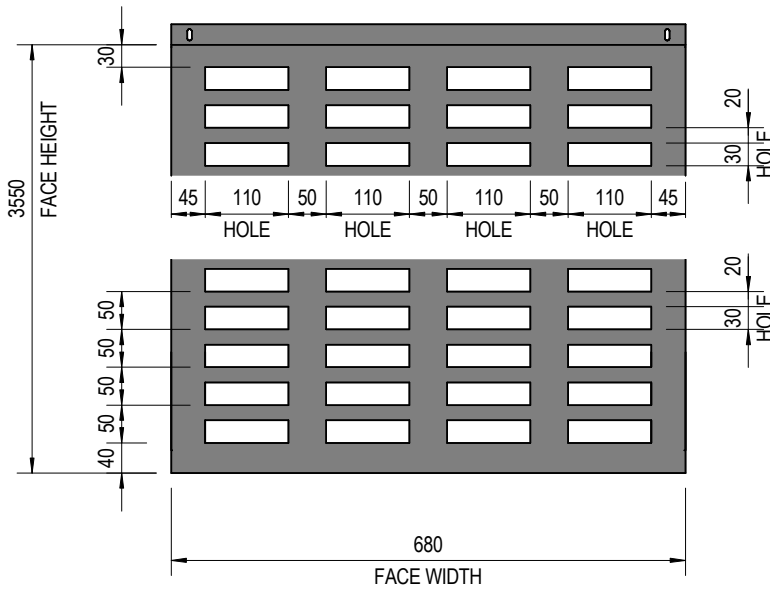
3 700 MODULE PANEL HOLE PATTERN  
SCALE 1 : 10

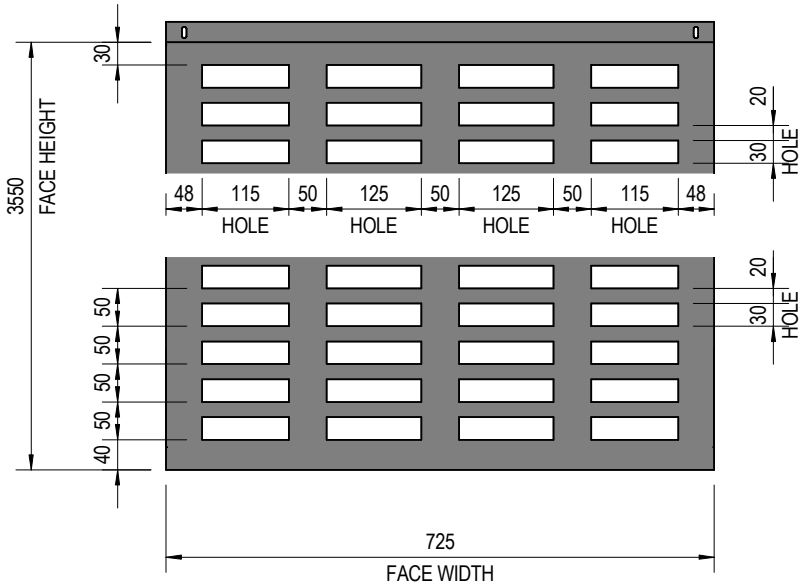
4 745 MODULE PANEL HOLE PATTERN  
SCALE 1 : 10

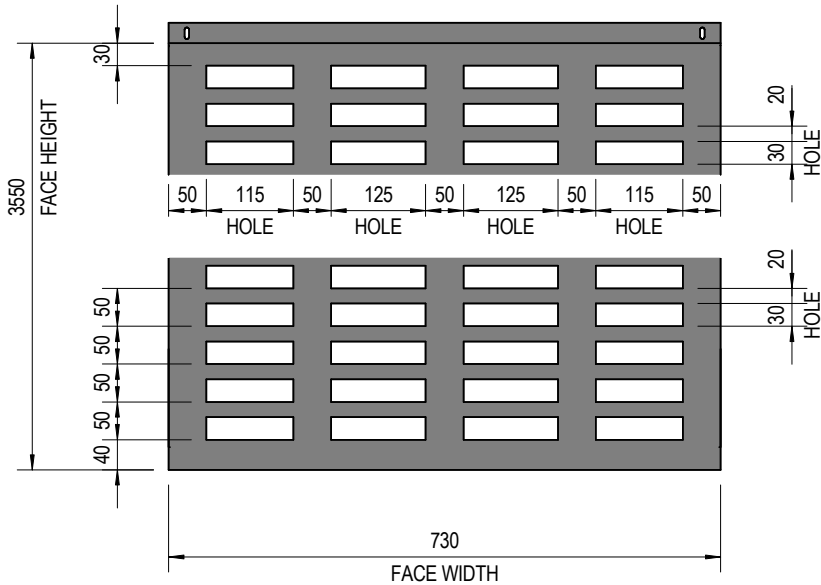
5 750 MODULE PANEL HOLE PATTERN  
SCALE 1 : 10
