# ARBORICULTURAL IMPACT ASSESSMENT

Didsbury High School  
Manchester  
M20 2ET

The development of a new extension

Andrew McLoughlin  
Treestyle Consultancy Ltd  
[info@treestyleconsultancy.co.uk](mailto:info@treestyleconsultancy.co.uk)

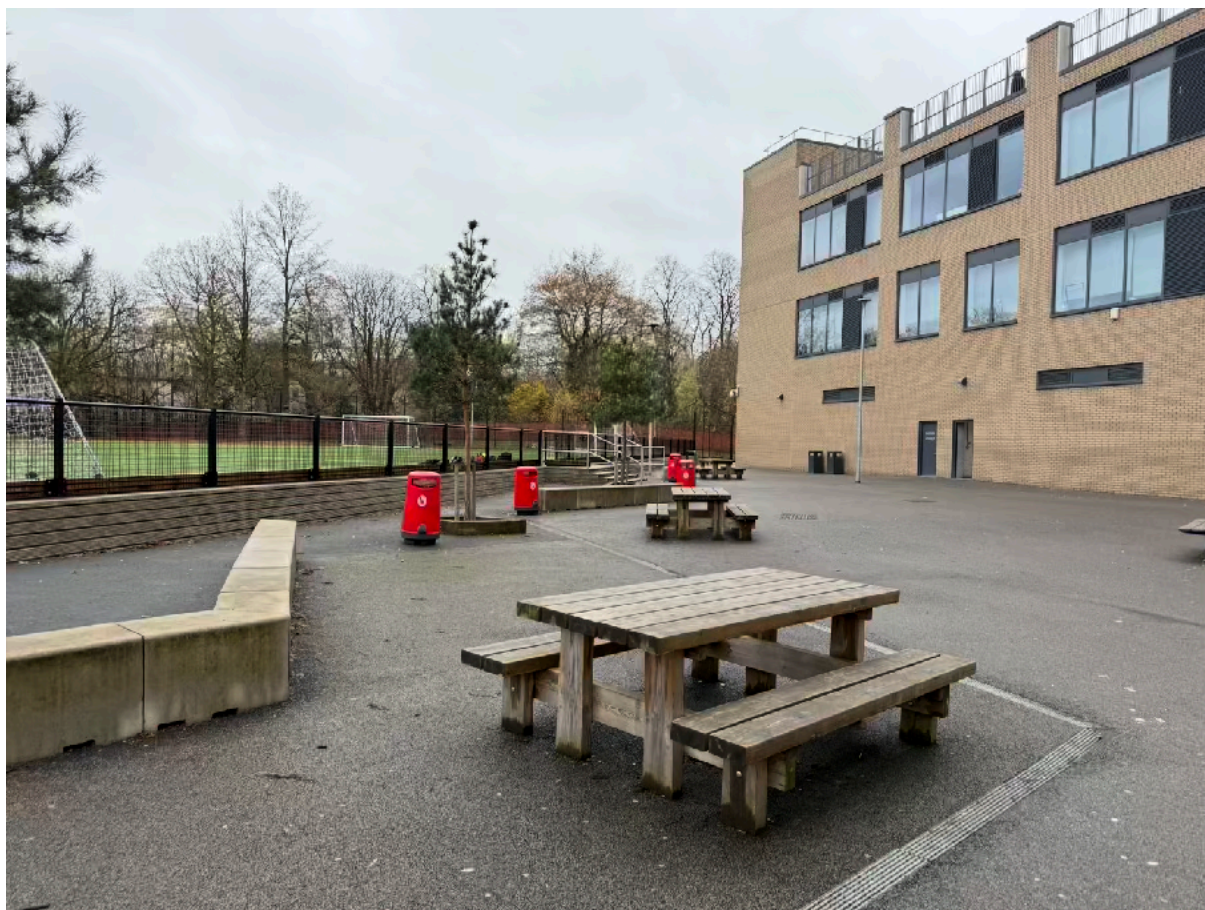
View of the trees looking towards where the proposed development is to be located

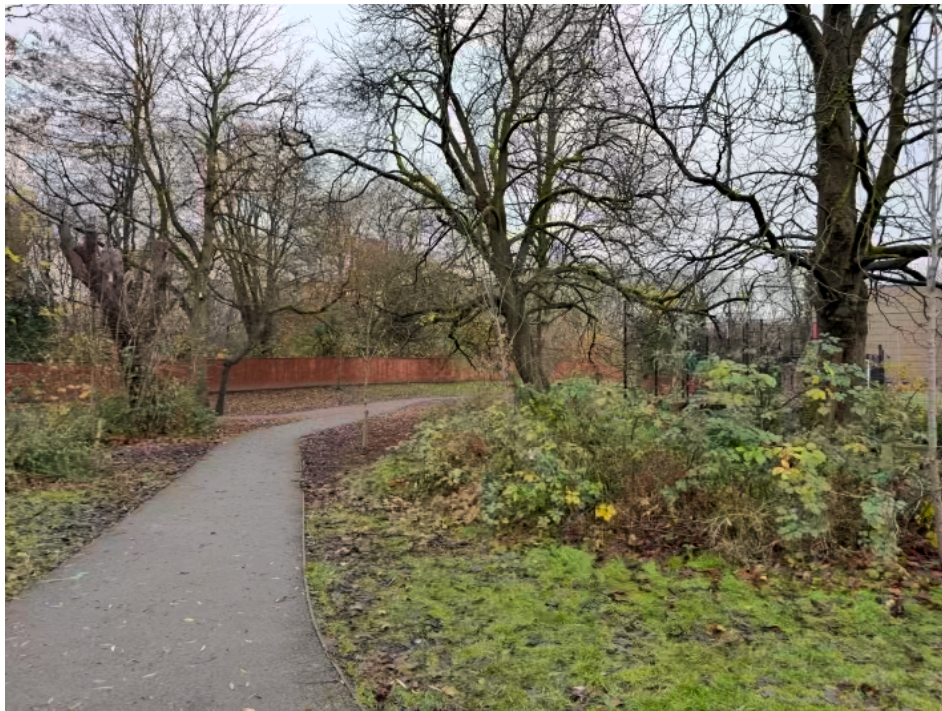
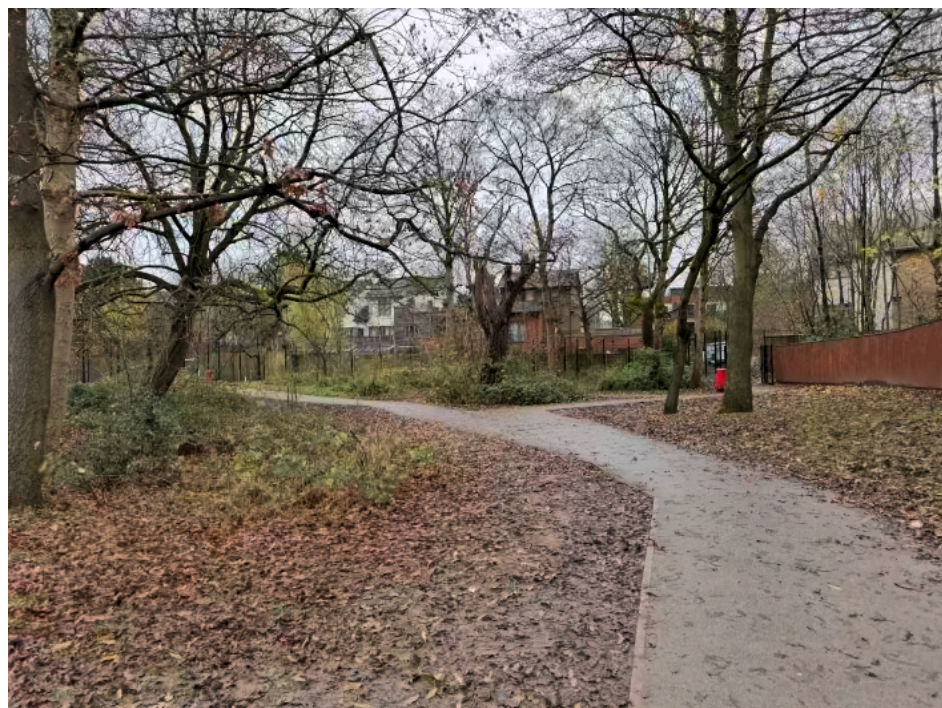
- 5.6.1 The impact of trees on the redevelopment and vice versa in allowing for future growth have all been considered. Tree size, future growth, light/shading, leaf and fruit nuisance etc have the potential to be an issue. This applies to all trees where there is potential for indirect impact on by the proposed demolition and development.
- 5.6.2 T2 horse chestnut (*Aesculus hippocastanum*) located next to a narrow footpath leading to the proposal has above and below ground constraints. The below ground constraints consist of a permeable RPA and the above ground constraints are with its low canopy.

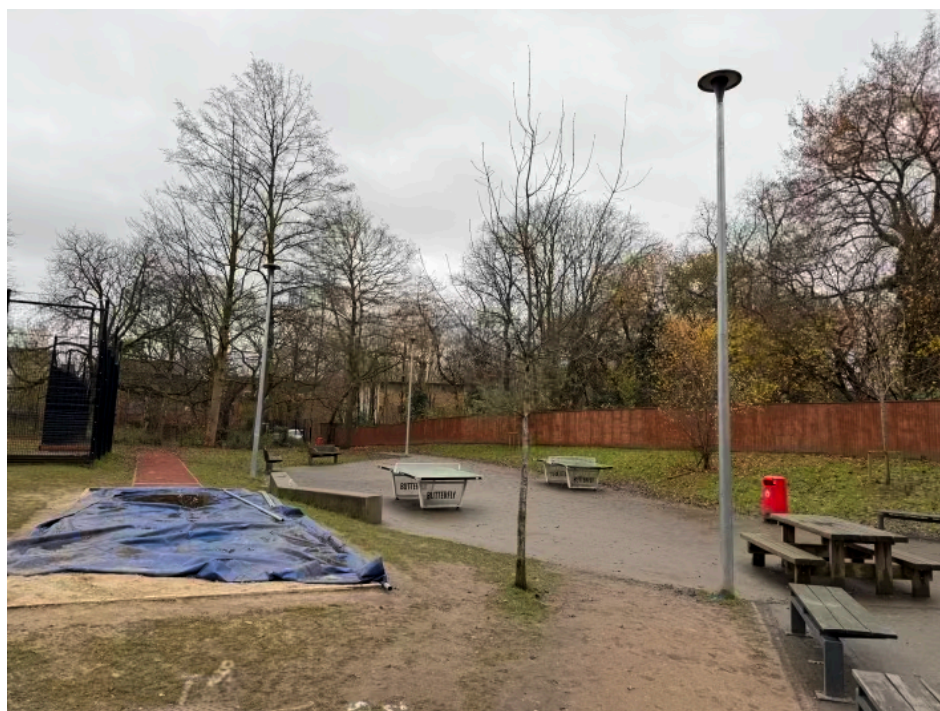
- 5.6.3 G9 surround the proposal where they are mostly on the far embankment, however, one tree, being on a lower profile has the greatest impact with the proposal.

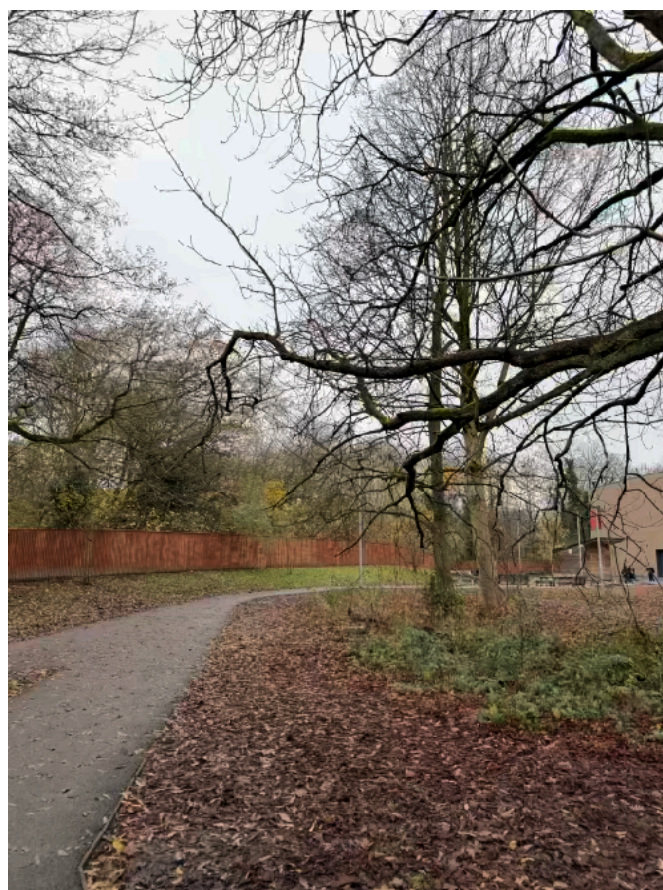
- 5.6.4 Trees lining the footpath have above and below ground constraints with the egress and access of materials onto site.

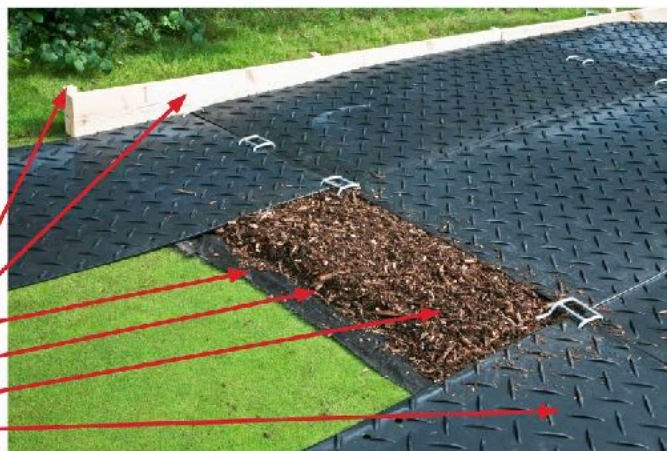
**GroundGuards** trackway mat systems are frequently used on construction sites to protect the ground from erosion and damage by construction vehicles. Where a temporary roadway must pass near to trees, the following extra precautions must be taken in order to provide cushioning for the ground under the tree canopy:

1. Edge rails of 200 x 50mm sawn timber should be installed where the trackway will pass under the tree canopy. These should be staked on either side of the trackway using 50 x 50 x 500mm timber stakes at 1.5m spacings.
2. A layer of geotextile membrane should be laid to cover at least the area under the tree canopy and preferably under the whole of the trackway.
3. A pad of trackway mats should be laid on top of the geotextile membrane, between the timber rails.
4. A 150mm deep layer of wood chipping should be laid over the mats
5. The trackway can then be laid so that it rises over the wood chippings as it passes under the tree canopy.

*50x50x500 timber stakes*  
*200x50 timber rails*  
*Geotextile Membrane*  
*Base layer of trackway mats*  
*Wood chippings*  
*Upper layer of trackway mats*

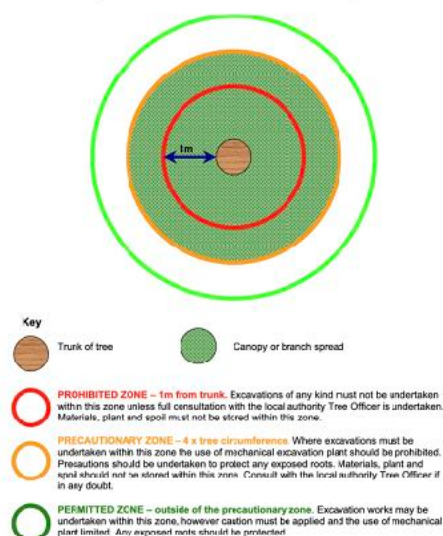
FIGURE 1 – Tree Protection Zone

NJUG Guidelines for the Planning, Installation and Maintenance of Utility Apparatus in Proximity to Trees

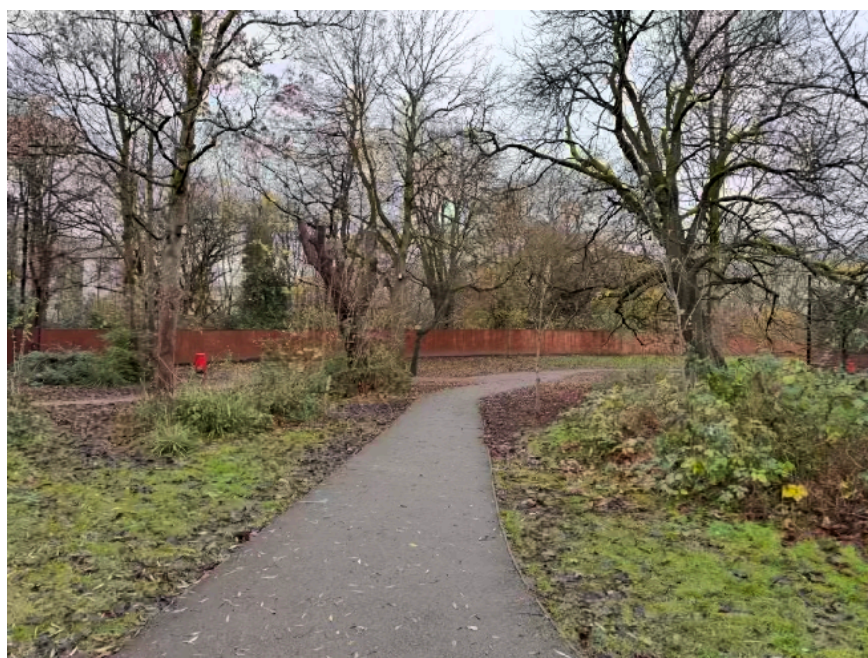
Left is the access where T5 oak can be seen heavily suppressed in the centre background.

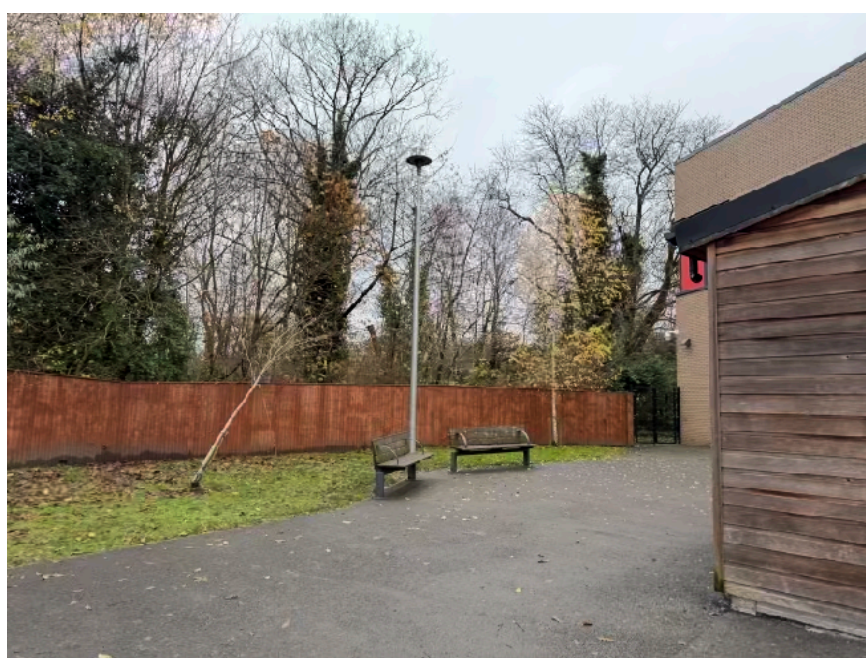
Below is one of the failed trees within G9.
