OUR TOWN HALL PROJECT

| DRAWING TITLE | Chimney Number CS06<br>Proposed repairs |
| DRAWING NO. | OTH-PUR-TH-RF-DWG-A-4166 02 |

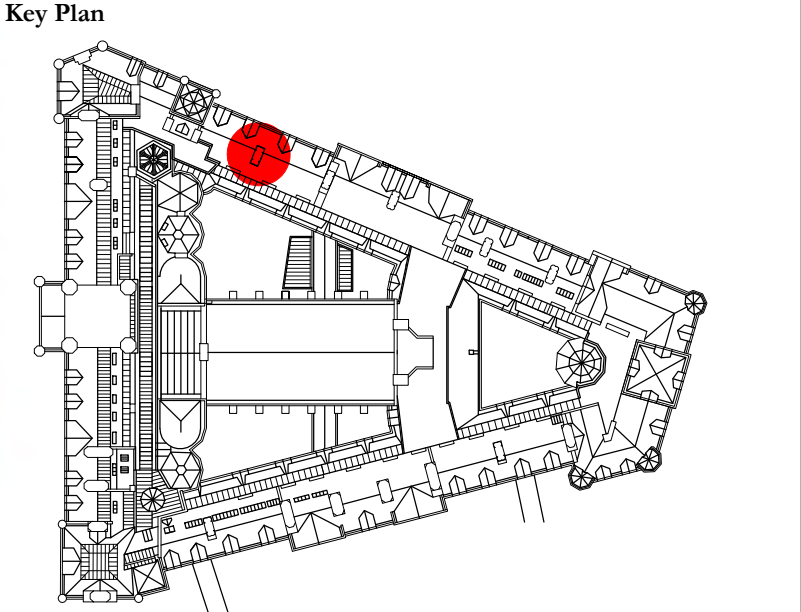
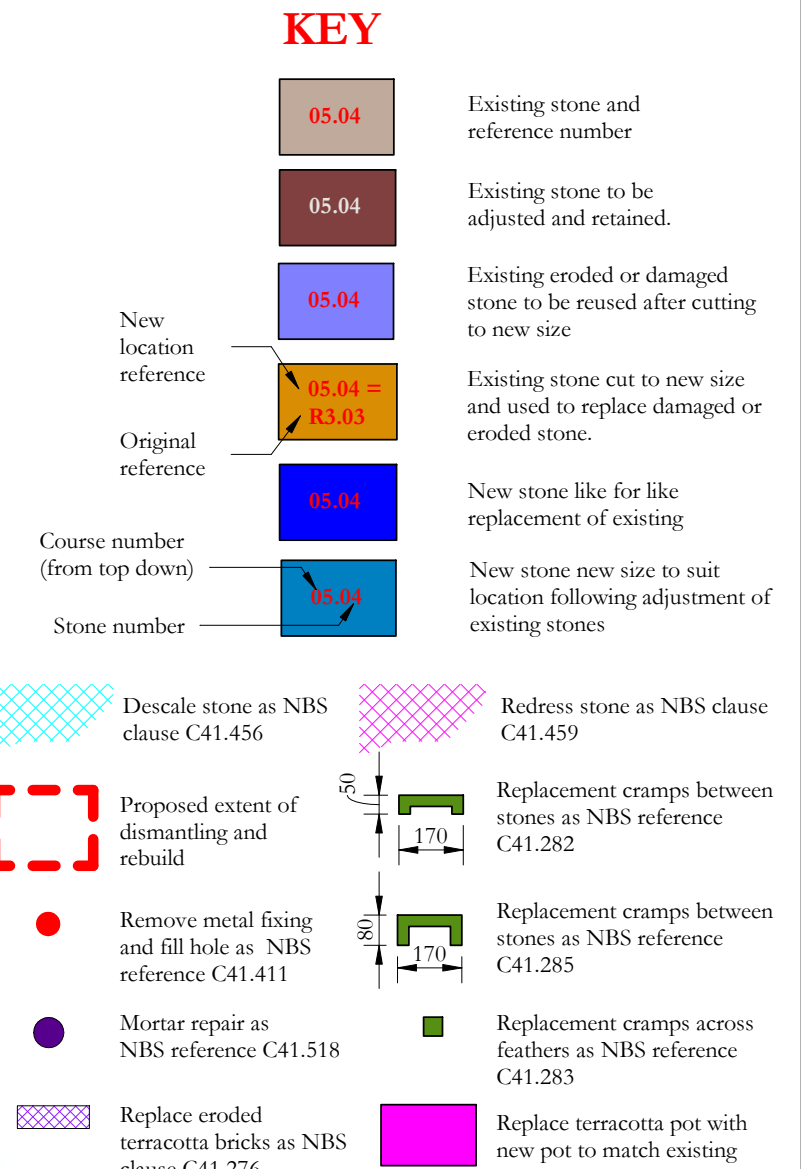
Revision 02: Circular flue component 07.N to be replaced and combined with 07.01 and 07.10 to form tie to main body of chimney. Components 03.N, 03.01 and 03.09 combined into one component to tie flue to main body of chimney. Bronze cramps added across feathers to section of chimney to be rebuilt. Lightning protection added.

**NOTES**  
Refer to NBS reference C41.321 for rebuilding chimneys.  
Sections of chimney that are not rebuilt are to be reported as NBS reference C41.821 with brick sections reported as reference C41.822  
The whole chimney is to be reported as NBS reference C41.805
