**Chimney CS02  
repairs at bottom**

**OTH-PUR-TH-RF-SKE-A-3709**

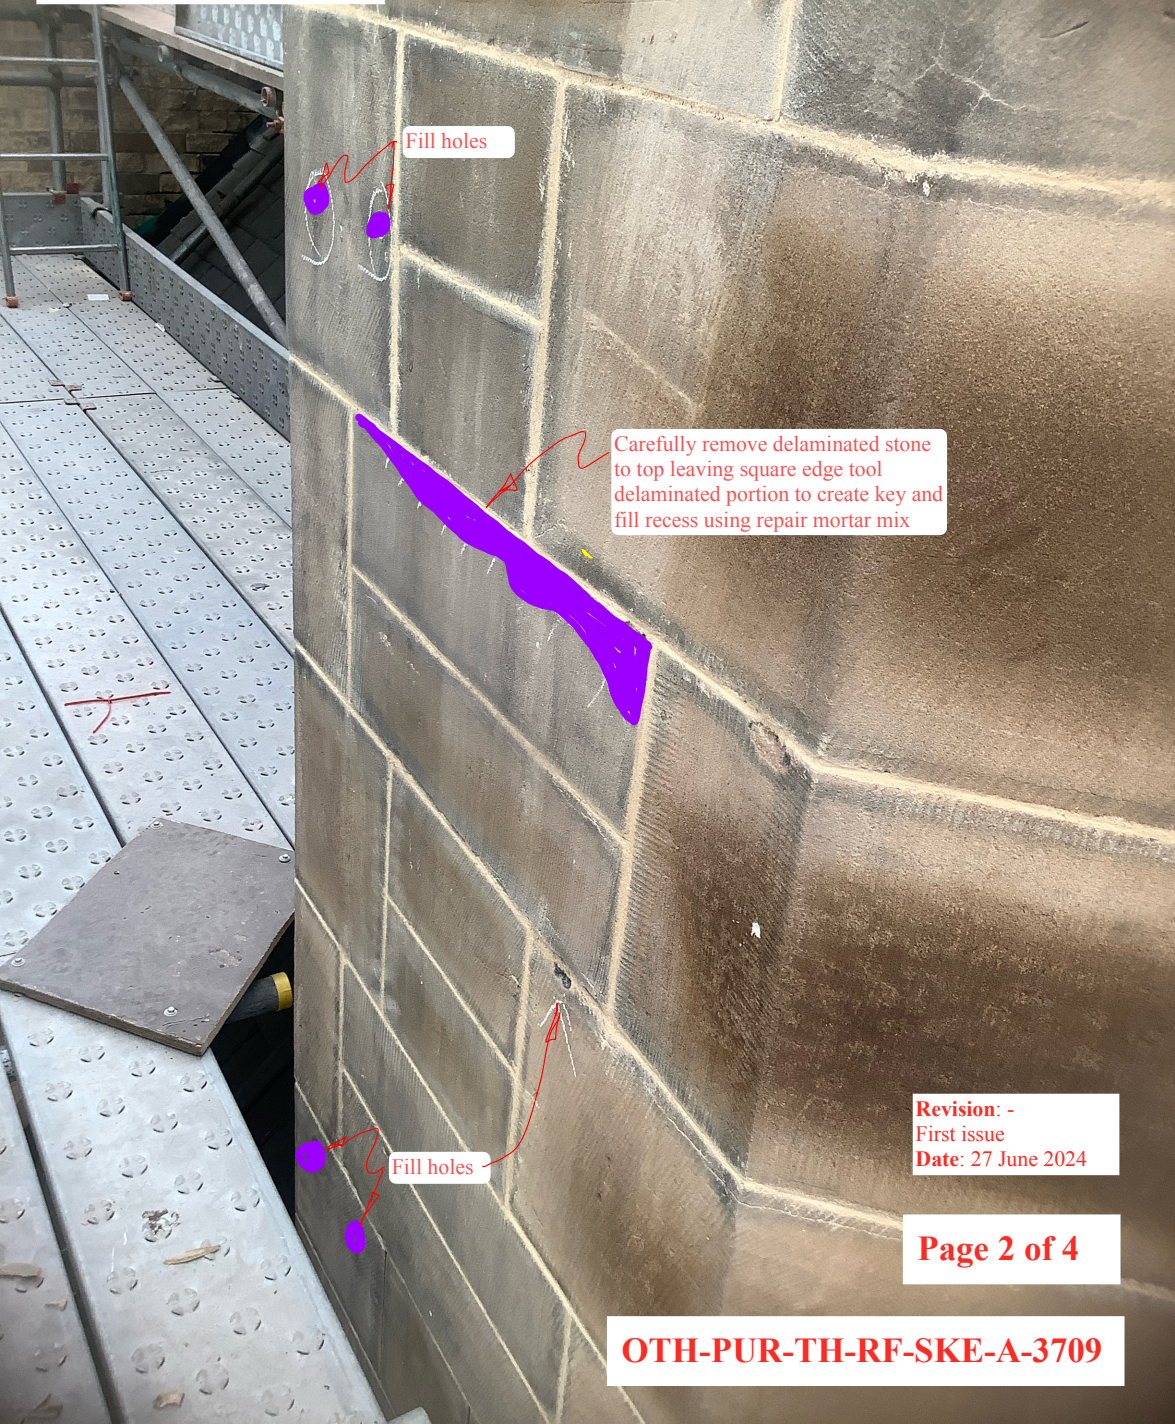
Page 2 of 4

Fill holes

Carefully remove delaminated stone to top leaving square edge tool delaminated portion to create key and fill recess using repair mortar mix

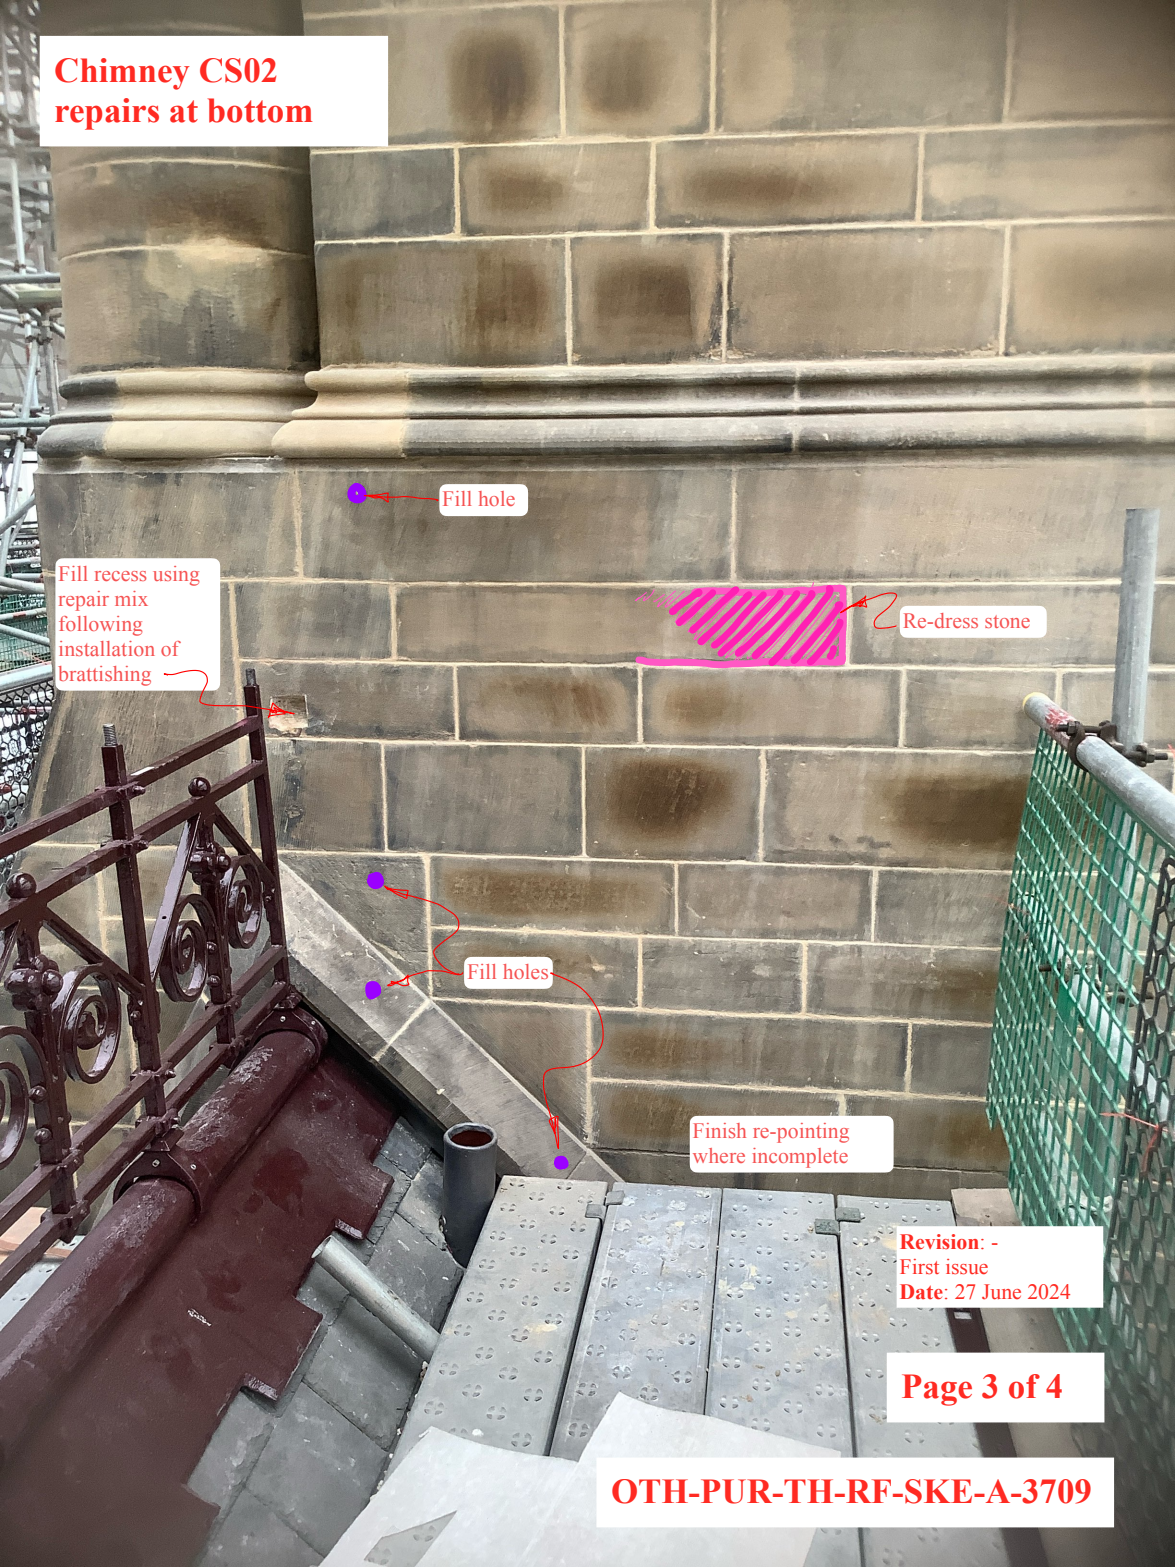
Page 3 of 4

Fill hole

Fill recess using  
repair mix  
following  
installation of  
brattishing

Re-dress stone

Fill holes

Finish re-pointing  
where incomplete

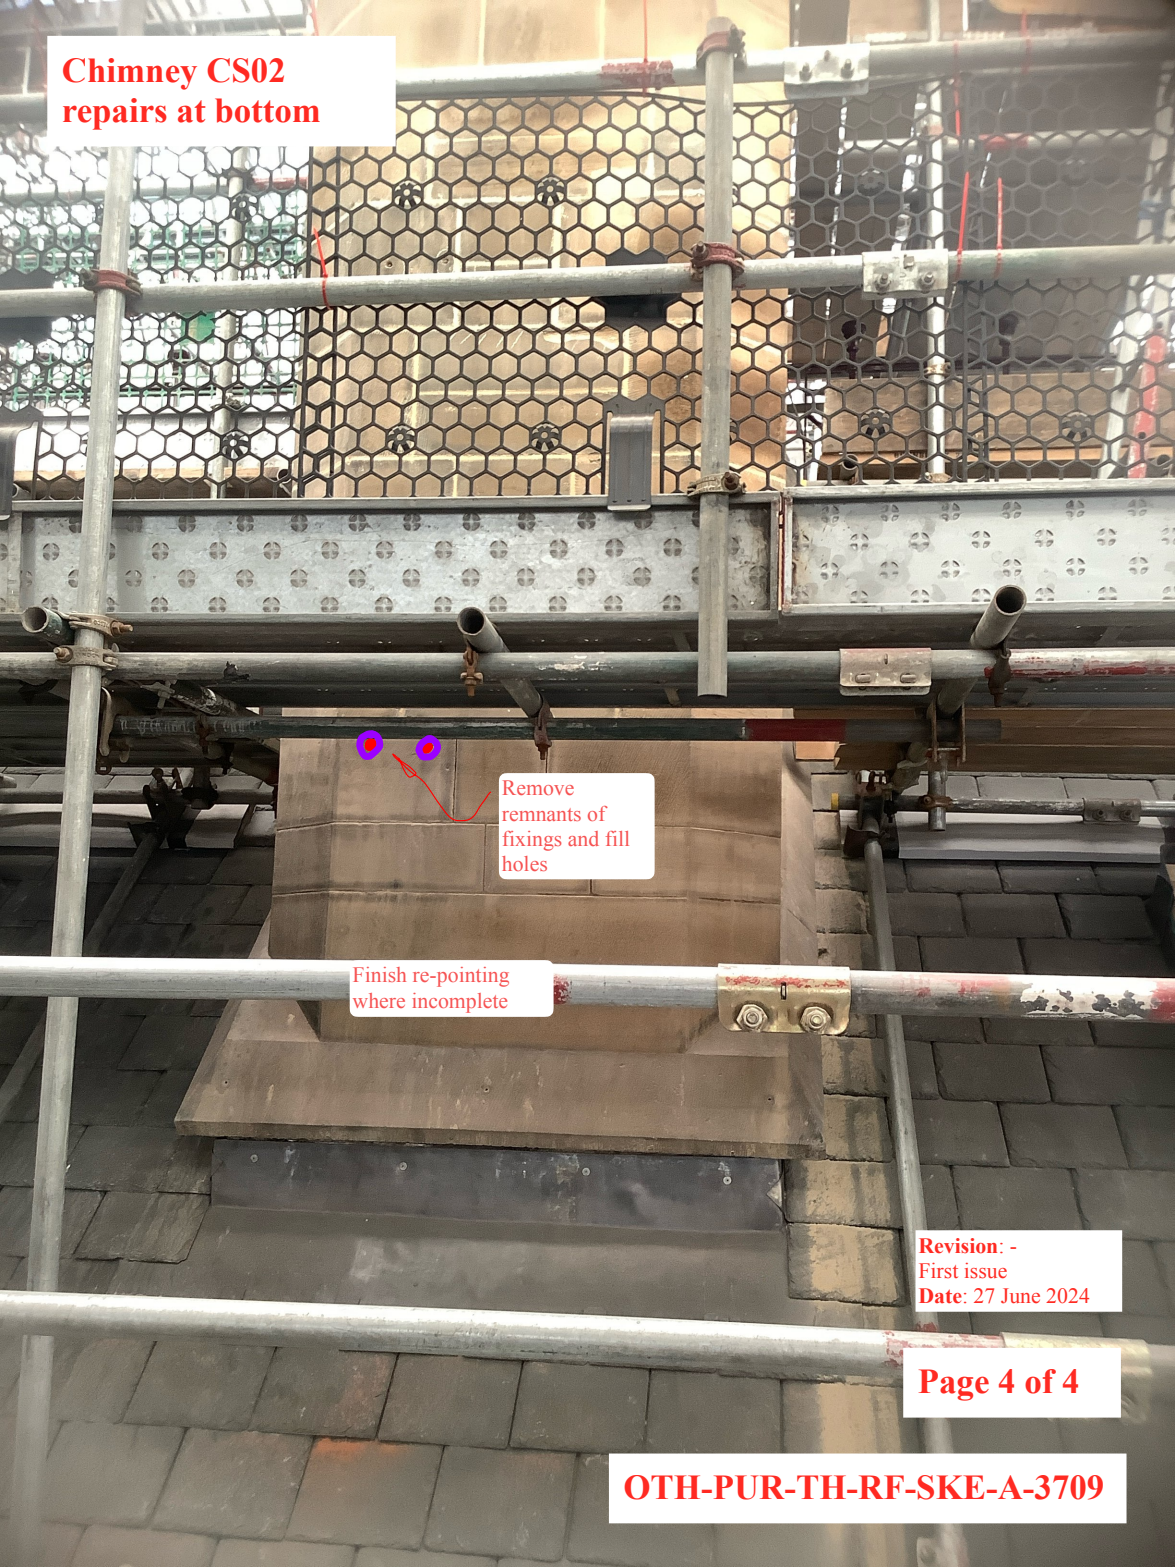
Page 4 of 4

A photograph of a chimney repair site. The chimney is a large, rectangular concrete structure. It is surrounded by scaffolding made of metal poles and cross-braces. A safety net with a hexagonal pattern is visible in the background. Two red circles with blue centers are marked on the chimney's surface, with a red arrow pointing from the text 'Remove remnants of fixings and fill holes' to them. A white box with the text 'Finish re-pointing where incomplete' is positioned below the chimney. The ground is covered with grey paving stones.

Remove  
remnants of  
fixings and fill  
holes

Finish re-pointing  
where incomplete
