| PROJECT | Our Town Hall | | |
| DRAWING TITLE | Repairs to balcony railing. Cooper St courtyard. Level 2 south-west corner | | |
| DRAWING NO. | OTH-PUR-EX-ZZ-DWG-A-7167 | | REV 01 |

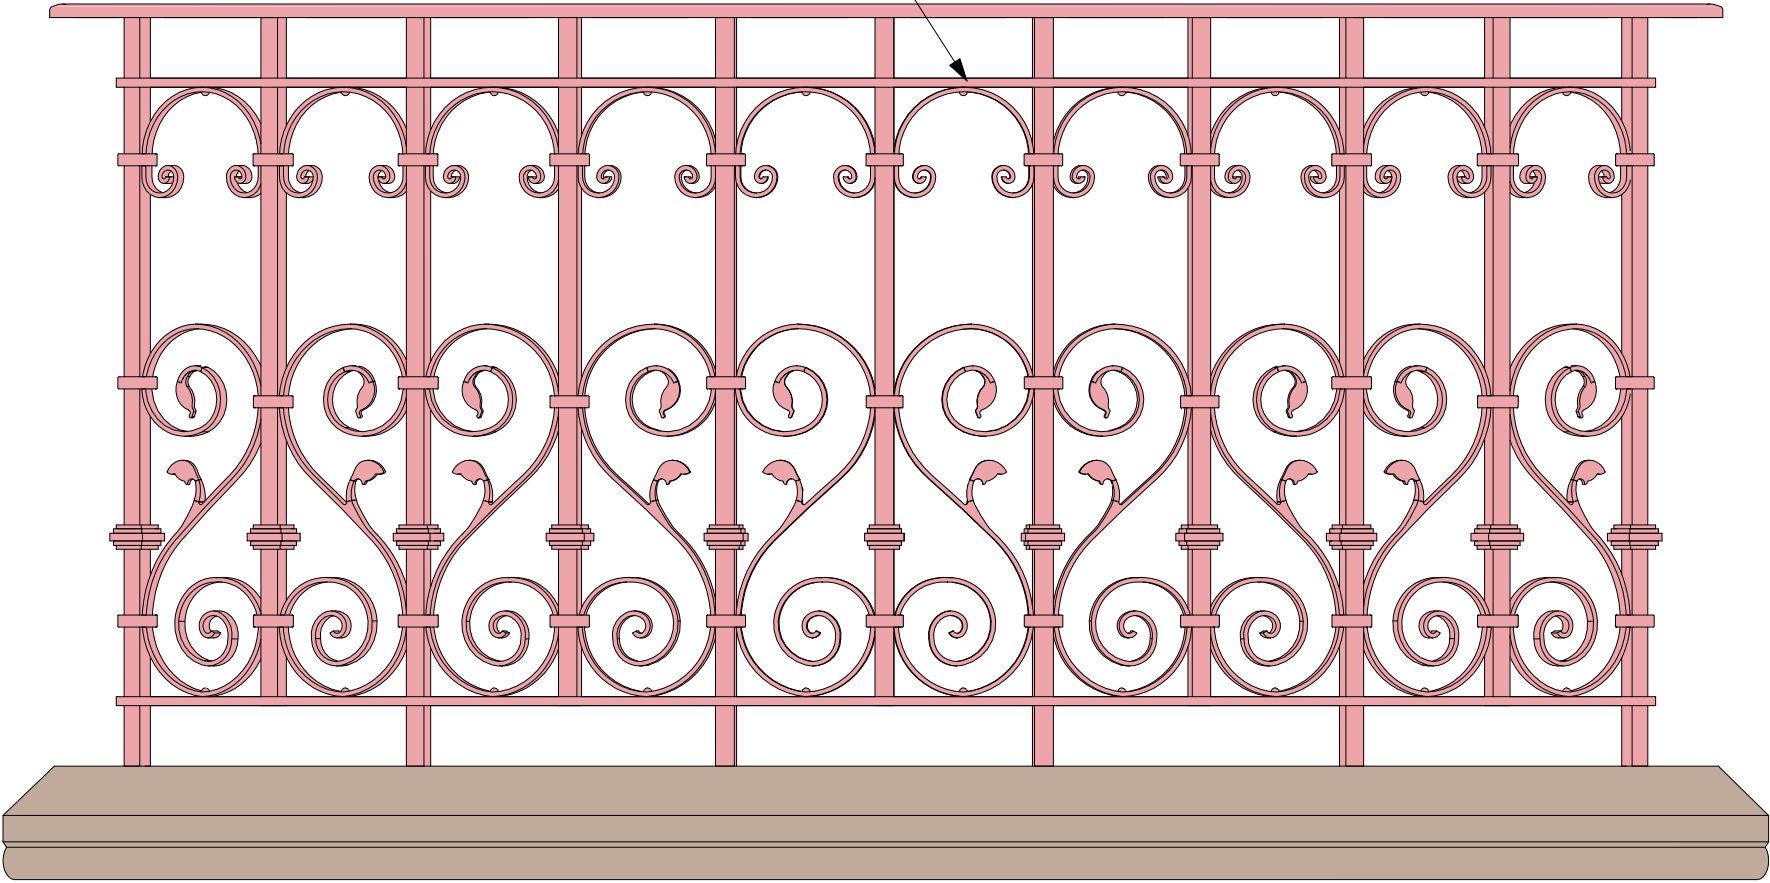
- Remove existing paint as NBS reference M60.539 and repaint as reference M60.135
- Fit new component fabricated from reclaimed wrought iron and paint as NBS reference M60.135
- Remove existing wrought iron component carry out repairs, re-fit in original location and paint as NBS reference M60.135

Preparation and painting to be carried out with railings retained in-situ

**Revision 01:** Drawing re-issued for construction. Details corrected to show every other upright embedded into stone balcony
