## Stone indent repair to Great Hall south-west cornice

OTH-PUR-EX-ZZ-SKE-A-3670

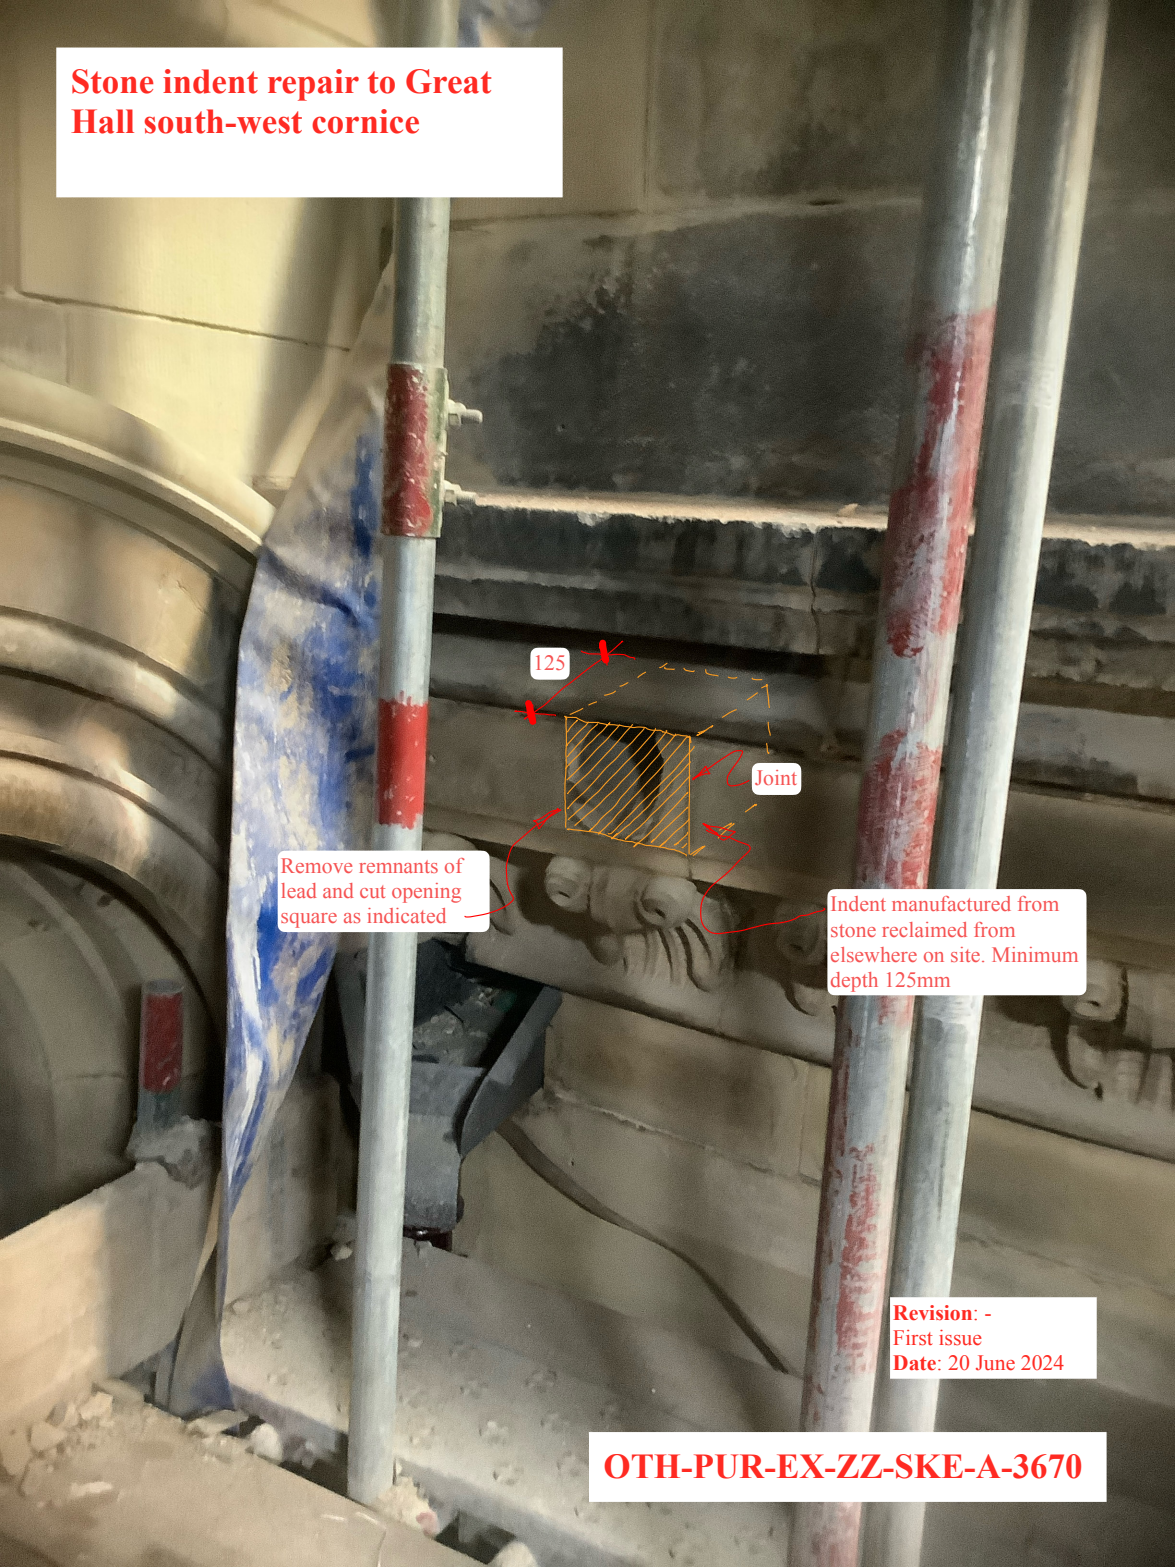
Remove remnants of lead and cut opening square as indicated

Indent manufactured from stone reclaimed from elsewhere on site. Minimum depth 125mm
