OUR  
TOWN  
HALL  
PROJECT

DRAWING TITLE Chimney Number CS33  
proposed brick repair

DRAWING NO. OTH-PUR-EX-RF-DWG-A-4213  
REV -

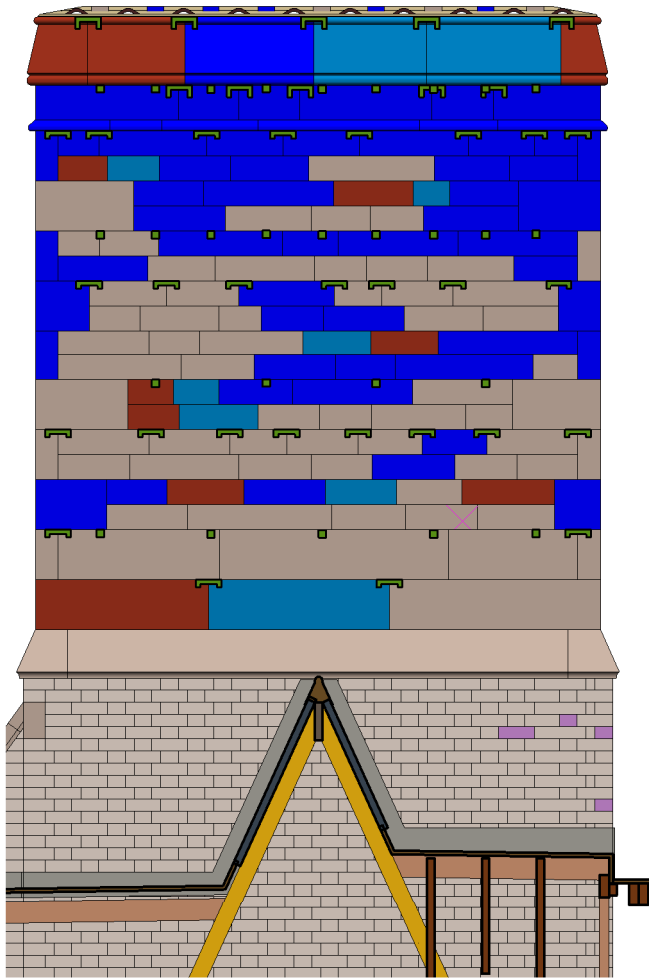
CS33 North Brick Repair  
1 : 50

Replace eroded terracotta bricks with reclaimed brick for gable repairs and new matching bricks as NBS clause C41.276 to wall extensions for plant deck
