PROJECT **Our Town Hall**

DRAWING TITLE **Repairs to balcony railing.  
Cooper St courtyard. Level 1  
south-west corner**

DRAWING NO. **OTH-PUR-EX-ZZ-DWG-A-7168** REV **01**

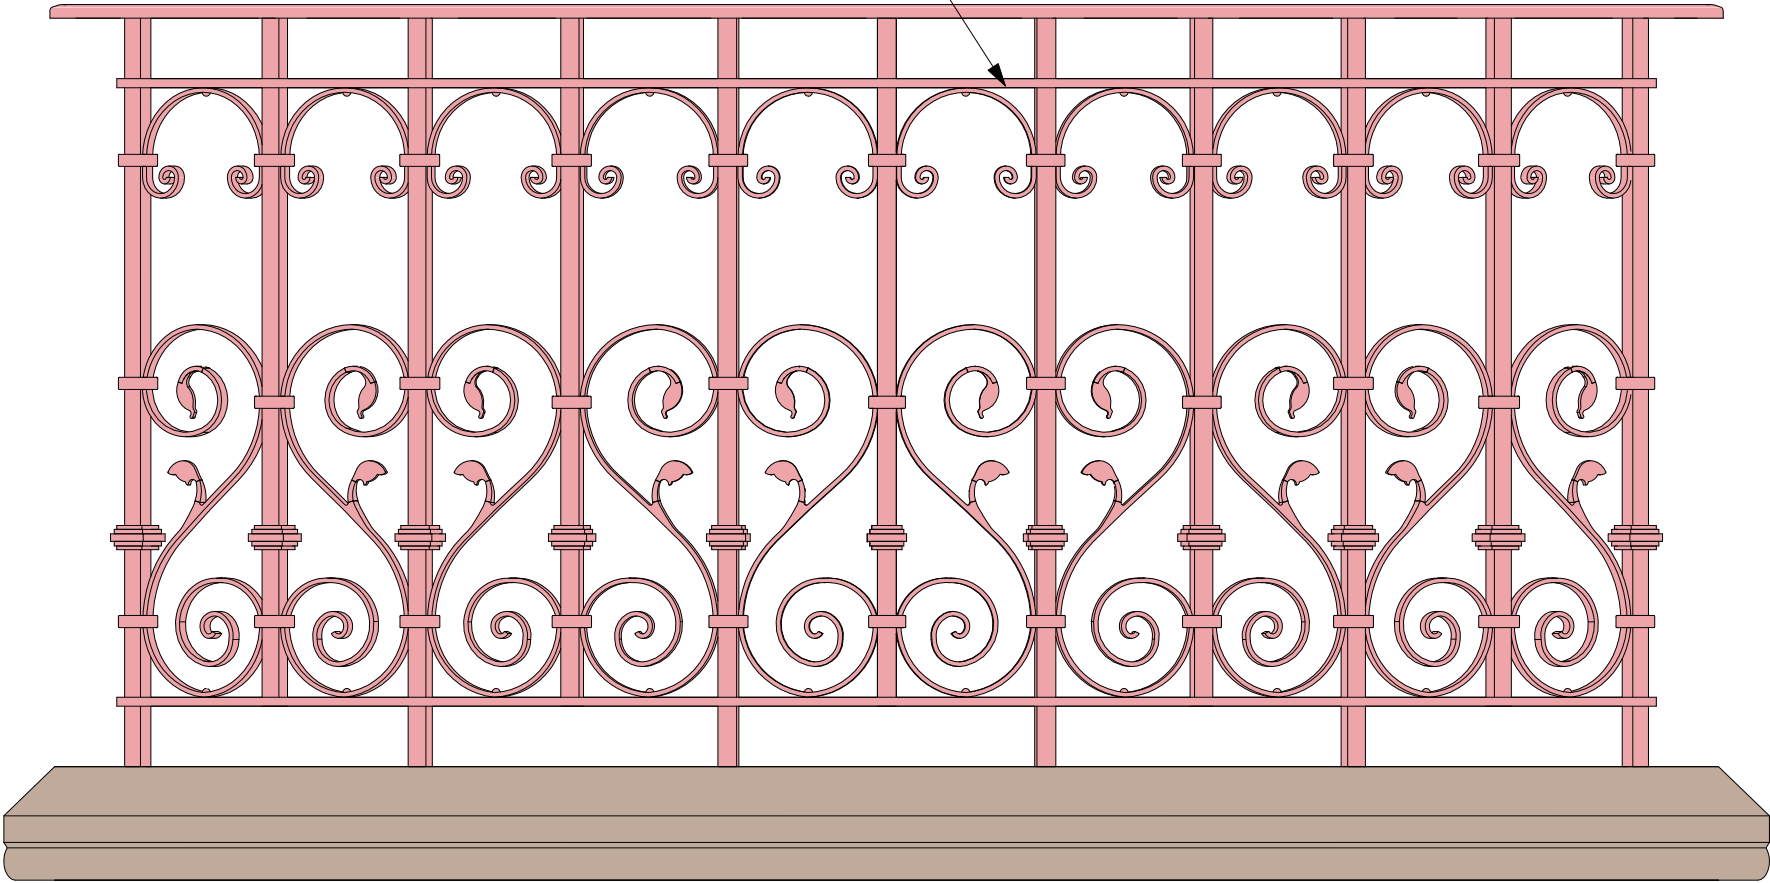
- Remove existing paint as NBS reference M60.539 and repaint as reference M60.135
- Fit new component fabricated from reclaimed wrought iron and paint as NBS reference M60.135
- Remove existing wrought iron component carry out repairs, re-fit in original location and paint as NBS reference M60.135

Preparation and painting to be carried out with railings retained in-situ

**Revision 01:** Drawing re-issued for construction. Details corrected to show every other upright embedded into stone balcony
